# Underwater Inspection of Bridge Substructures Using Imaging

# Underwater Inspection of Bridge Substructures Using Imaging Technology

June 14, 2018

**Sponsored by**  
Federal Highway Administration  
Office of Infrastructure  
FHWA-HIF-18-049

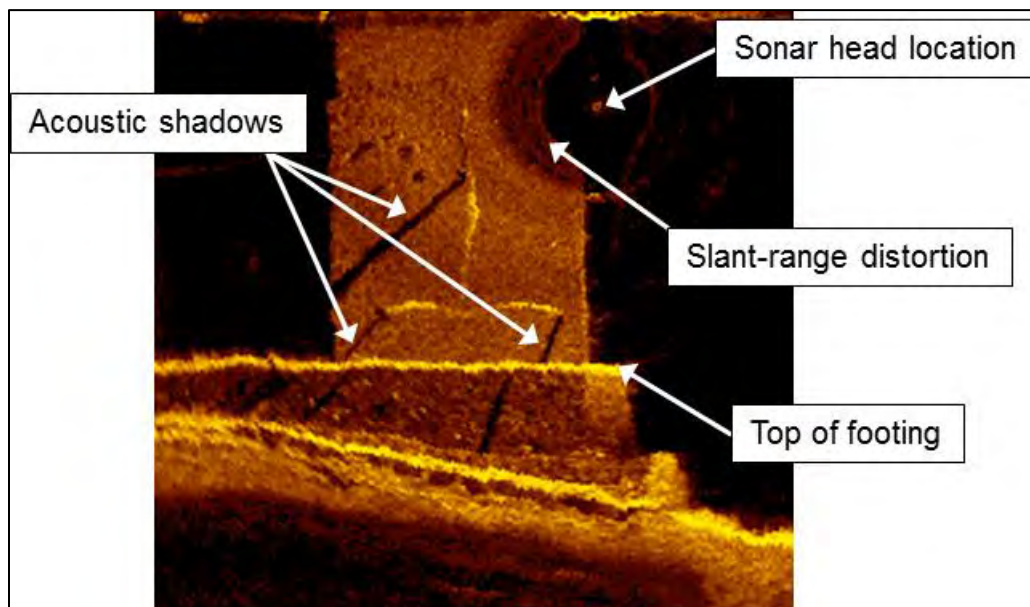
**Figure 18. Image. Sector-scanning sonar image with shadows on the face of a concrete pier.**

Shadows can easily be misinterpreted as defects in a bridge substructure. For example, an inverted T-shape is apparent on the face of the concrete pier in figure 18. An inspector unfamiliar with sonar may misinterpret this image as concrete deterioration or cracking. However, as shown in the bridge plans for this location in figure 19, the shape is actually a steel frame designed to mount a fixed scour monitoring device to the pier. The acoustic shadow connects to the target that formed it at the location where the steel frame is connected to the pier face.

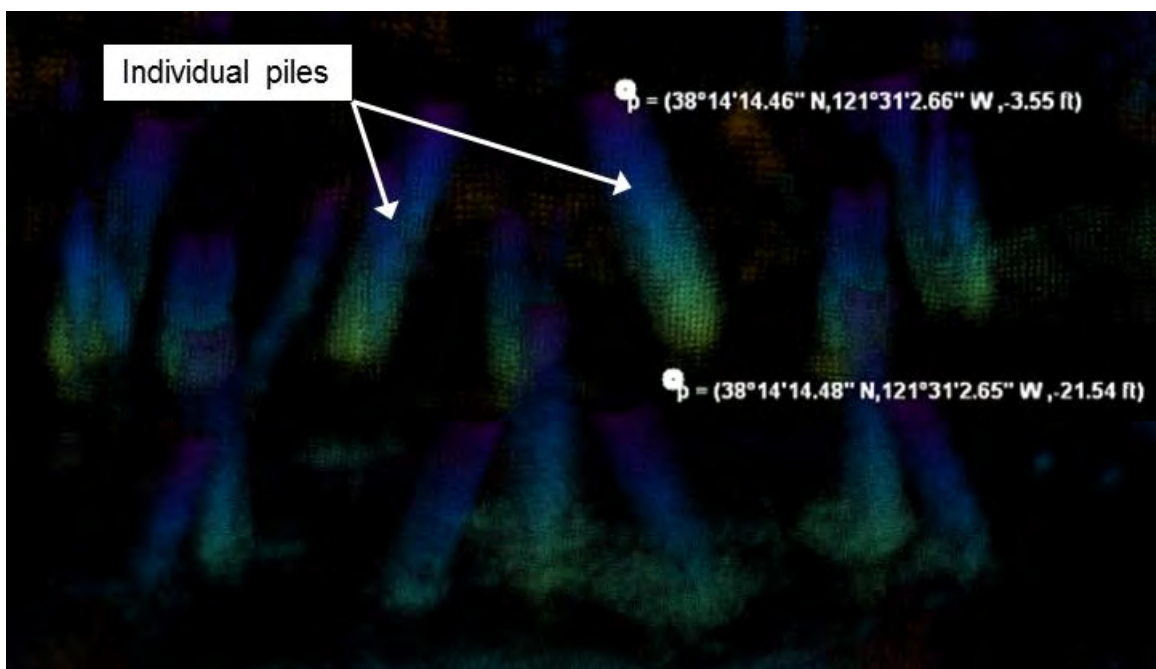
Figure 28. Image. Coordinates from which length of a pile is estimated (Georgiana Slough).

Figure 28 displays a close-up of several piles. With the x,y,z capability, it is possible to estimate feature dimensions such as object length.

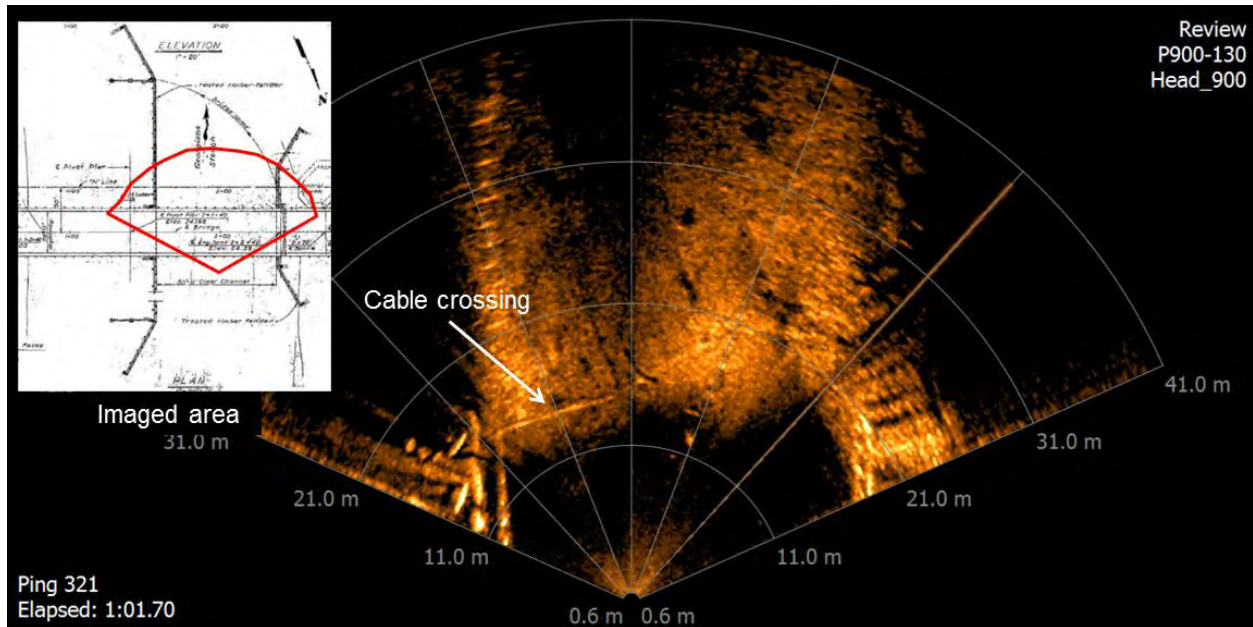
**Figure 29. Image. 2D image from a single ping at Georgiana Slough (plan view).**

Inspection team B employed two sonar technologies for the inspection of the Georgiana Slough Bridge. Figure 29 shows an example image from a 2D multibeam sonar along with the inset providing the location of the image at the site. The image resulted from a single ping and was captured from boat-mounted equipment. The piles on either side of the channel are evident as is a cable crossing the channel.

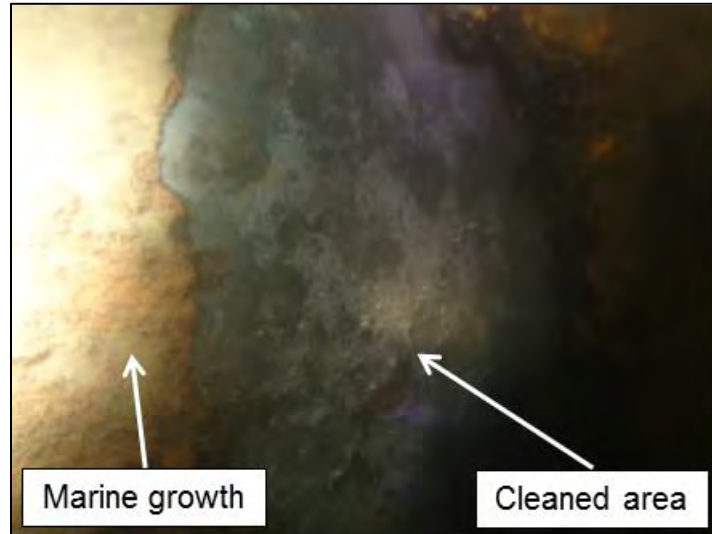
**Figure 36. Photo. Steel pile showing marine growth and a level II cleaned area.**

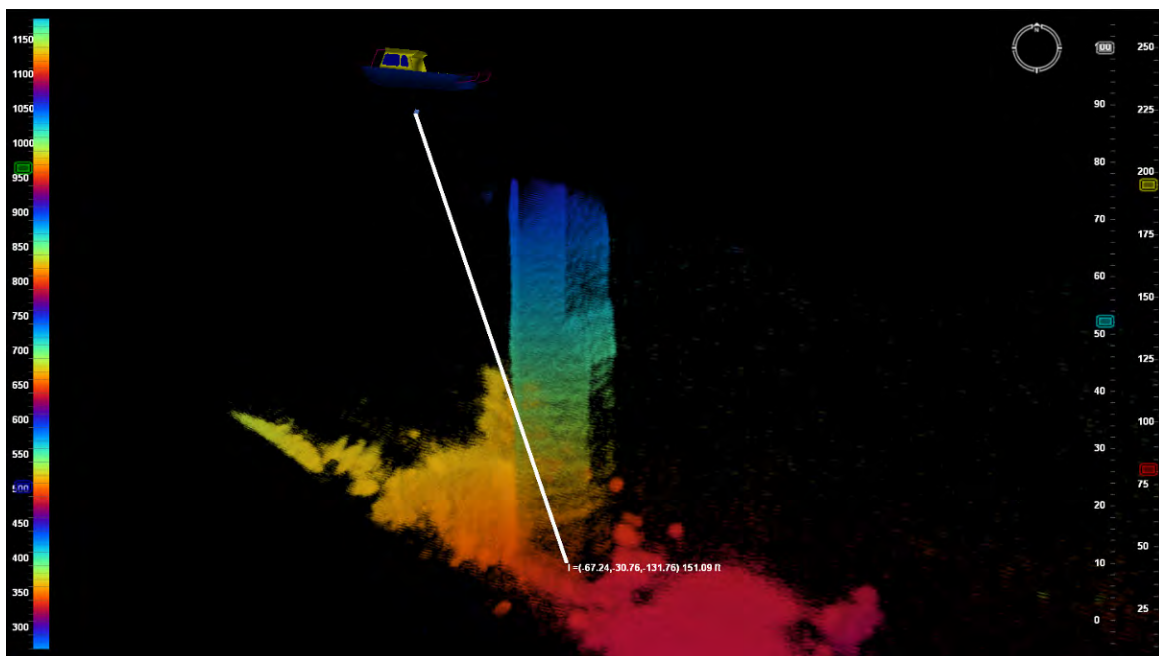
Figure 40. Image. Bent 4 with boat location showing sonar range.

Figure 40 shows the image of bent 4 captured by the sonar. A symbol representing the data collection boat is also shown to illustrate the range required of the sonar at this site. Figure 41 is a data mosaic showing bents 4 and 5 as viewed from the west side of the bridge. The annotations on the figure demonstrate how structure dimensions can be obtained from the image. Close analysis of the images may reveal reportable observations. For example, a closer view of the base of bent 4 shown in figure 42 provides an indication of scour at the base of the bent.

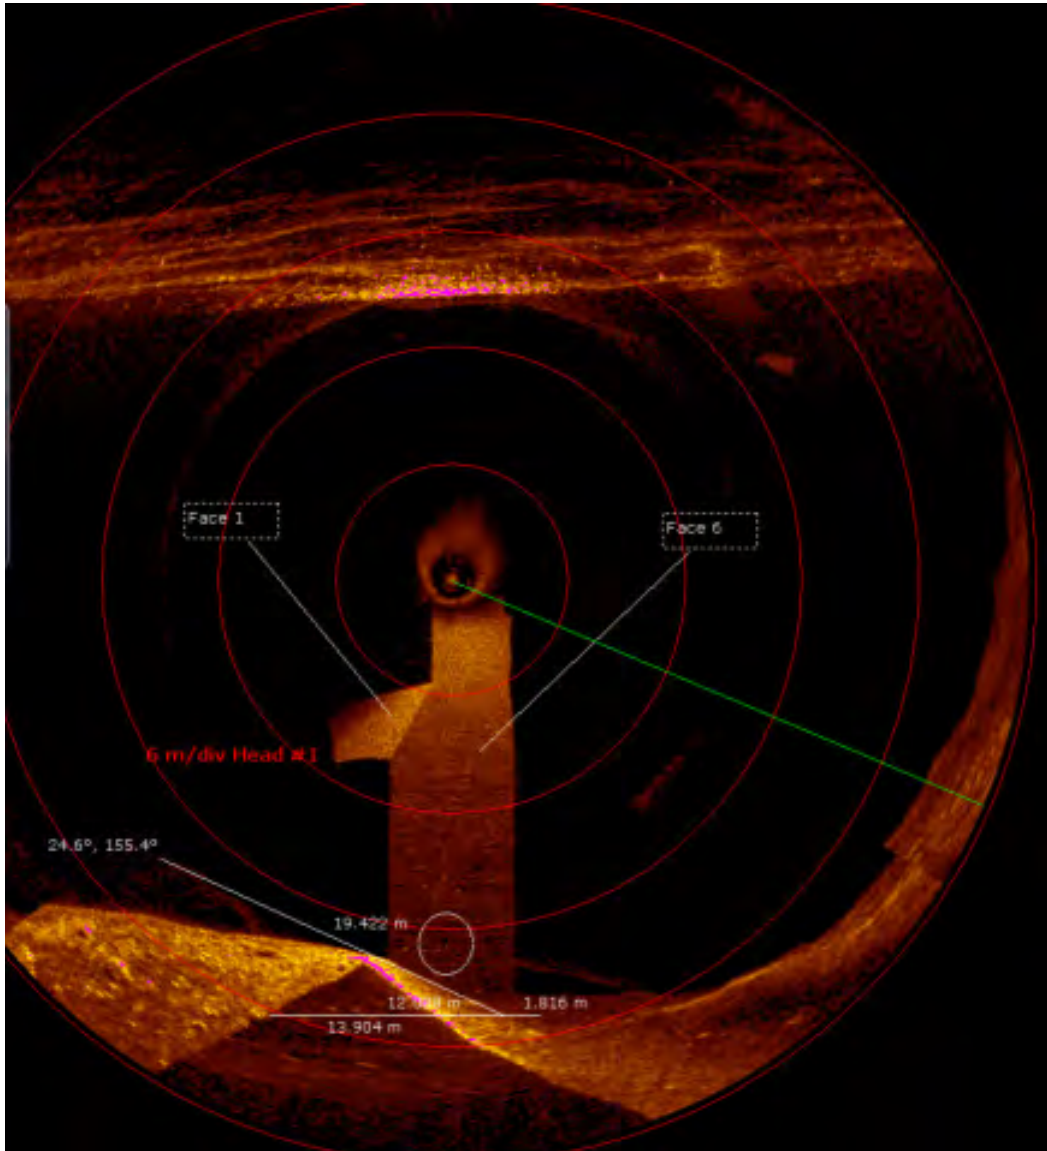
**Figure 47. Image. Face 6 of the James E. Roberts Bridge.**

After completing the bottom scans the head was fitted into a drop frame and lowered along each face of the pier. As an example, figure 47 displays the image for face 6. It appears in good condition with the lakebed slope at the mud line at 24.6 degrees. The circled 'target' is 7.2 ft (2.2 m) above the mud line and may be a small void in the concrete face. Various anomalies were reported on other faces.

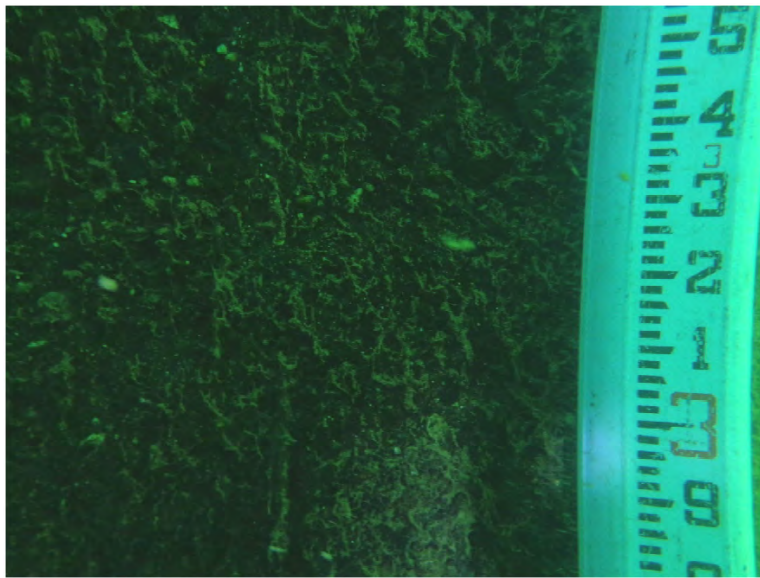
**Figure 48. Photo. Marine growth on concrete 15 ft (4.6 m) below the waterline.**

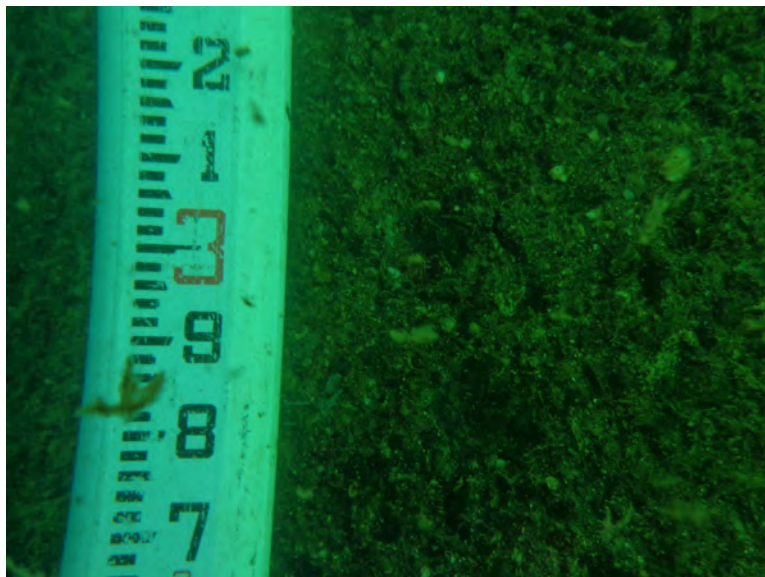
**Figure 49. Photo. Typical concrete condition with level II cleaning (15 ft (4.6 m) below the waterline).**

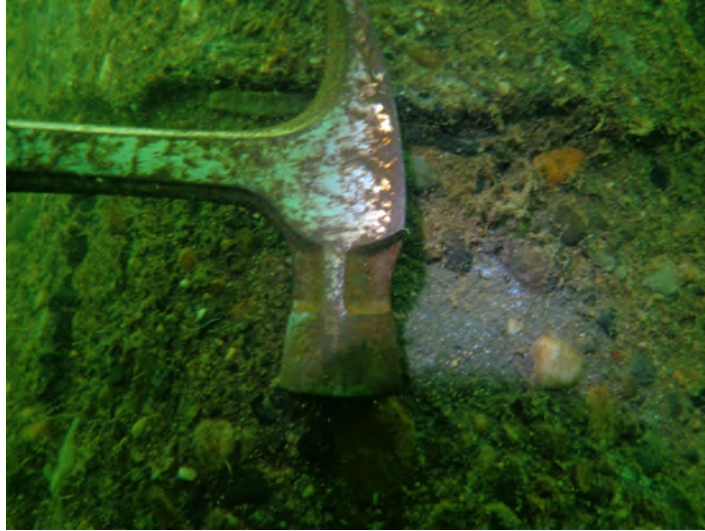
**Figure 50. Photo. Typical cold joint after cleaning.**
