# **OSHA Fatal Facts: *Fatalities Caused by Improper Work Practices***

Course No: C04-026  
Credit: 4 PDH

Mark Rossow, PhD, PE, Retired

# **OSHA's Fatal Facts: Fatalities Caused by Improper Work Practices**

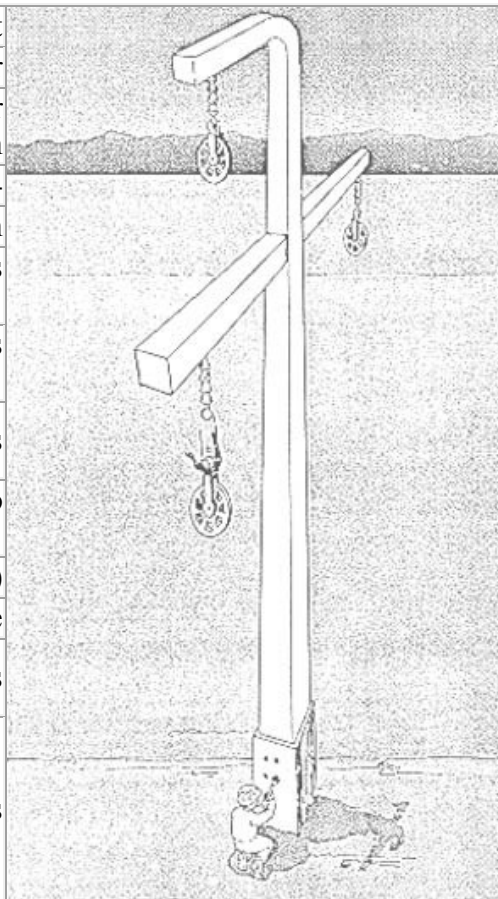
Ball and socket connectors are used to attach conductor stringing blocks to insulators on the arms of 90 foot metal towers of electrical transmission lines. Normally stainless steel cotter keys secure the ball and socket connector in place. In this case, however, black electrical tape was wrapped around the socket to keep the ball in place rather than a cotter key. The tape apparently stretched and the ball came loose, dropping the stringing block approximately 90 feet onto the head of an employee below, one of a four-man erection crew.

1. Rigging and equipment must be inspected regularly and maintained in safe operating condition as required by general provisions of OSHA's construction (29 CFR 1926.995).
2. Employees must be instructed to recognize and avoid unsafe conditions and be made aware of regulations which apply to the work and the work area to eliminate safety and health hazards as required in the safety training and education section of OSHA's construction safety standards (29 CFR 1926.21(b)(2)).

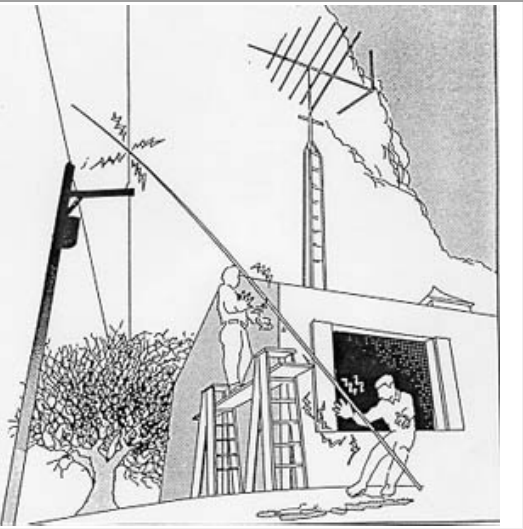
Two employees were installing aluminum siding on a farmhouse when it became necessary to remove a 36-foot high metal pole CB antenna. One employee stood on a metal pick board between two ladders and unfastened the antenna at the top of the house. The other employee, who was standing on the ground, took the antenna to lay it down in the yard. The antenna made electrical contact with a 7200-volt power transmission line 30 feet 10 inches from the house and 23 feet 9 inches above the ground. The employee handling the antenna received a fatal shock and the other employee a minor shock.

1. Note the presence of power lines and be extremely cautious when working near them. Train employees to recognize and avoid electrical hazards (29CFR 1926.21(b)(2)).
2. Do not permit employees to work near any part of an electrical power circuit which might be contacted in the course of the work. Guard all electrical power circuits against accidental contact by insulating the circuit or deenergizing it or by other effective means that would protect the employee (29CFR 1926.400(C)(1)).

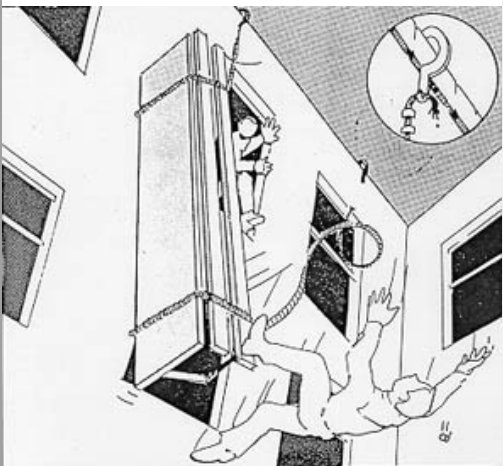
## ACCIDENT SUMMARY No. 12

Two laborers were working on a motorized two-point suspension scaffold 70 feet above ground level without safety belts, lanyards, or lifelines. Three wire rope clips forming an "eye" for connecting the wire rope to the C. hook failed and that end of the scaffold came down. One employee fell to the ground, and the second employee at the other end was catapulted through an open window where he was pulled to safety by office workers. Two of the rope clips were still attached to the end of the rope after the accident. The inside tread of the third clip, which fell, was found to be stripped.

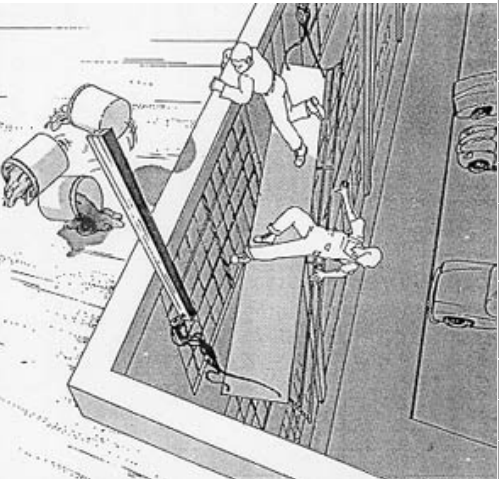
## ACCIDENT SUMMARY No. 14

Two employees were painting the exterior of a three-story building when one of the two outriggers on their two-point suspension scaffold failed. One painter safely climbed back onto the roof while the other fell approximately 35 feet to his death. The outriggers were inadequately counterweighted with three 5-gallon buckets containing sand and were not secured to a structurally sound portion of the building. Neither painter was wearing an approved safety belt and lanyard attached to an independent lifeline.

1. Develop and maintain a safety and health program to provide guidance for safe operations (29 CFR 1926.20(b)(1)).
2. Institute, a program for frequent and regular inspections of the job site, as well as materials and equipment by a competent person(s) (29 CFR 1926.20(b)(2)).
3. Instruct each employee on how to recognize and avoid unsafe conditions which apply to the work and work areas (29 CFR 1926.21(b)(2)).
4. Construct scaffolds and their components so that they can support at least four times the maximum intended load (29 CFR 1926.451(a)(7)).

5. Install outrigger tiebacks of  $\frac{3}{4}$  inch rope, or equivalent, to a structurally sound portion of the building to provide a secondary means of anchorage (29 CFR 1926.451(i)(4)).
6. Require employees to wear approved safety belt and lanyard equipment attached to an independent lifeline that is attached to a substantial structural member (29 CFR 1926.451(i)(8)).

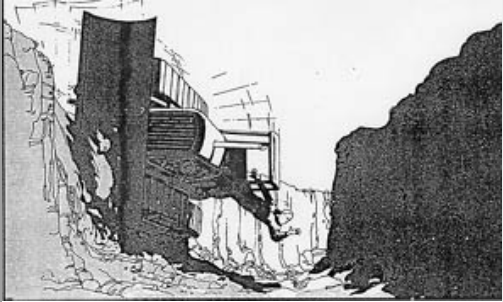
## ACCIDENT SUMMARY No. 19

OSHA's inspection resulted in one citation for one alleged serious violation of its construction standards. If the bulldozer operator had been wearing a seat belt, as required by OSHA standards, this fatality might have been prevented.

1. Employees must be instructed to recognize and avoid unsafe conditions associated with their work (29 CFR 1926.21(b)(2)).
2. Employers must require employees to wear appropriate personal protective equipment - such as a seatbelt - whenever it is necessary to reduce a hazard (29 CFR 1926.28(a)).

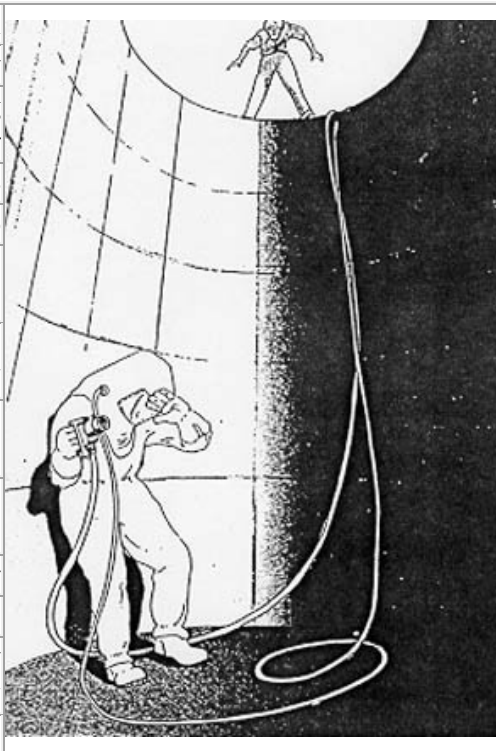
A contract employee was assigned to sandblast the inside of a reactor vessel during turnaround activities at a petrochemical refinery. Instead of relying on the contract company's own air compressors in accordance with the contractor's policy, the contract foreman connected the employee's supplied air respirator to a hose containing what he thought was plant air. Instead it was nitrogen. Both hoses were identical except for markings at the shutoff valve. The sandblaster entered the vessel, descended to the bottom, placed the respirator hood on his head and was overcome.

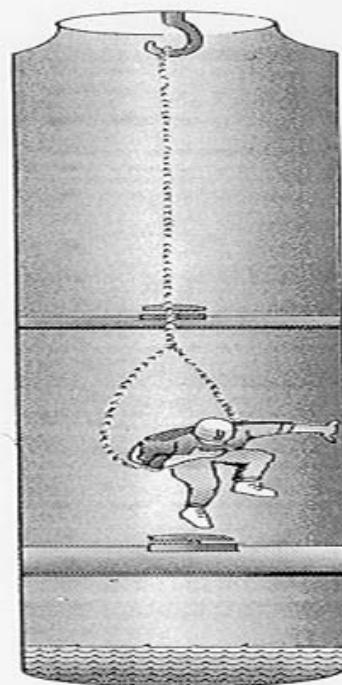
An employee sitting in a looped chain was lowered approximately 17 feet into a 21-foot deep manhole. Twenty seconds later he started gasping for air and fell from the chain seat face down into the accumulated water at the bottom of the manhole. An autopsy determined oxygen deficiency as the cause of death.

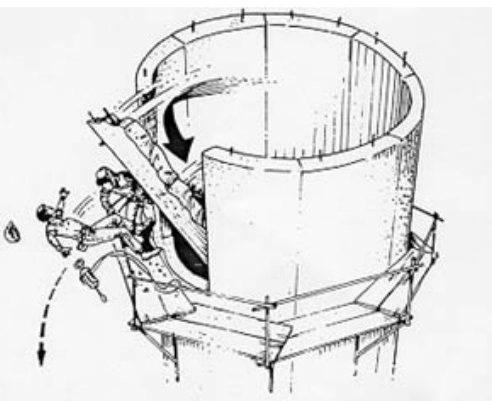
An employee was working on a scaffold near the top of a 250-foot smoke stack when a section of concrete being removed fell onto the scaffold, knocking the employee off. The employee was not tied off with a safety belt and lanyard and fell to the ground below.
