**43<sup>rd</sup> Turbomachinery  
30<sup>th</sup> Pump SYMPOSIA**

# MORTON-LIKE EFFECT IN A CENTRIFUGAL PUMP

- Two 50% capacity (Pacific 20x17 HVF) pumps were installed in 1984 in a nuclear facility in Louisiana. The pumps were designed with a single-stage double-suction arrangement in feed water service, driven by a steam turbine. Pump rotor supported by tilting pad bearings.

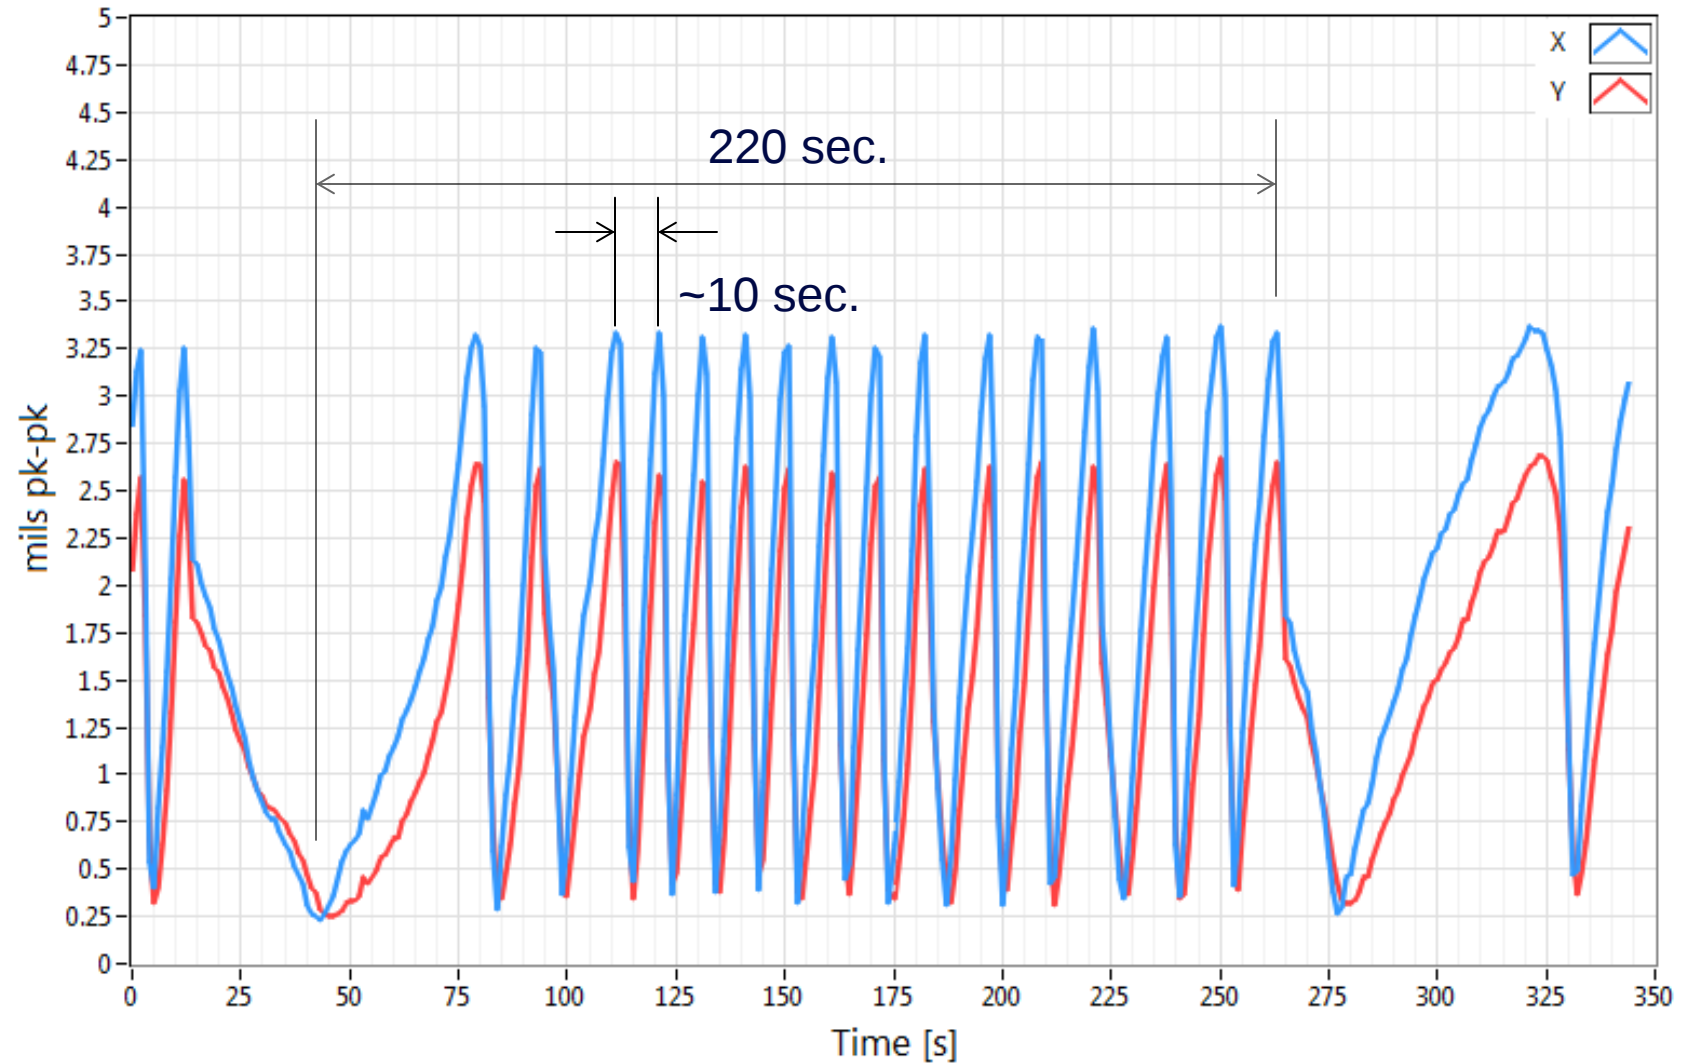
# Vibration Testing – Shaft OBB Vibration Trend

- The vibration amplitude was not constant. The overall amplitude was fluctuating with a period between 10 to 60 seconds.

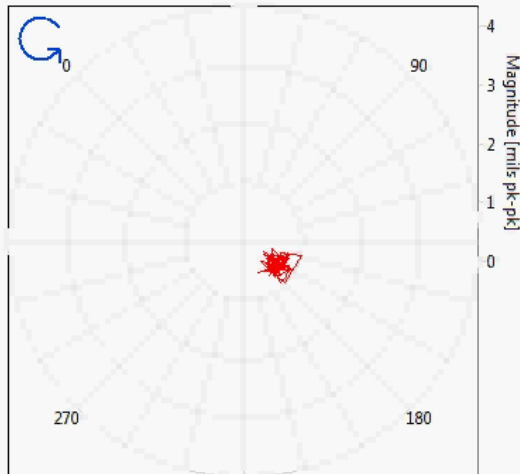
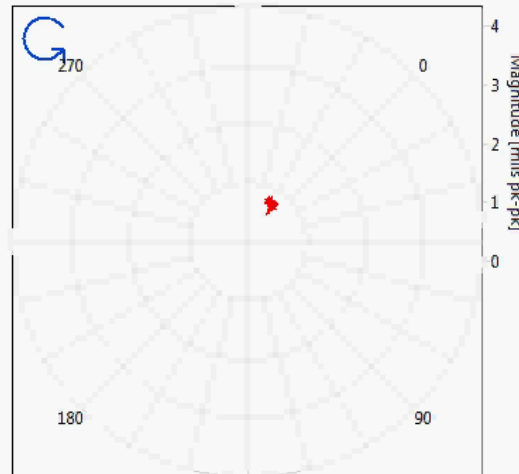
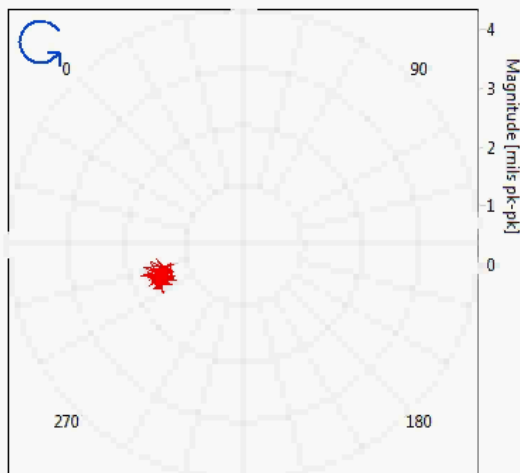
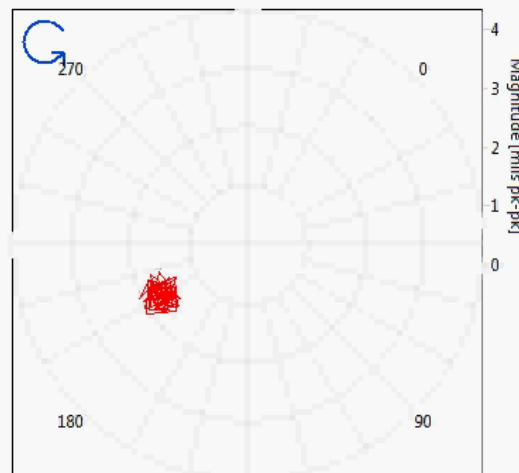
# Vibration Testing – Polar Plots

Note:  
These plotted points shift in amplitude and phase, following a circular pattern (see animation).

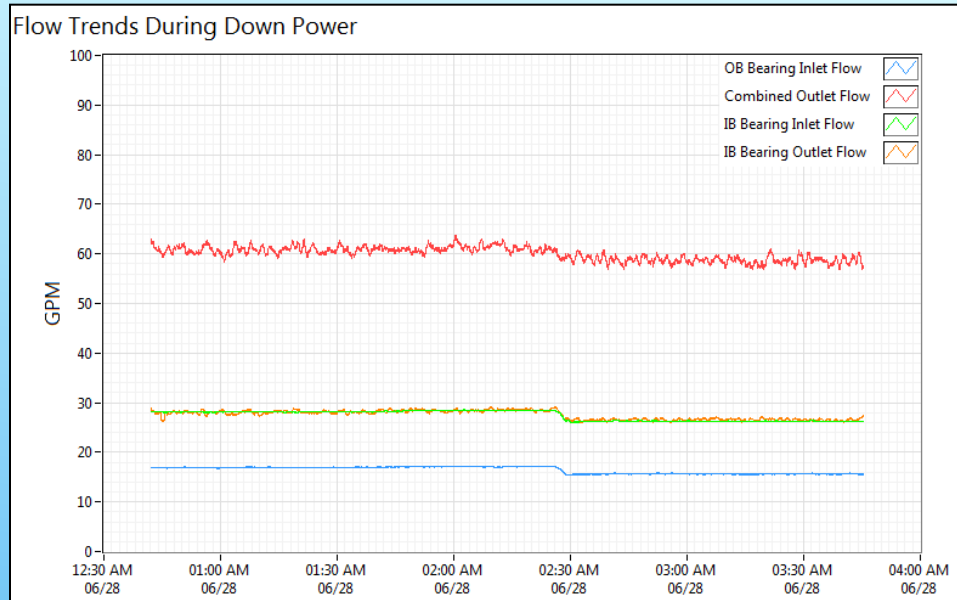
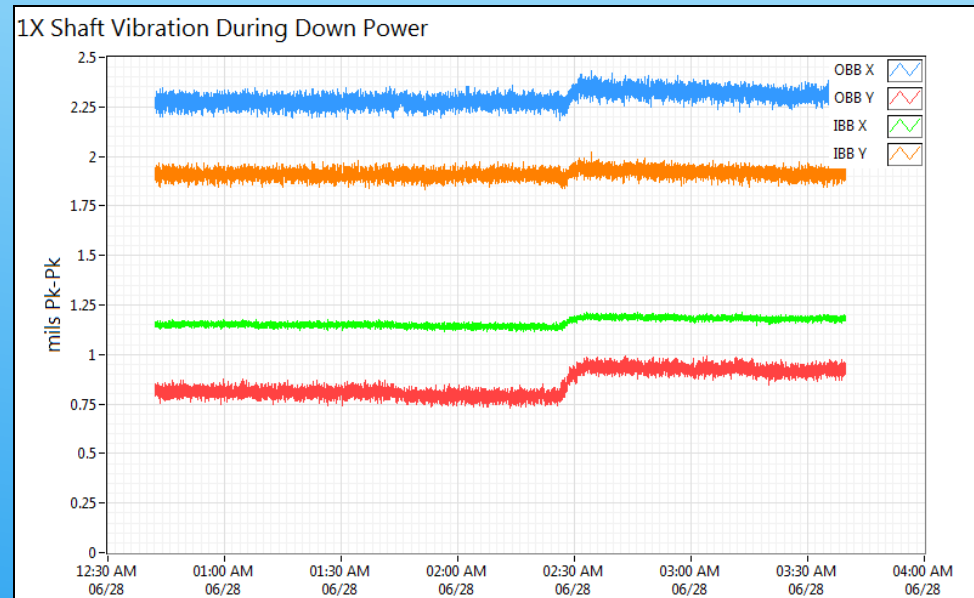
June 2012

Morton-like Effect not detected after slight reduction of seal water injection flow and increment of drain temperature.

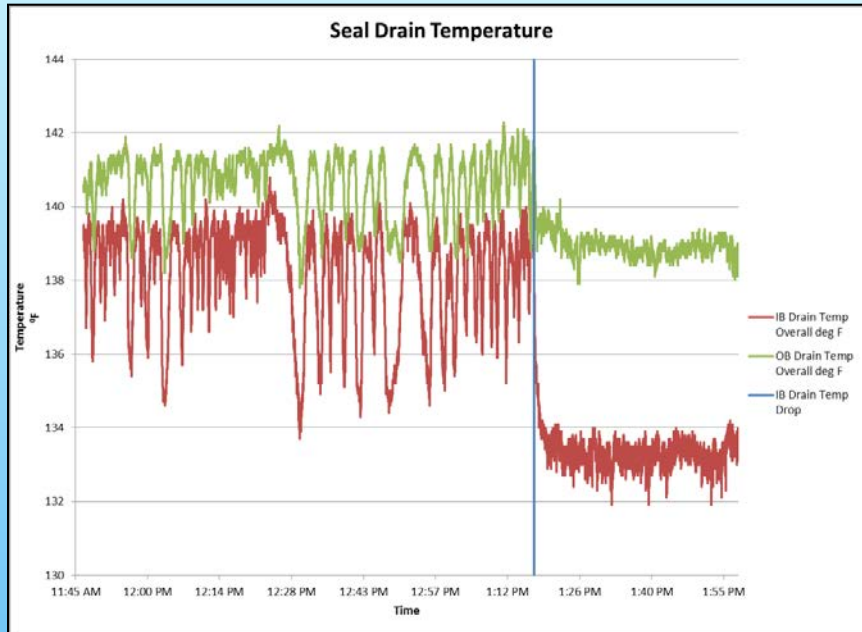
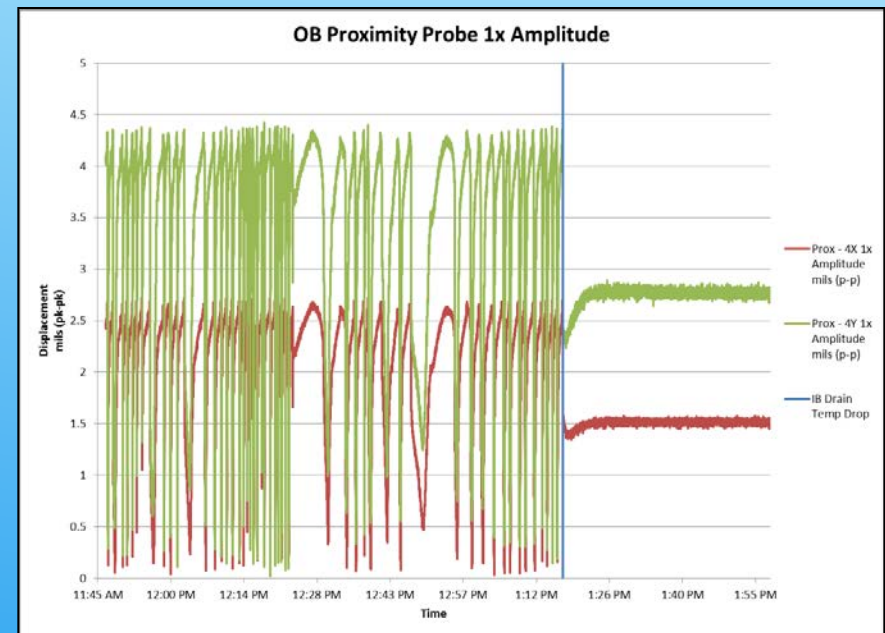
August 2012

End of Morton-like Effect  
after increasing seal water  
injection flow and  
reducing drain  
temperature.

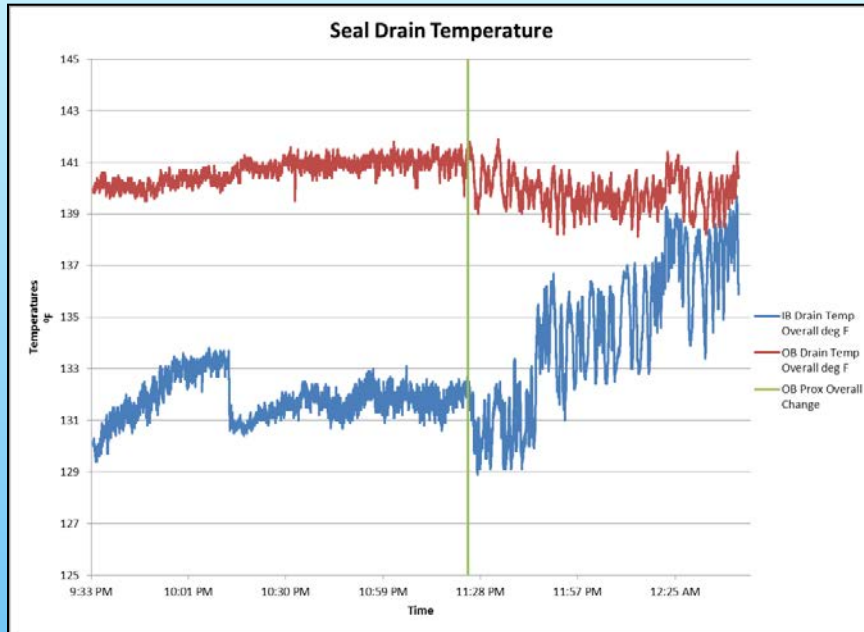
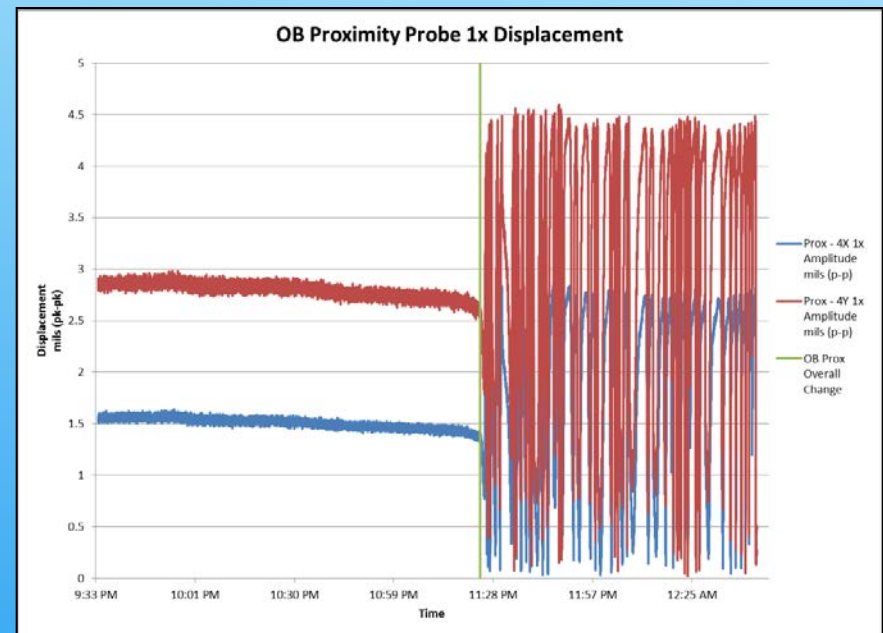
August 2012

Start of Morton-like Effect after slight reduction of seal water injection flow and increasing drain temperature.

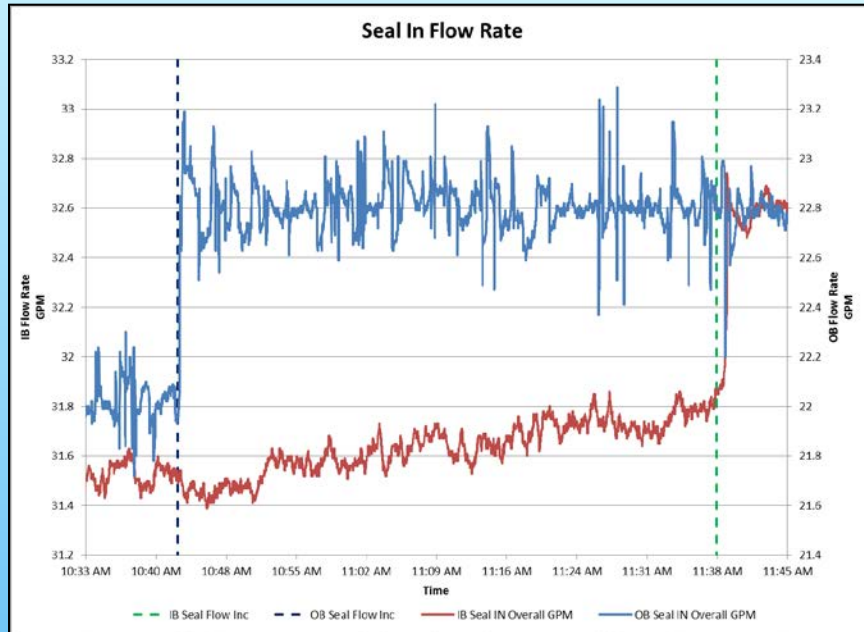
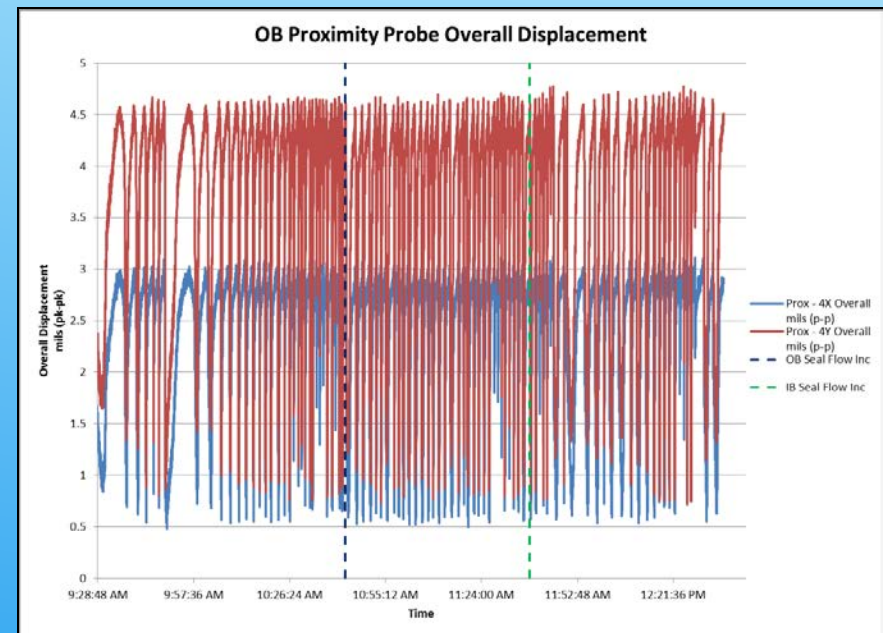
August 2012

No effect on Morton-like  
Effect after seal water  
injection flow increased and  
reduced drain temperature.

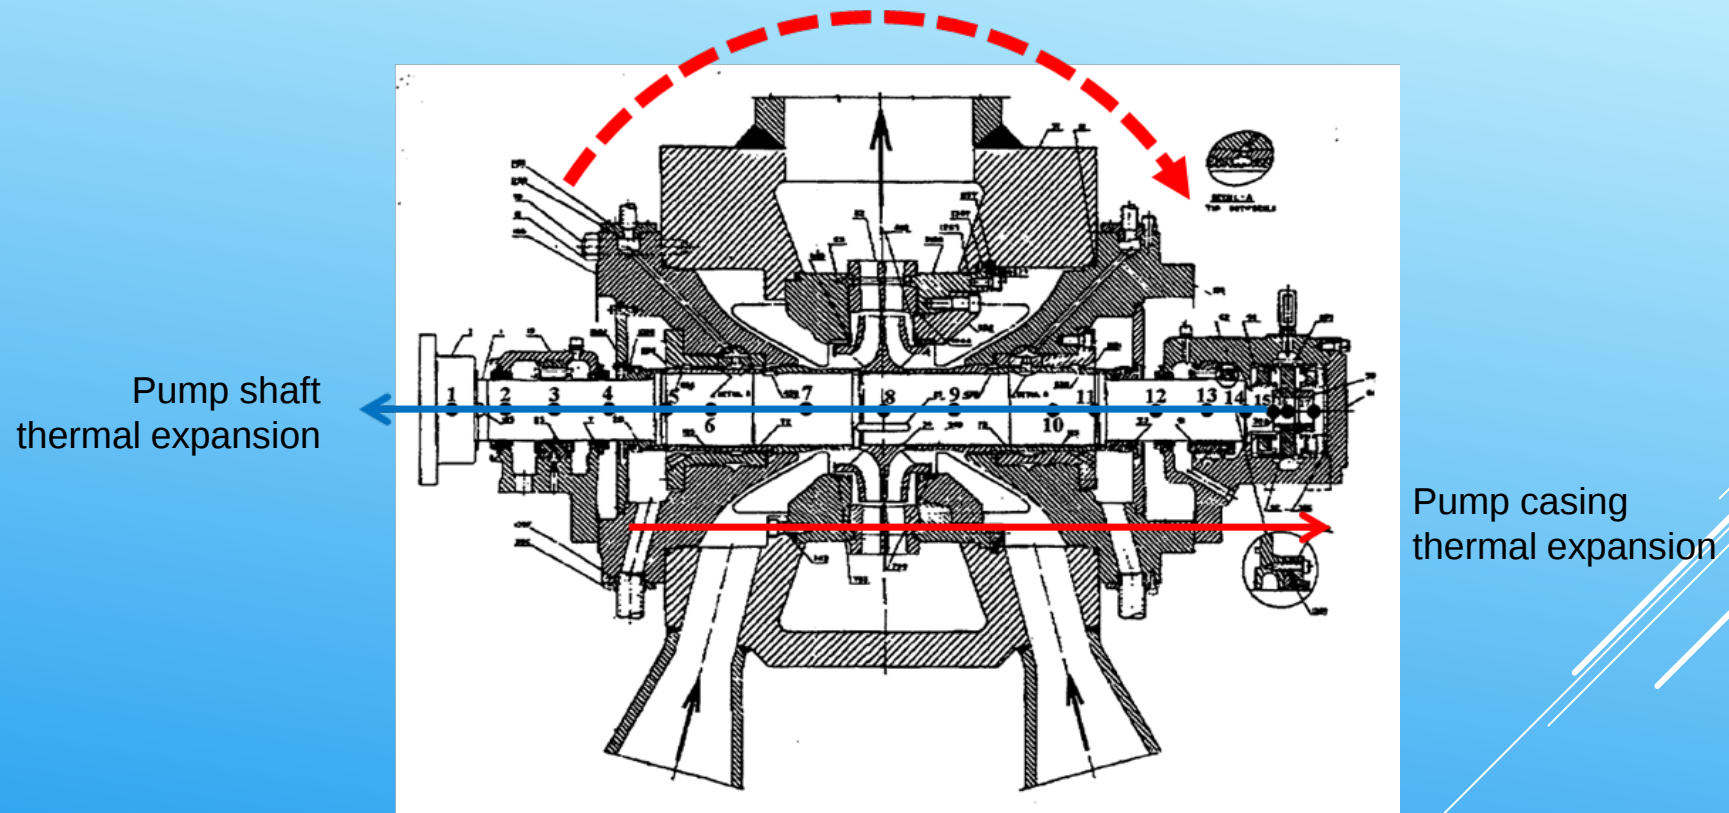
- After a thorough investigation between site personnel and MSI, it was concluded that the root cause of the Morton-like Effect was due to a casing distortion that was altering the internal clearances between the shaft and the long seal sleeve.

- The torque applied to the hold-down bolts to the pedestals at the outboard and inboard end of the pump was approximately 4,400 ft-lb. The required torque, based on the OEM manual, is 1,800 ft-lb at the inboard end and 550 ft-lb at the outboard end. This would allow the casing to grow axially while it reaches the thermal equilibrium.
- Once the torque of the hold-down bolts were corrected, the Morton-like Effect vibration was eliminated.
