ASIA **TURBOMACHINERY** & **PUMP** SYMPOSIUM  
MARCH 2018 | SUNTEC SINGAPORE

# Large Vibrations on Centrifugal Compressor Caused by Inappropriate Operation During Mechanical Running Test

Y. Bidaut, MAN Diesel & Turbo Schweiz AG

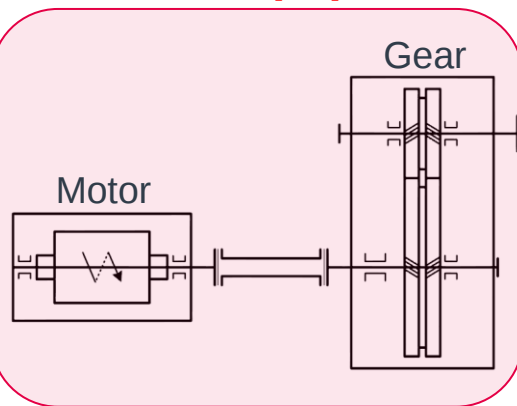
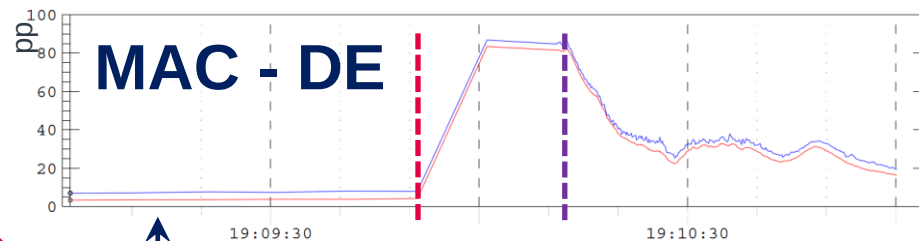
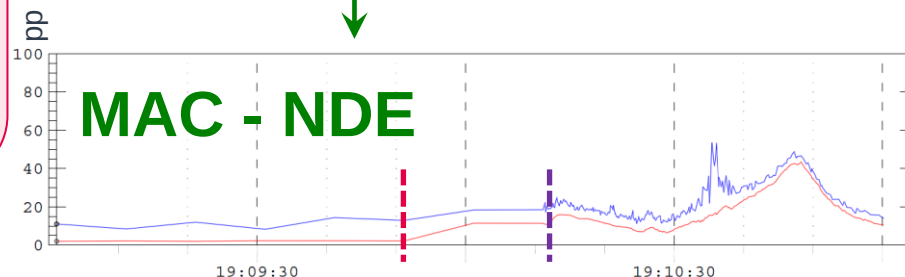
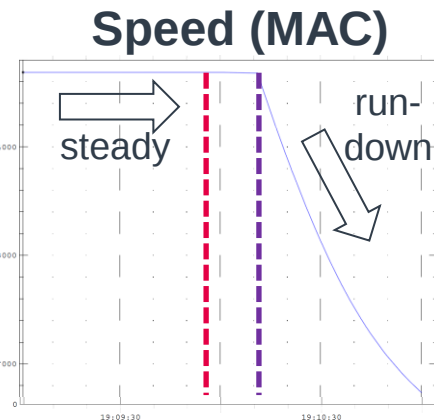
→ Sudden increase of vibrations at DE (constant speed)

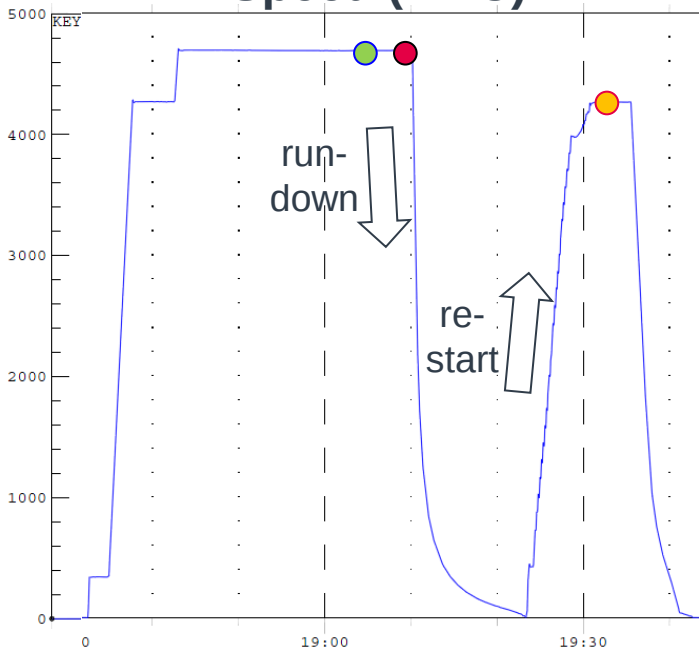
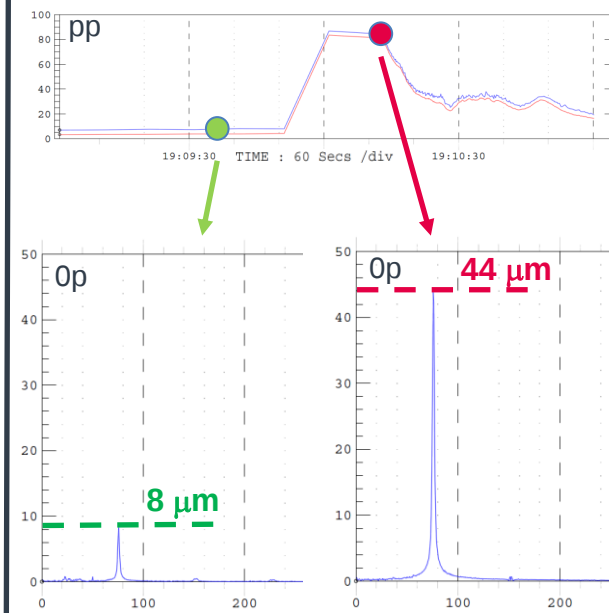
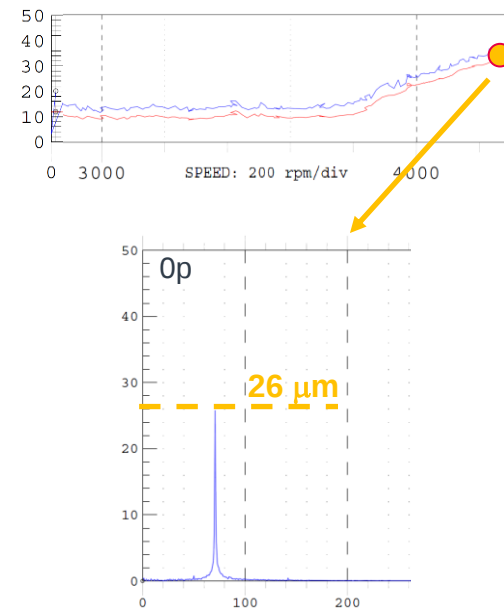
→ Vibration levels too high after re-start

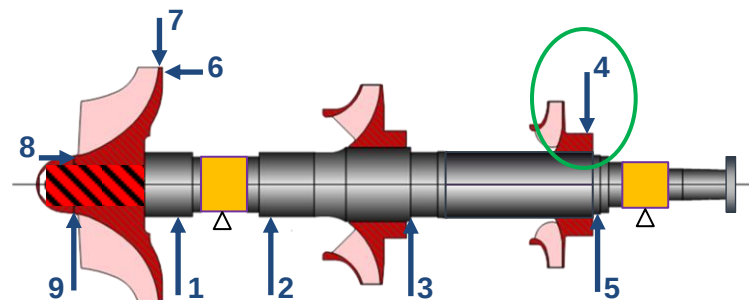
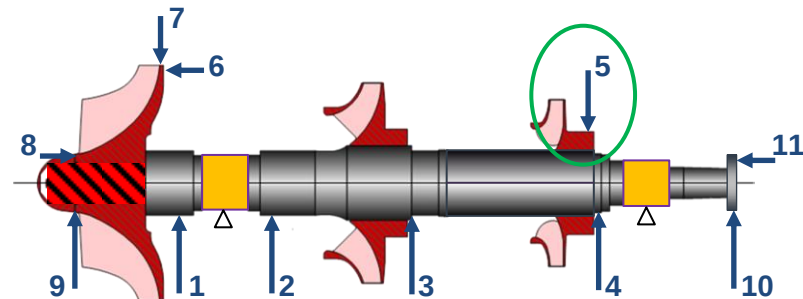
→ Run-out at Impeller 3 increased from 5  $\mu\text{m}$  up to 34  $\mu\text{m}$  !

→ Run-out just behind Impeller 3 increased only from 3  $\mu\text{m}$  up to 12  $\mu\text{m}$

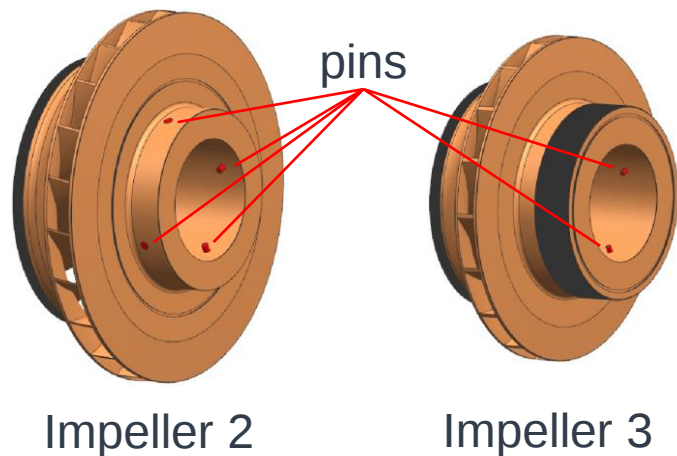
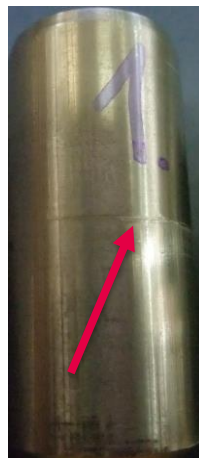
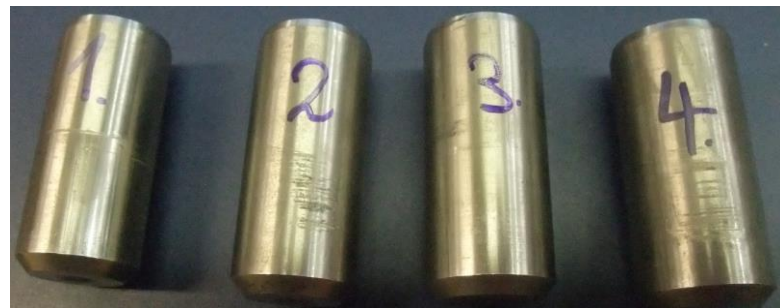
Removed pins from impeller 3

Impellers 2 & 3 are mounted onto the shaft by an interference fit along with pins.

- Clear traces of shear on pins of impeller 3
- This confirms the impeller had moved on the shaft during the test

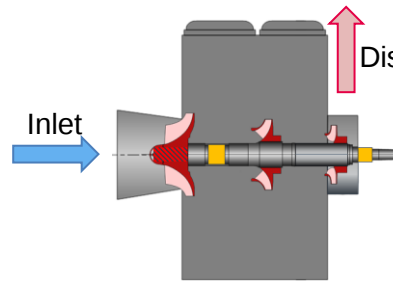
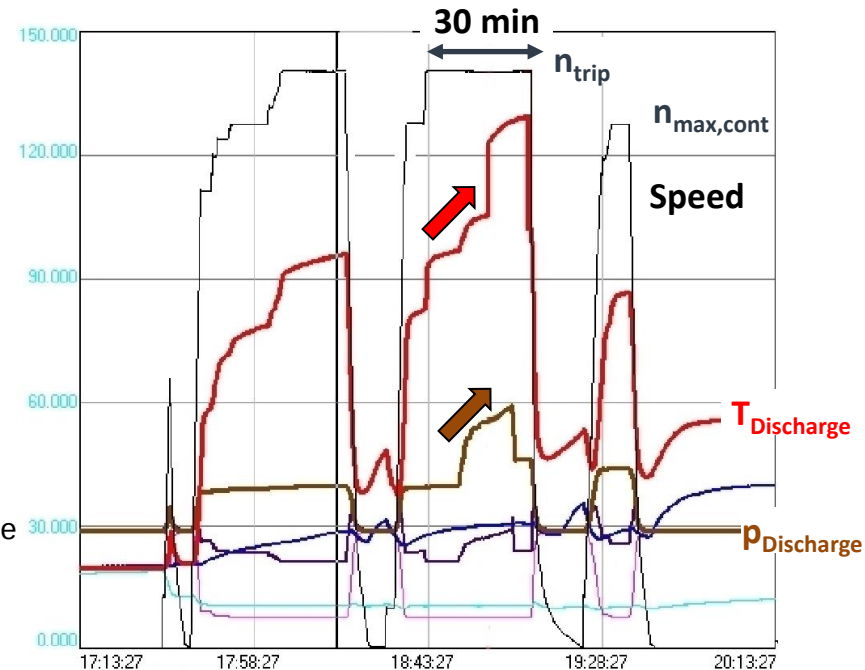
- For internal investigation purpose, a surge test at trip speed had to be performed (no customer specific requirement)
- Event happened after:
  - 30 min in operation at trip speed (4'686 rpm)
  - Continuous increase of discharge pressure and temperature

➔ High vibrations appeared while running at trip speed and close to surge

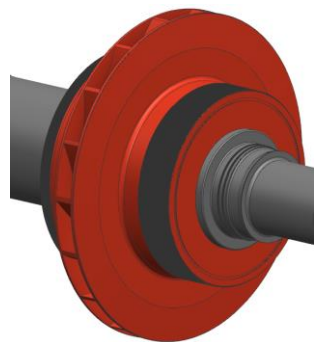
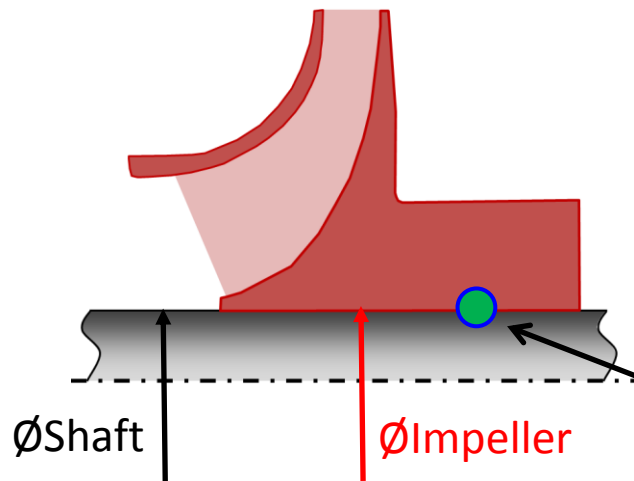
Interference fit evaluated from Manufacture Data records

Interference fit (realized shrink):

$$\frac{\varnothing_{\text{Shaft}} - \varnothing_{\text{Impeller}}}{\varnothing_{\text{Shaft}}} = 1.22 \%$$

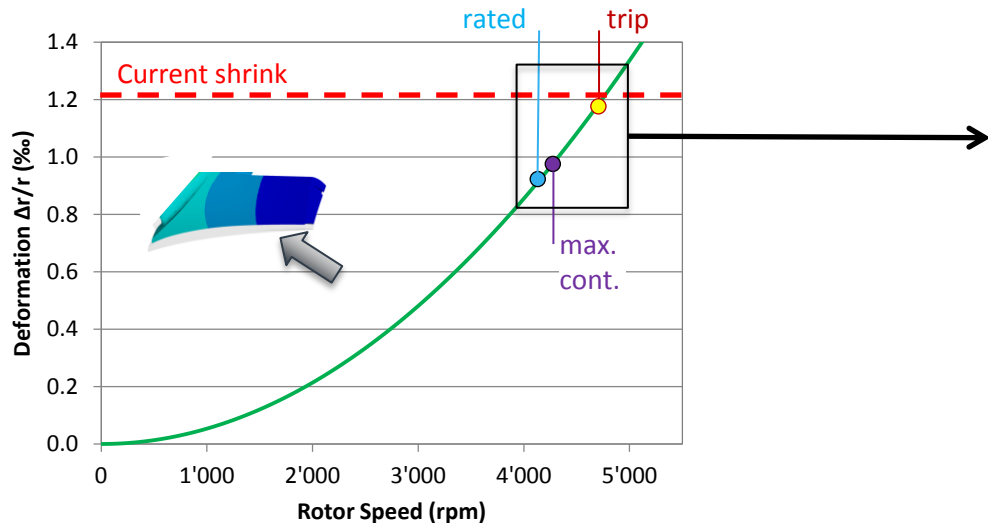
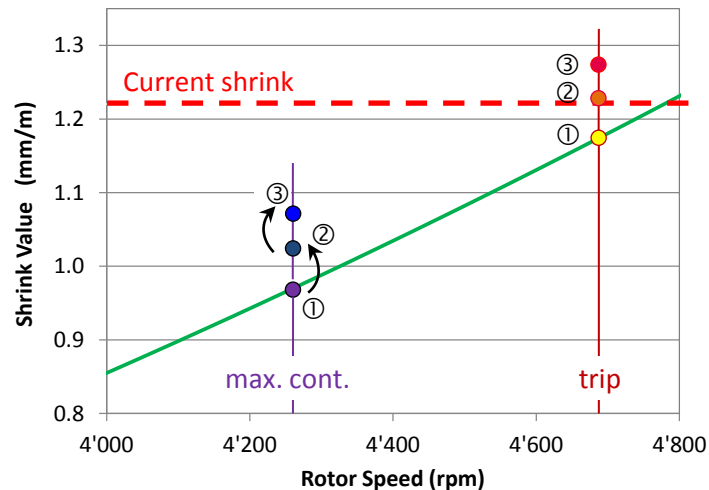
Radial displacement at impeller fit  
due to centrifugal forces (only)

Required shrink at impeller fit  
due to overall loads

- Current shrink 1.22 ‰ is sufficient for normal operating conditions
- Shrink is not sufficient for operation at  $n_{\text{trip}}$  & surge !

1. Shrink increased from 1.22 ‰ to 1.40 ‰
2. Mechanical test run carried out at trip speed for 15 minutes duration and well outside the stability limit

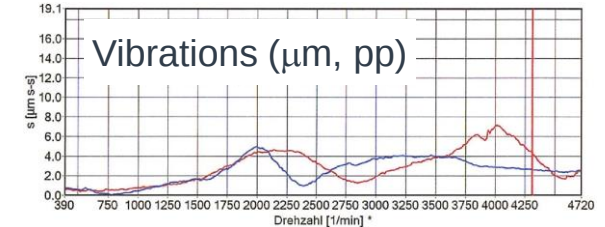
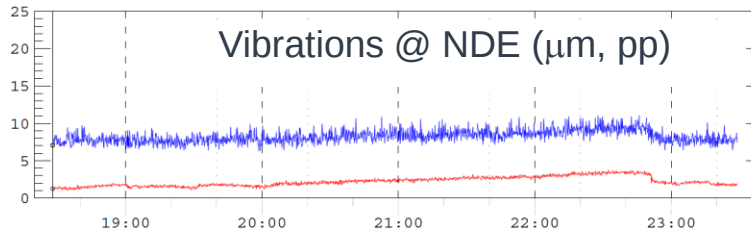
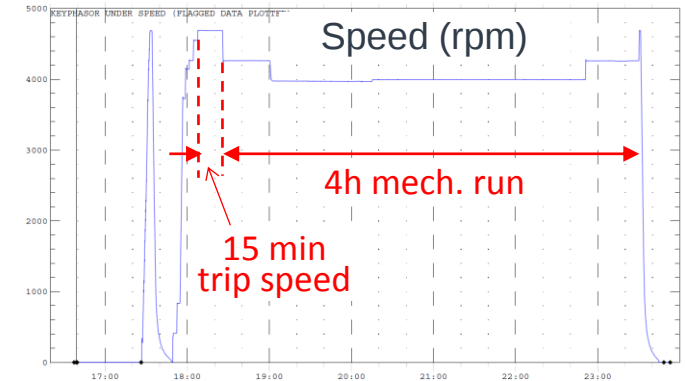
- After modification, this rotor was successfully balanced and delivered to site.

- Afterward, a second rotor (same geometry) with increased shrink was tested in the machine

→ No peculiar vibration observed, machine accepted and delivered
