# FIELD INVESTIGATION OF GEARBOX VIBRATION DUE TO CRACKED MOTOR ROTOR BARS

BY ROSS PINNER  
AND TROY FEESE

42<sup>nd</sup> Turbomachinery  
29<sup>th</sup> Pump SYMPOSIA

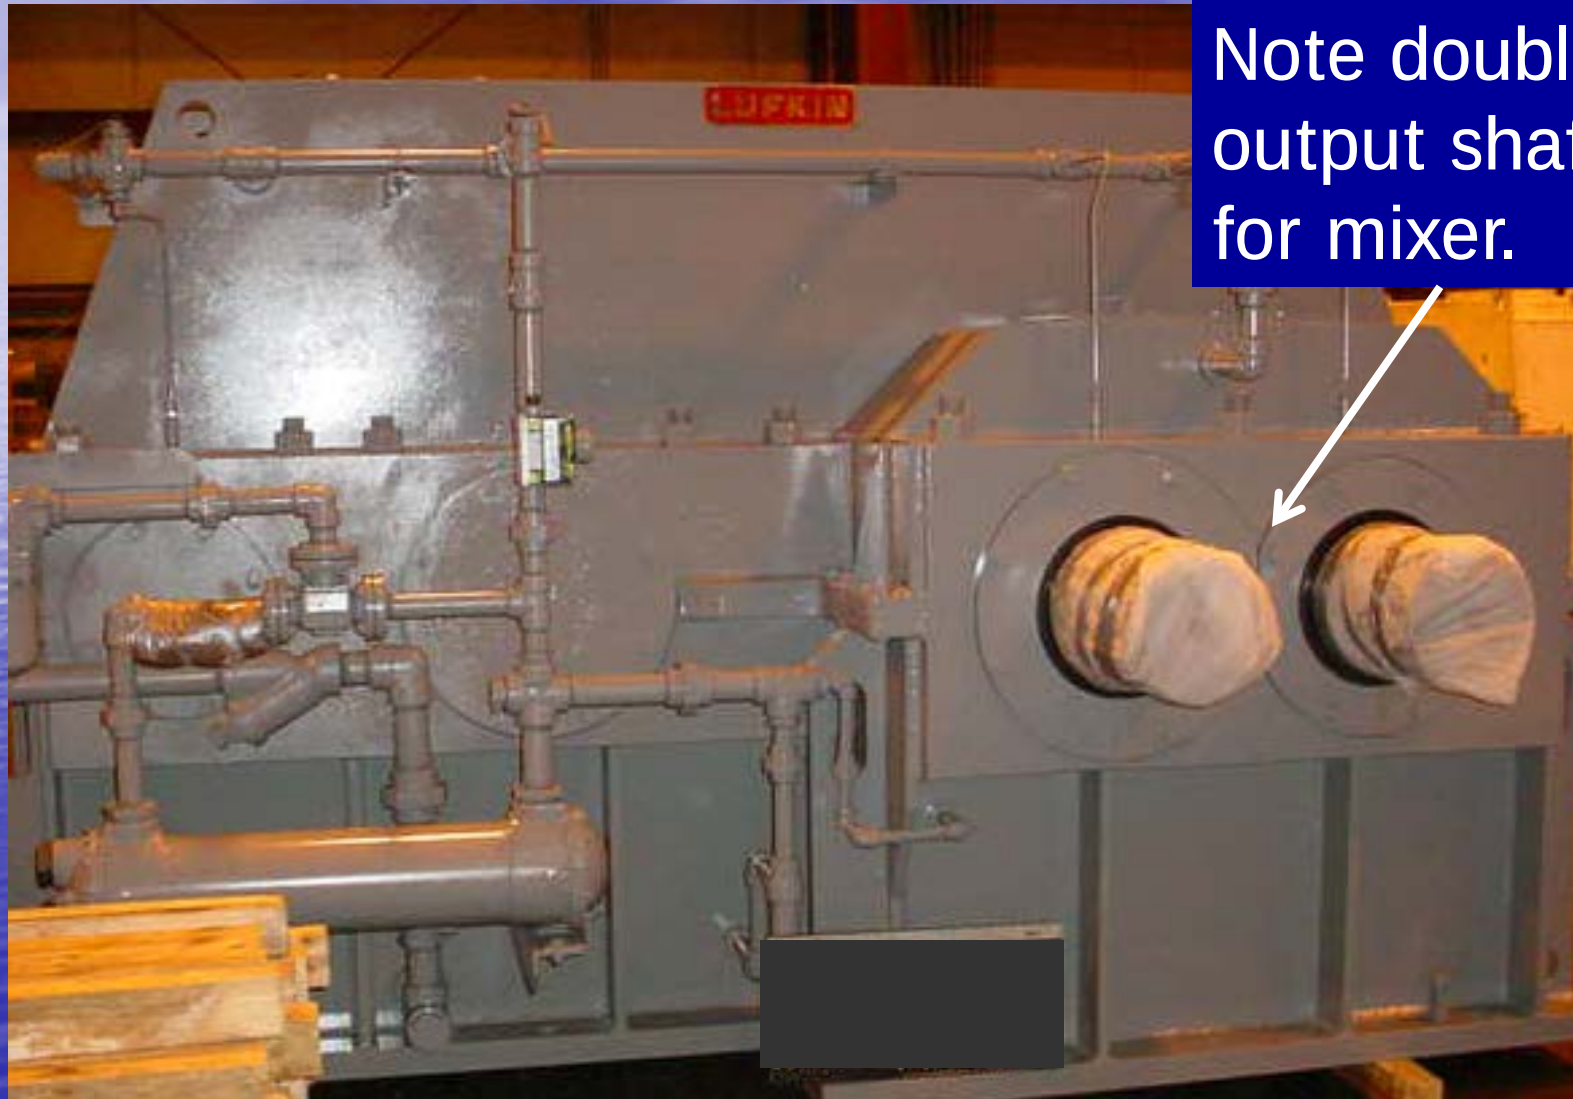
# New Gearbox at Shop

Note double  
output shafts  
for mixer.

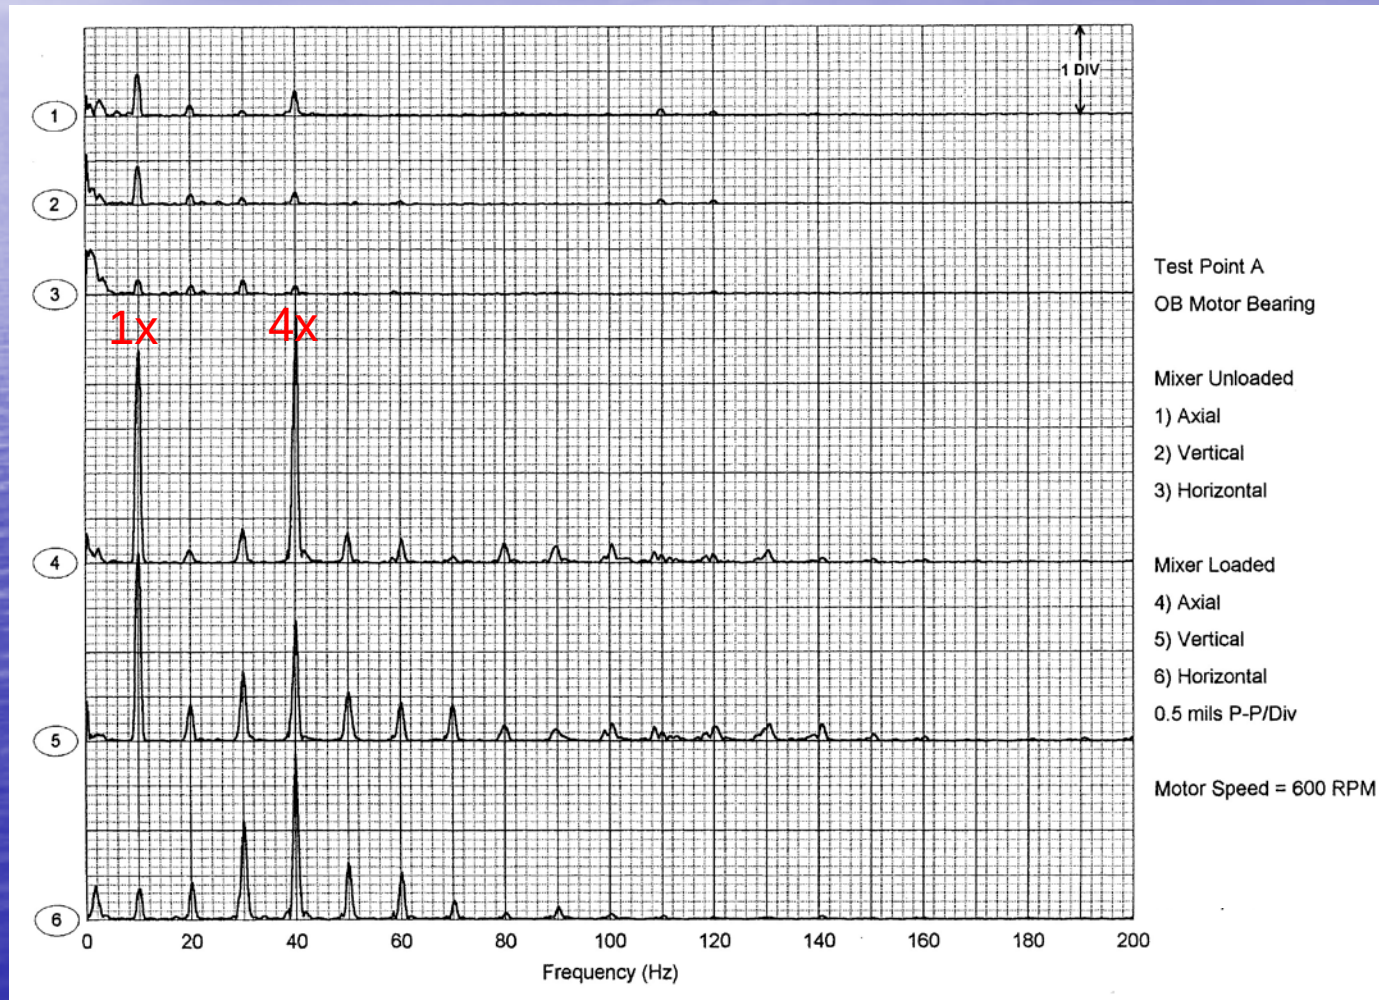
# Note high vibration at 4x motor speed when mixer was loaded.

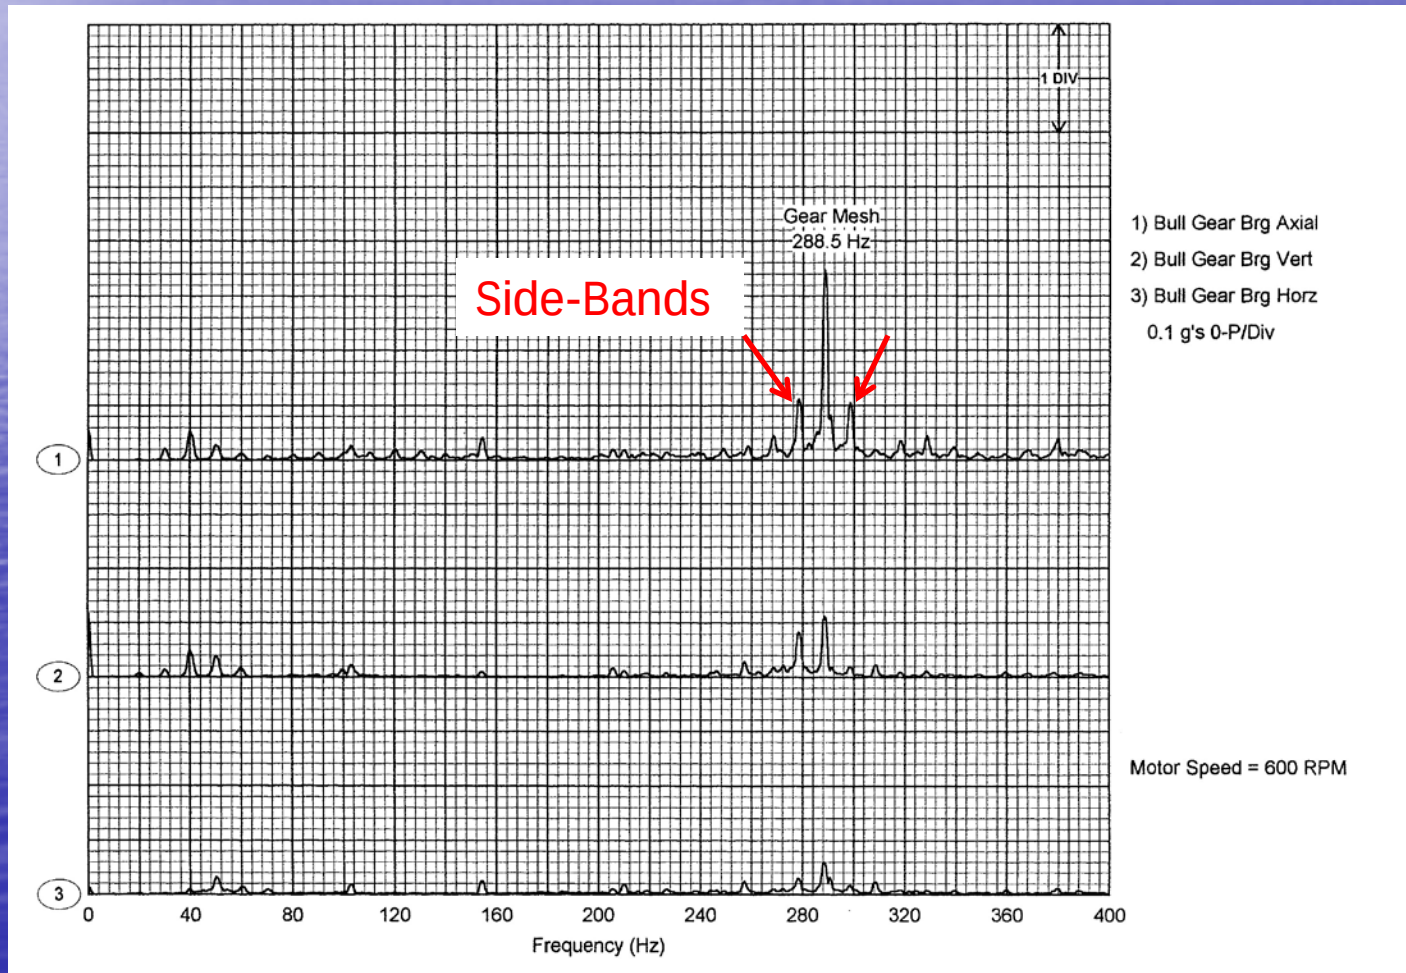
0.17 g's peak at gear mesh frequency  
Note side-bands with 10 Hz spacing  
This indicates fluctuating motor speed

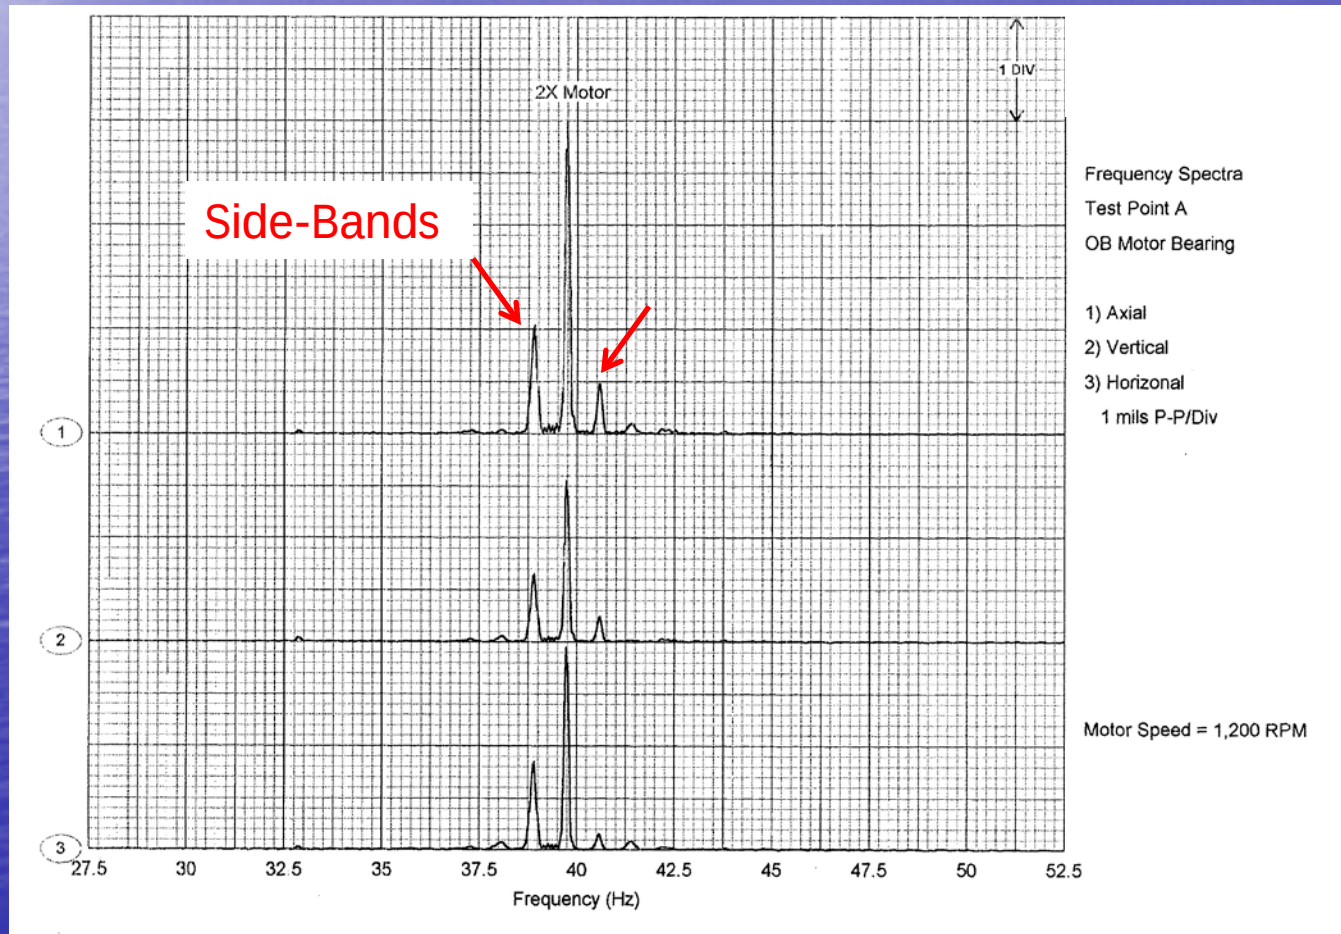
# Frequency Zoom Window of Motor Vibration

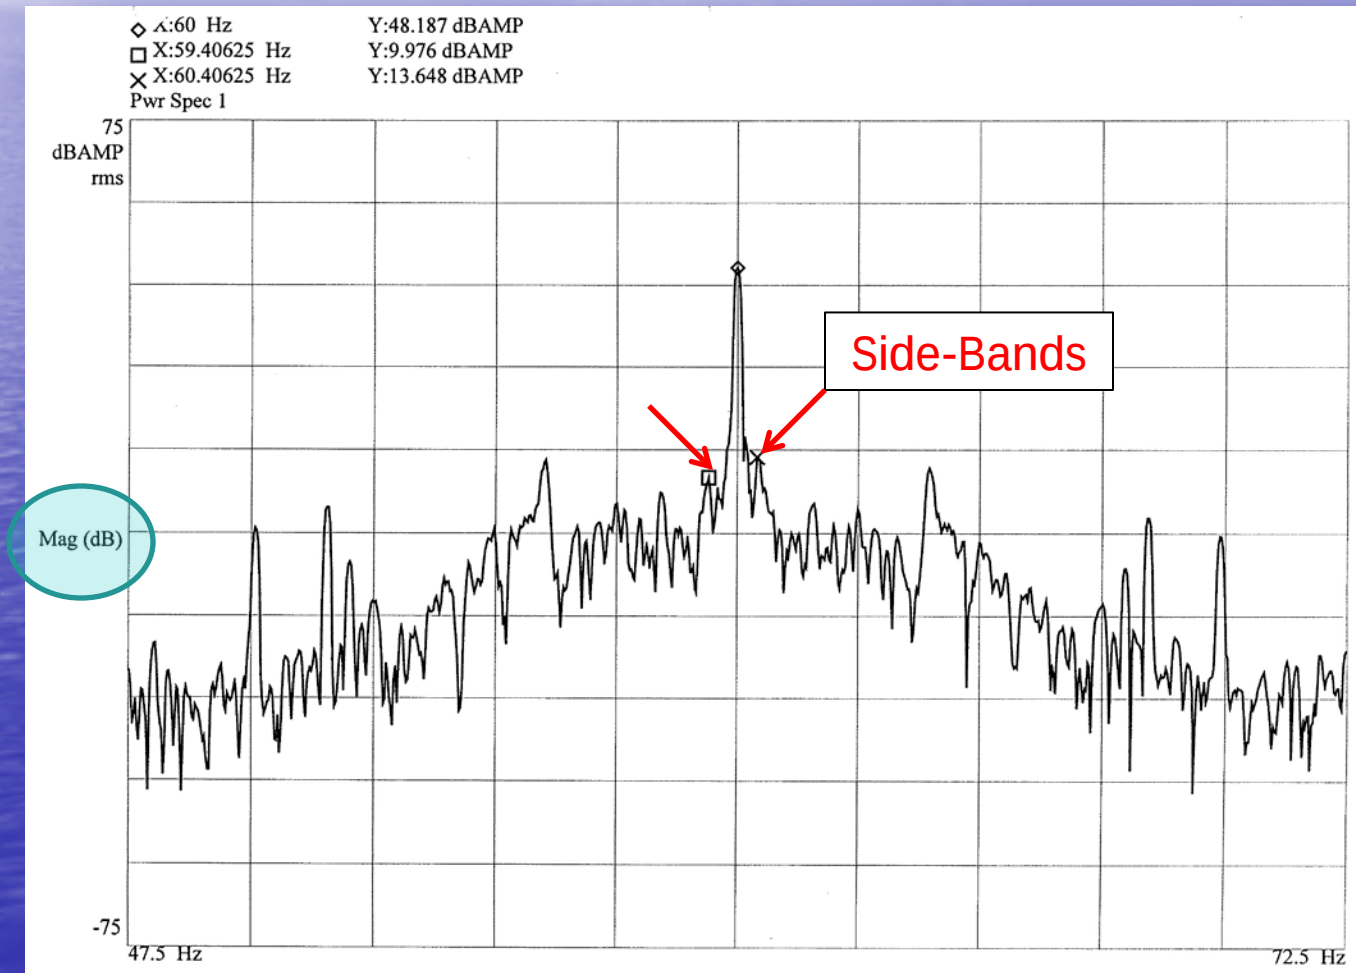
- Mixer not loaded long enough at low speed.
- At high speed, side-bands less than 45 dB below line frequency indicates a problem.
- Motor Speed at Full Load = 1192 RPM,  
Slip Frequency = 8 RPM or 0.1333 Hz
- Spacing of Side-Bands =  
Slip Freq x No. Poles ( $0.133 \times 6 = 0.8$  Hz)
- Repeated loading / unloaded hard on motor and believed to cause fatigue cracks.

48 – 10 = 38 dB Perform Vibration Test  
48 – 14 = 34 dB Overhaul ASAP
