46<sup>TH</sup> TURBOMACHINERY & 33<sup>RD</sup> PUMP SYMPOSIA  
HOUSTON, TEXAS | DECEMBER 11-14, 2017  
GEORGE R. BROWN CONVENTION CENTER

# RESOLVING STRUCTURAL VIBRATION ISSUES ON A WATER FLOOD PUMP

This case study is designed to outline how the high vibration issue of two Water flood modules was successfully diagnosed, the root cause for the high vibration and finally how it was mitigated using some structural analysis techniques.

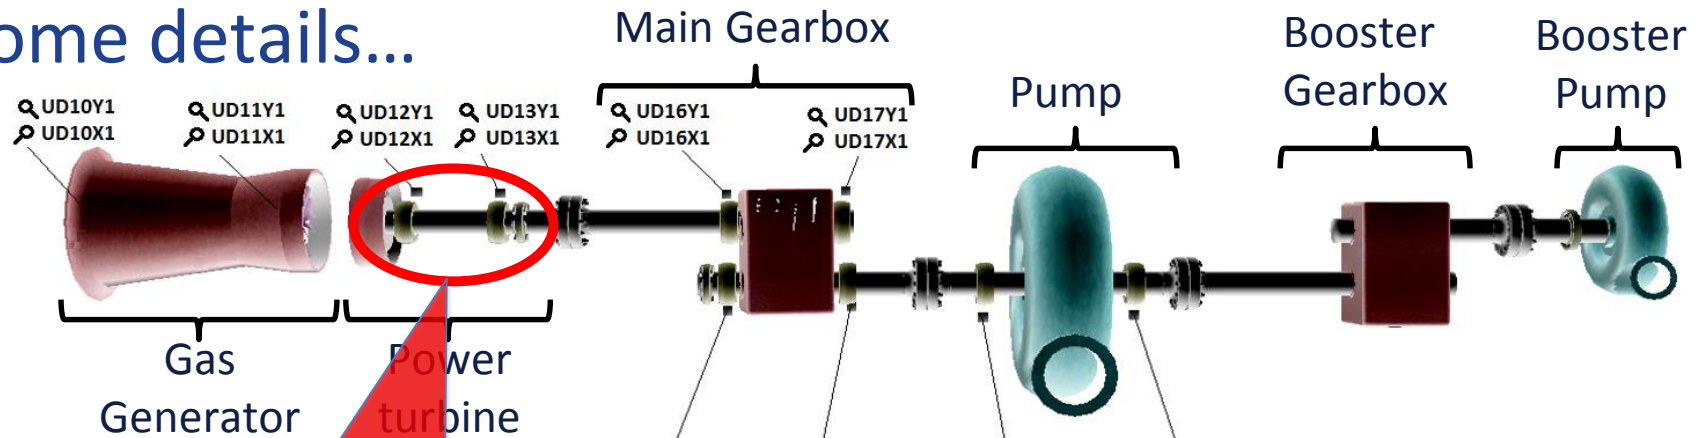
**Power Turbine**  
 High level of Shaft  
 relative vibration  
 > 90  $\mu\text{m pp}$  (3,5 mils)

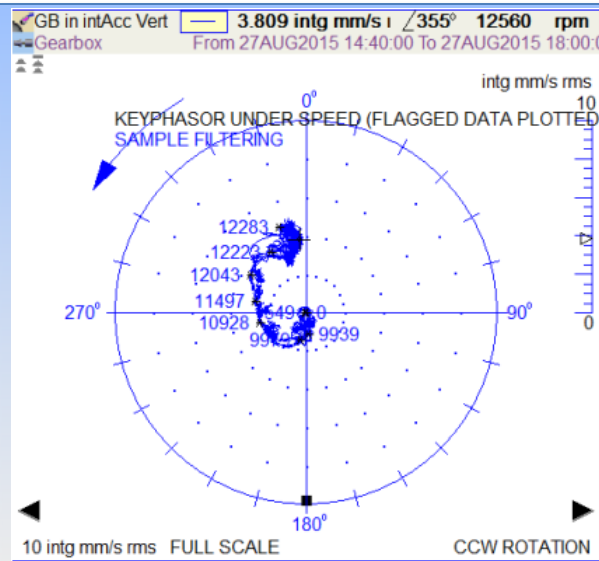
Over 160° phase shift –  
well above resonance

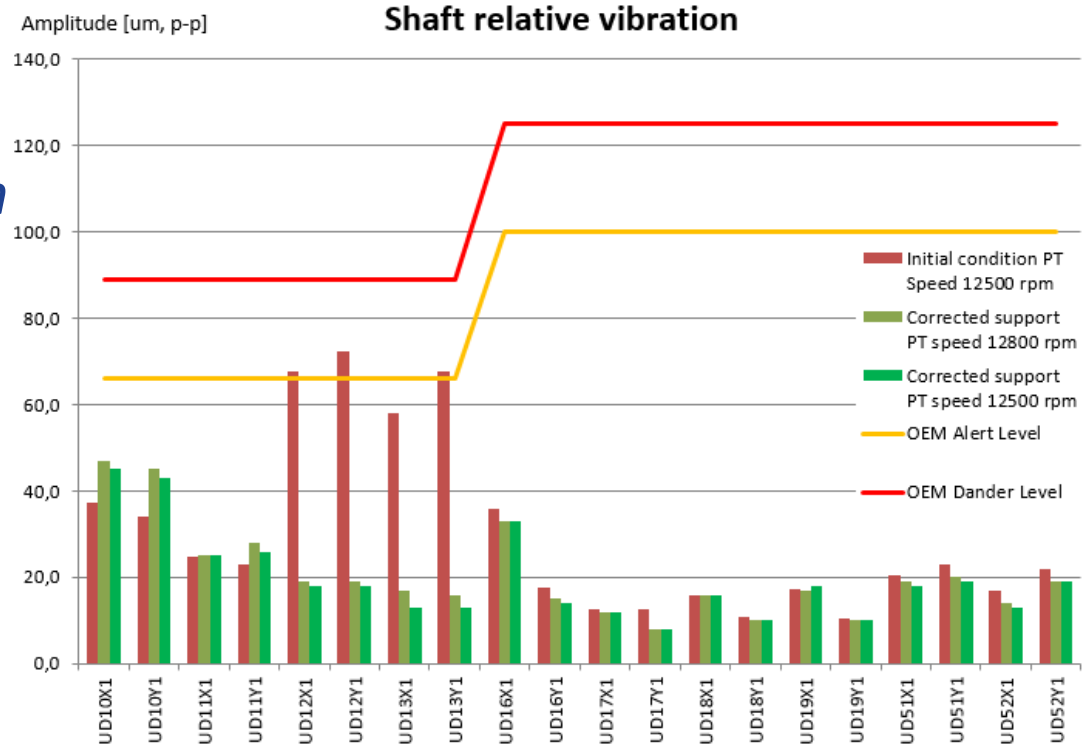
*After supporting system modification it was possible for Unit A to reach maximum designed speed, maximum flow with acceptable vibration level.*

*Unit B modification done during next planned overhaul.*
