# Bearing Failure on a Boiler Feed Water Pump

# Background Information

- BB3 Between bearing multistage centrifugal pump.
- Ingersoll-Rand 5-HMTA-5
- Service is Boiler Feed Water, 240F Operating Temperature, 10 PSIG Suction Pressure, 895 PSIG Discharge Pressure
- The pump was originally built for high pressure amine service at a different facility and was acquired in 1974 for use in the boiler feed water service.

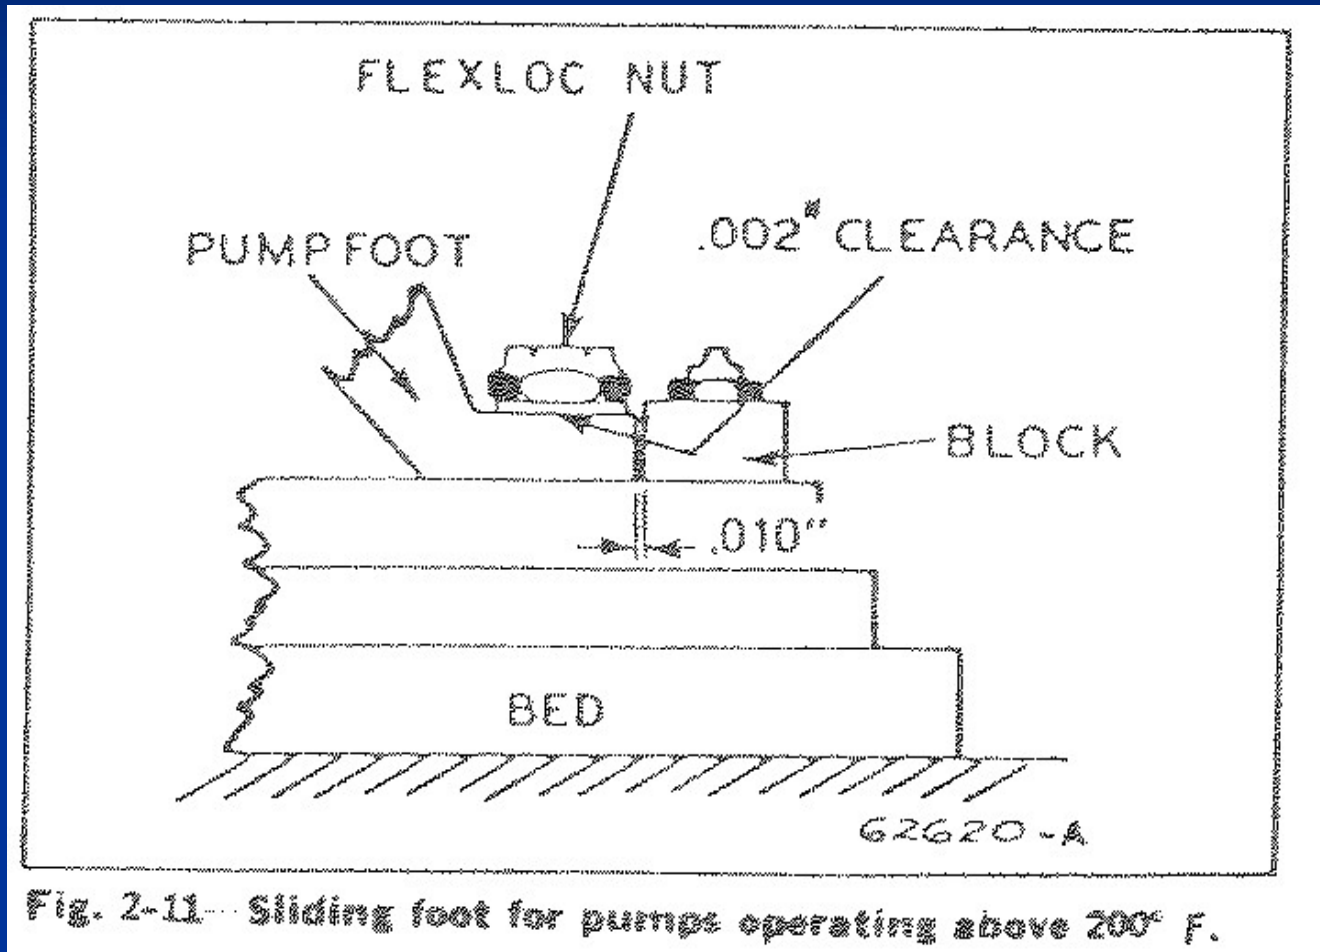
# OEM Recommended Mounting

- One issue identified after the 2<sup>nd</sup> shop repair was possible thermal growth of the casing binding the pump.
- The pump was not installed per the OEM recommendations for 200F and higher applications.
- On each repair after the 2<sup>nd</sup> shop repair the base bolts were loosened after heating with an indicator placed on the bearing housing.
- Thermal growth was found as high as 0.025”.
