Water Arabia 2011
CONFERENCE & EXHIBITION

Cleaning Clay from Fouled Membranes

Authors: Matthew Armstrong, Silvia Gallego, Fernando del Vigo, Stephen Chesters.

Genesys International Limited

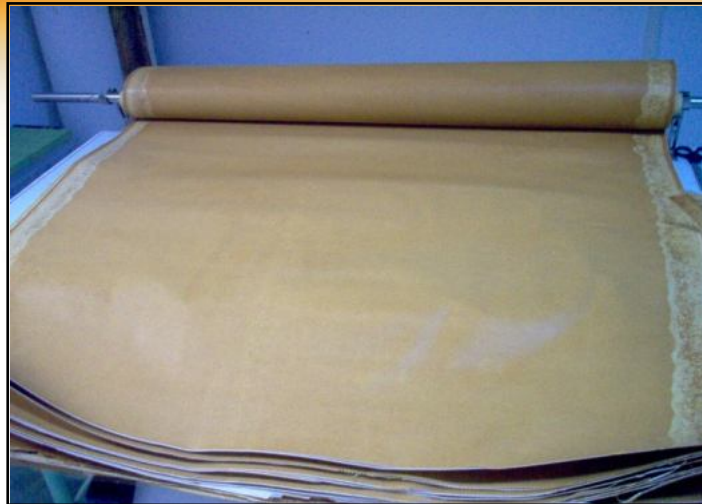
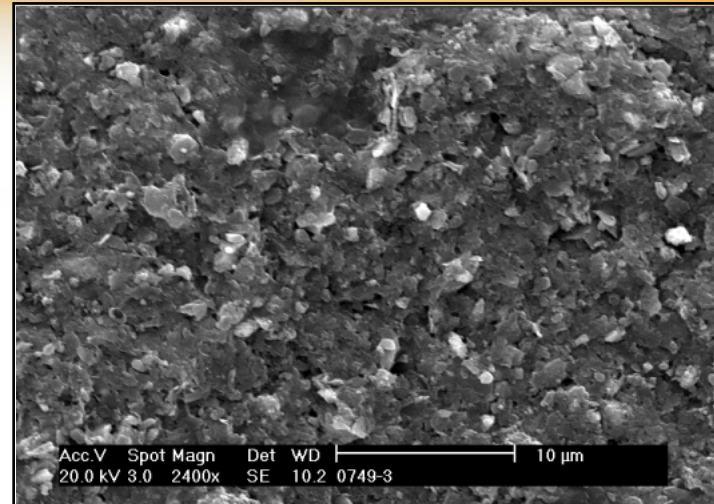
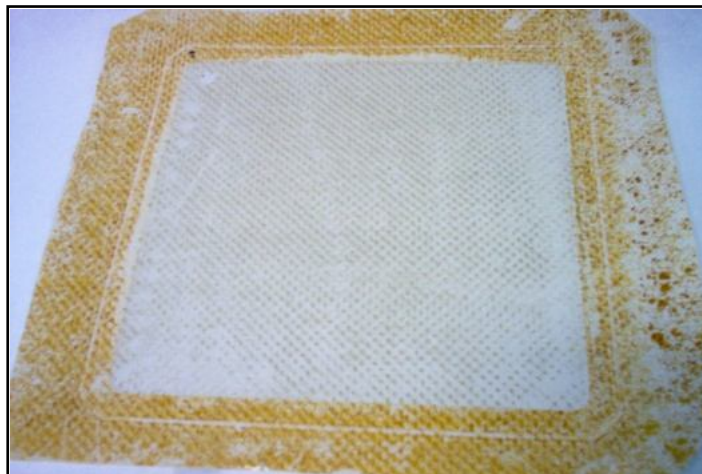
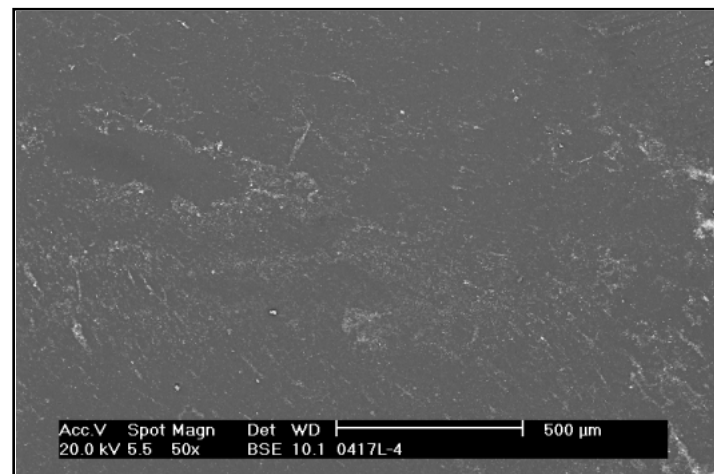
CASE STUDY 3

<p>Hydranautics LFC3 Characterization conditions: 150 psi, 1000 ml/min, 1,500 ppm NaCl</p>	<p>Dark brown homogenous deposit covering membrane surface. Deposit mainly inorganic (> 90 % dry mass). Composed of aluminosilicates and iron oxides.</p>
---	---

Cleaning solution	Temp	pH	Time	Flowrate (l/m ² h 25°C)			% Salt Rejection	
					Before	After	%	Before	After
Case 3	Genesol 703 (1 wt%)	35°C	11.5	4 hrs	17.33	58.43	+237.2	93.8	96.5

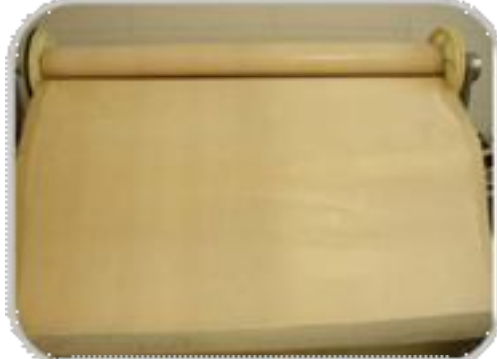
Hydranautics SWC5
Lead element first stage, first pass

Thin brown gelatinous deposit
Bacteria, fungi, iron, clay
(alumino-silicate)

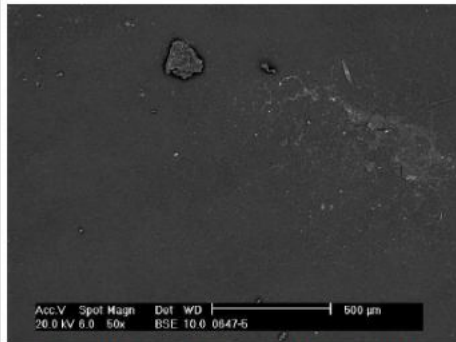
Microphotograph 13.- General view of membrane GA 100647 - rejection sample

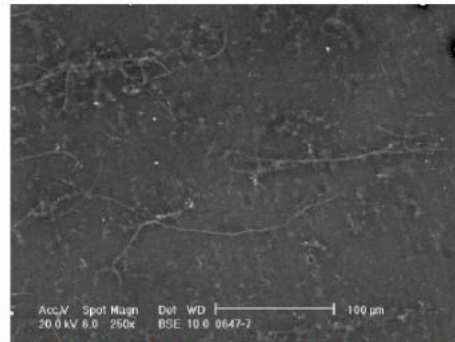
Microphotograph 14.- Detail of foulant - GA 100647 rejection sample

- Anthracite particles
- Bacteria, Biofilm
- Aluminosilicate
- Iron

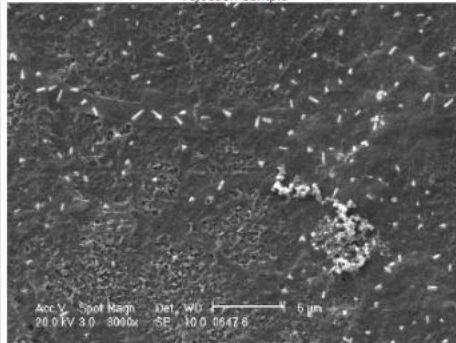
Microphotograph 15.- Detail of membrane surface - GA 100647 rejection sample

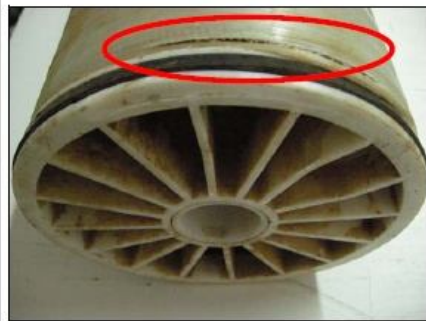
Photograph 1.- Side 1

- Damage to casing
- Damage to ATD
- Dark brown inorganic deposit

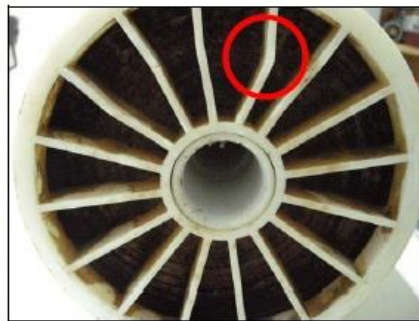
Photograph 2.- Side 2

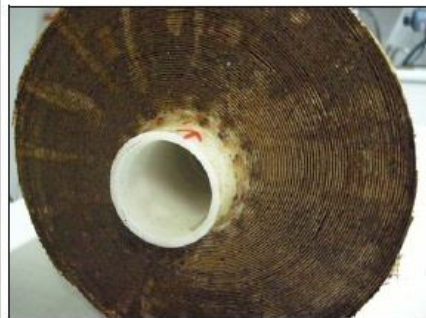
Photograph 3.- Side 1-detail

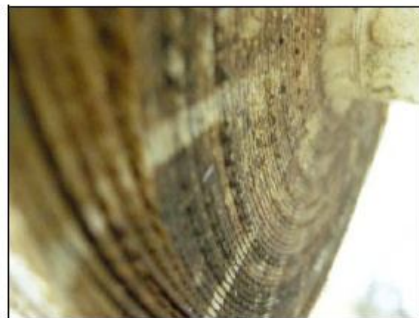
Photograph 4.- Side 2-detail

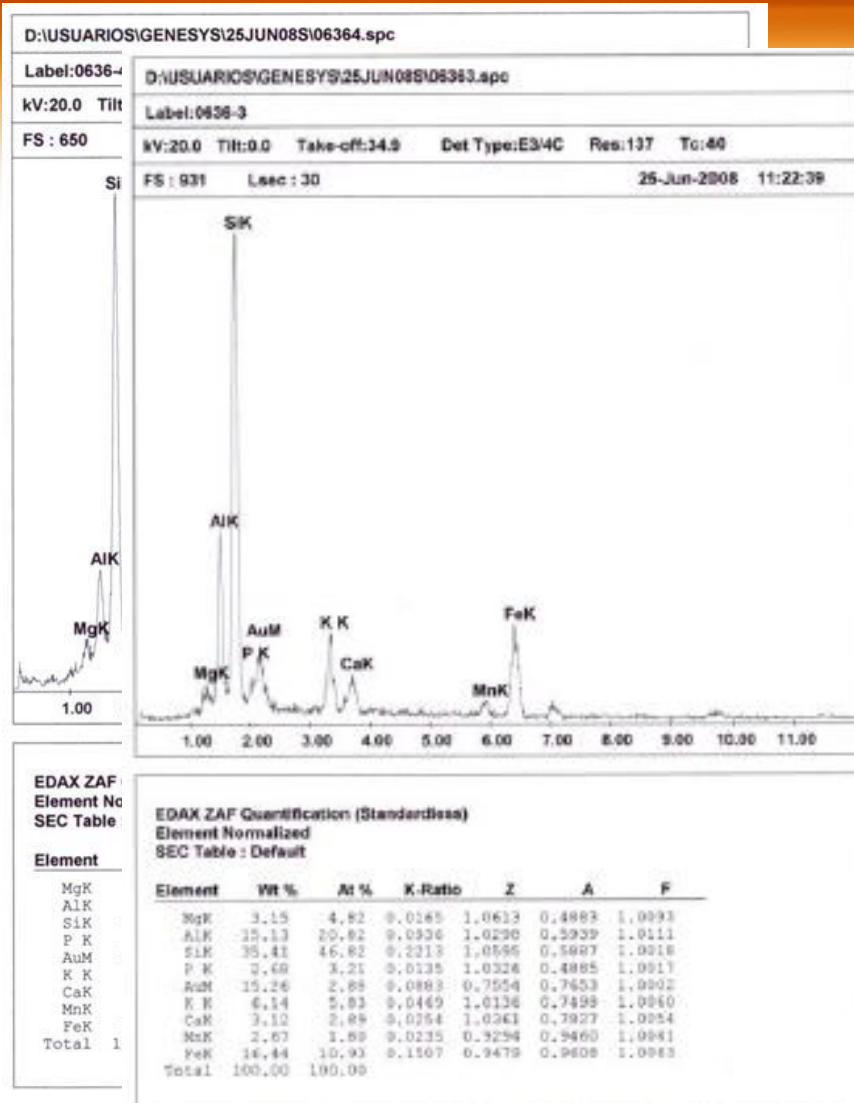
- Scanning Electron Microscopy – Energy Dispersive X-ray Analysis
- Elemental peaks of deposits
- Aluminium 5-15%
- Silica 19-35%
- Iron 16-38%
- Alumino-silicate (clay) and iron
