**SO WHAT DID WE LEARN ABOUT PUMPS DURING THE PAST 20 YEARS?**  
**AN ESKOM PUMP STORY / EXPERIENCE**

The paper discusses and highlights the most prominent critical pump related challenges and experiences Eskom has been faced with during the past 20 years.

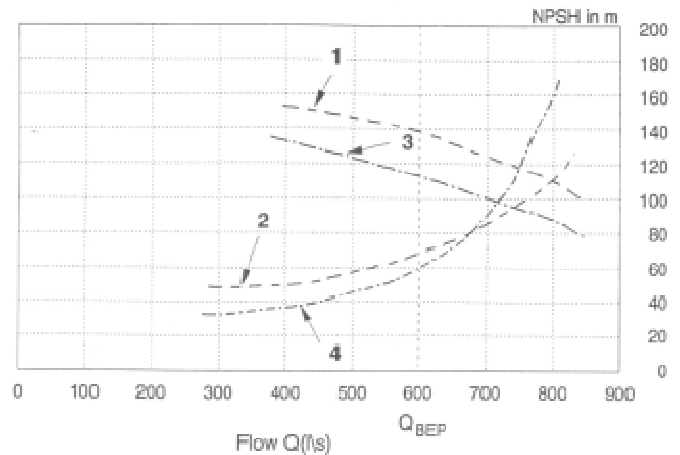
The SFP's (Steam Turbine Driven Boiler Feed Pumps) were actually running at ( $Q > Q_{BEP}$ ). For this duty, the safety margin between the NPSH required and the NPSH available was reduced, which promotes the onset of cavitation damage, see Figure 1.2.

Figure 1.2: Design Feed Pump NPSH requirements compared to actual Plant NPSH requirements

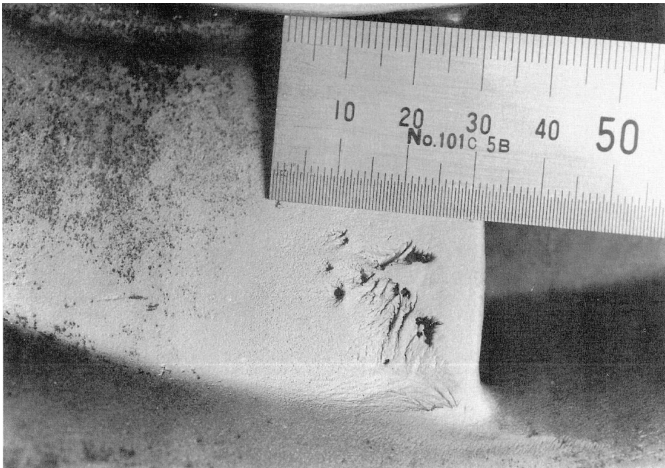
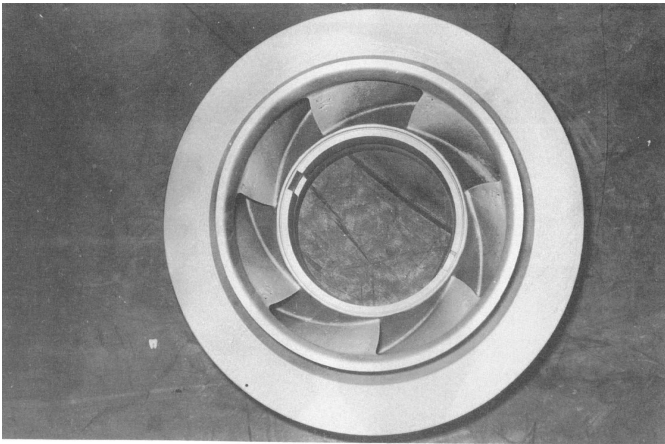
Typical back of the vane cavitation damage is shown in Photographs 1 to 4 which is a combination of the above mentioned phenomena and the part load operating due to the different load demands on the power stations.

*Photographs 1 and 2: Feed pump impeller with pressure side cavitation damage through the complete vane thickness*

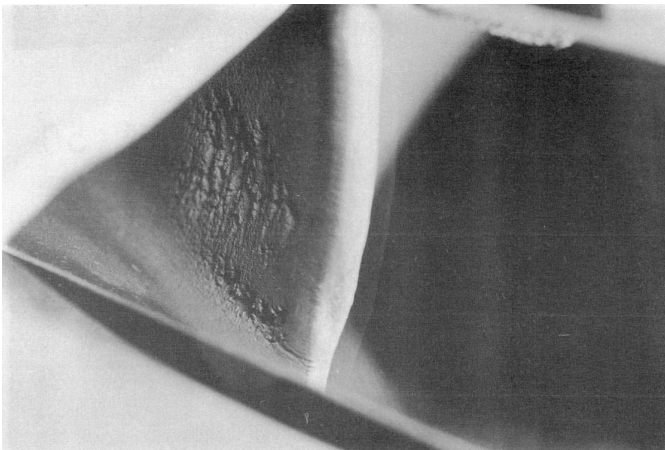
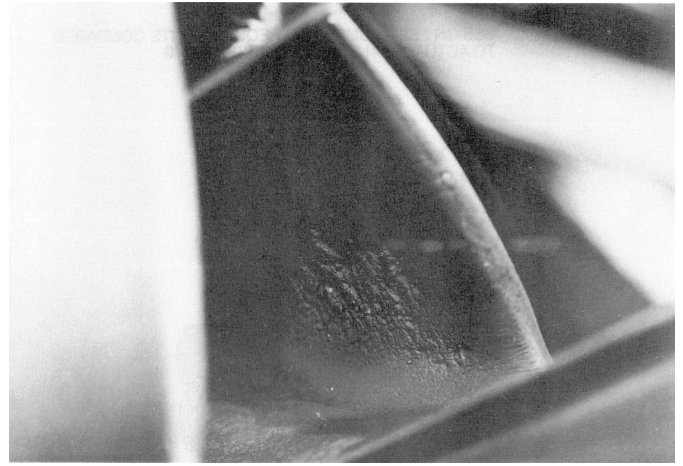
*Photographs 3 and 4: Feed Pump Impeller vane – pressure side cavitation damage*

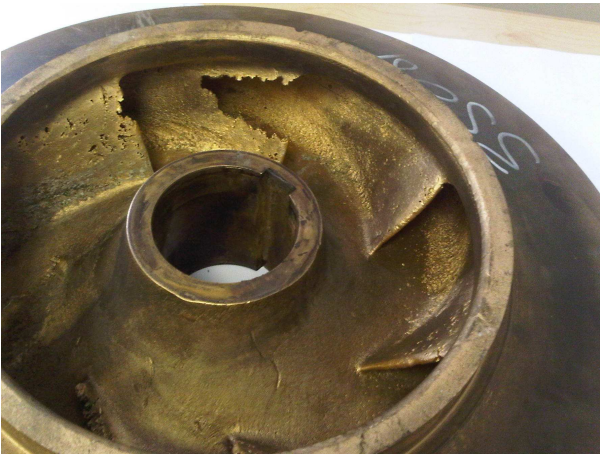
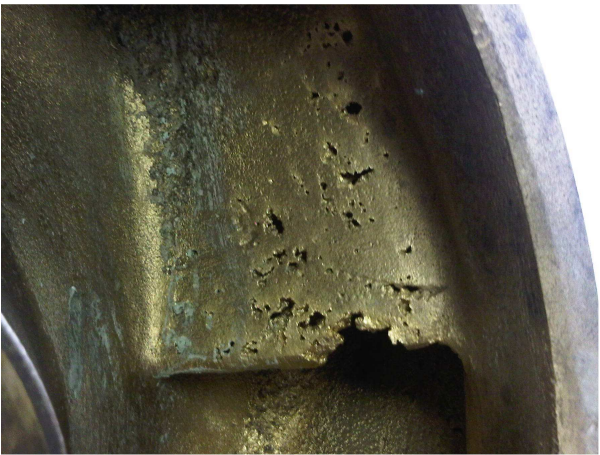
Severe cavitation damage has been observed on the pressure side of the suction impeller vanes of the high lift pumps, see Photographs 5 and 6.

- The pumps were running to the right of the duty point and BEP – overload operation, see Figure 1.4
- The NPSH available from site versus the NPSH required by the pump were found to be marginal, especially when pump is running to the right of the duty point and BEP, see Figure 1.4. Figure 1.5 indicates the NPSH curves and cavitation identification for radial impeller designs.

- The actual system resistance was found to be lower (lower frictional loss due to new pipe) and that the control valves installed on each pump was not controlling the pump within the preferred operating point.

- All the above factors has led to severe cavitation damage to the first stage impellers of the pumps and also caused the pumps to run in overload with a lower efficiency and higher power consumption.
- Severe cavitation damage has been observed on the pressure side of the suction impeller vanes of the high lift pumps, see Photographs 5 and 6.
- This pressure side cavitation damage is typical when operating above the 100% duty point as indicated in Figure 1.5.
- The recommendations to rectify the problem was to replace the first stage impellers with 13-4 CrNi impellers and ensure that control valves are set correctly ensuring the pumps run as close as possible to original duty point or BEP.

Photographs 5 and 6: Grootvlei high lift pump suction impeller  
 - pressure side cavitation damage

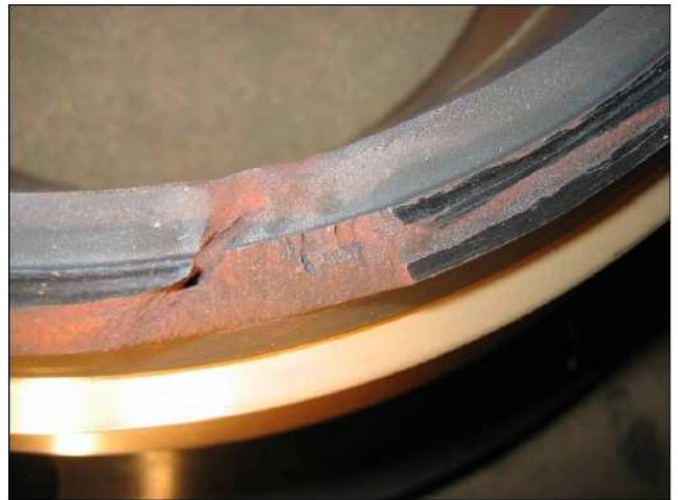
In a number of cases selective leaching of the Antimony from the Carbon-Graphite seal faces has occurred, which results in chipping of the Carbon-Graphite seal face and ultimately in seal failure (elevated seal face temperatures due to excessive leakage across the seal faces) see Photographs 9 and 10. The leaching out of the Antimony from the Carbon-Graphite seal faces is associated with relatively low Conductivity (0.60 to 0.70  $\mu\text{S}/\text{cm}$ ) and relatively high pH (8.3 to 8.5) limits associated with the use of COT as the feed water chemistry treatment regime.

Photograph 9: Tutuka SFP (100 percent Steam Driven Boiler Feed Pump) Main Pump Mechanical Seal - Antimony Impregnated Carbon-Graphite seal face damage

The high seal face sliding velocities results in the generation of static charges in the Mechanical Seal faces. Due to the relatively low Conductivity (0.60 to 0.70  $\mu\text{S}/\text{cm}$ ) of the feed water in use, these built-up static charges cannot be safely diverted back to earth. Electro-static charging occurs as soon as two seal faces separate from each other, where at least one of the seal faces is highly insulated. This leads to an effect similar to the principle of galvanic corrosion as these stray currents inevitably track through the Feed Pump Mechanical Seal faces, causing tracking or arcing marks and pitting which ultimately result in premature Mechanical Seal failure.

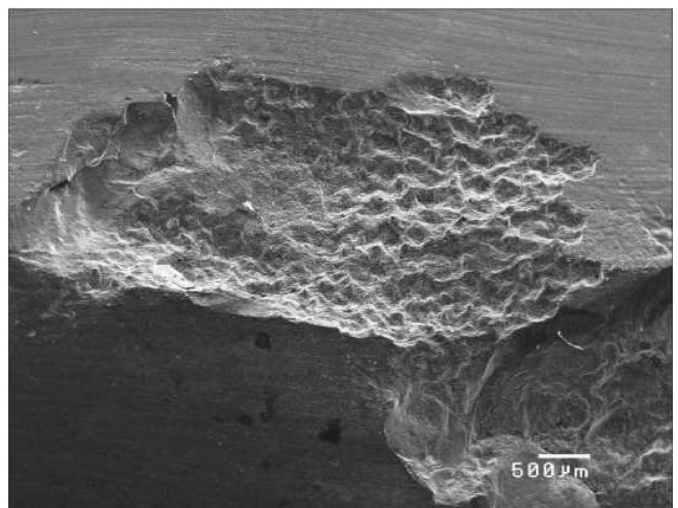
Photograph 10: Tutuka SFP (100 percent Steam Driven Boiler Feed Pump) Main Pump Mechanical Seal – electron microscope image of selective leaching of Antimony from the Carbon-Graphite seal face

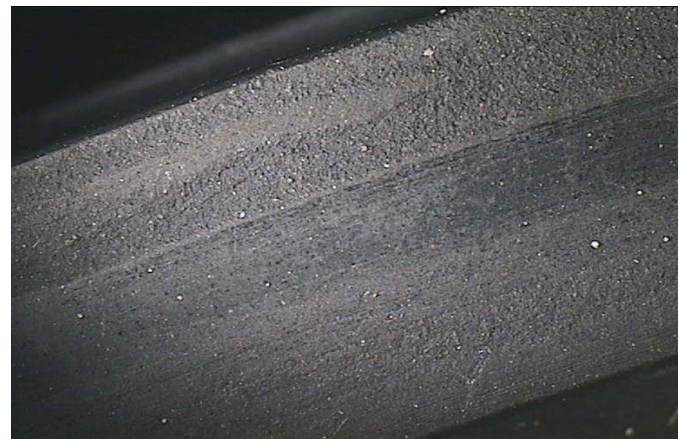
In 2010, the Mechanical Seal supplier recommended the use of "Pure" Carbon-Graphite seal faces instead of Antimony impregnated Carbon-Graphite seal faces and of late the Resin impregnated Carbon-Graphite seal faces. Each of the converted Mechanical Seals was uniquely identified and their performance closely monitored. The first of the converted Mechanical Seals was installed in a feed pump in late 2010. The implementation of the use of "Pure" Carbon-Graphite seal faces in the Tutuka Mechanical Seals however proved to be unsuccessful. The failure mode as experienced previously with the Antimony impregnated Carbon-Graphite seal faces; chipping and tracking of the seal faces was eliminated, but the new "Pure" Carbon-Graphite seal faces proved to be "Too Soft". The failure mode being experienced was that the seal faces were being worn away – see Photograph 11.

Mechanical Seals fitted with "Pure" Carbon-Graphite seal faces failed after less than 10 000 running hours where previously about 15 000 running hours were achieved on Mechanical Seals fitted with Antimony impregnated Carbon-Graphite seal faces. The "Pure" Carbon-Graphite seal faces, as the description indicates are "Pure" Carbon-Graphite, with no additives, thus accounting for its relative "Softness".

*Photograph 11: Worn Carbon-Graphite seal face – "Pure" Carbon-Graphite*

Due to unsuccessful implementation of the use of “Pure” Carbon-Graphite seal faces in the Tutuka Mechanical Seals, the decision was made in early 2013 to revert back to using the Resin impregnated Carbon-Graphite seal faces. Timeline as per Table 2.2 below:

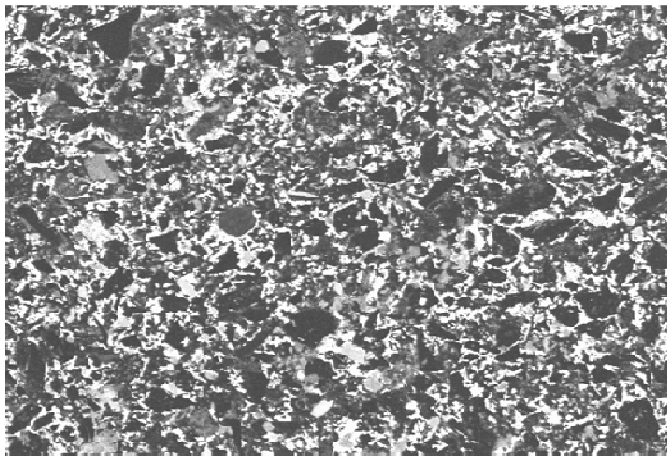
Photograph 12 below indicates a microscopic image of the seal face from a Kendal Main Boiler Feed Pump Mechanical Seal face after 60 000 running hours.

Photograph 12: Kendal Boiler Feed Pump Mechanical Seal Carbon-Graphite Seal Face

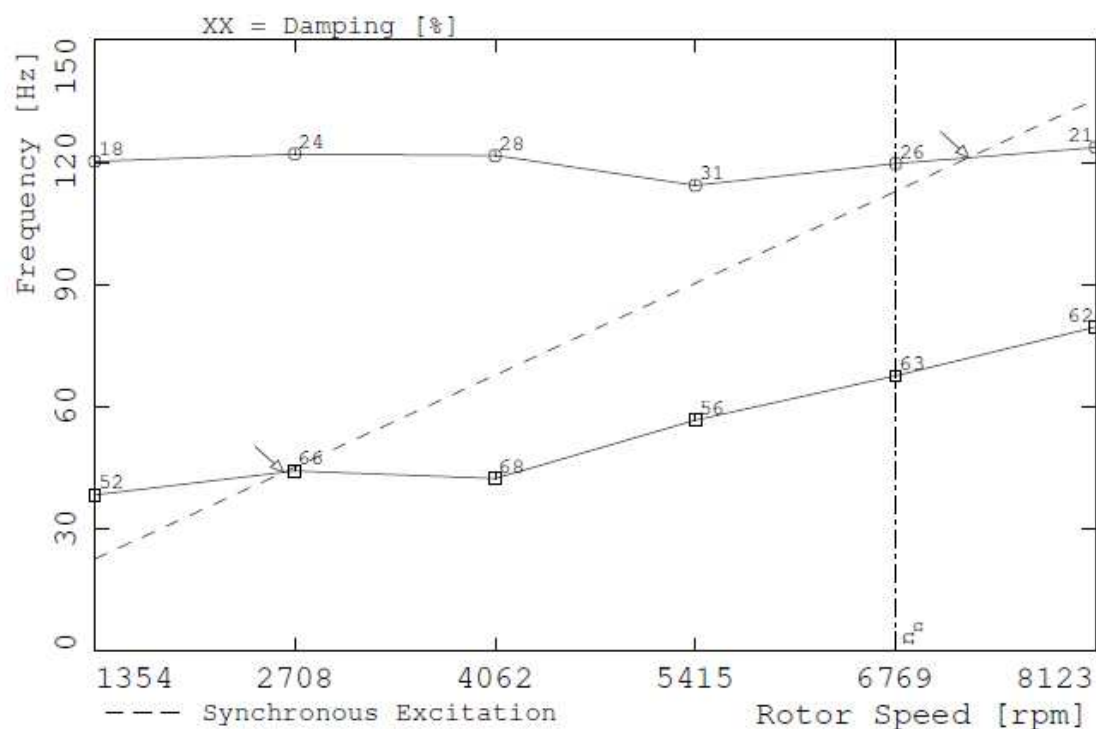
Figure 4.3: Frequency and Campbell Diagram

During the Lateral Vibration Analysis investigation conducted on the new upgraded Arnot EFP (Electric Motor Driven Standby Boiler Feed Pump) it was found that the EFP (Electric Motor Driven Standby Boiler Feed Pump) actually runs very close to its second critical speed see Figure 4.3 below of the Frequency and Campbell diagram.

Critical Speeds: Mode 1: nc = 2631 rpm D = 65.1 %  
 Mode 2: nc = 7266 rpm D = 24.0 %  
 Symbol for Crit. Speed: \

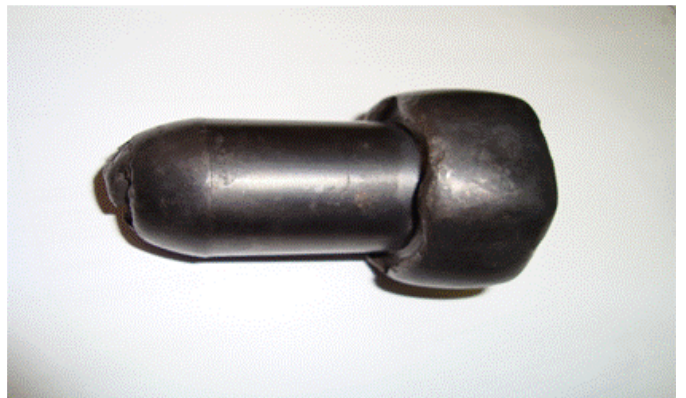
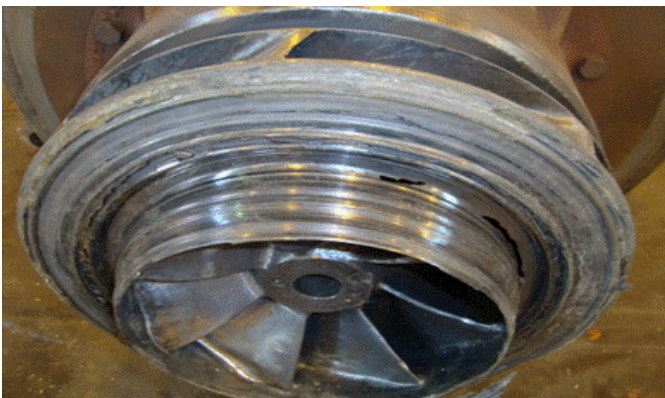
Photographs 19 to 22: Failed Non-OEM supplied BWCP components

Eskom has removed all the BWCP's repairs and refurbishments from the Non-OEM repairer.

All BWCP's are now being repaired / refurbished through their respective OEMs. BWCP refurbishment / repair contracts are in place with these OEM's or their appointed and authorized agents for the repair and refurbishment of BWCP's.

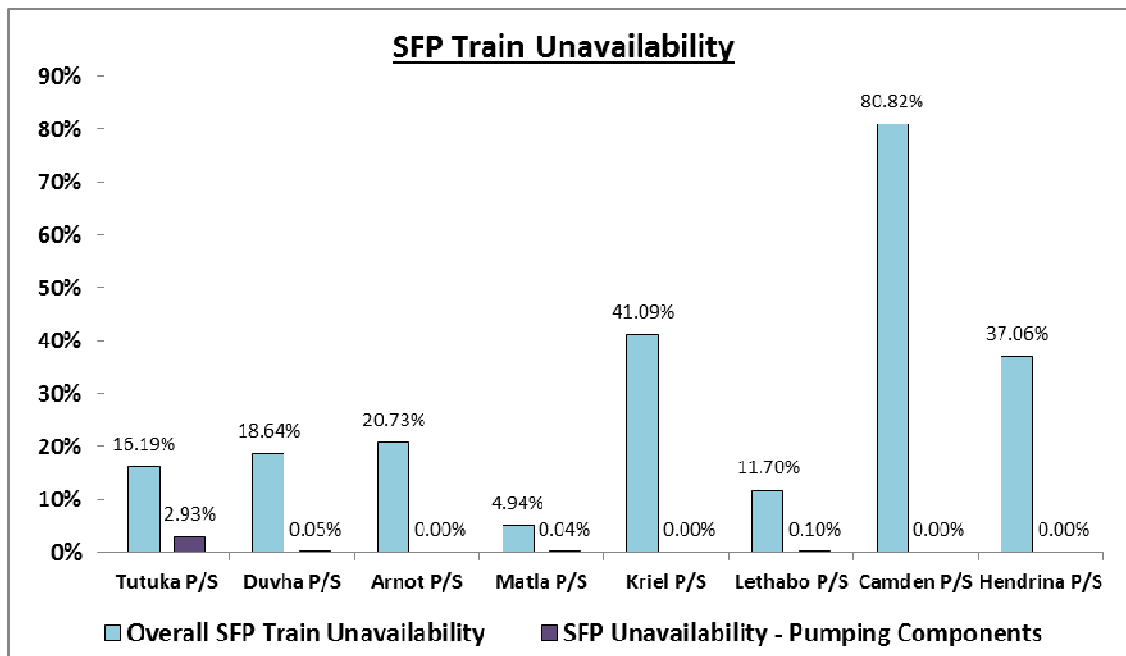
Figure 8.1: SFP Train and Pumping Components Unavailability

It should be noted that a major contributor to the recorded SFP (Steam Turbine Driven Boiler Feed Pump) train unavailability due to pumping components at Tutuka Power Station are the frequent replacement of the Main Pump Mechanical Seals (see Section. 2).

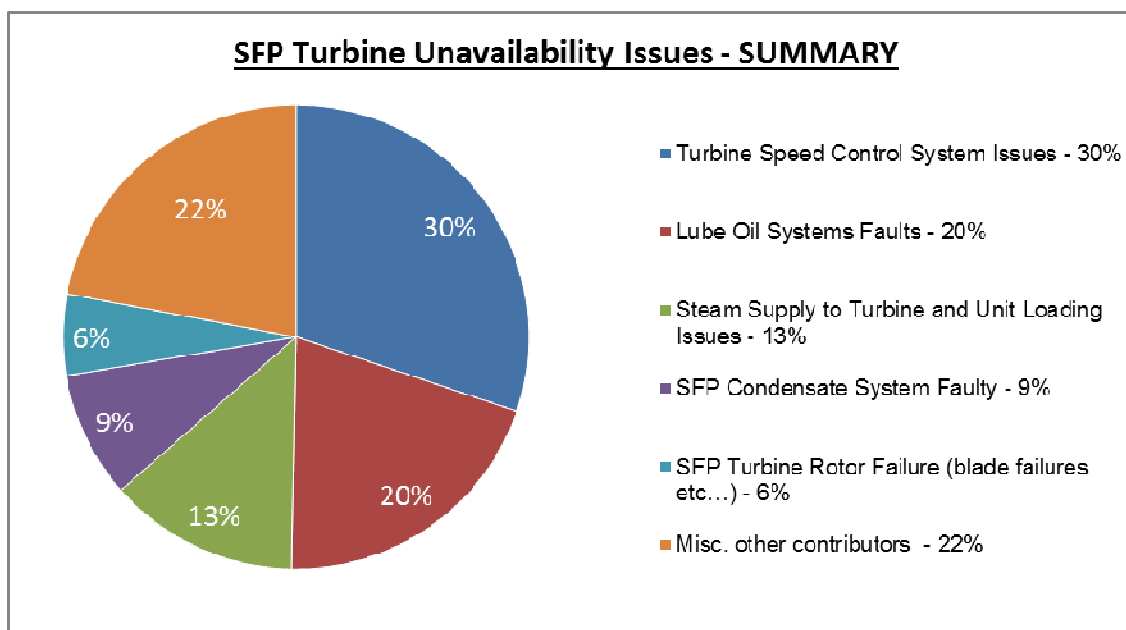
Figure 8.2: SFP Turbine Unavailability Issues

The graph below Figure 8.2 indicates as a percentage of severity, each of the issues being experienced.
