TURBOMACHINERY
& PUMP SYMPOSIA

Poor Hydraulic Performance from Large Barrel Pumps

Johnny Pellin

Flint Hills Resources, Pine Bend, MN Refinery

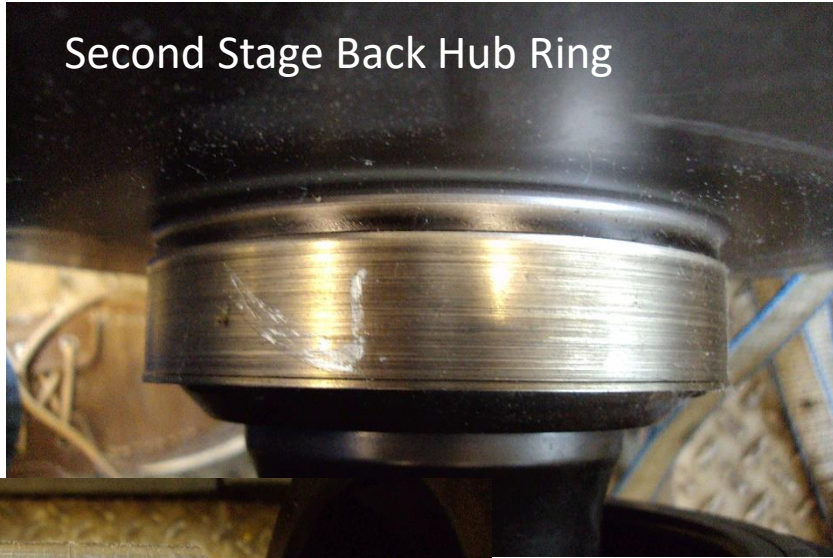
Second Stage Back Hub Ring

- A and B pumps running for 22 and 15 years since last overhaul
- C and D pumps require overhauls every 3 to 5 years
- Conditions found at overhauls:
 - Spec clearance in impeller eye rings
 - Extreme damage to hub rings
 - Extreme damage to separation bushing (1st to 2nd stage)
 - Spec clearance in center bushing
 - Extreme damage to throttle bushing

The location and appearance of the damage is indicative of abrasive wear from passing hard solid particles. Pictures and notes from past overhauls confirmed the presence of abrasive solids.

- Harder materials on the affected wear rings and bushings
- The back wear rings, bushings and sleeves were upgraded to 420 and 440A stainless steel with Direct Laser Deposition surfacing. Hardness increased to 44 to 50 Rc
- Upstream changes to reduce the concentration of abrasives in the process stream

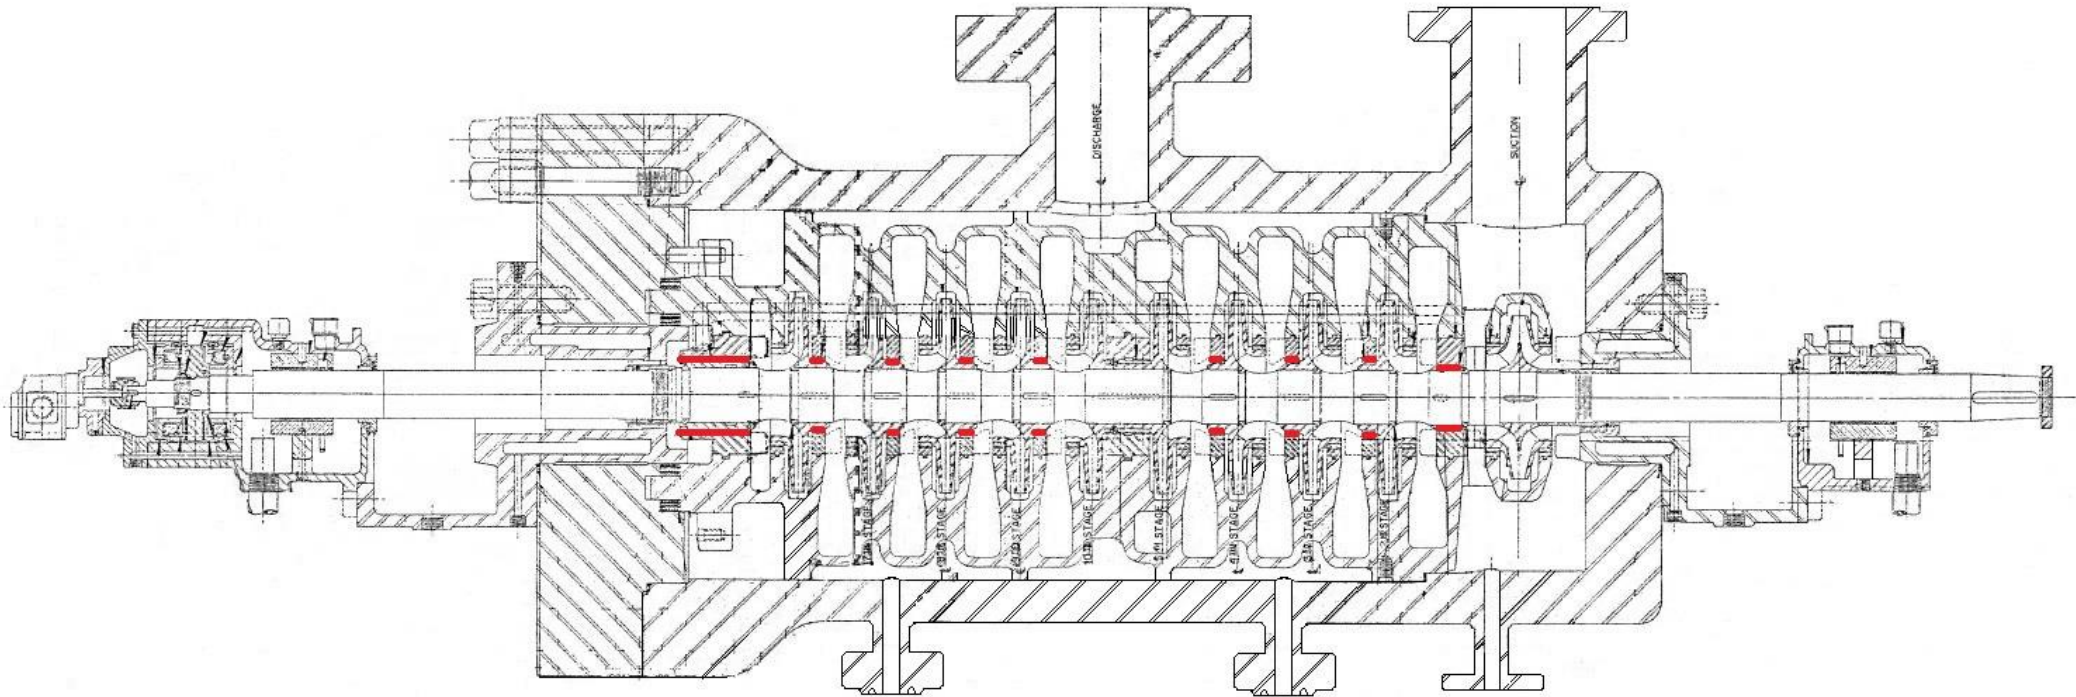
Wear rings and bushings shown in **RED** were badly damaged. The others were in near perfect condition.

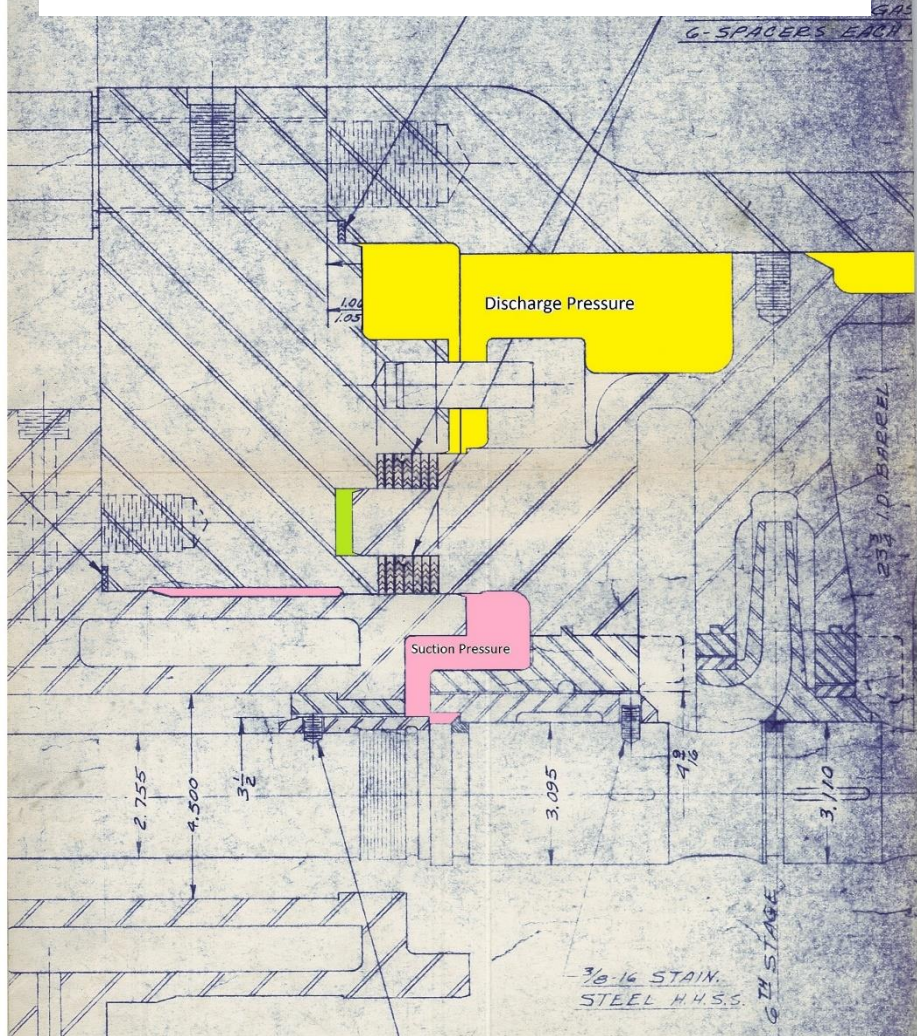
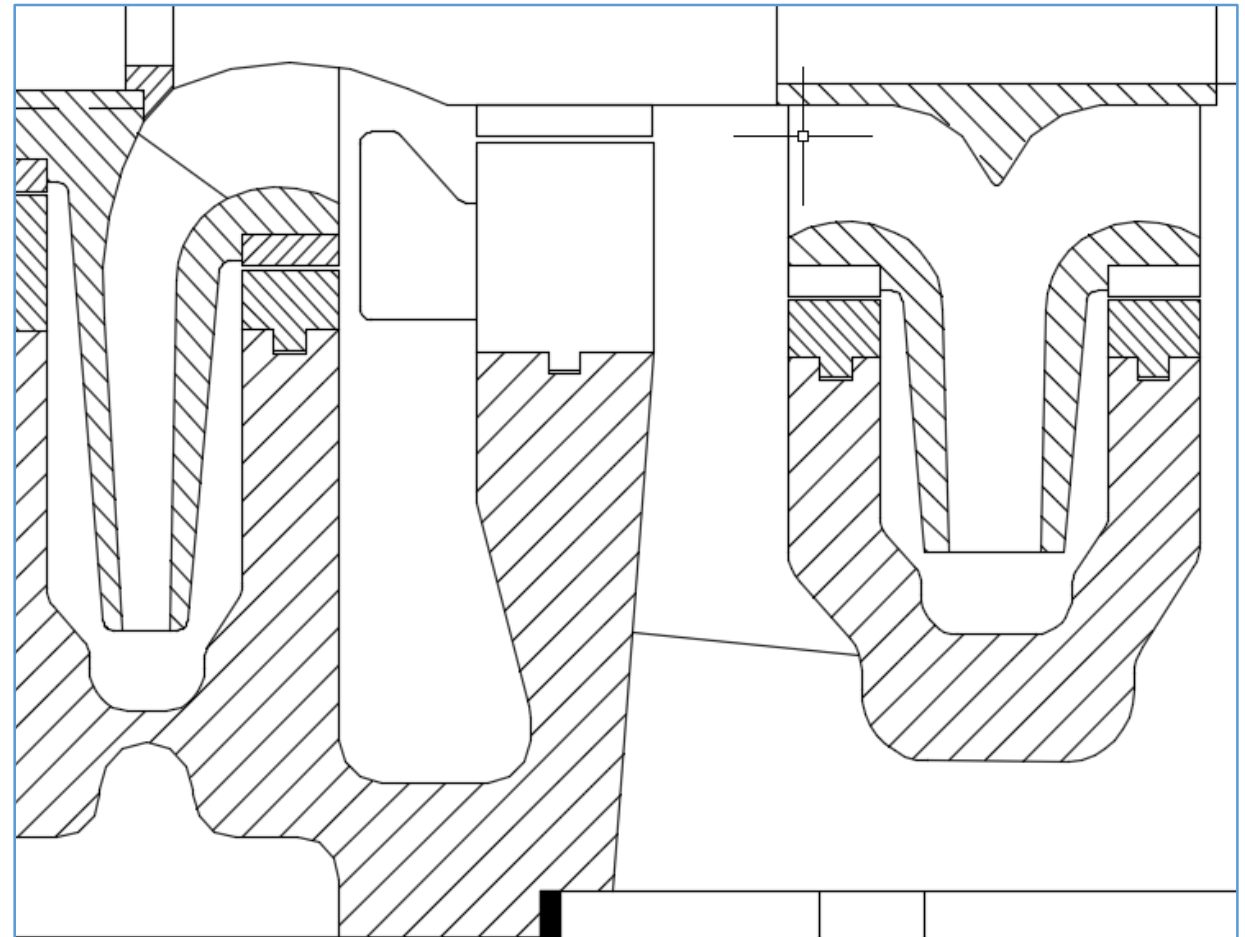
Stacks of compensator gaskets with spacers separate discharge pressure from suction at the outer head.

One internal gasket separates full discharge pressure from suction where the inner casing seals to the outer casing.

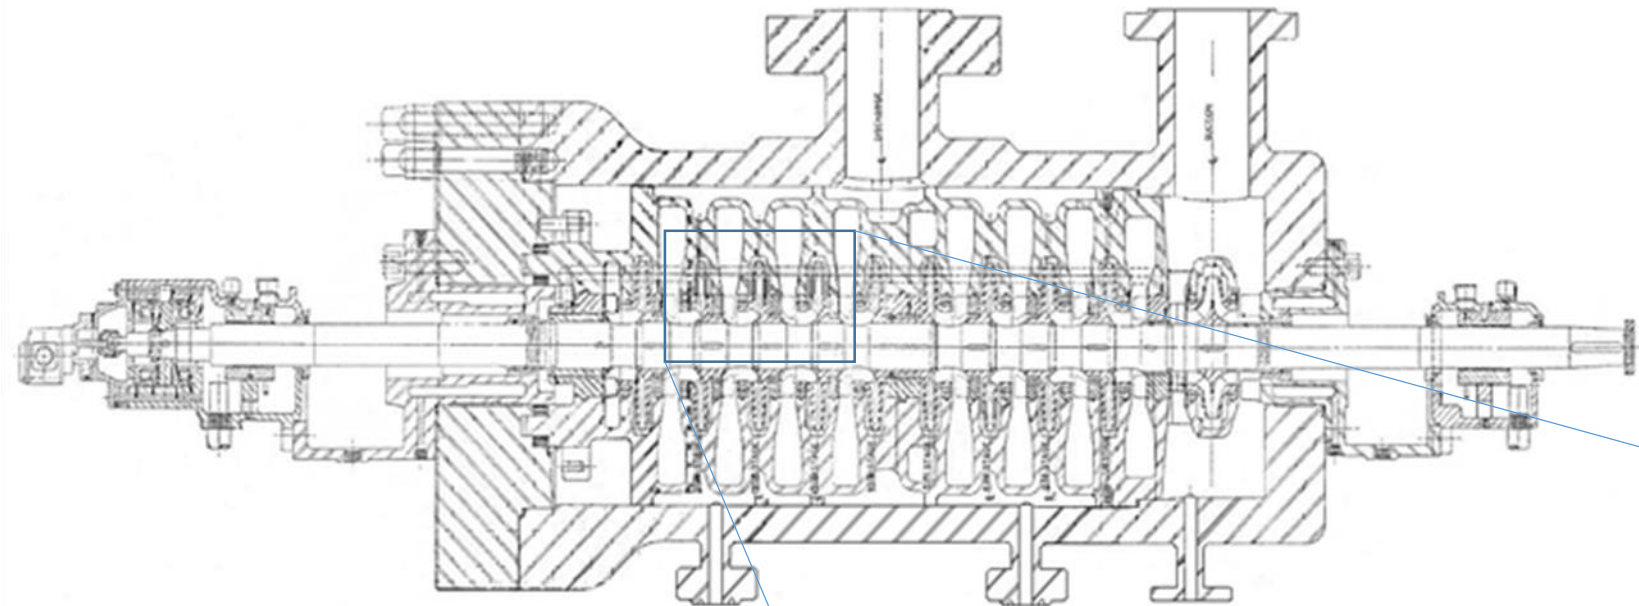
Because of the flow path, solids tend to be directed into the back hub rings and away from the eye rings.

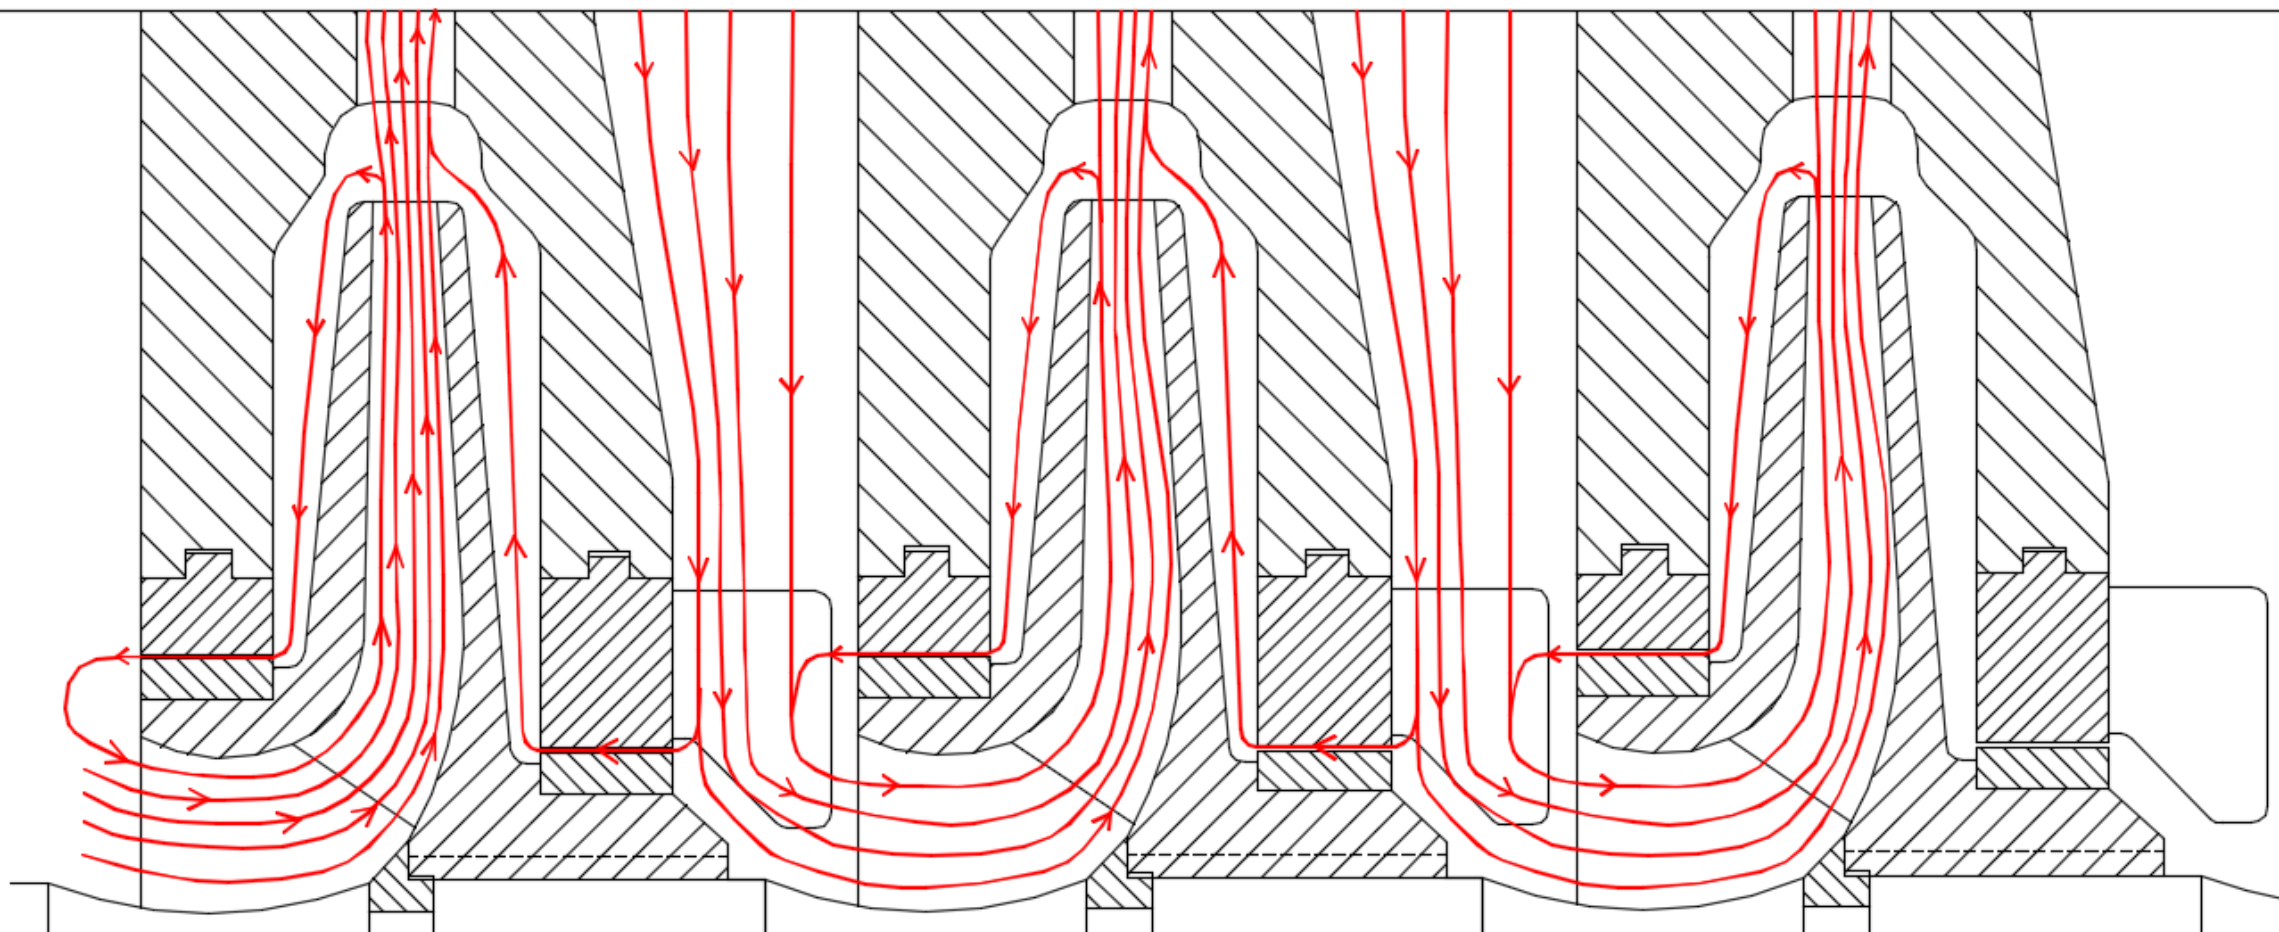
Flow entering the eye rings has been drawn inward against centrifugal force which tends to remove heavy solids.

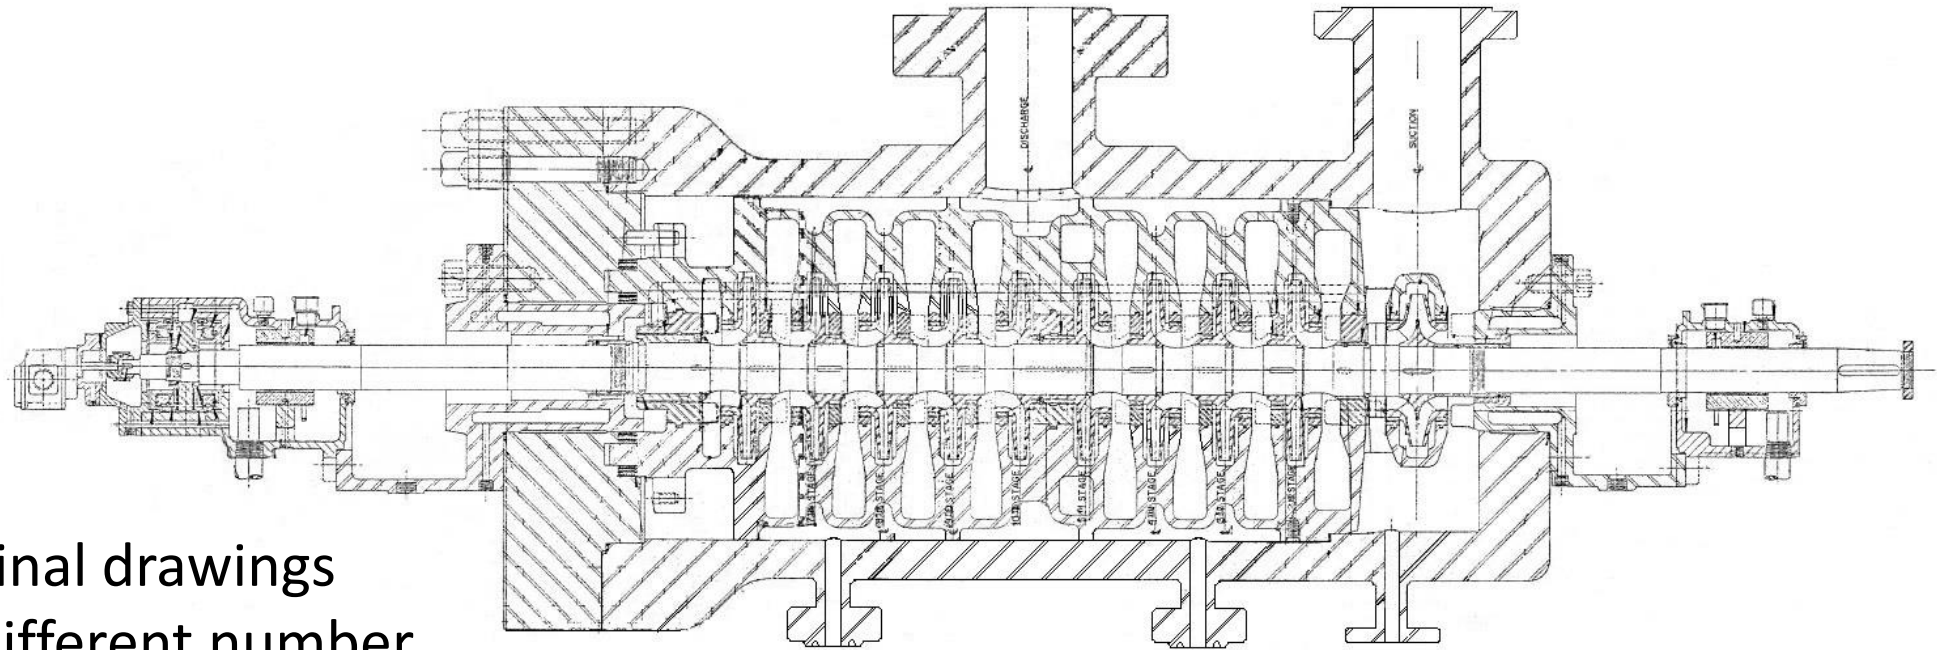
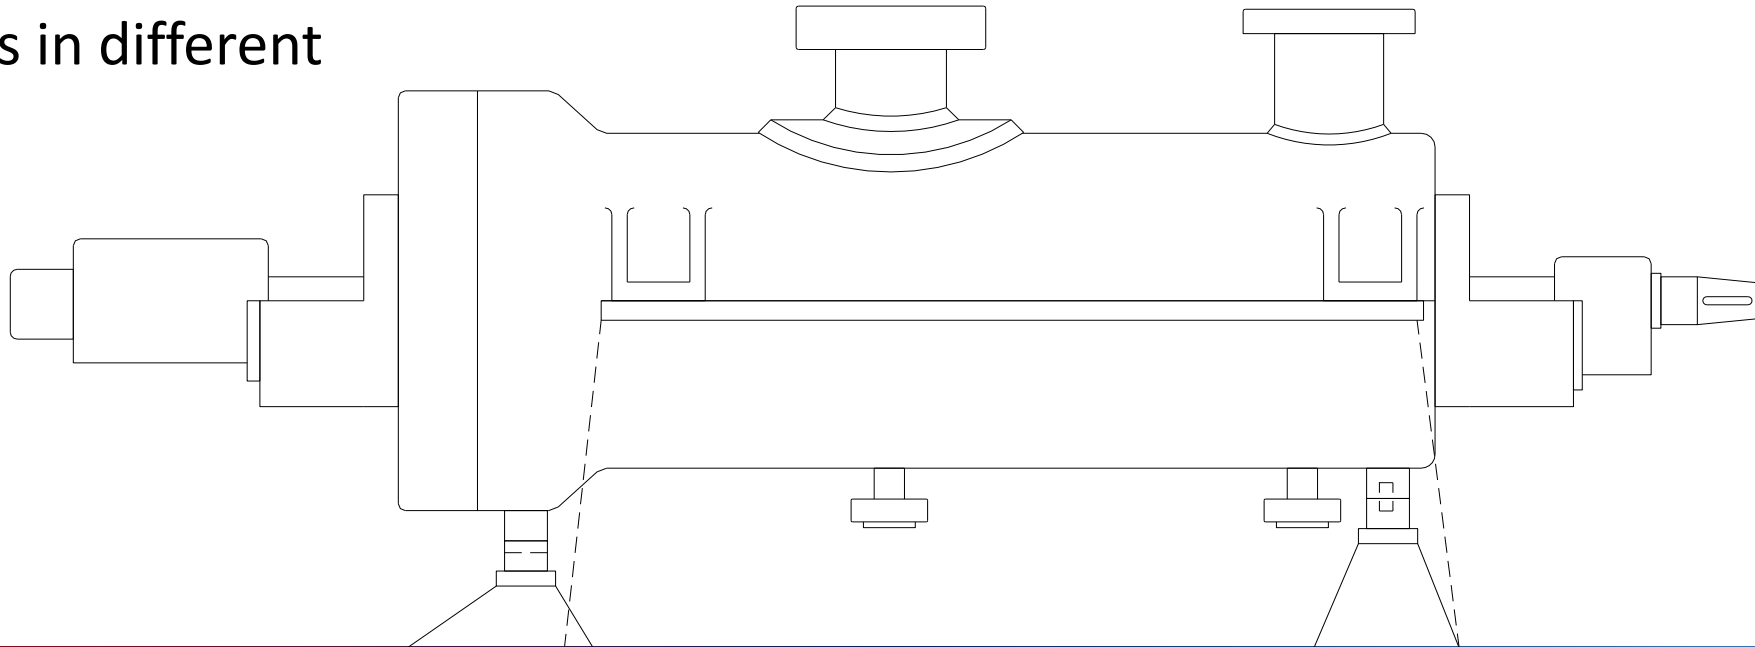
A team was formed and another analysis was started to try and determine the root cause. This time, a discrepancy was noted almost immediately. There was a critical difference between the depiction of the case drains in the pump cross-sectional drawing and the general arrangement drawing. The Cross-Section showed three case drains. The General-Arrangement only showed two case drains.

Two original drawings
show a different number
of case drains in different
locations.

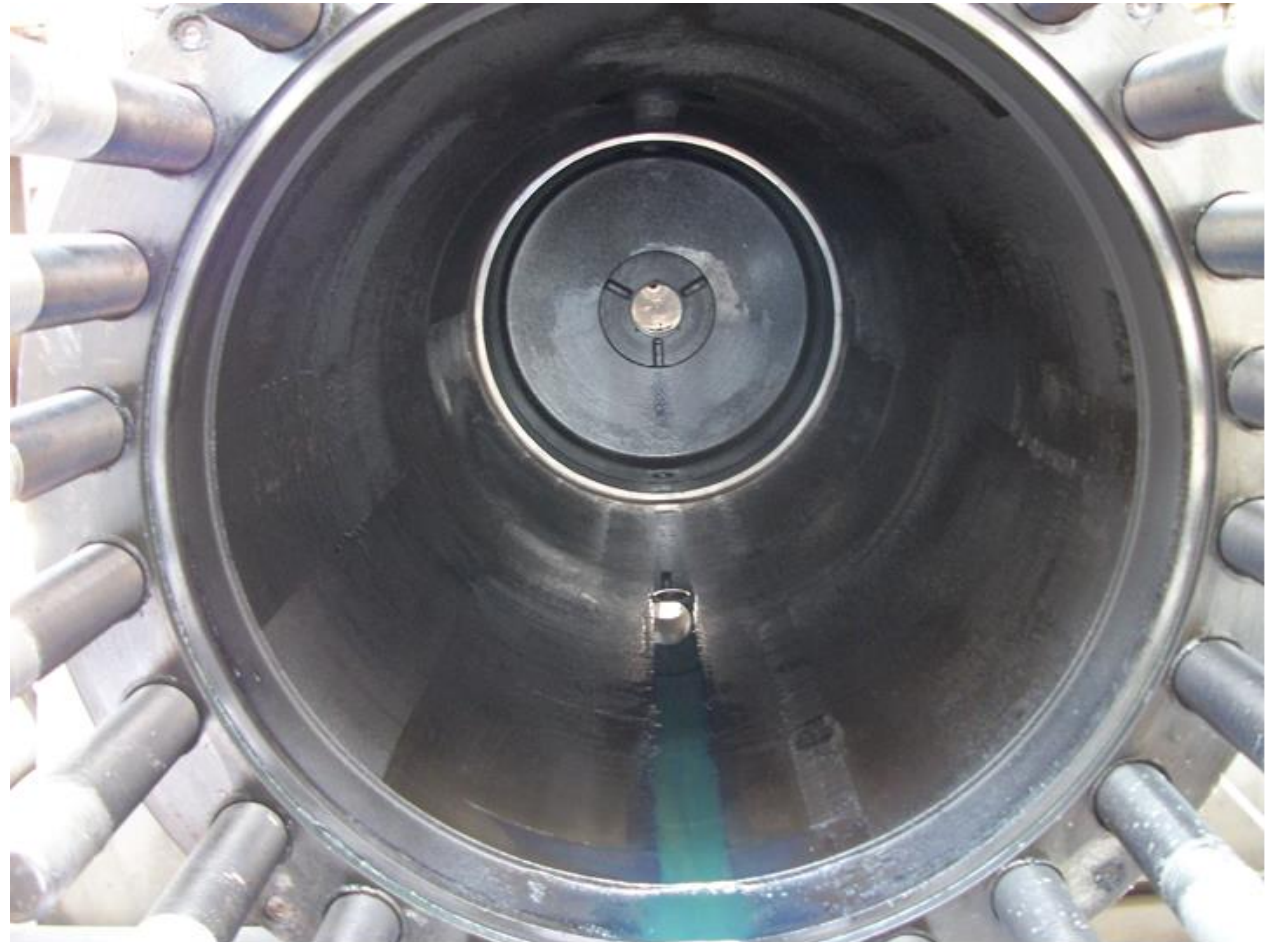
Pictures from previous repairs clearly showed two case drains inside the outer casing. One was located in the suction portion of the casing. The other one was in the discharge portion of the casing.

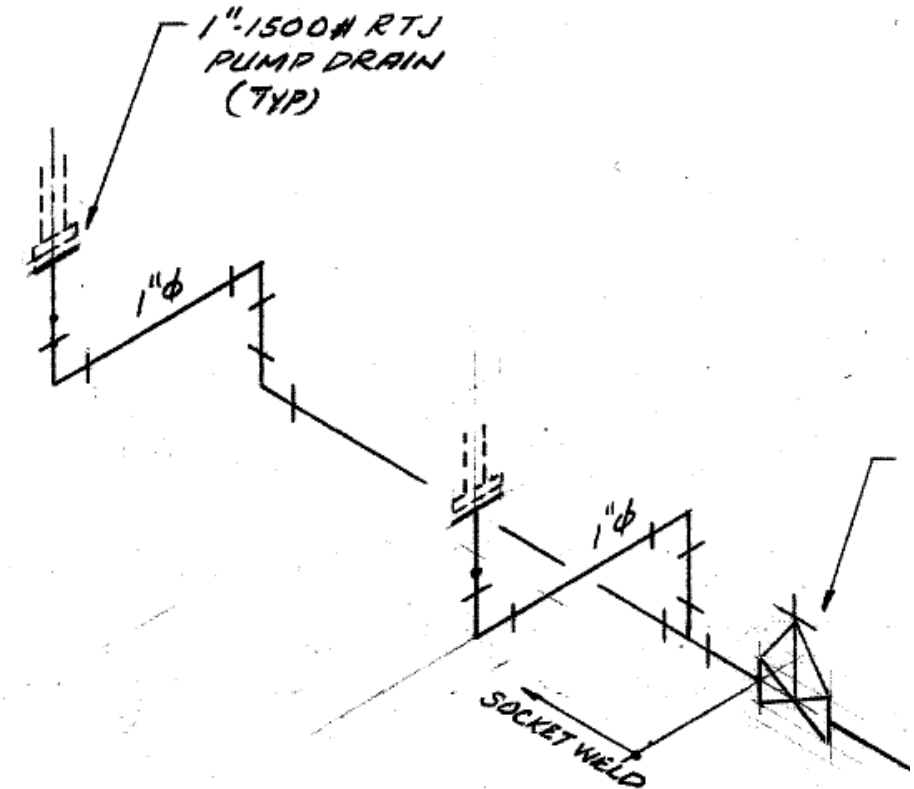
A field walkdown was performed to verify the configuration of the piping. The piping matched the isometric drawing. The two drain lines were manifolded together with a single block valve on the common line.

The two case drains were piped together making a direct bypass of discharge pressure back to suction.

- The piping was modeled. With a differential pressure of 1800 psi (124 bar), the drain piping was bypassing about 200 gpm (45 m³/hour) or one third of the rated flow of the pump.
- The location of the discharge drain was at the largest diameter inside the casing and at the low point of the case. This was serving to concentrate the solids like a centrifuge and direct them back into the pump suction, accelerating the abrasive wear.

Replace the case drain piping. Run two independent lines with separate drain valves.

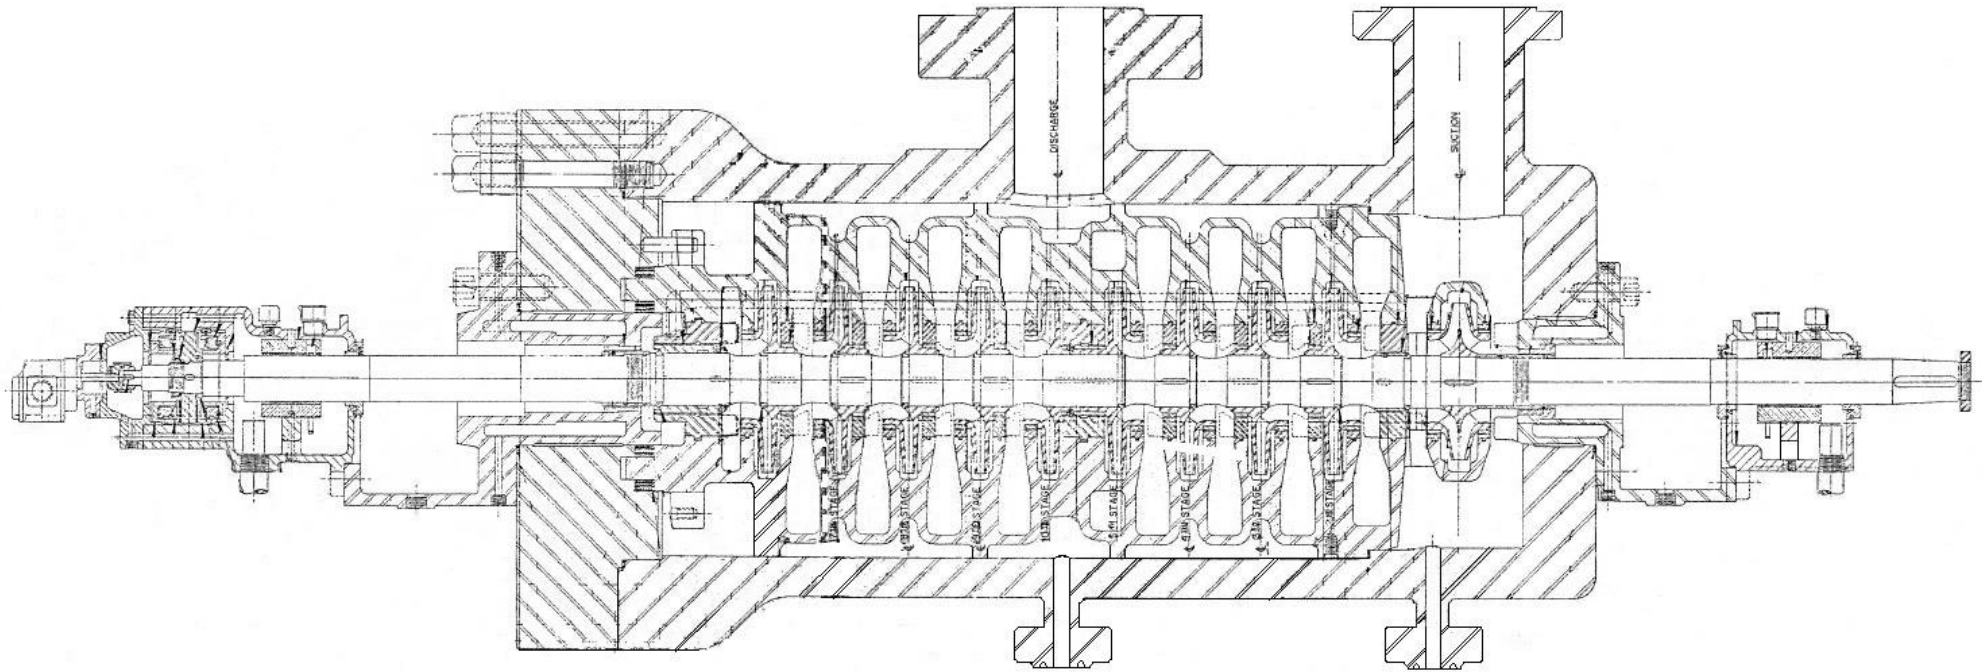
The original cross-sectional drawing was modified to show the actual location and configuration of the case drains
