Case Study on Failure of Gearbox of Cooling Tower Fan in Cement Mill

Mr. Rateesh Venugopalan
VIBSpECTRUM International LLC

Equipment Details:

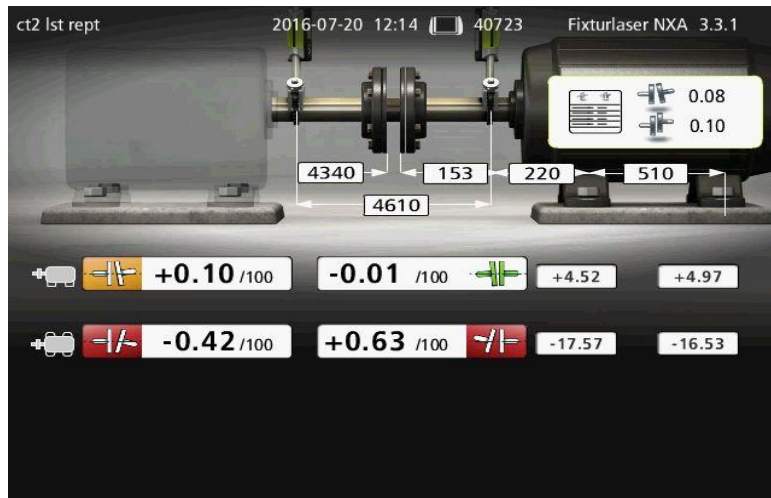
As Found

- The results indicated the spacer coupling between the motor and gearbox shaft was misaligned.
- The correction was performed in the vertical axis and brought to acceptable limits but in the horizontal axis, the correction wasn't possible as the motor was bolt bound in one direction.

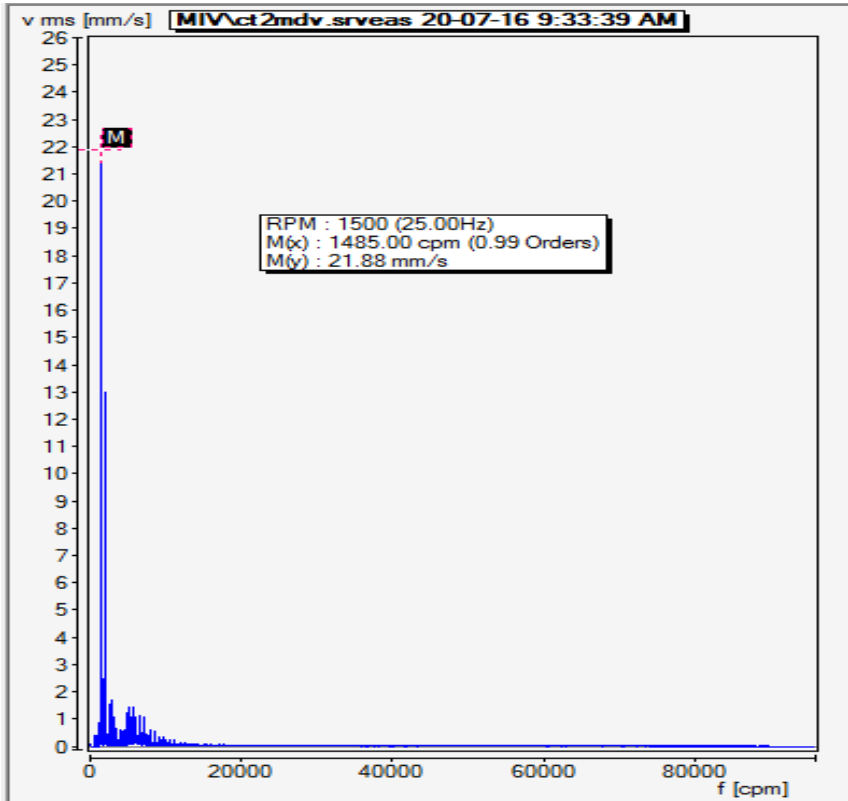
Before Balancing

- The machine was run at full speed after the alignment correction.
- High vibration still persisted on the motor with predominant 1x peak vibration of motor rpm.
- Long cable was laid to capture the vibration on the gearbox and the spectrum was dominated by 1x running speed of the motor rpm.
- Balancing was advised to reduce the high 1x amplitude.
- It was decided to add weight on the coupling for balancing the 1x frequency amplitude.

- The coupling balancing was performed and the vibration levels on motor reduced from 21mm/s to 4.24mm/s RMS.

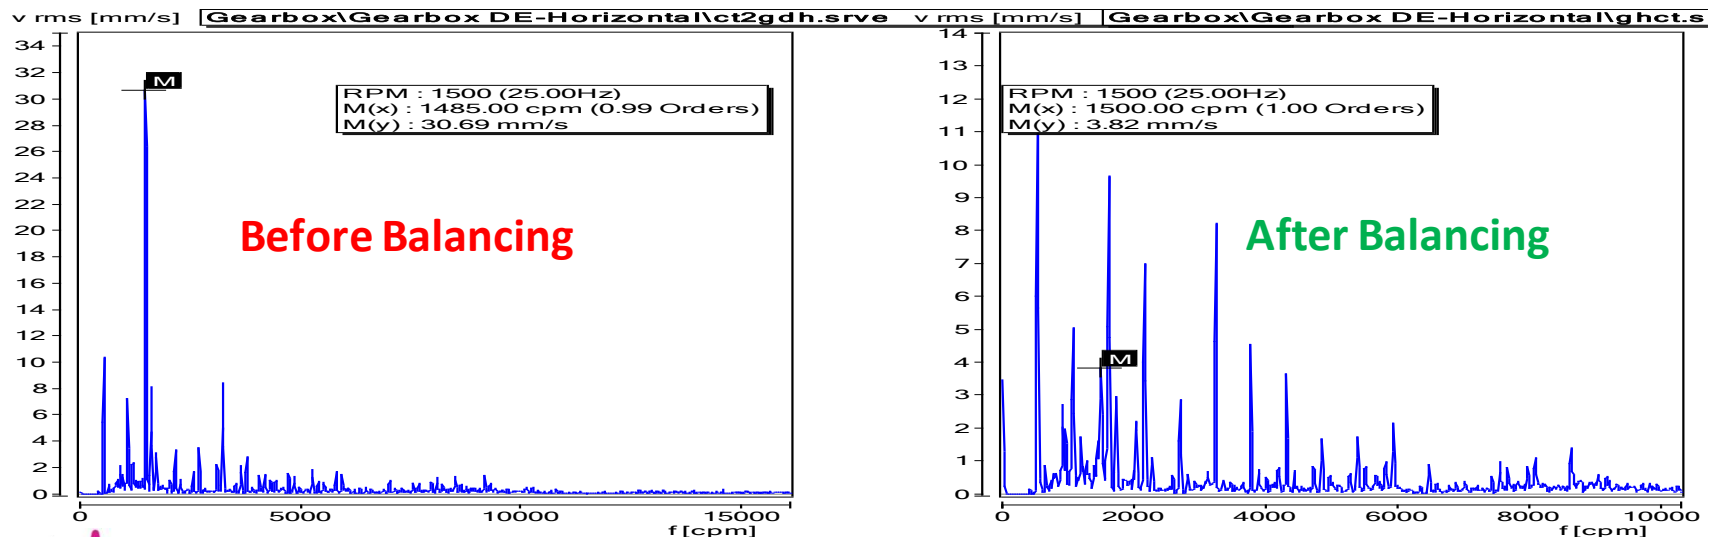
- The vibration on the motor side reduced but the vibration on the gearbox was still above acceptable limits.
- The high vibration was dominated by 1x peak of motor rpm and hence again balancing was advised with sensor mounted on the gearbox input shaft.

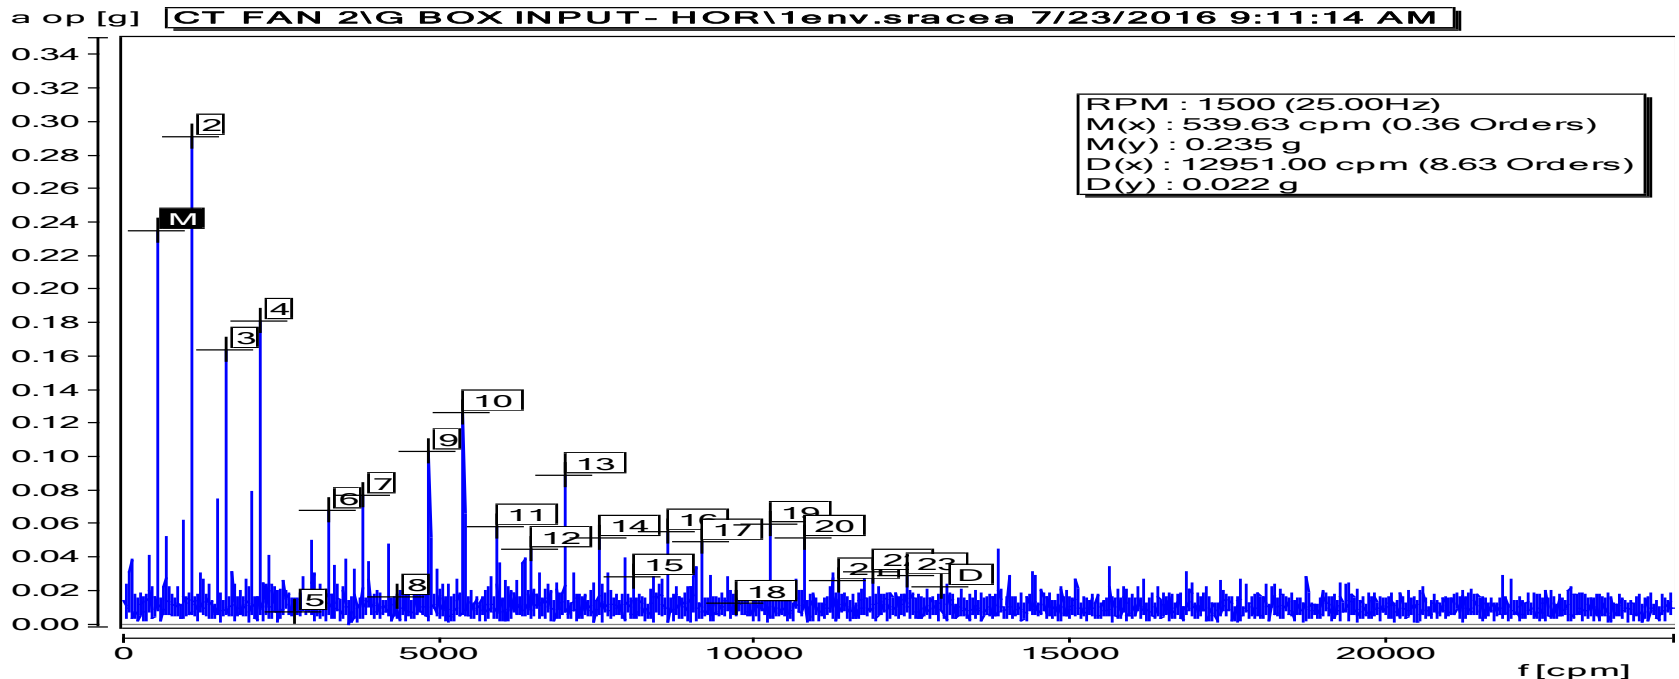
- The new peak of vibration suggested a possible gear failure and on thorough study of the spectrums, the peak 540cpm was co related to the intermediate gear speed.

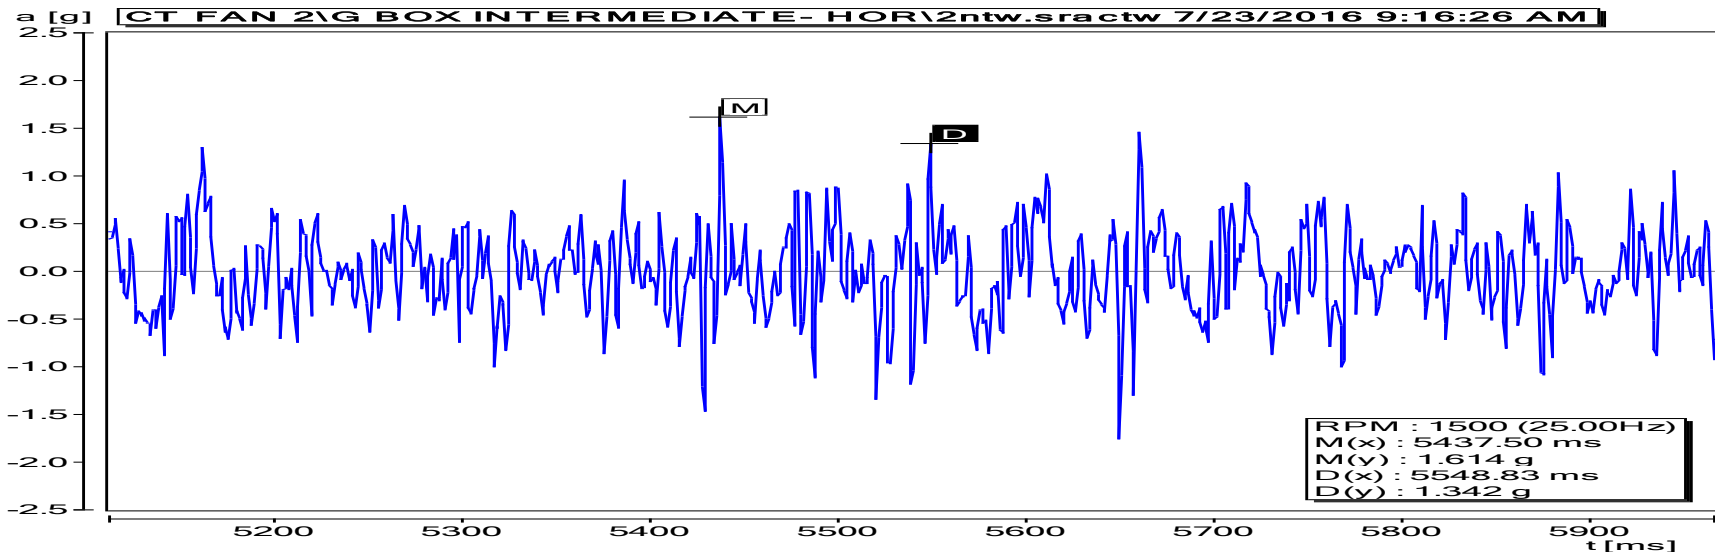
Time waveform:

- The time waveform obtained on the gearbox indicated peaks distinctively spaced at 540cpm.

- The sound profile from the cooling tower was compared with that of a healthy cooling tower gearbox and suggested clear impacts.
- Hence based on the above findings it was concluded to inspect the gearbox.

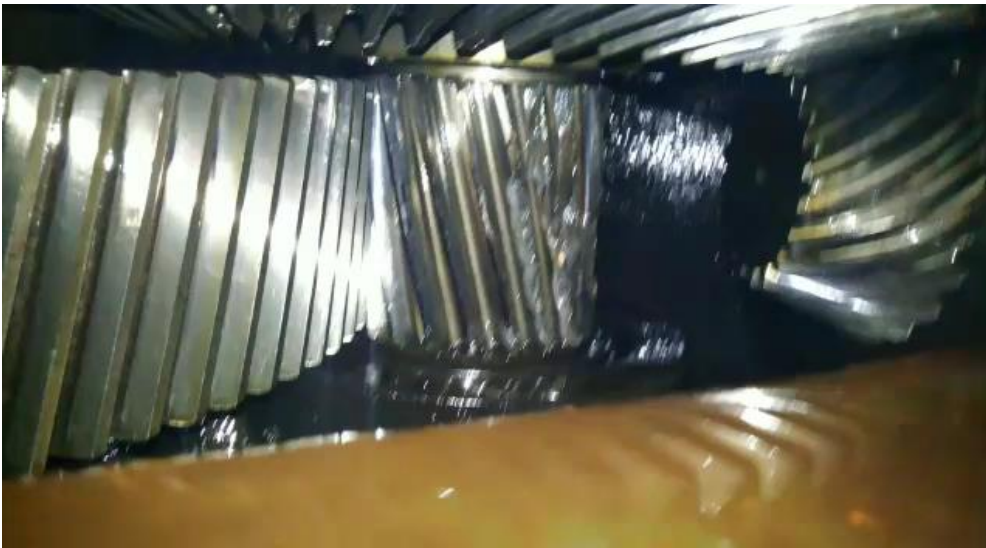
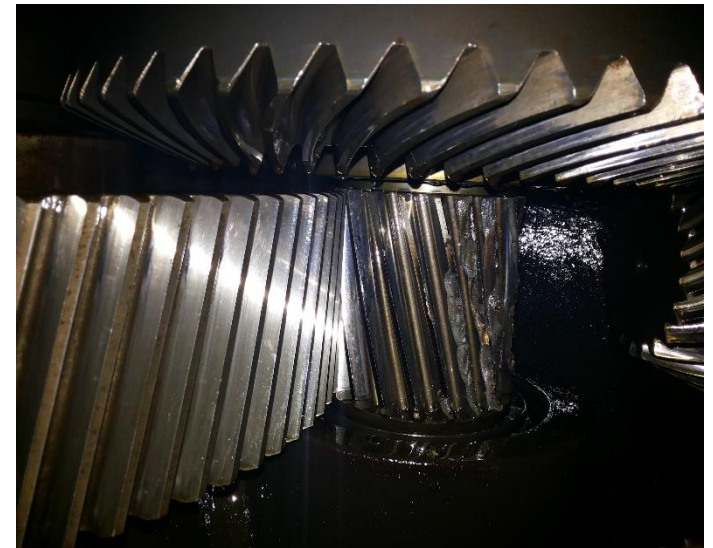
- On inspection, the intermediate shaft pinion was found to be severely damaged.

- The damage corresponds to bending fatigue damage. The probable reasons for this kind of damage are excessive loads or inclusions in the steel.

- The high vibration on the cooling tower was due to failed gear.
- The probable reason of failure on the gear was due to load on the gear which can be due to misalignment or unbalance.
- Vibspectrum was able to capture the gear fault using techniques as time waveform and sound profile of the gear.
- The timely finding of the gear failure helped Gulf Cement avoid catastrophic failure.
- The machine has been operating smoothly ever since July 2016.

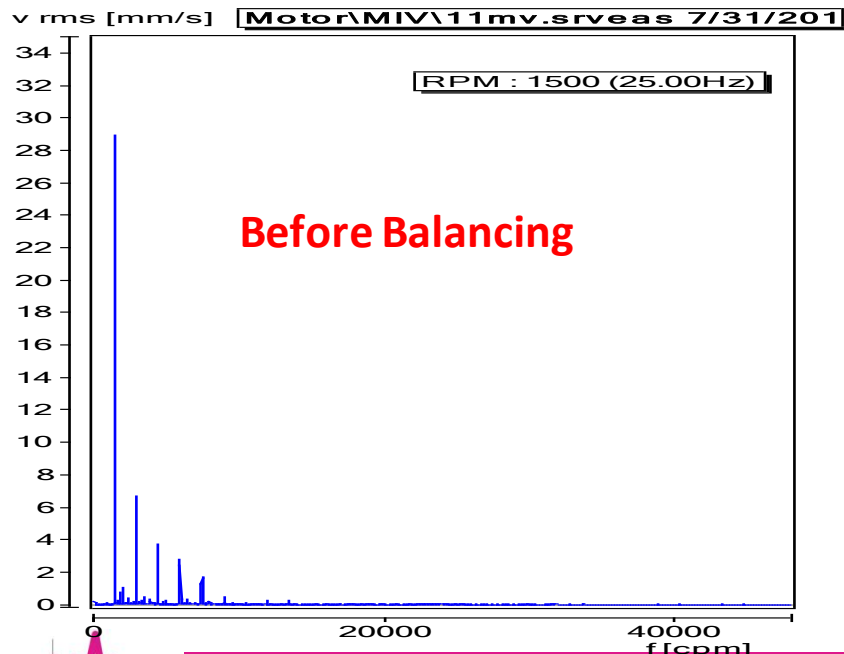
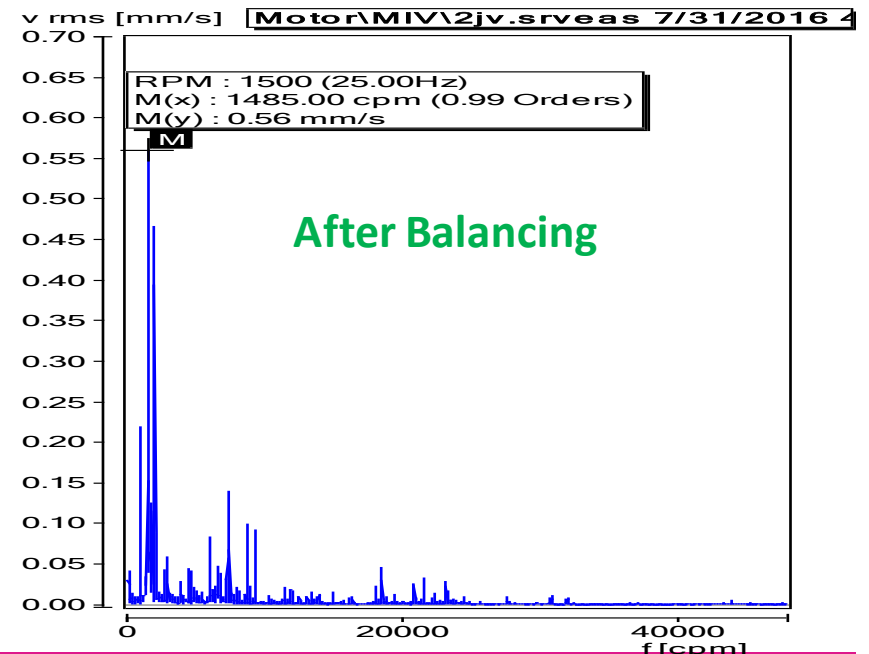
Vibration spectrum after gearbox replacement :

- After replacement of the gearbox, the initial vibration was still high with 1x peak of the motor running speed.
- Coupling balancing was carried out on both couplings and the vibration values reduced to below 1mm/s RMS.
