# Centrifugal Compressor Over Speed Trip Case Study

Authors: Thota Praveen Kumar  
&  
Ali Abdullah

*Qatar Shell GTL Limited-Doha Qatar.*

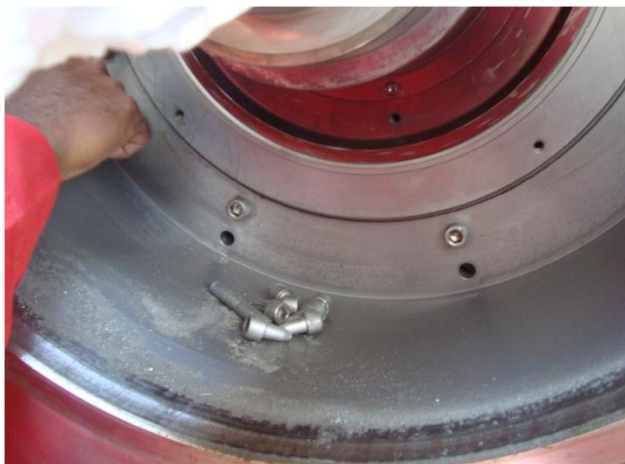
- ❖ Seven of the eight Allen head bolts holding diffuser plate in position were broken. One bolt was completely missing.
- ❖ Seven of the bolt heads were found sitting in the bottom of the balance chamber.
- ❖ One bolt broken had backed out and was found in balance chamber.
- ❖ 5 of bolts had been elongated.

After opening Casing end cover- Balance chamber area

- ❖ Rotor sent back to vendor for repair. Used the spare Rotor for assembly.
- ❖ The threads of the diffuser plate increased from M12 to M16 as they were found loose, and holes in the volute also increased to match.
- ❖ Diffuser plate Dye penetrant test carried out and found that there were no crack caused by the contact.
- ❖ All bolts were tightened with 130NM torque as per vendor recommendation and found no gap between diffuser plate and volute insert.
- ❖ Thrust and Radial bearings were reused.

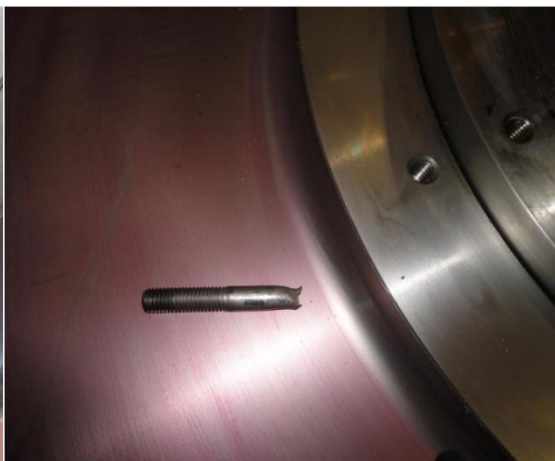
Broken bolt found the section of discharge cover

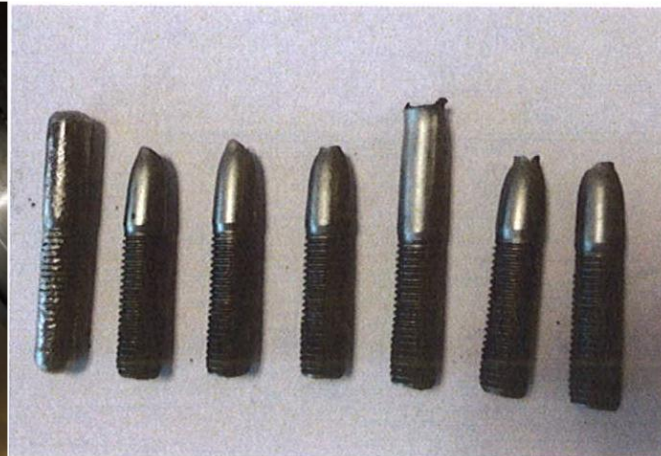
Broken bolts after remove

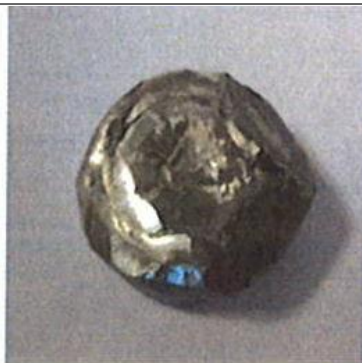
Allen head back side

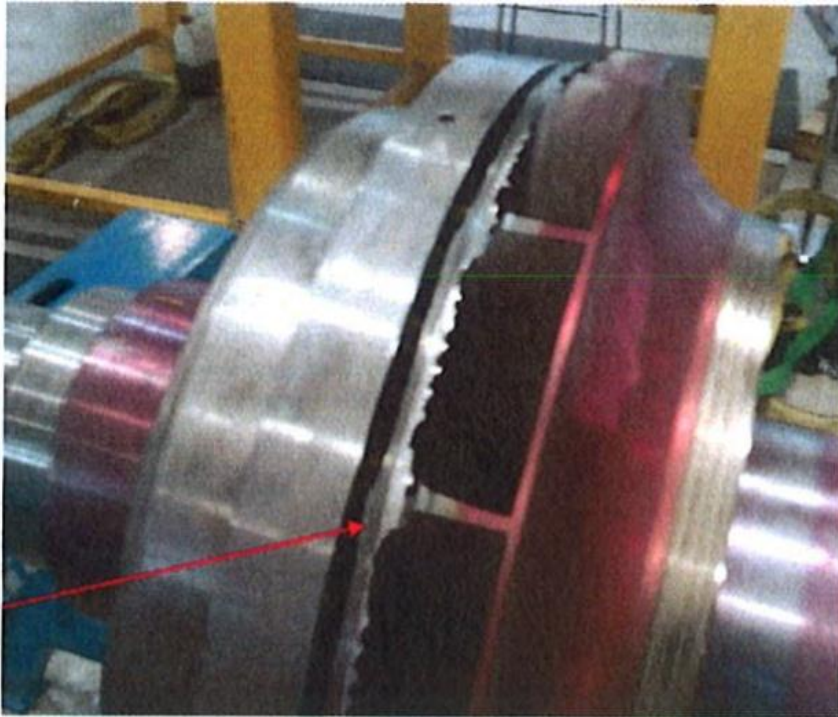
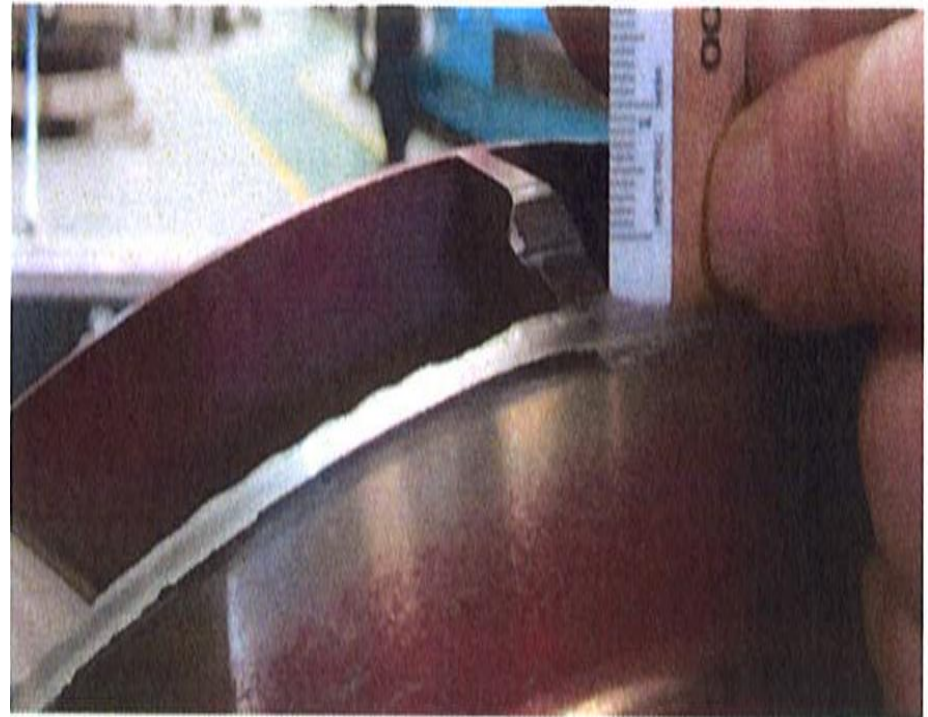
- ❖ The compressor was dismantled and found that outer diameter of the impeller was cut axially 18mm by the diffuser. The cut removed 16 mm from the impeller OD.

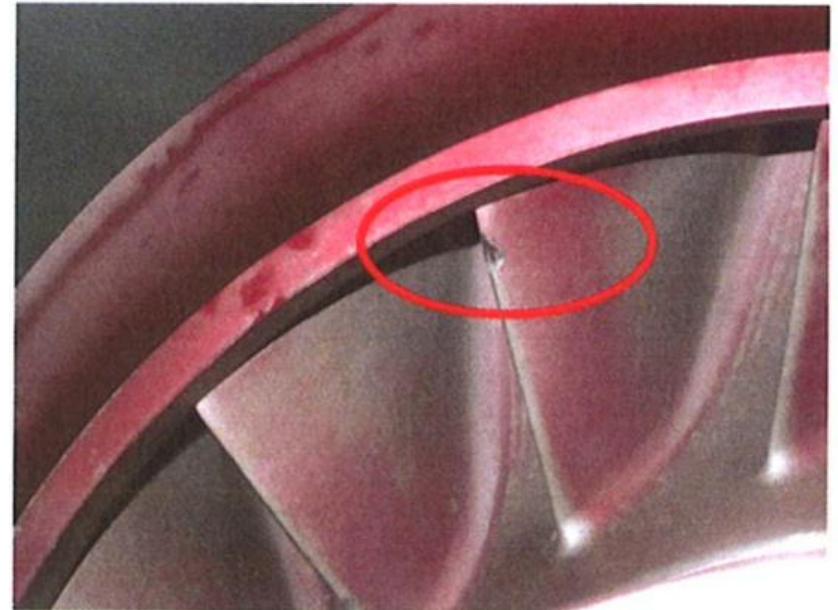
- ❖ At the impeller inlet one blade was found in significant damage and another 2 blades were with minor dents.
- ❖ Balance piston and all labyrinths are found in good condition
- ❖ The both radial and axial bearings were found in good condition.
- ❖ The missing bolt passed through the balancing line to the compressor suction and hit the impeller vane.

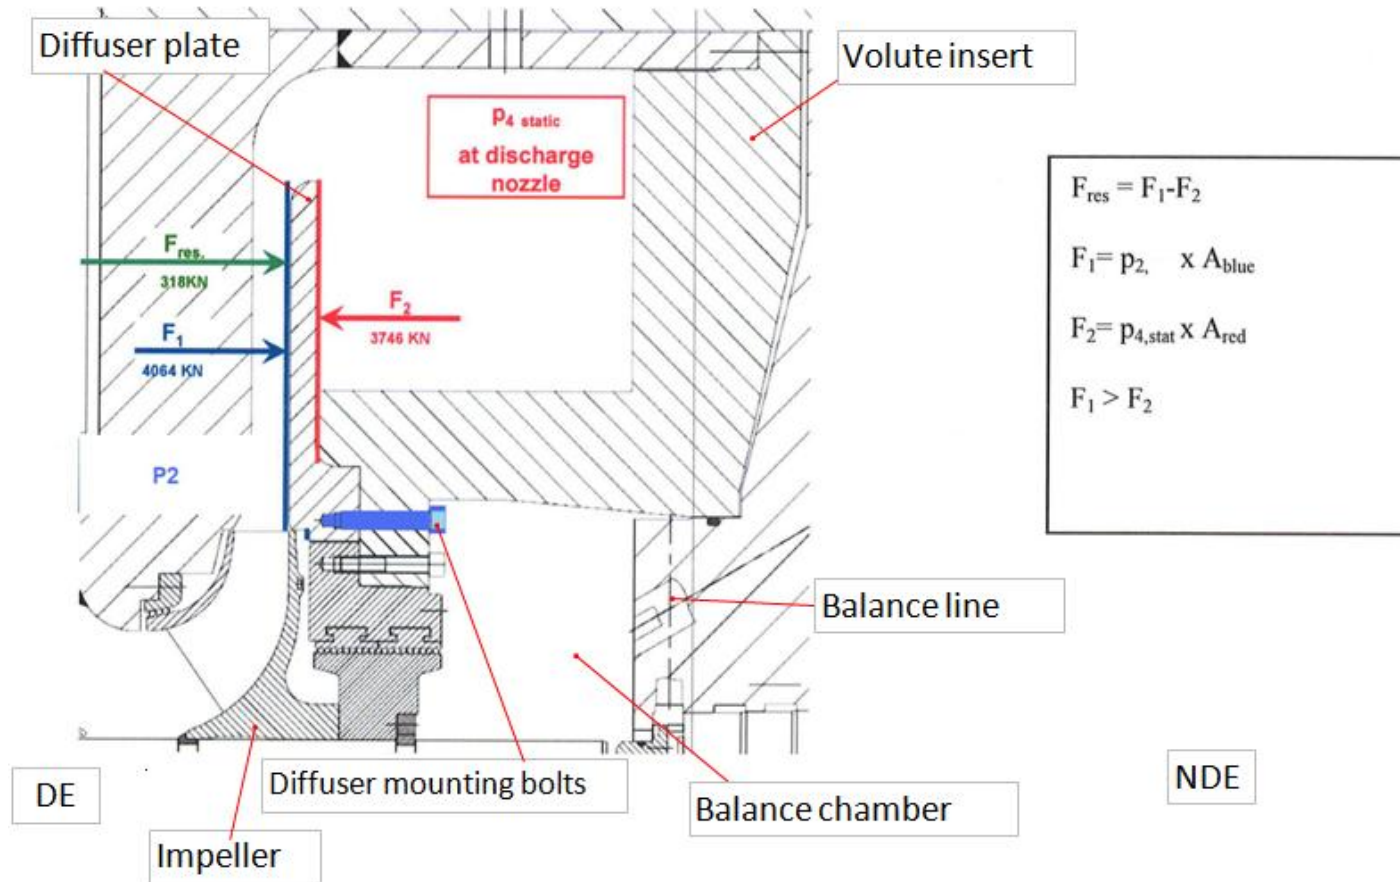
- ❑ The diffuser plate is fixed with 8 bolts. The resultant force during operation pushes the diffuser plate towards the NDE side of the compressor.

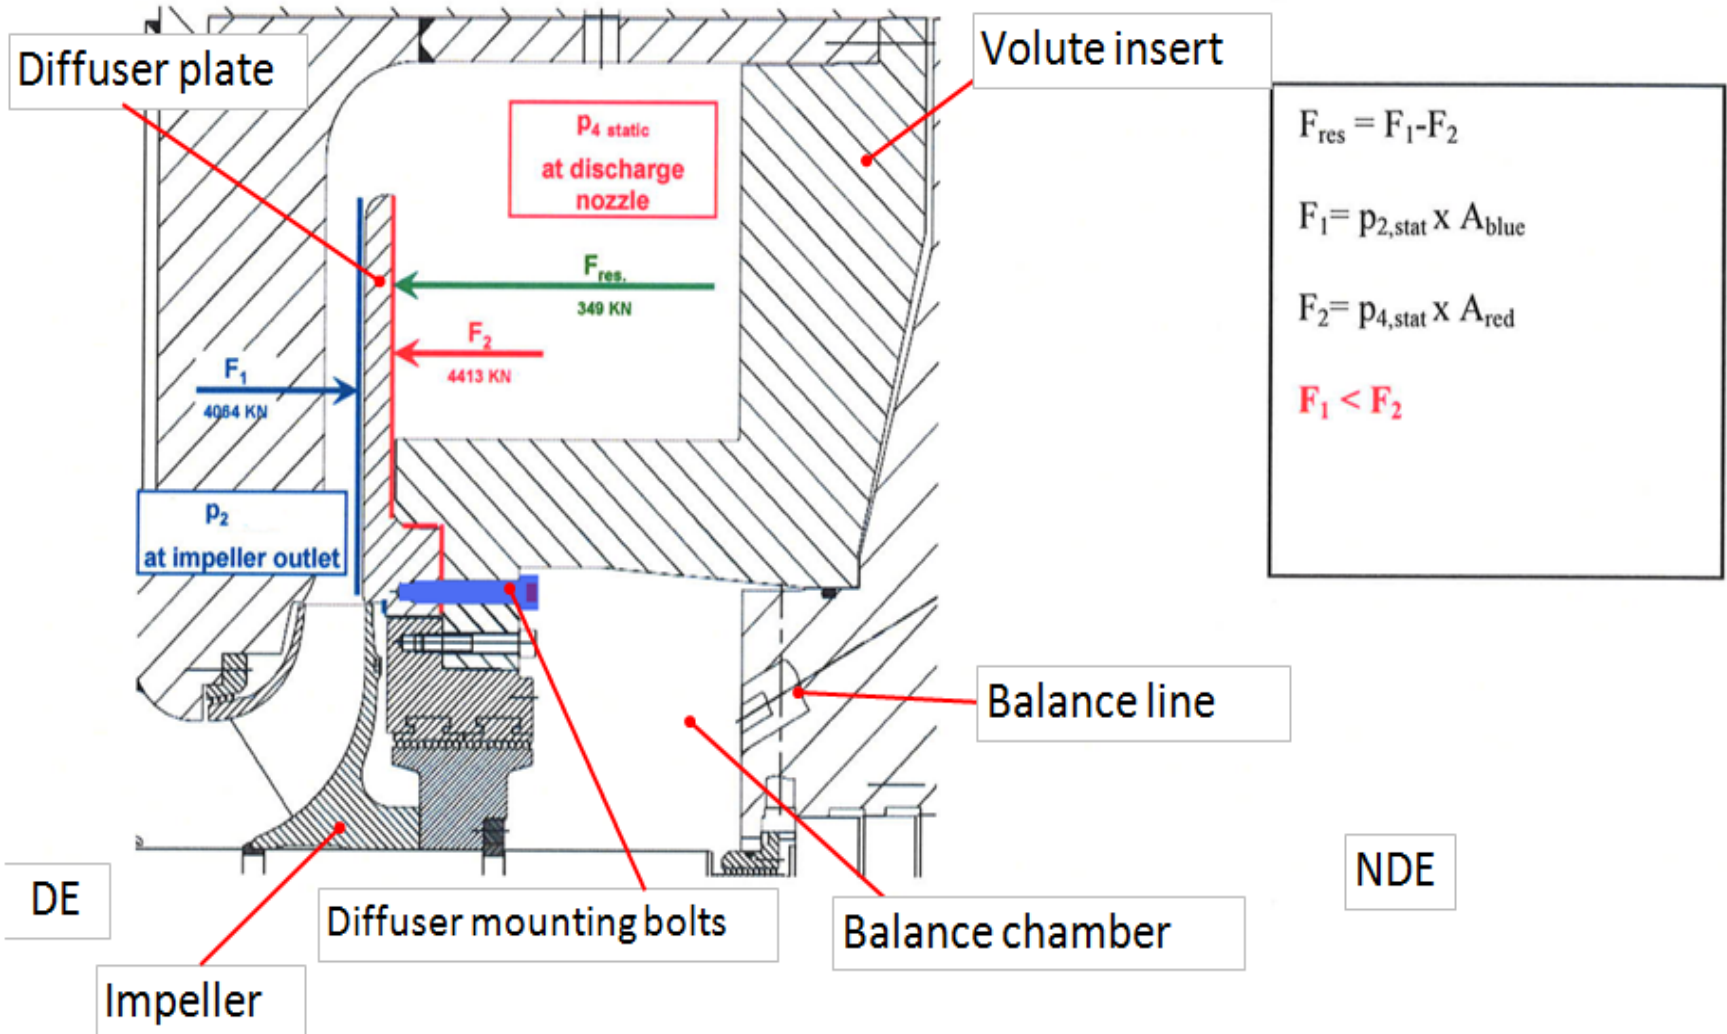
- ❖ The bolts holding the diffuser plate in position were not tightened properly.
- ❖ Additional area behind the diffuser was eventually exposed to discharge pressure (P4) effecting forces on the diffuser.
- ❖ The orientation of the resultant force on the diffuser changed to opposite direction (towards Drive End).
- ❖ The new resultant force exceeds the yield strength of the bolts.

- ❖ The pressure in the balance chamber increased due to a bypass at location of missing bolt head and changed the axial position of the rotor.
- ❖ The diffuser plate pushed towards the impeller and caused the damage of the Rotor

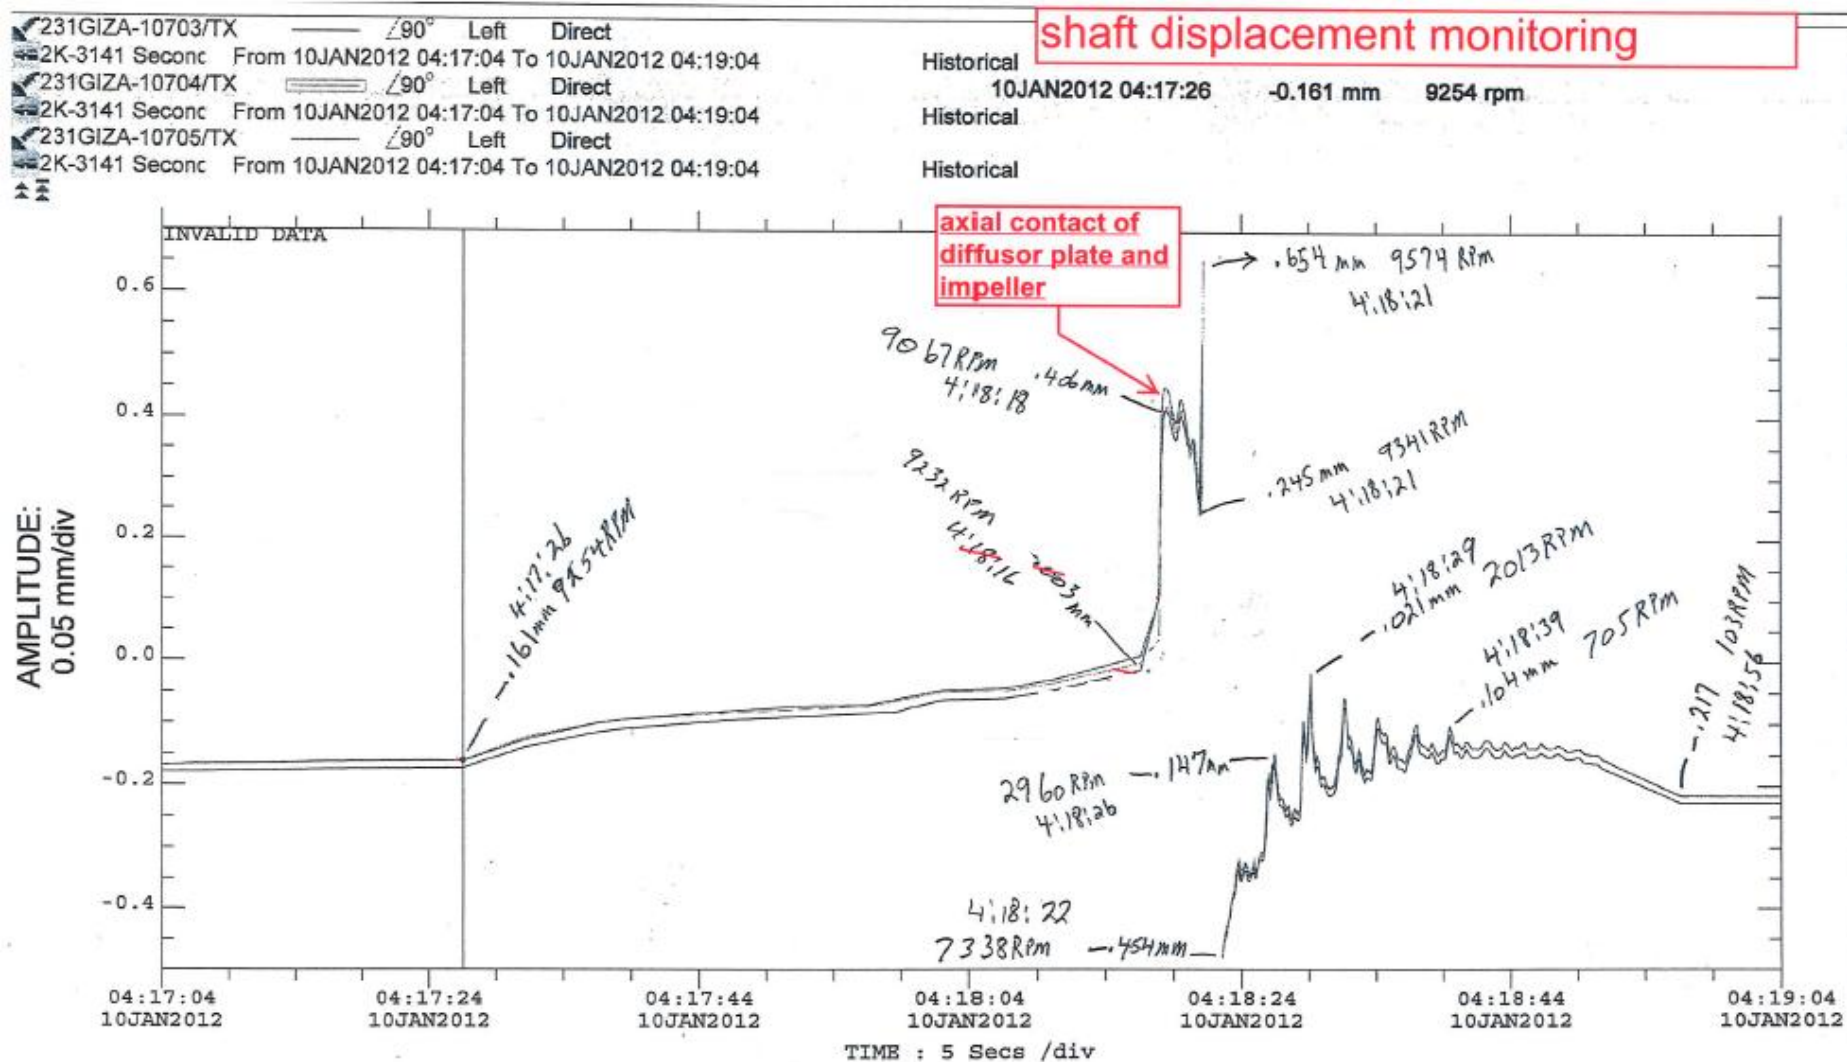
# Evidence in Trend display

- ❖ As per the trends analyzed, the failure is due to the bolts improper tightening.
- ❖ Metallurgical failure analysis also concludes that one bolt is fractured by fatigue and others are due to tensile over load.
- ❖ The OEM did not have as QC step for ensuring the diffuser bolts were properly tightened.
- ❖ There are no other evidences that could lead to this failure other than improper tightening.
