45TH TURBOMACHINERY & 32ND PUMP SYMPOSIA
HOUSTON, TEXAS | SEPTEMBER 12 – 15, 2016
GEORGE R. BROWN CONVENTION CENTER

Thermal Load Effect on Vibration on a Reactor Feed Water Pump (FWP)

Nine Mile Point Nuclear Station (NMPNS) Unit 2 – 1150 MW (Oswego, NY)

Application:	Reactor Feed Water Pump (FWP)
Type:	20x20x22 – 2 Stage (barrel type radial split)
Capacity:	8,000 gpm (min flow) to 22,870 gpm (max flow) Normal operation steady slightly above BEP
Suction Press.:	550 psig
Discharge Press.:	1,200 psig
Speed:	3,339 rpm (55.7 Hz)
Temperature:	382 °F
Normal Load:	10,500 to 11,500 BHP
Driver:	Induction Motor (16,500 HP @ 1785 rpm (29.8 Hz))
Gearbox:	Speed Increaser (Gear ratio 1:1.87)

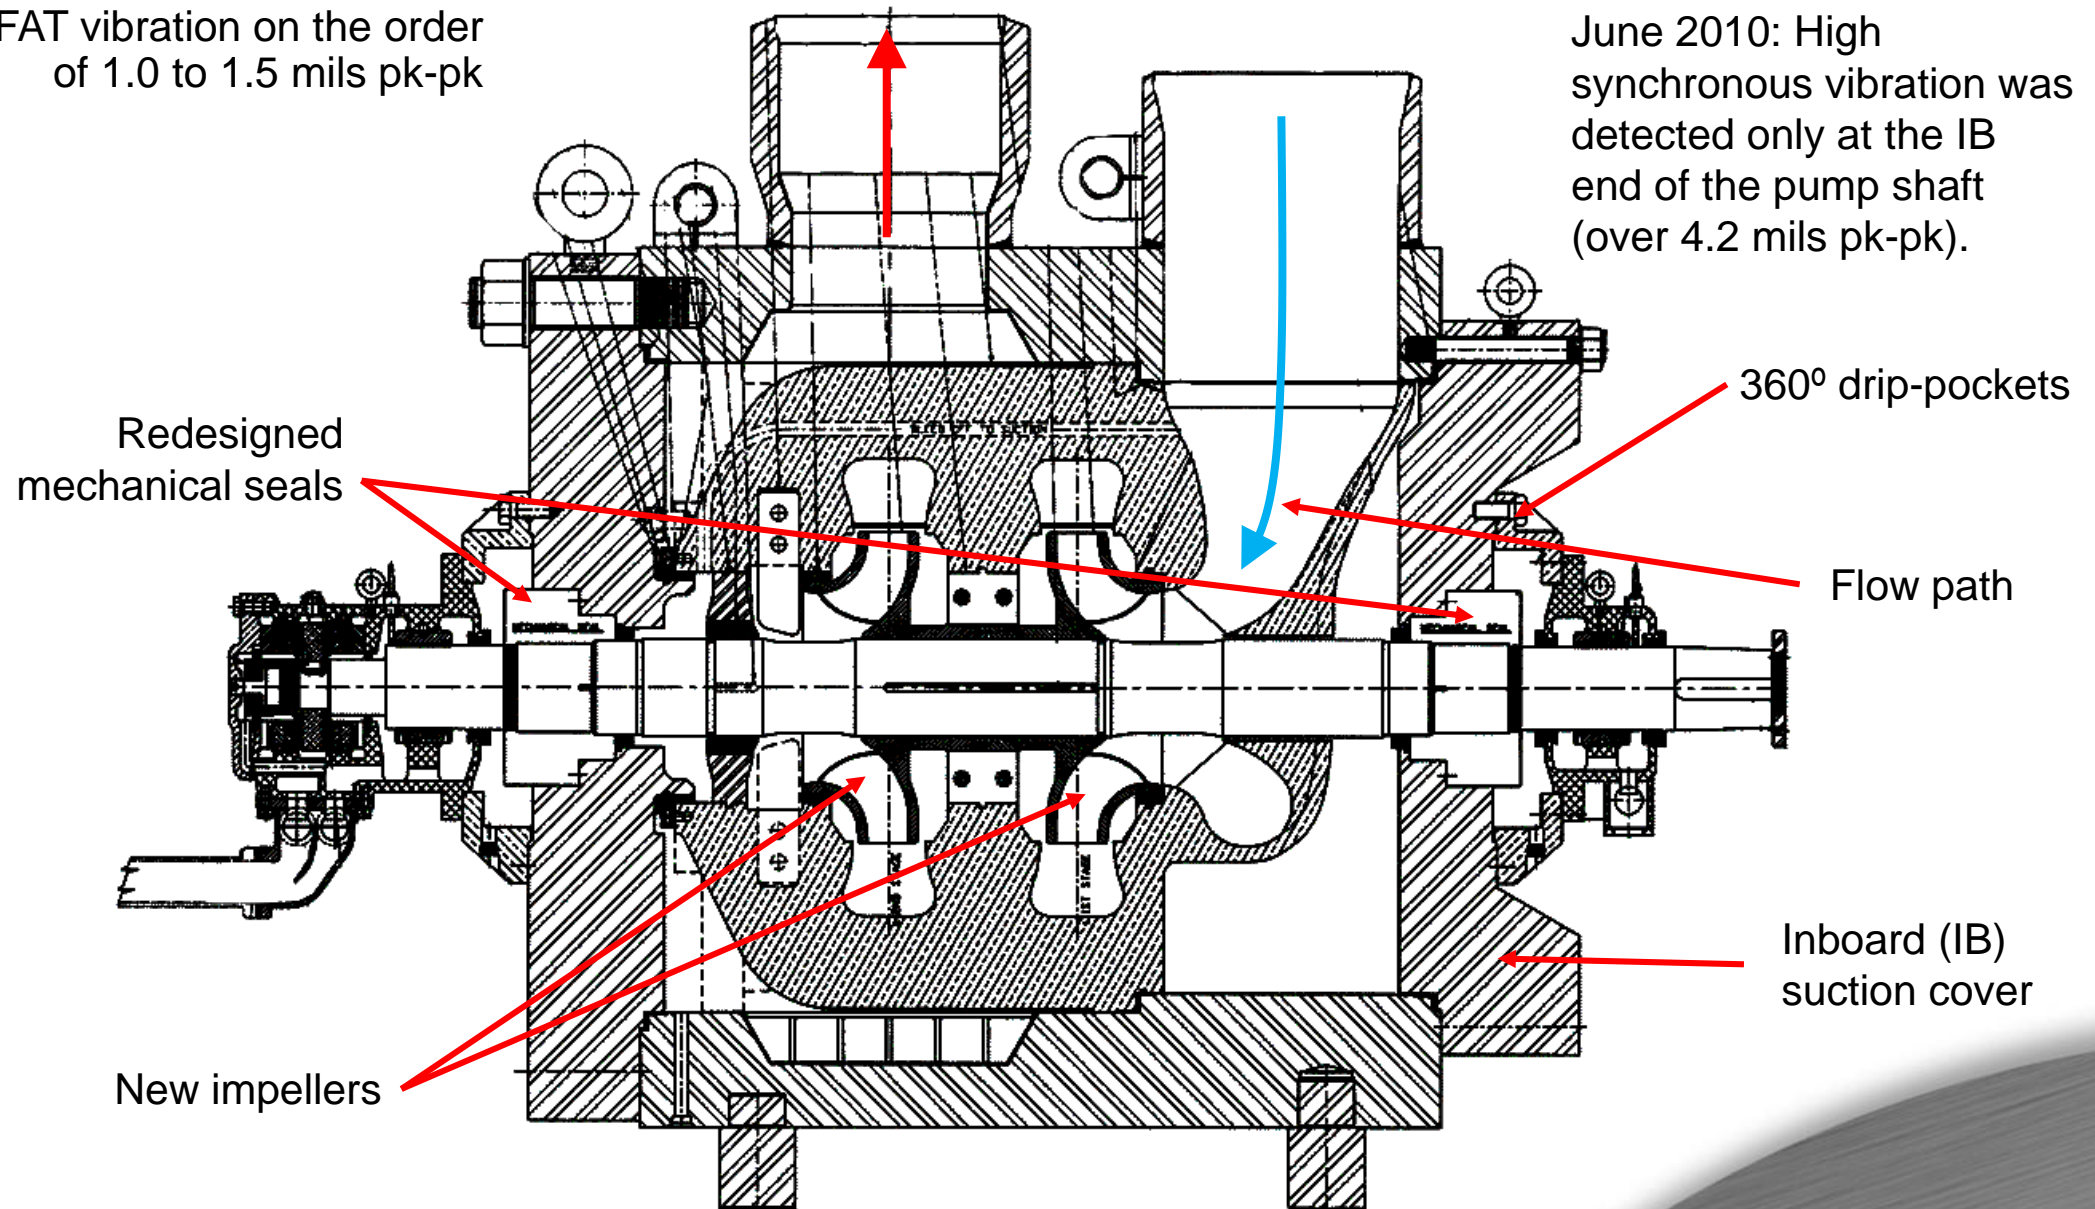
FAT vibration on the order of 1.0 to 1.5 mils pk-pk

June 2010: High synchronous vibration was detected only at the IB end of the pump shaft (over 4.2 mils pk-pk).

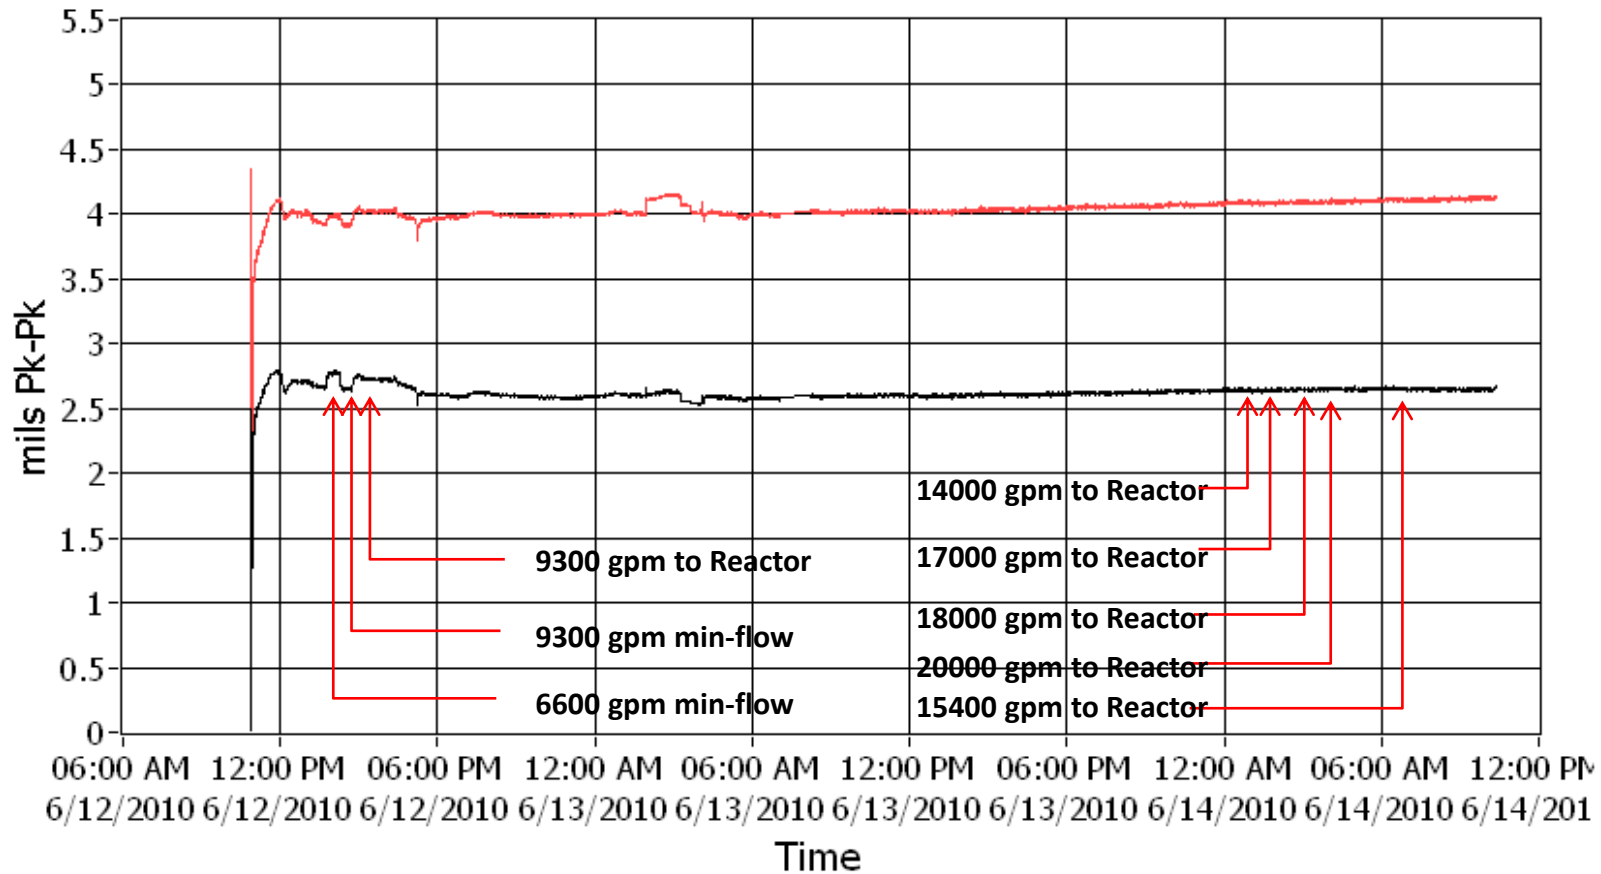
Pump IBB Radial Proximity Probes Overall Pk-Pk Vibration

Shaft vibration mostly at 1x rpm
Bearing housing vibration was acceptable

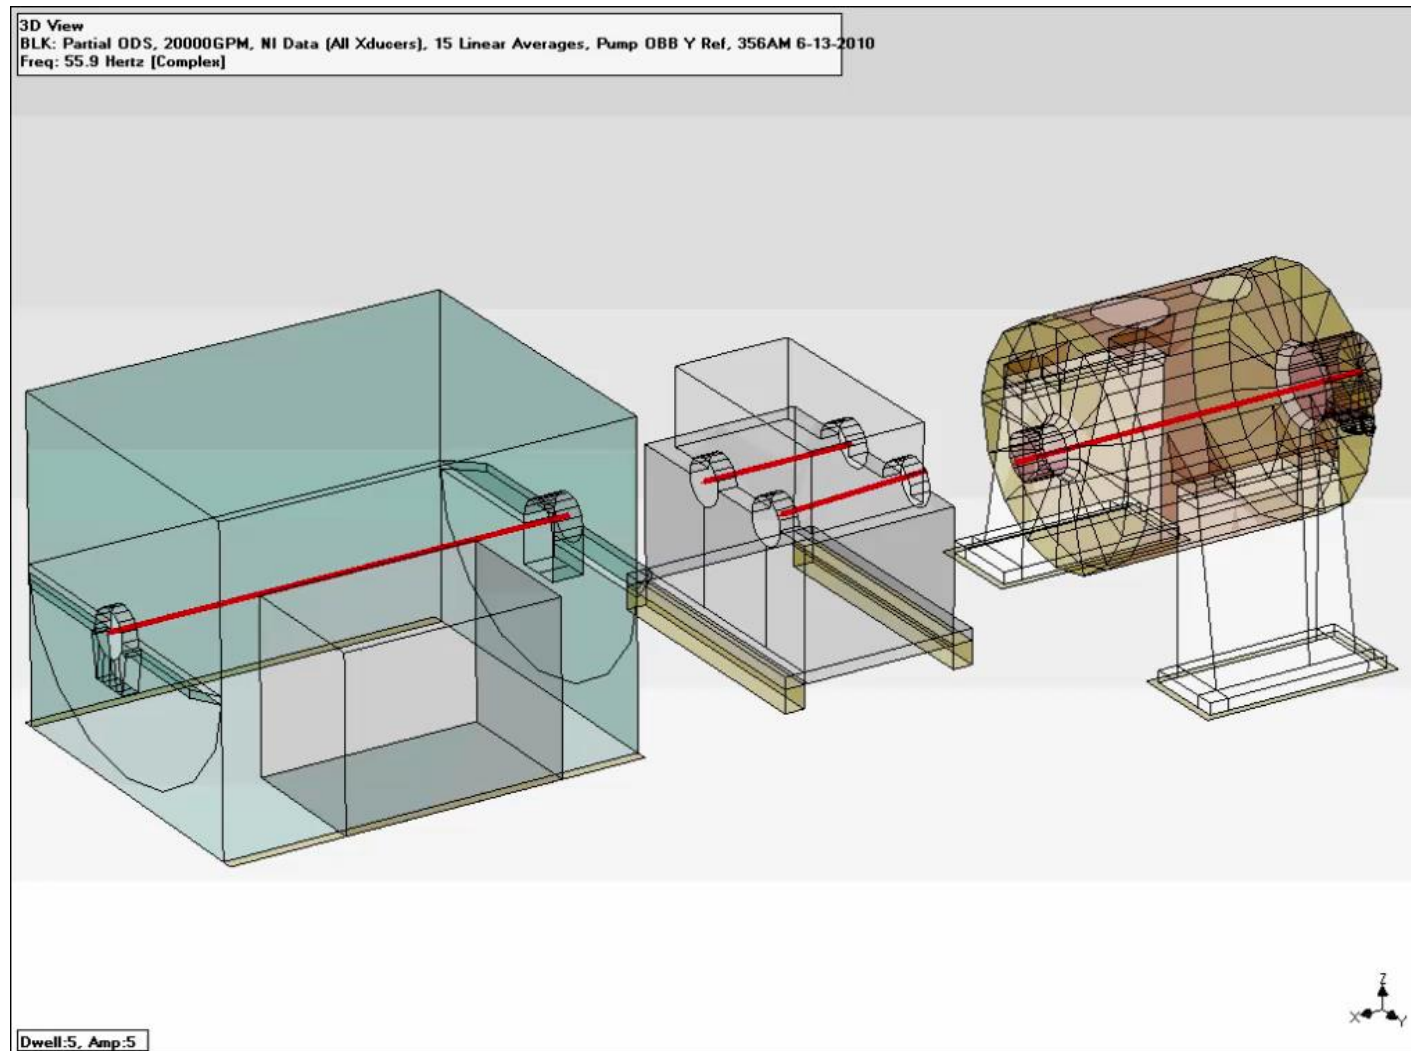
ODS Animation at 1x rpm

- Misalignment: Severe offset misalignment between the HS gearbox pinion shaft and the pump. Modify the cold alignment.
- Coupling Imbalance: Eccentricity of the coupling spacer from the coupling mounting center line.
- Thermal growth between the pump shaft and the HS gearbox pinion.
- Verify the radial position of the coupling spacer for potential eccentricity that could lead to imbalance forces.

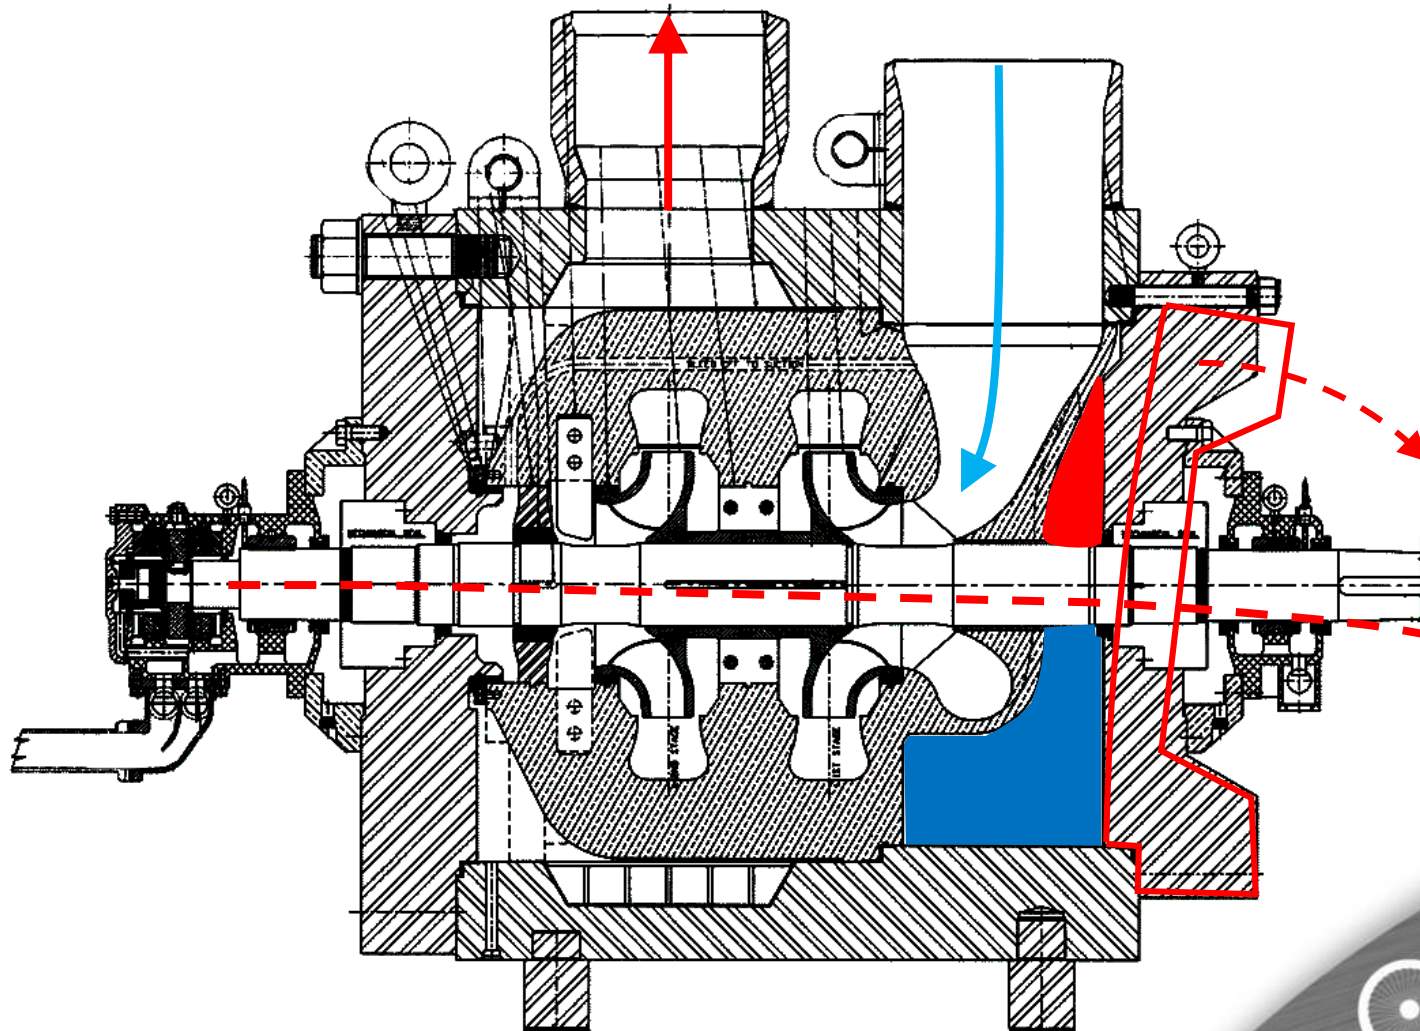
1st stage flow path did not allow uniform thermal expansion of the pump casing at the IB end cover. Former seal injection design allowed accumulation of condensate seal water at the bottom of the pump casing with lower temperature than the reactor feed water. This was causing distortion of the inboard cover plate and therefore internal misalignment at the IBB.

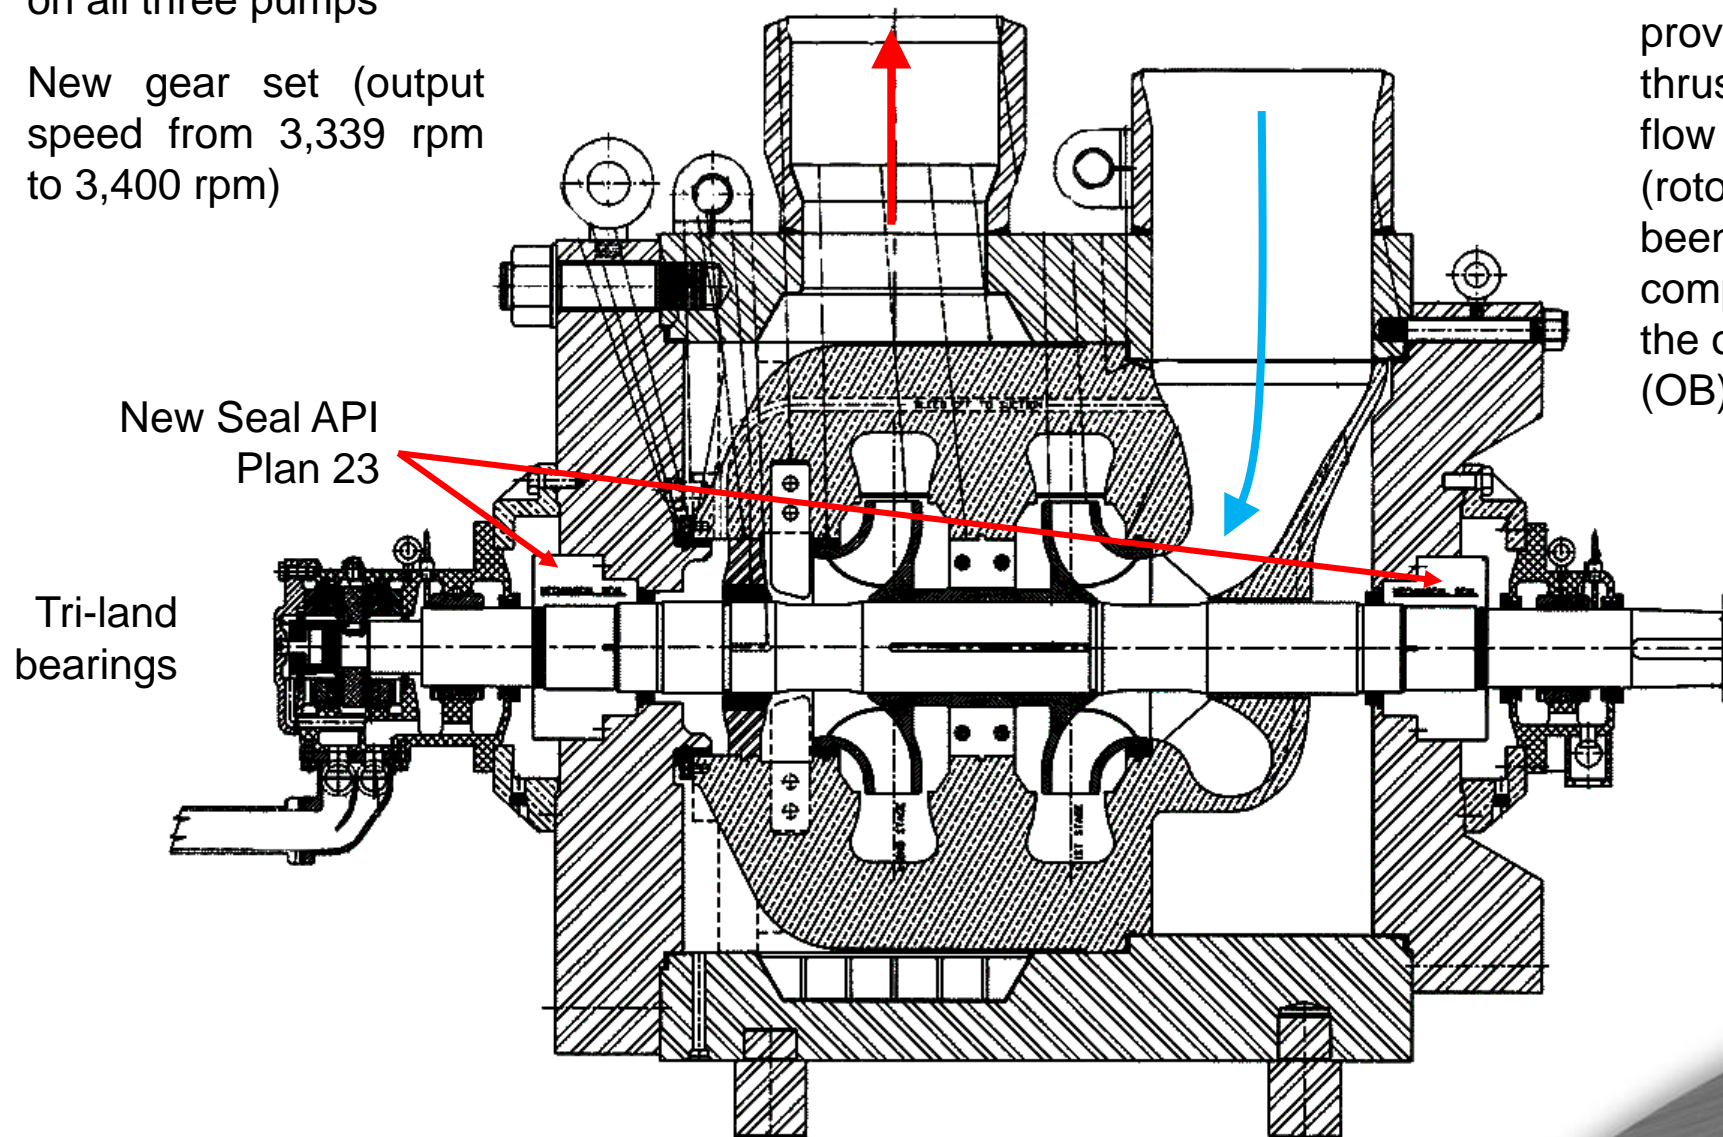
June 2012 Vibration Data FWP A/B/C Follow-Up Testing

Balance drum re-dimensioned to provide unidirectional thrust load at any flow rate.
(rotor at times had been under compression towards the outboard (OB) end)

- New rotating elements on all three pumps
- New gear set (output speed from 3,339 rpm to 3,400 rpm)
