47<sup>TH</sup> TURBOMACHINERY & 34<sup>TH</sup> PUMP SYMPOSIA  
HOUSTON, TEXAS | SEPTEMBER 17-20, 2018  
GEORGE R. BROWN CONVENTION CENTER

# *A Case Study of Vibration in Positive Displacement Pump Systems*

- *Reciprocating pump installation for salt water disposal*
- *Multiple reported piping failures*
- *Failure of pulsation dampener bladders*
- *Reported piping/skid vibration*

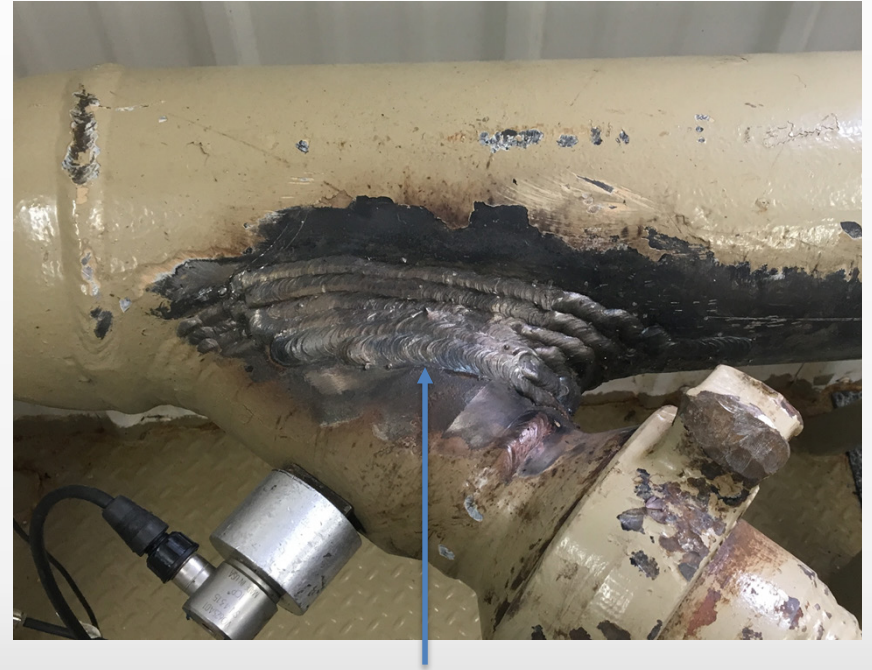
*Location of Previous Failure*

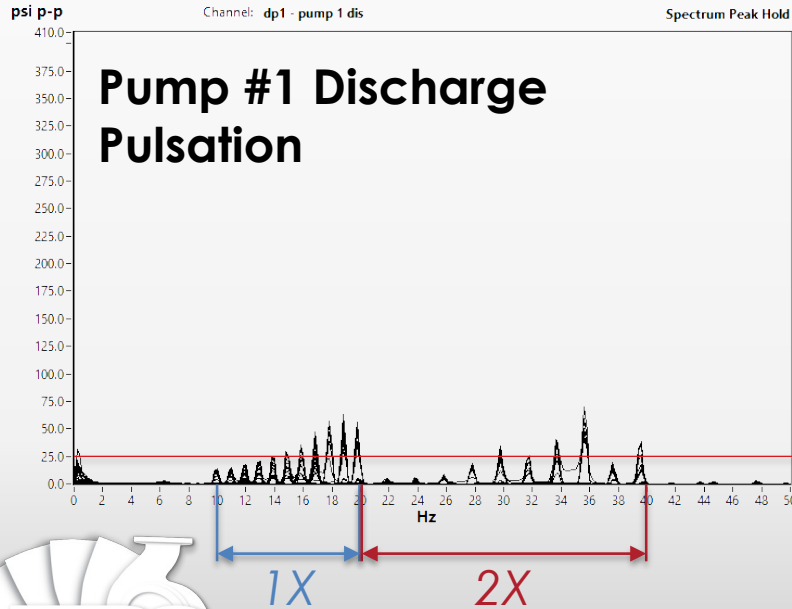
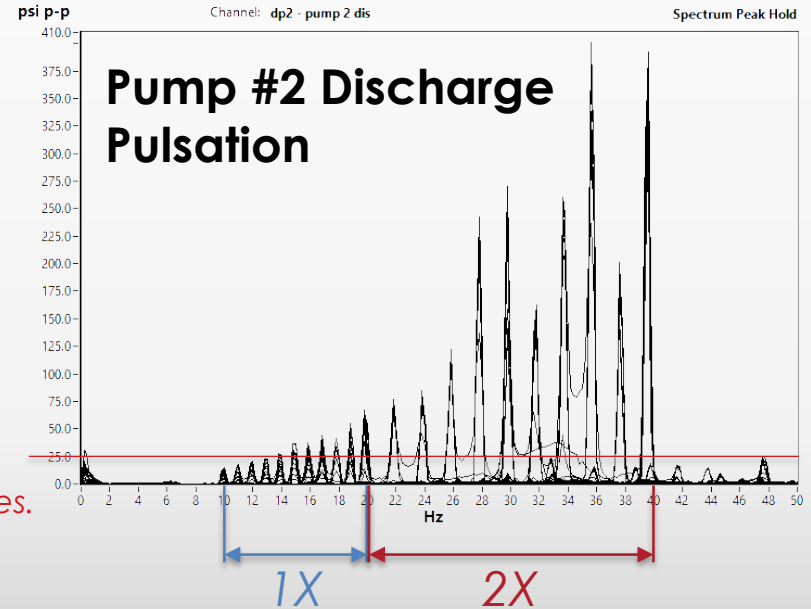
- Parallel operation and speed sweep (200-400 RPM) of Pumps #1 and #2- in original configuration

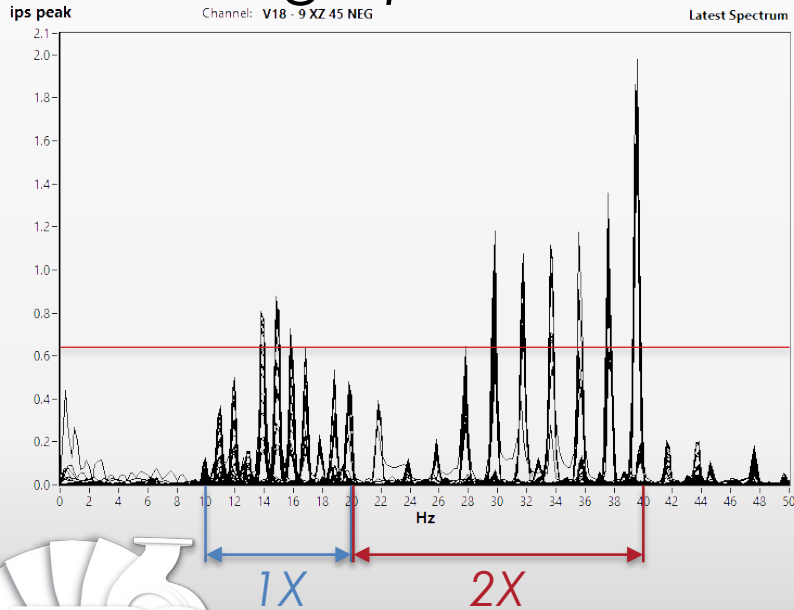
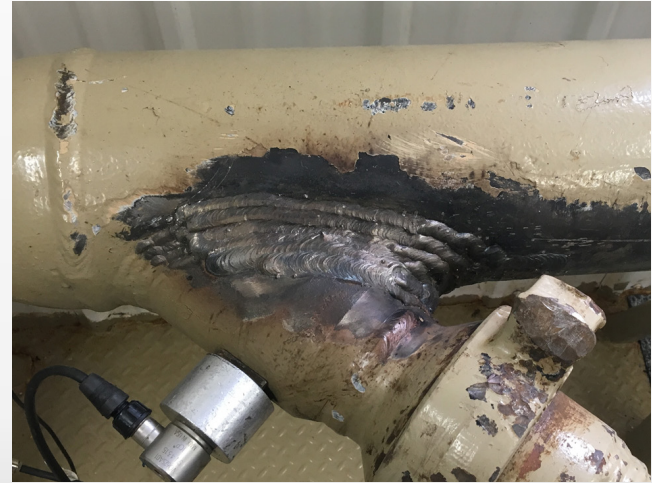
*Previous Failure*

- *Vibration at wye (location of previous failures)*
- *Vibration frequencies consistent with Pump#2 discharge pulsations*

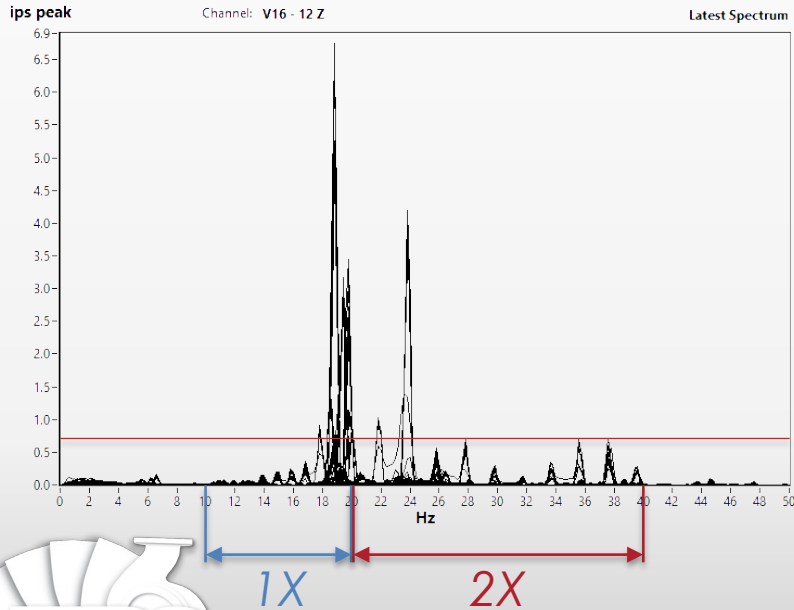
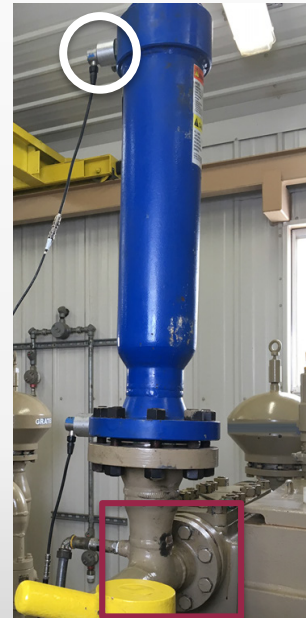
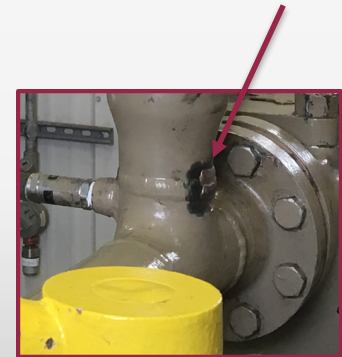
*Previous Failure*

- *Vibration of Pump #2 pulsation dampener (top)*
- *Mechanical resonance near 19 Hz*

- *Pump #2 pulsation dampener had failed- would not hold charge*
- *High amplitude pulsations (undamped) caused high amplitude piping vibration across operating range*
- *Multiple mechanical piping/support modes excited by high amplitude pulsations*
- *Next Test-- replacing Pump #2 pulsation dampener with alternative model- at site from previous use*

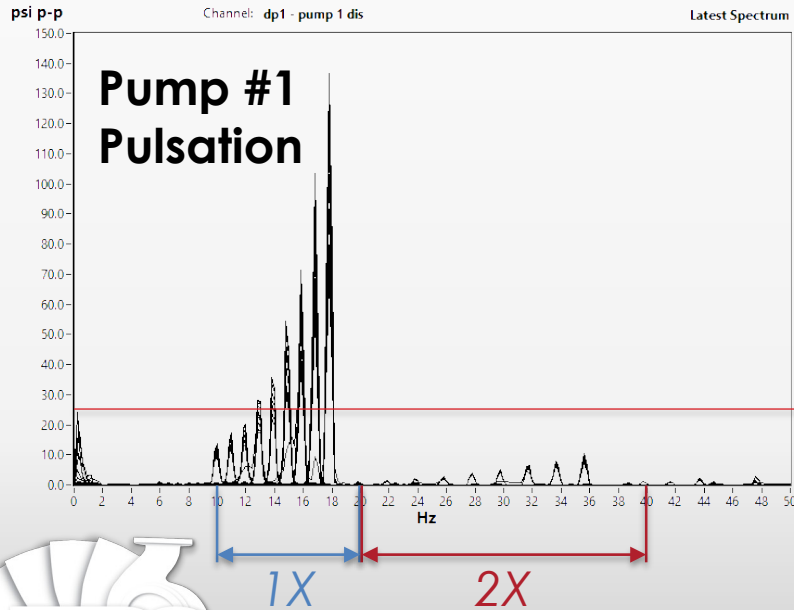
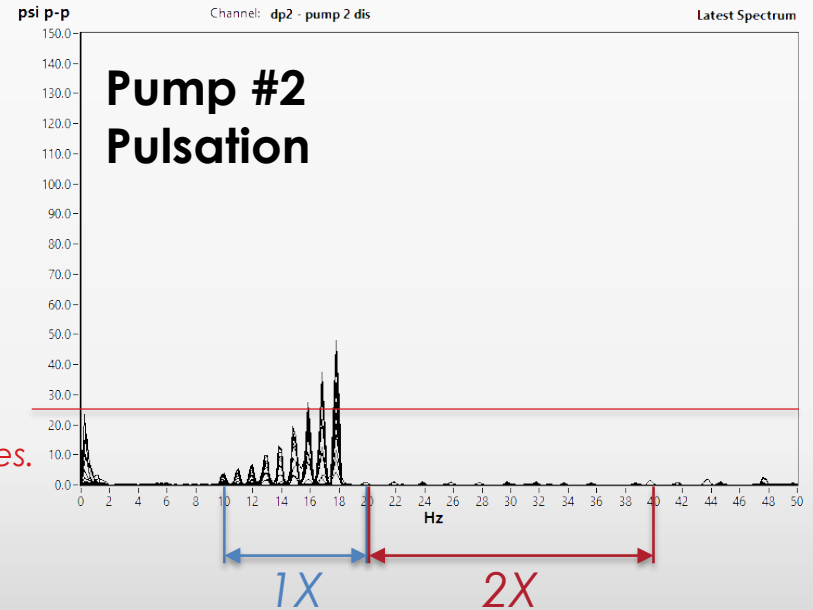
- Parallel operation and speed sweep (200-400 RPM) of Pumps #1 and #2- alternative dampener on Pump #2

- *Replacing the Pump #2 failed pulsation dampener with alternative dampener significantly reduced pulsation amplitudes in system*
- *Pump #1 still had high amplitude pulsations and vibration still persisted, despite general reduction in amplitudes*
- *Next Test--replacing Pump #1 pulsation dampener with alternative model- to match Pump #2*

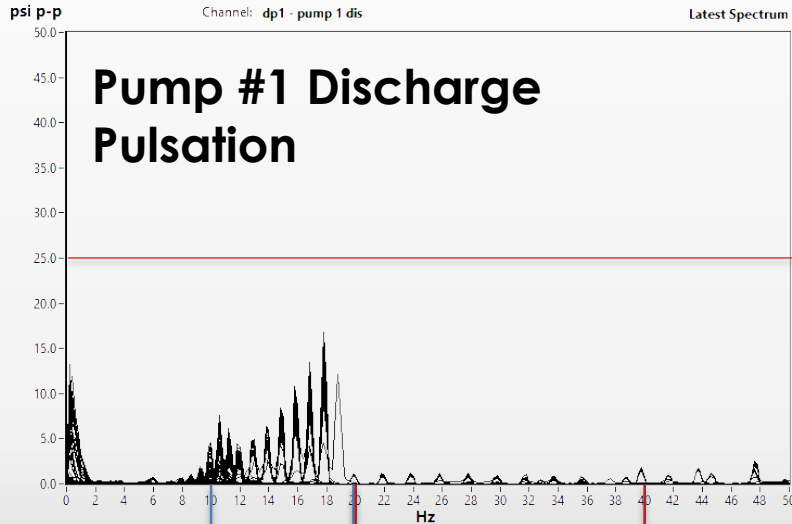
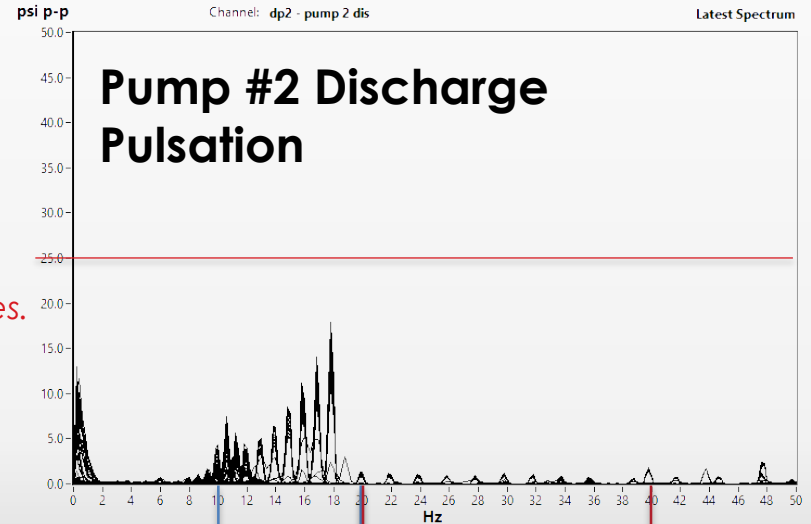
- Parallel operation and speed sweep (200-400 RPM) of Pumps #1 and #2- with alternative dampeners

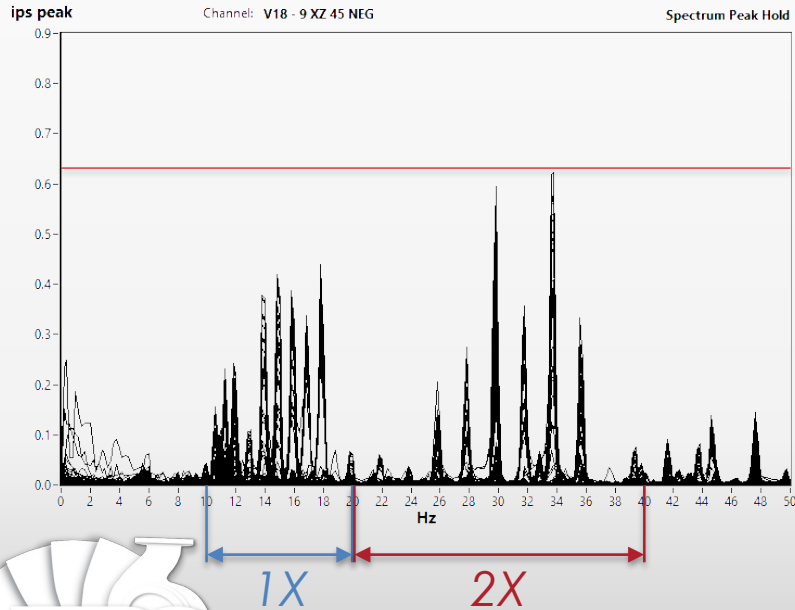
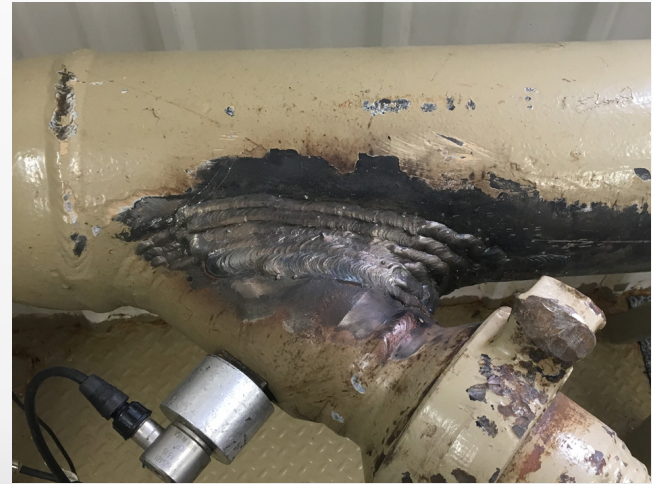
*Previous Failure*

- *Vibration at wye significantly reduced*
- *Potential mechanical resonances still at 2X*

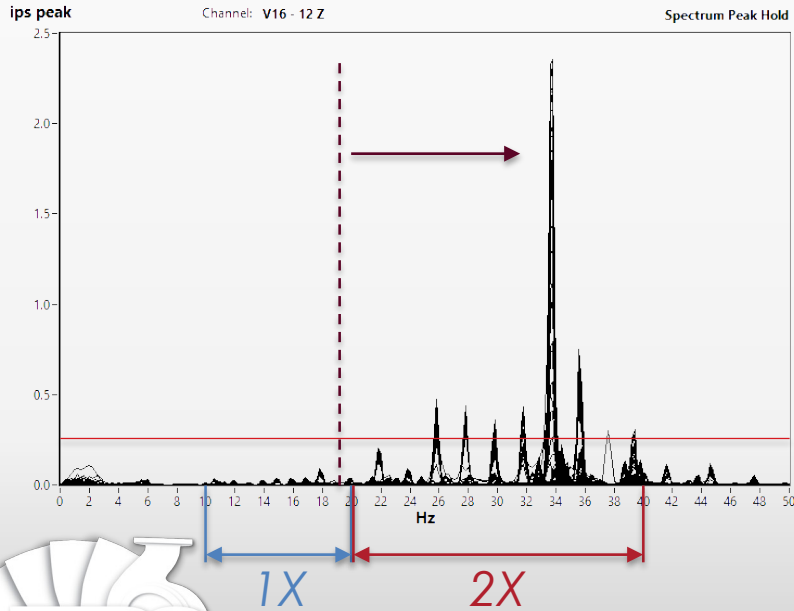
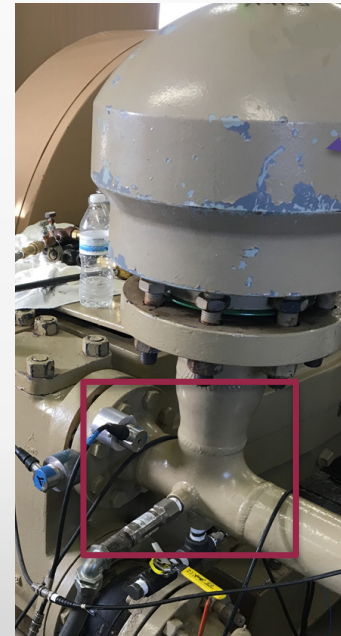
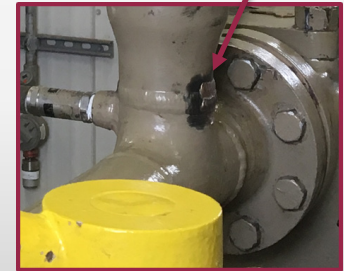
Alt Dampener

- *Vibration of Pump #2 pulsation dampener (top)*
- *Mechanical resonance near 34 Hz (shifted)*

- *Replacing both Pump #1 and #2 dampeners with alternative design reduced the system pulsation amplitudes within acceptable limits*
- *System vibration amplitudes significantly reduced with alternative dampeners*
- *Some high amplitude vibration still persistent- associated with mechanical resonances*
- *Pulsation dampeners recommended to be re-sized*
- *Additional modal analysis and bracing recommended*

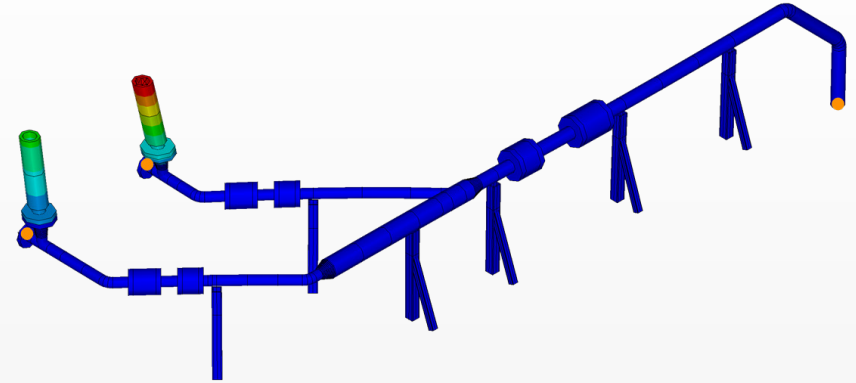
*FEA Modal Results ~22 Hz*

- Impact test data collected in the field
- Modal analysis evaluated with FE model

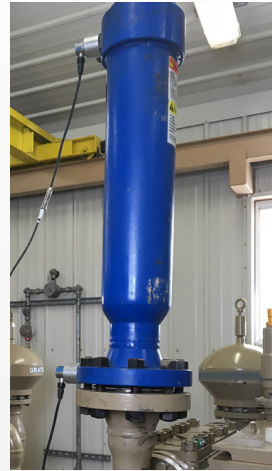
Original

- Dampeners need to be charged to 70-90% line pressure
- Avoid tall and heavy dampeners that have low MNFs
- Use bladder material suited for the application
