Think Out of the Box: Not All Sea Water Submerged Pump Failures Are Mechanical

by
Hussain Al-Baloshi & Isham Sudardjat
Reliability Section– Operations Engineering (Offshore)

2011

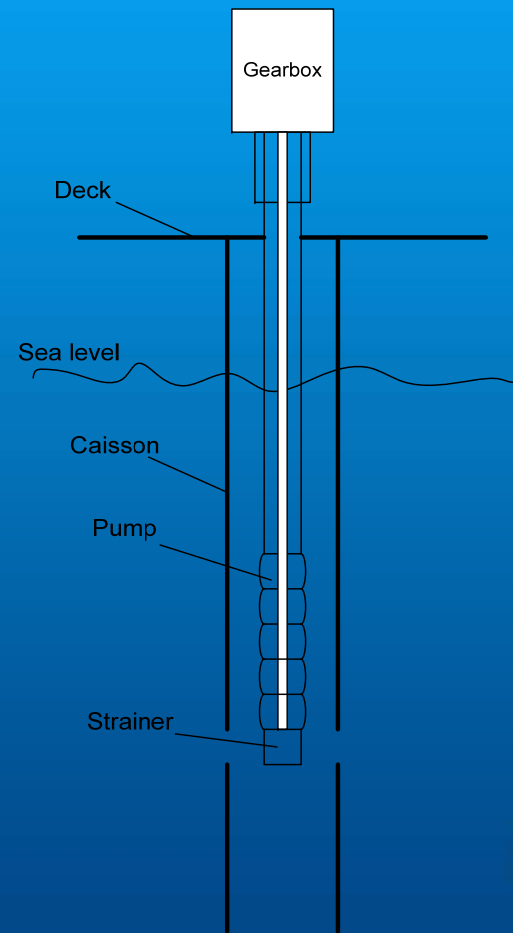
LQ FWP (July 08)

* Modified in July 08 to allow access for cleaning of strainer

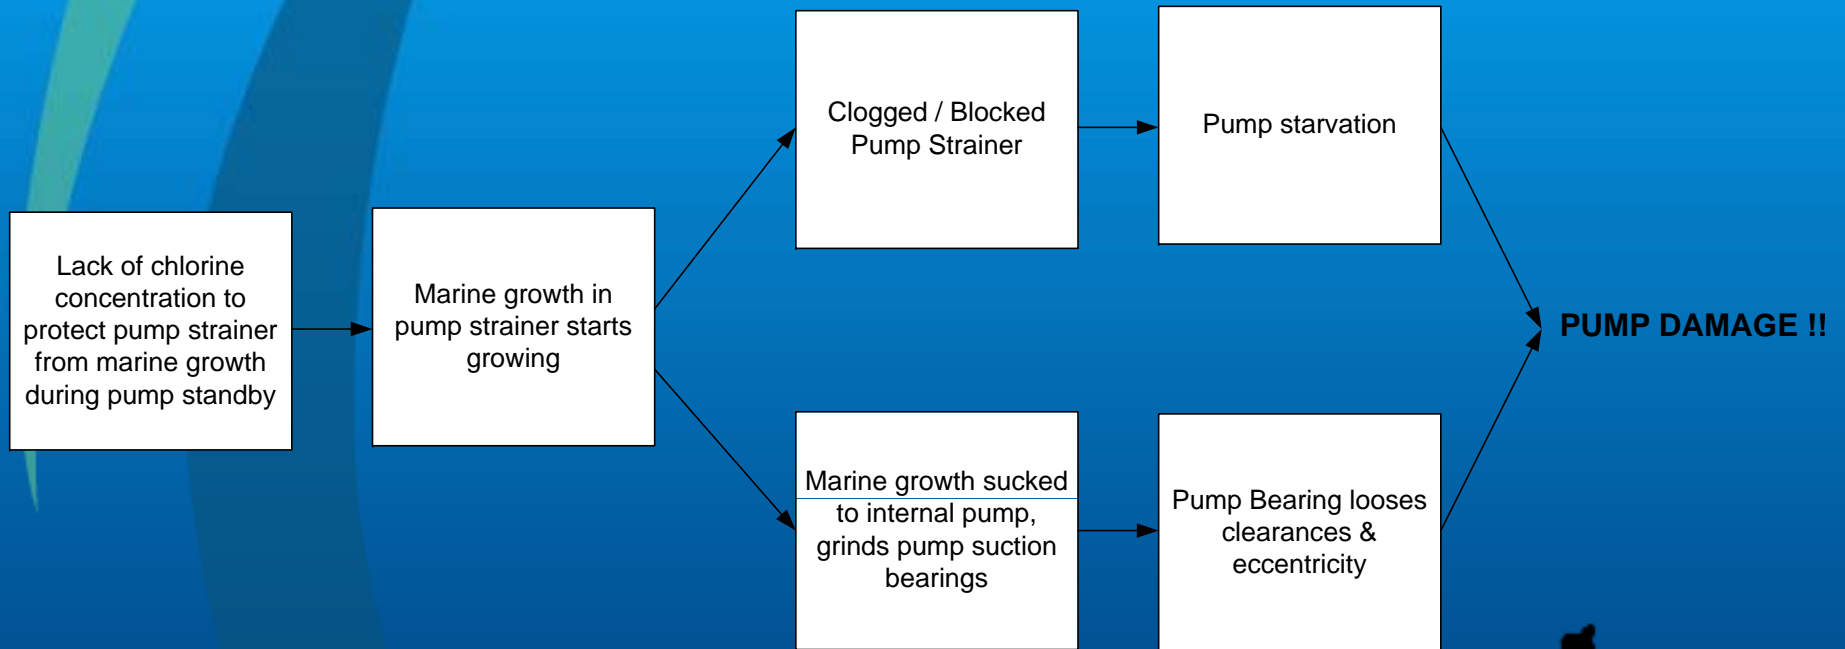
Failure Mechanism (Sequence of Failure)

- ❖ The longer caisson design has the following advantages:
 - Retains chlorine concentration inside the caisson from being washed away by sea current
 - Prevents flying young mussels or barnacles brought by sea current to attach to the strainer body and grow inside it
 - Avoids direct chlorine injection to open sea
 - Protects the pump against force from sea bed
 - Allows our stations to meet MoE (formerly SCENR) requirement for residual chlorine content (0.1 mg / L)
 - Eliminates the need for diving inspection for cleaning the strainer
- ❖ The type of suction bearing has contribution to the pump reliability due to better abrasive resistance capability

- Close the windows of LQ FWP caissons to retain original design
- Extending the caisson's length for Raw Water Pumps (P-4213A/S & P-4313A/S)
- Study the replacement of suction bearing type for Raw Water Pumps with bronze - rubber with groove type.
