## Manufacturing: ERW Pipe Defects

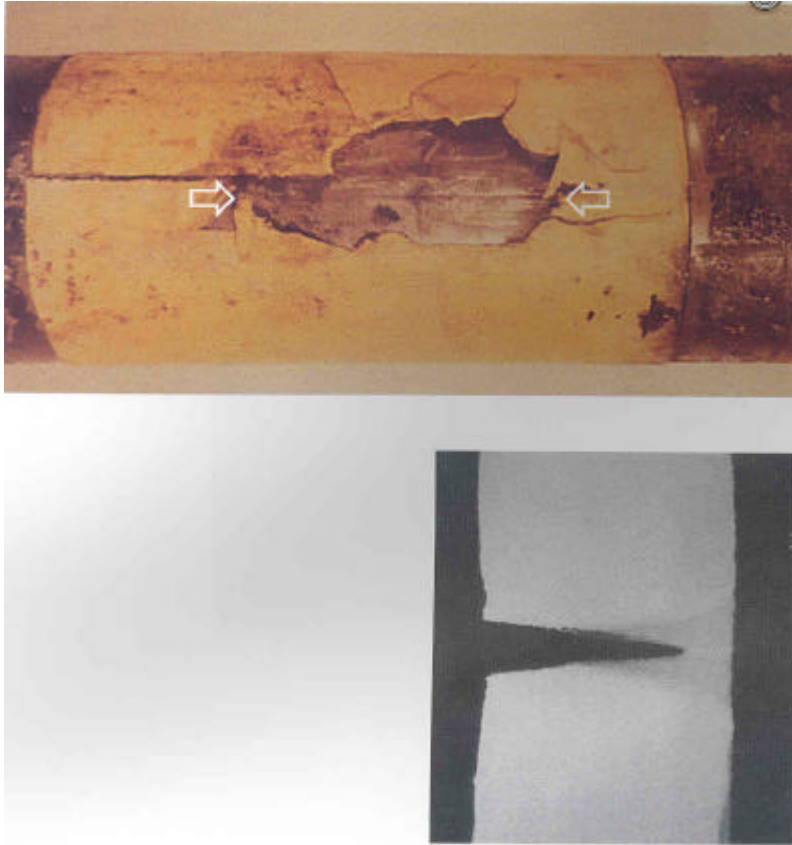
### LACK OF FUSION

Axial, crack like, planer faults at the mid point of the weld.

Incorrect welding parameters, for example low welding current input which leads to insufficient resistance heating at the joint line.

Lack of fusion may be associated with burn marks on the outer surface of the pipe.

Ensure good maintenance and operation of the pipemaking equipment in the mill.

Replace pipe or install repair clamps or repair shells as appropriate.

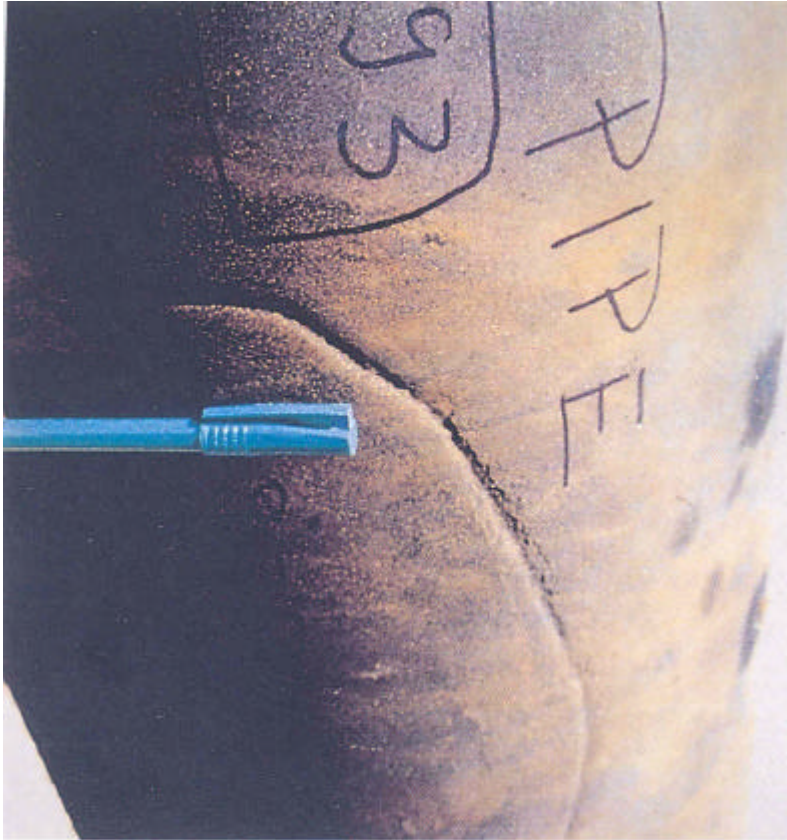
## **DAMAGE AND CORROSION**

Corrosion of pipe steel exposed by mechanical damage.

Exposed steel will corrode if the applied cathodic protection is ineffective. Clean steel in gouges may be anodic to the surrounding pipe wall.

On above ground pipe areas exposed by mechanical damage will suffer atmospheric corrosion.

Assess the significance of the damage, check for cracks and apply an appropriate repair procedure.

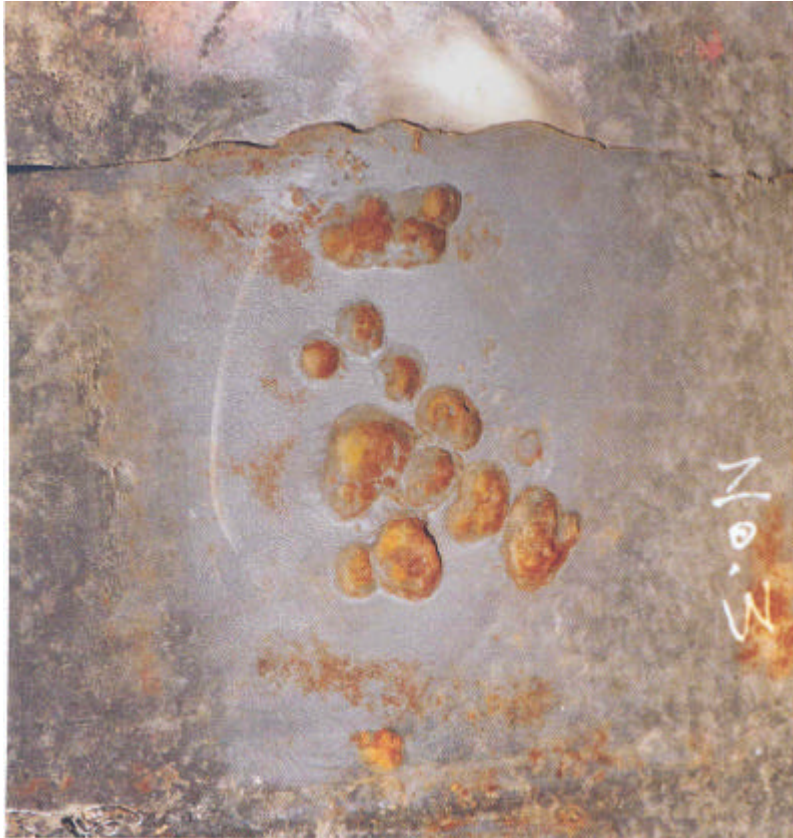
## MIC – MICROBially INDUCED CORROSION

Typically deep, sharp sided pits. Usually found under disbonded coating or hard accumulations on the pipe surface. When disturbed the area may smell of hydrogen sulphide.

The corrosion product within the pits is often soft, has no structure and is deep black in colour.

Bacterial activity in anaerobic conditions under the coating or surface deposit. The immediate area of microbial activity may be anodic to the surrounding pipe.

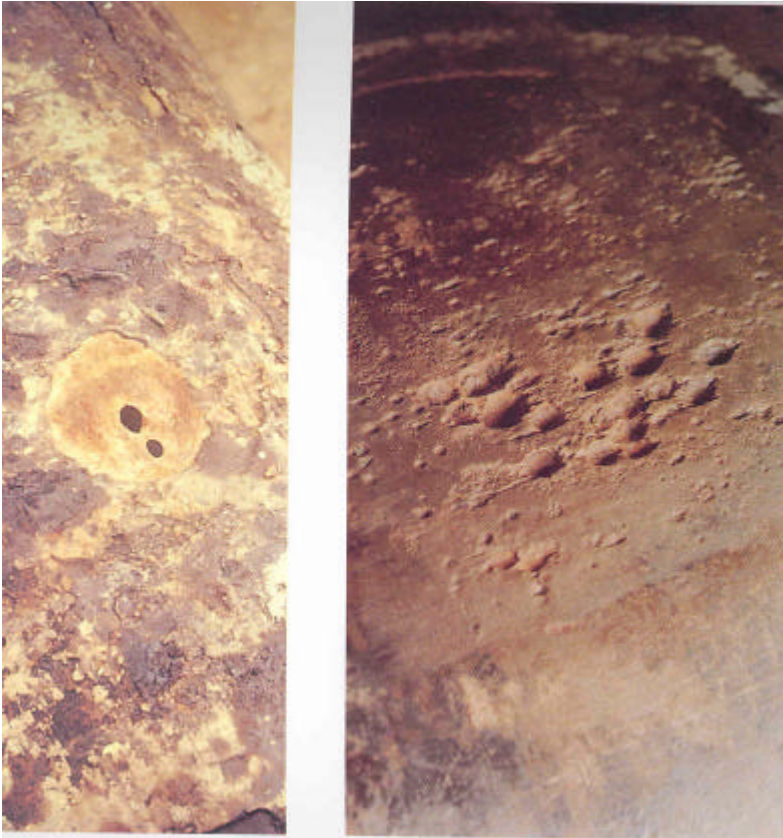
### Pitting

Localised corrosion, typically at areas where the coating has suffered impact or stone damage.

Damage to the coating and ineffective cathodic protection, for example where the pipe to soil potentials are less negative than  $-850\text{ mV}$  (with respect to a saturated copper – copper sulphate reference electrode).

Pitting may also be caused by microbial corrosion, stray current activity and galvanic effects.

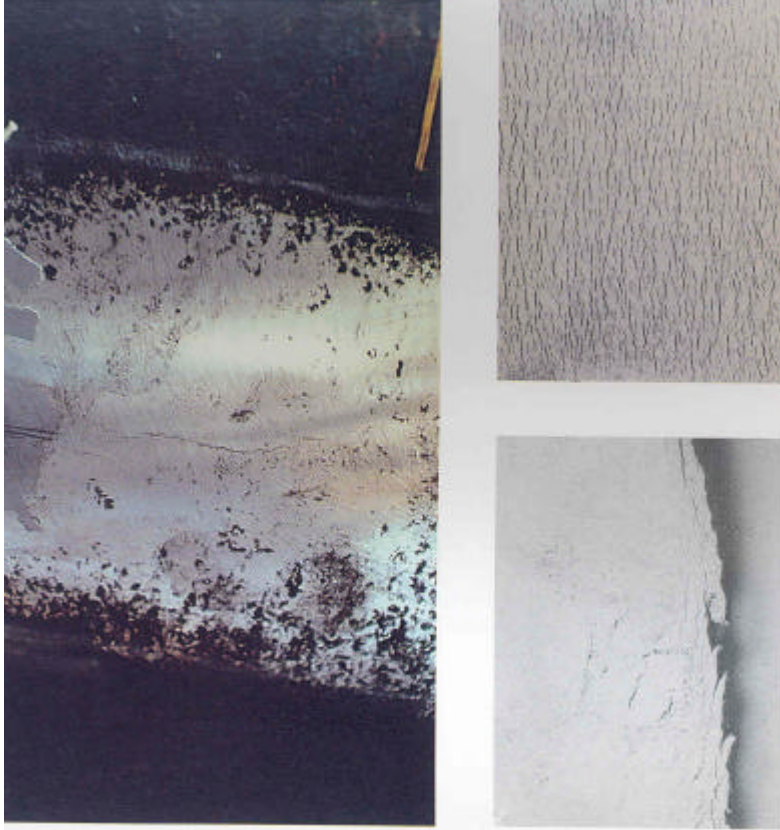
## **SCC – STRESS CORROSION CRACKING, HIGH**

Irregular, intergranular cracks that are most commonly aligned axially on the pipe. Cracks are not usually associated with any pitting or general corrosion.

A complex array of factors contribute to the initiation and growth of high pH stress corrosion cracking including: high stress, pressure cycling, development of a carbonate – bicarbonate environment, partial shielding of the applied cathodic protection and permanent or seasonal wetness in the soil.

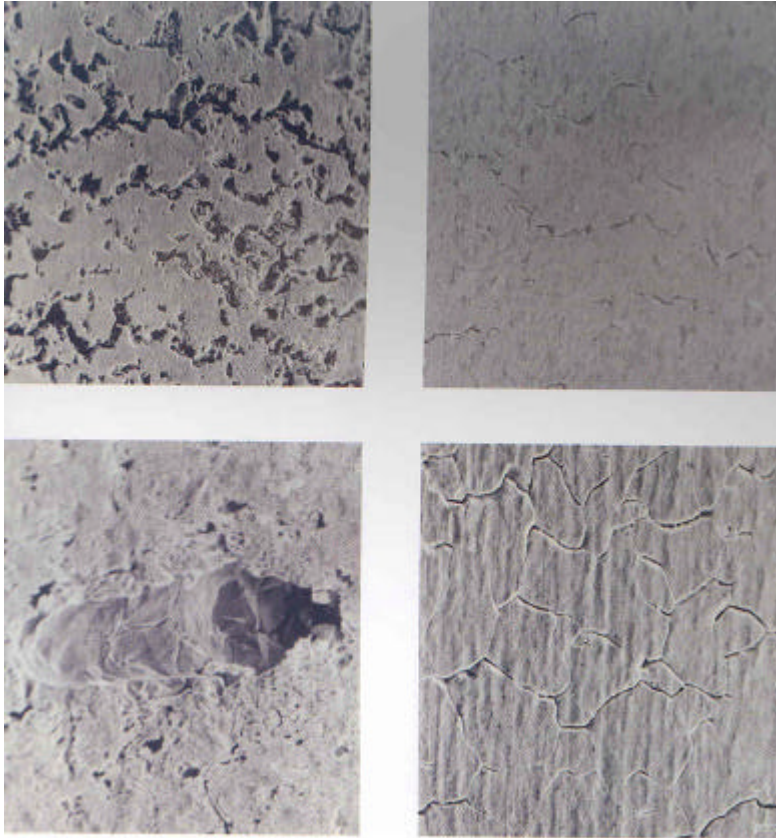
## **SCC – STRESS CORROSION CRACKING, INITIAL STAGES**

These photo micrographs show preferential corrosion and crack initiation at grain boundaries aligned at right angles to the principal, cyclic stress acting on the pipeline.

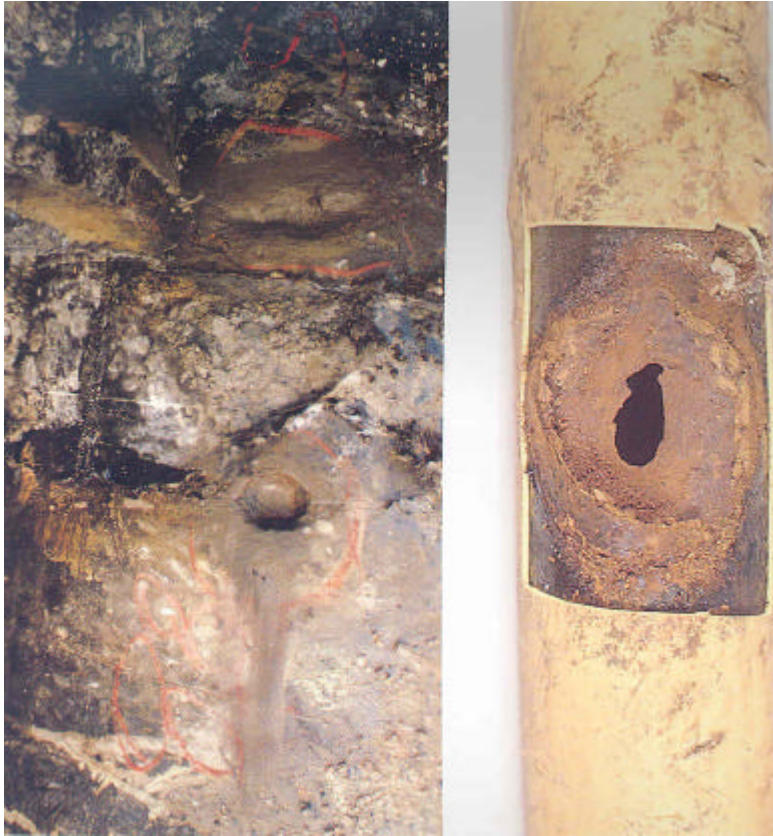
## STRAY CURRENT

Concentration of deep corrosion at one, isolated location on the pipeline where there is one, or more, coating faults.

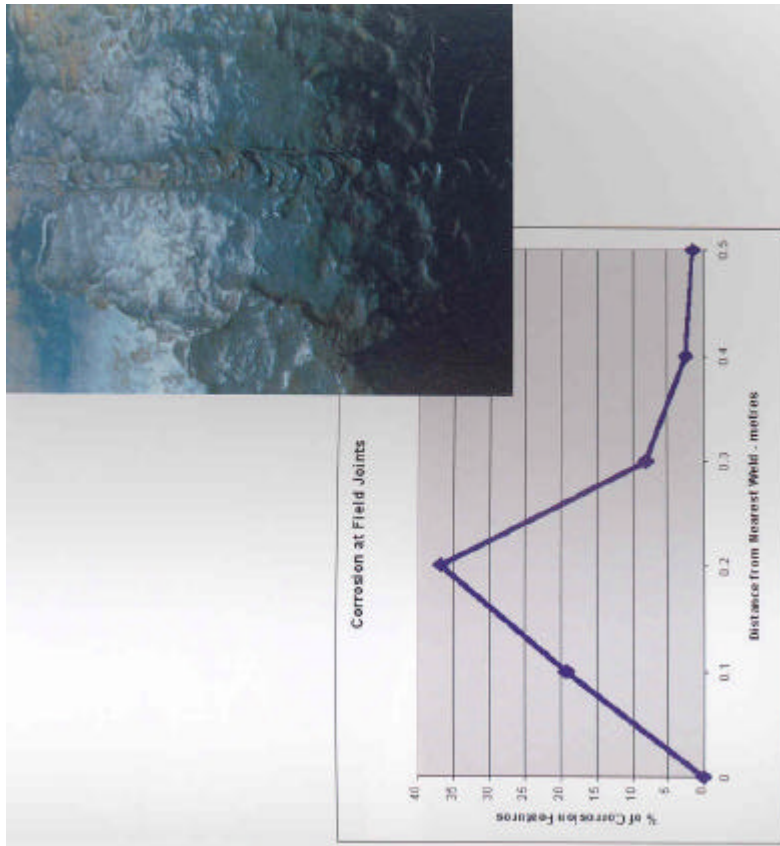
## WELD AREA CORROSION

Corrosion limited to the immediate area of the field joint between the factory applied coating on the body of the pipe.

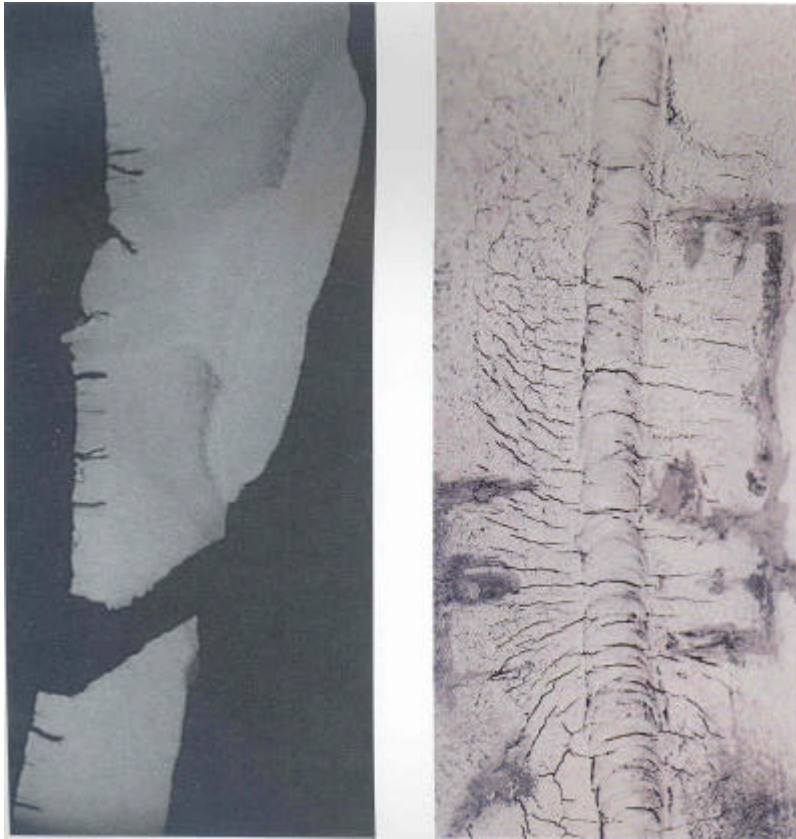
## CO-CO<sub>2</sub> SCC – STRESS CORROSION CRACKING

Internal cracking aligned at right angles to the principal stress.

A protective layer is formed on the pipe surface by a monolayer of adsorbed carbon monoxide. This film is dislocated at grain boundaries and exposes the steel to localized corrosion by water containing carbon dioxide.

This is only a problem in 'town gas' or manufactured gas containing carbon monoxide, carbon dioxide and water. The minimum carbon monoxide concentration for crack initiation and growth is ~1 %. Oxygen may accelerate cracking if it is present at a concentration of less than 2 %.

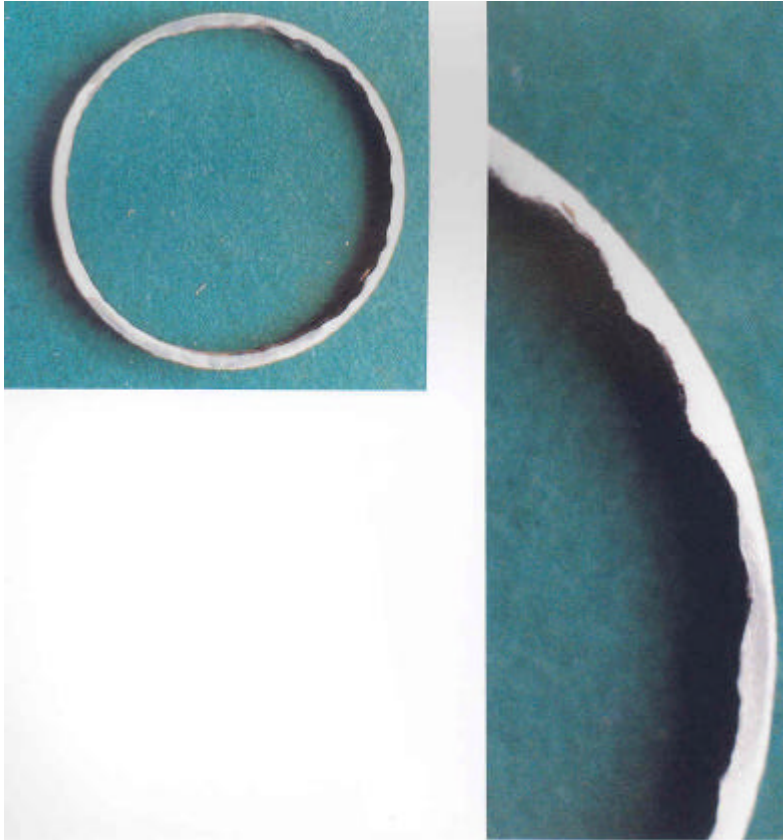
## GENERAL

Areas of corrosion with a large surface area compared to depth.

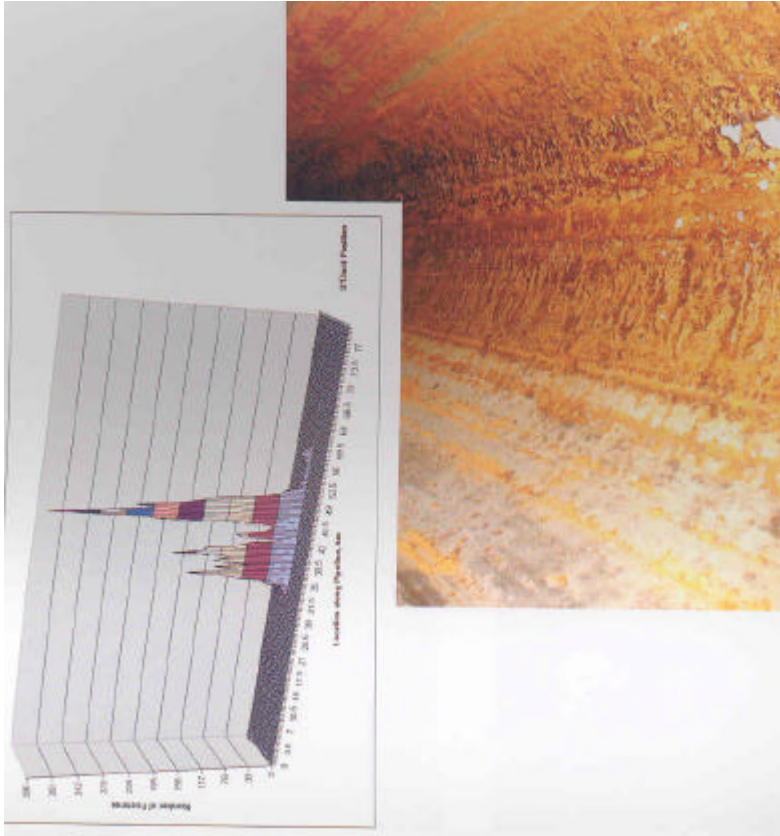
## GROOVING

Narrow lines of pitting at the 6 o'clock position in a pipeline. The pits may join up to create an axial groove in the bottom of the pipeline.

Long, linear defects may be structurally significant. Corrosion control may be possible by dosing the product with an appropriate inhibitor and routine pigging to remove the water phase.

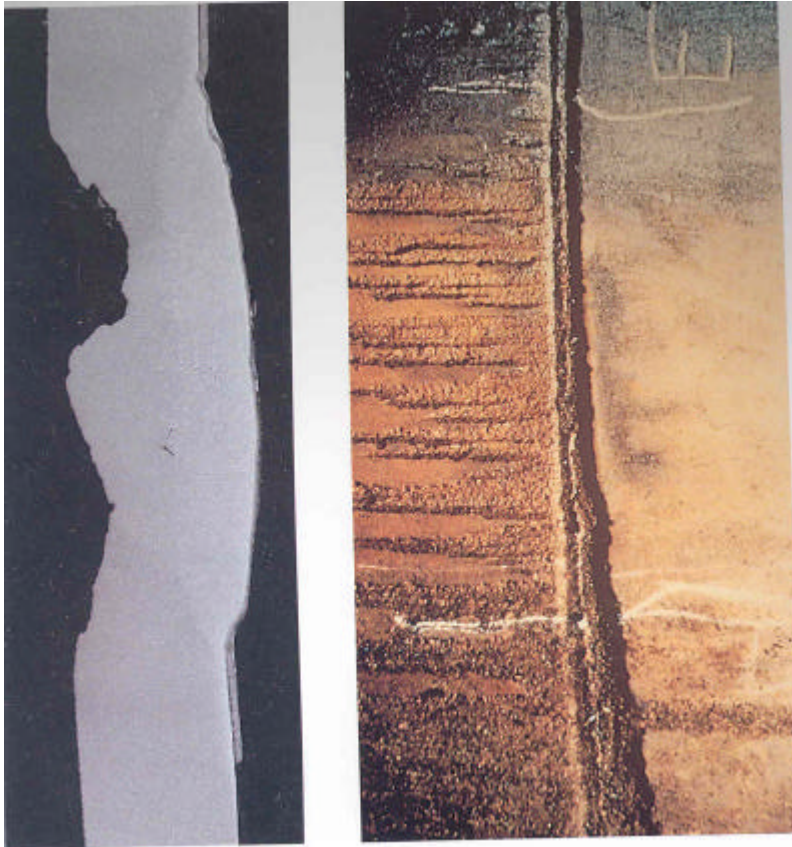
## HAZ – HEAT AFFECTED ZONE CORROSION

Corrosion that is concentrated in a narrow band on either side of a weld, within the heat affected zone.

The heat affected zone is anodic to the pipe metal and weld metal. This forms a galvanic corrosion cell.

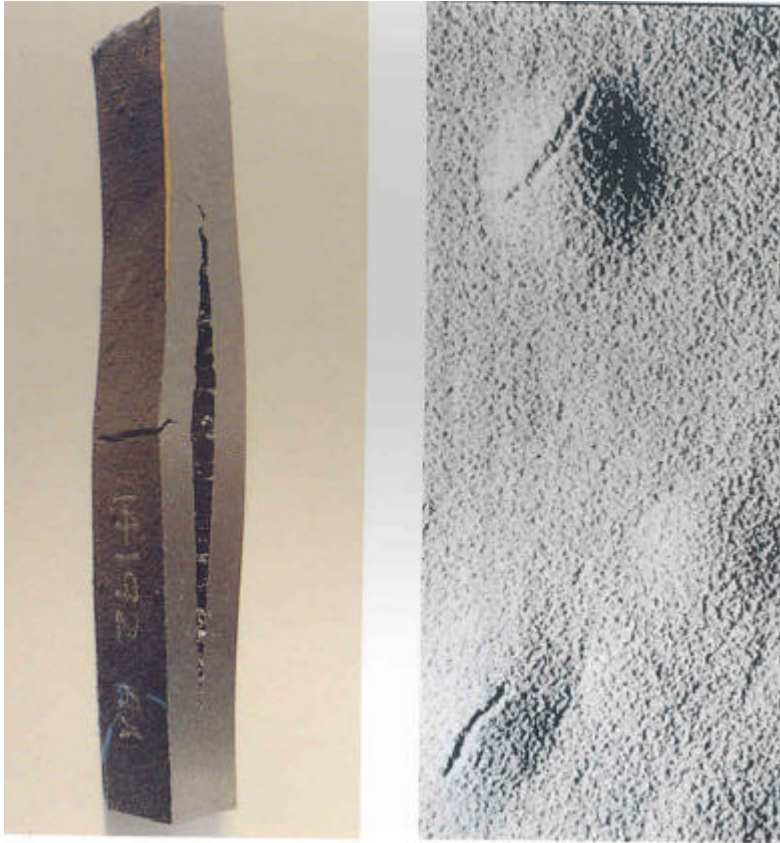
## HIC – HYDROGEN INDUCED CRACKING

Mid-wall cracks that run parallel to the pipe wall. Cracks may join up, at different levels through wall cracks. Surface blisters may also contain cracks.

Hydrogen permeation from internal corrosion on sour service conditions. Atomic hydrogen diffuses into the pipe wall and hydrogen blisters form at inclusions. The gas pressure from these blisters generates crack growth.

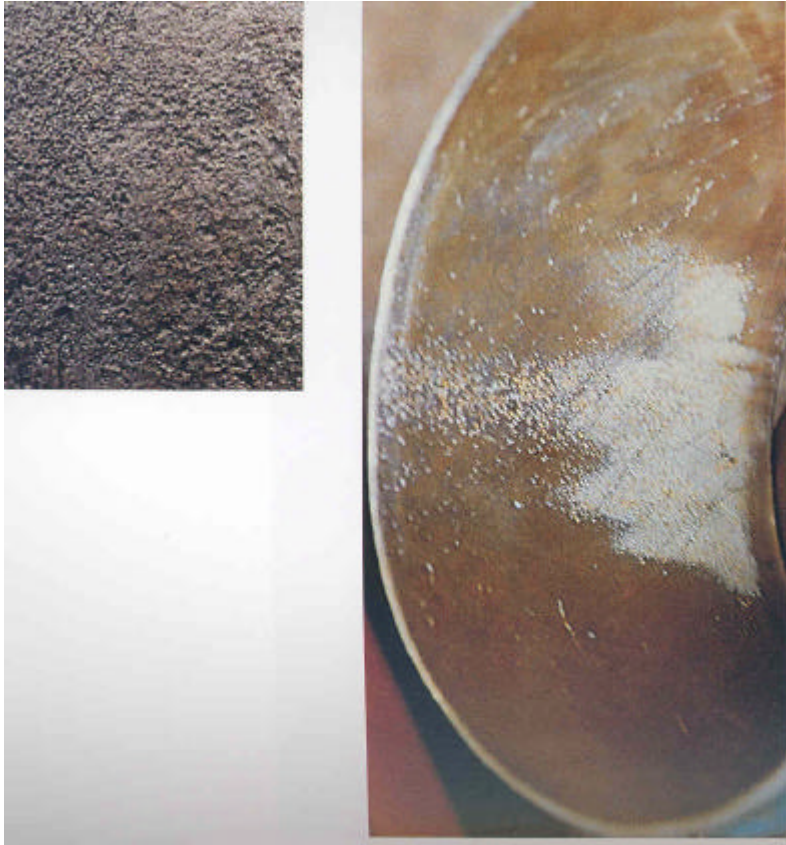
### PITTING

Localized metal loss occurring in a random pattern.

Pitting occurs where water is present as a separate phase. In gas pipelines this may be caused by water condensation from the gas phase where the pipeline is cooled, for example by exposure to the sea water. In oil pipelines it may be caused by water drop out.

Control of the gas humidity / dew point is the most effective control. Localized cooling, for example where a buried subsea pipeline has been exposed by erosion of the sea bed, may be controlled by placing mats over the pipeline. Inhibitor treatments can be effective if inhibitor transport to the affected area can be guaranteed.

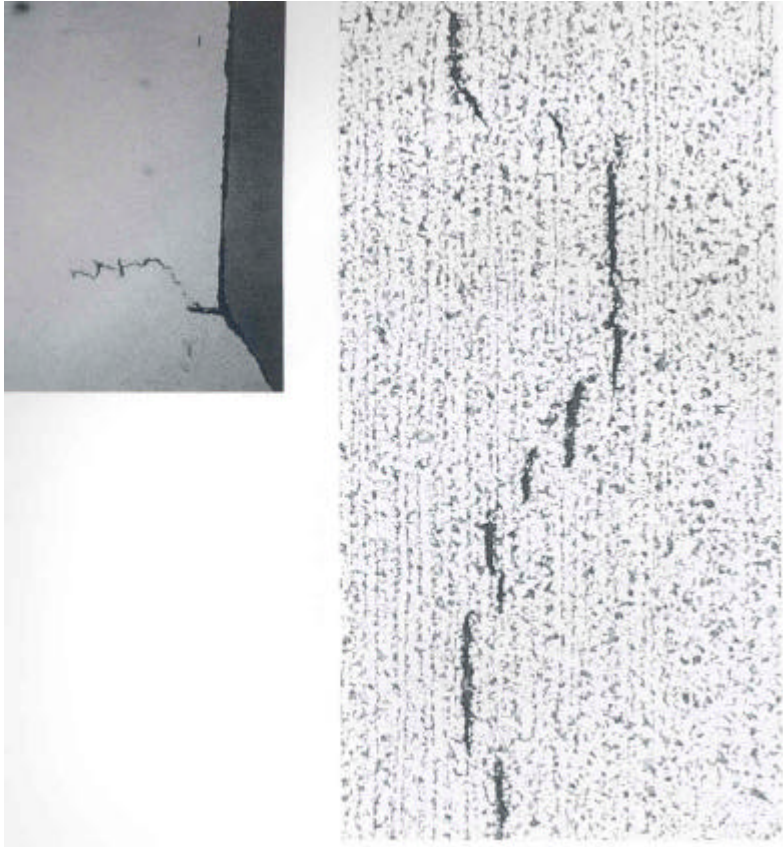
## **SOHIC – STRESS ORIENTED HYDROGEN INDUCED CRACKING**

Cracks that run parallel to the pipe wall that join up, at different levels through wall cracks. Can occur in softened regions of the weld heat affected zone.

Hydrogen permeation from internal corrosion in sour service conditions. Atomic hydrogen diffuses into the pipe wall and hydrogen blisters generates crack growth. Cracks link together under the action of an applied stress, such as the operating pressure.

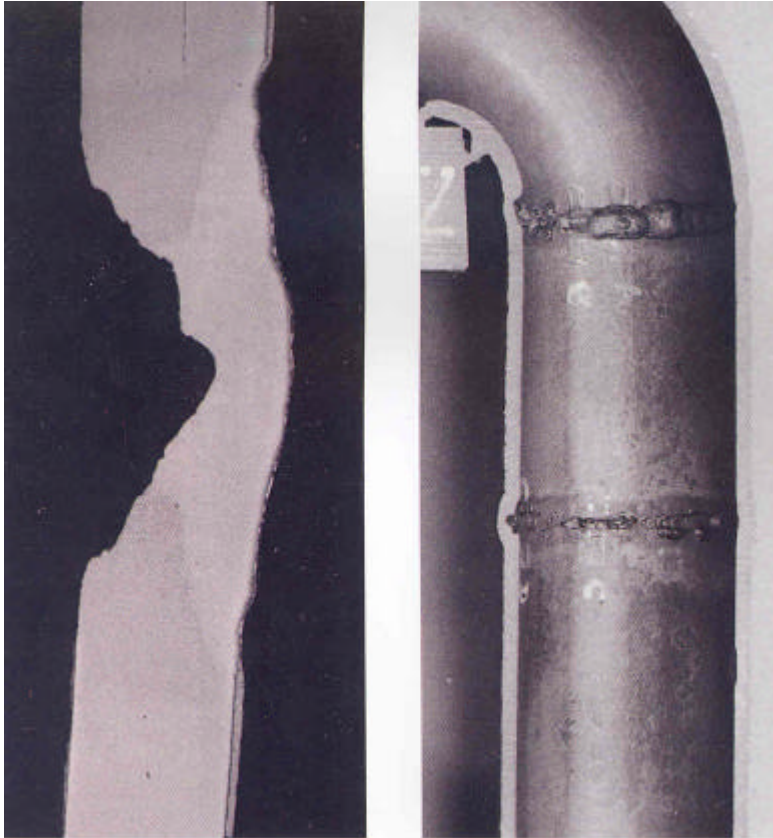
## WELD CORROSION

Preferential corrosion of the weld metal.

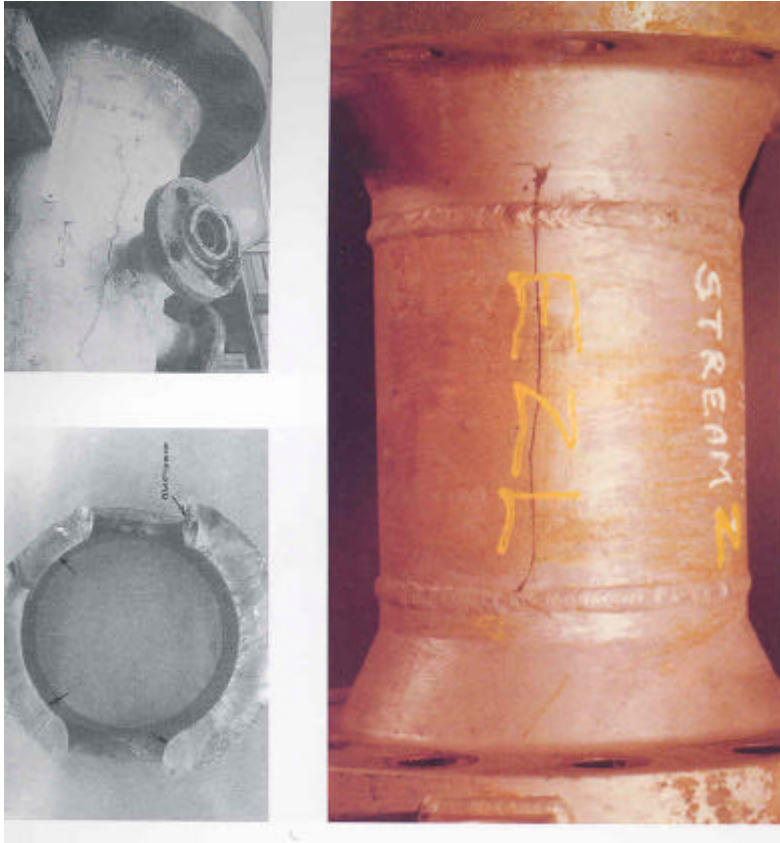
## FATIGUE

Cracks aligned at right angles to the principal stress. Crack surfaces may show characteristic 'beach marks' that were formed at each stage of crack growth.

Cracks grow in response to stress, or pressure, cycling. Stress concentration occurs at the initiating defect or at the growing crack tip.

Conduct a fatigue analysis to assess the risk of cracking.

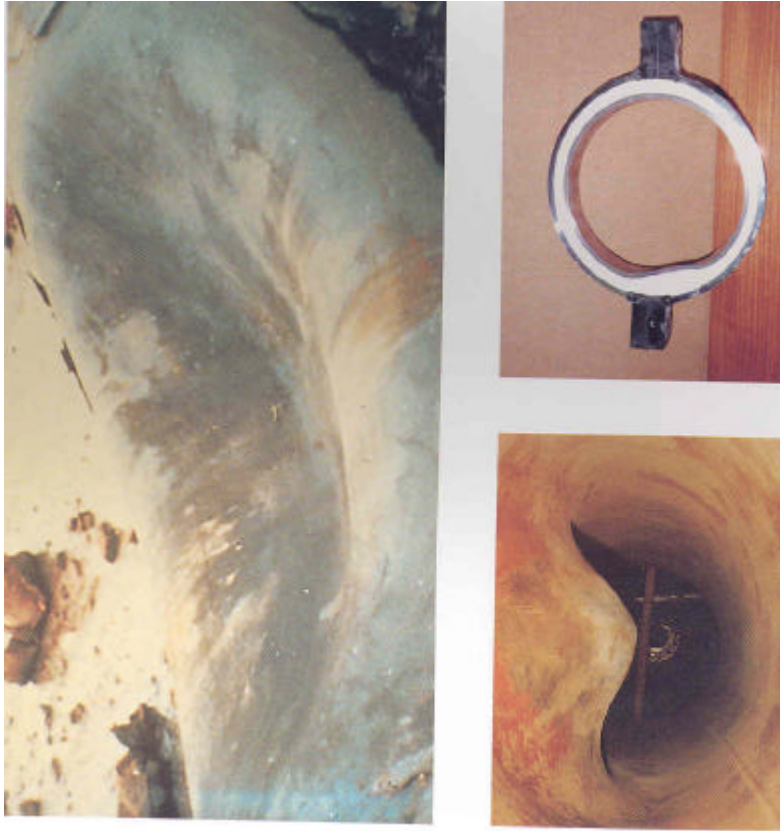
## DENT

An indentation in the pipe wall.

Measure the dent and carry out a structural assessment.  
Cut out the damaged section and replace or repair.

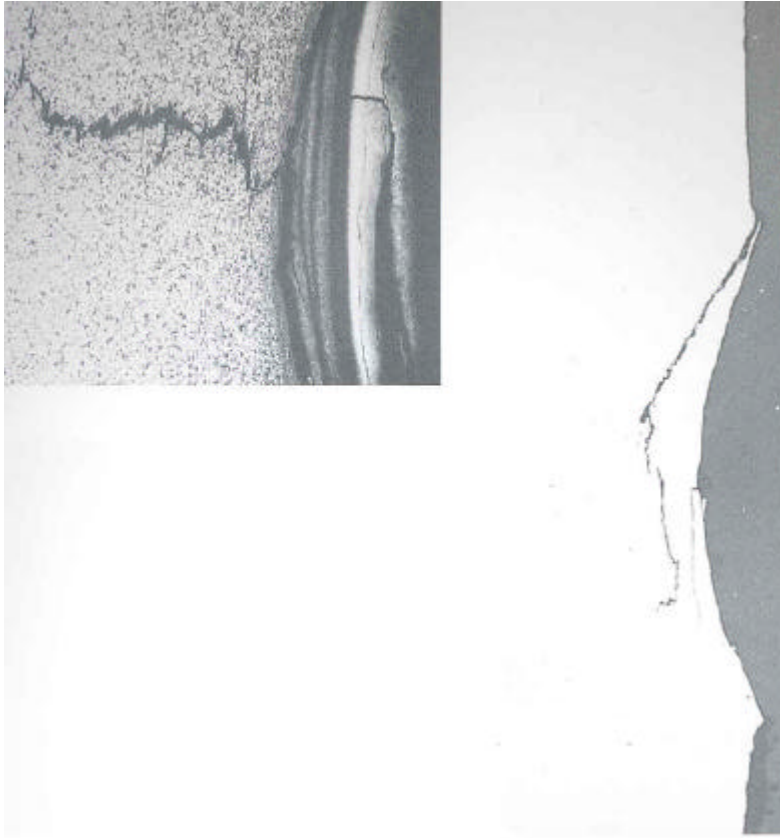
## **GOUGE AND CRACK**

Irregular scores and gouging of the metal surface with cracking beneath the mechanical damage.

Mechanical damage by construction, excavation, drainage or agricultural equipment.

Carry out a full defect assessment and cut out or repair as appropriate.

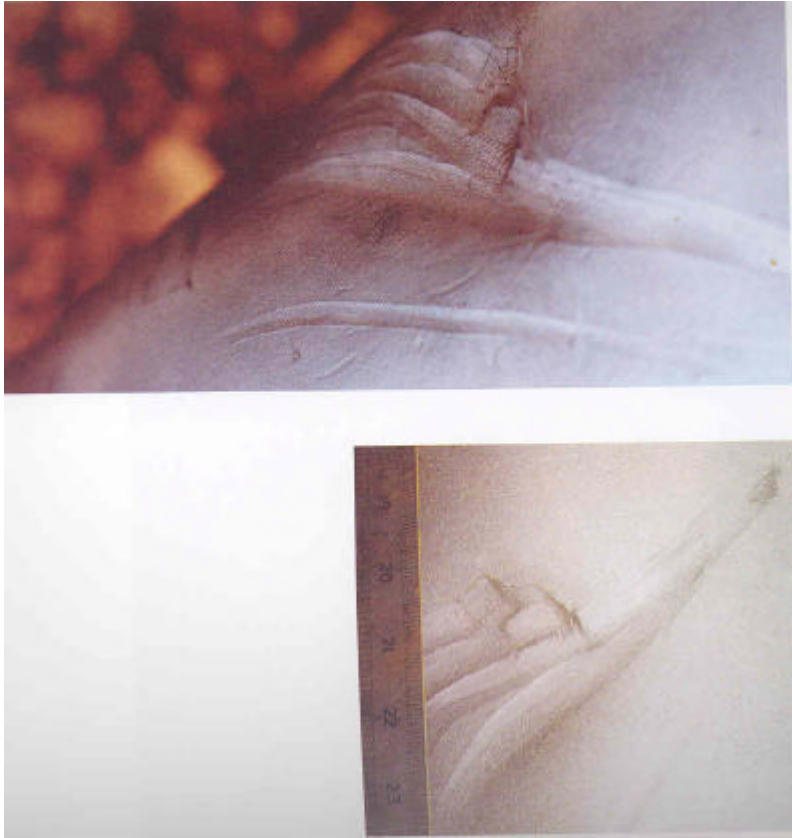
## **GOUGING**

Irregular scores and gouging of the metal surface.

Mechanical damage by construction, excavation, drainage or agricultural equipment.

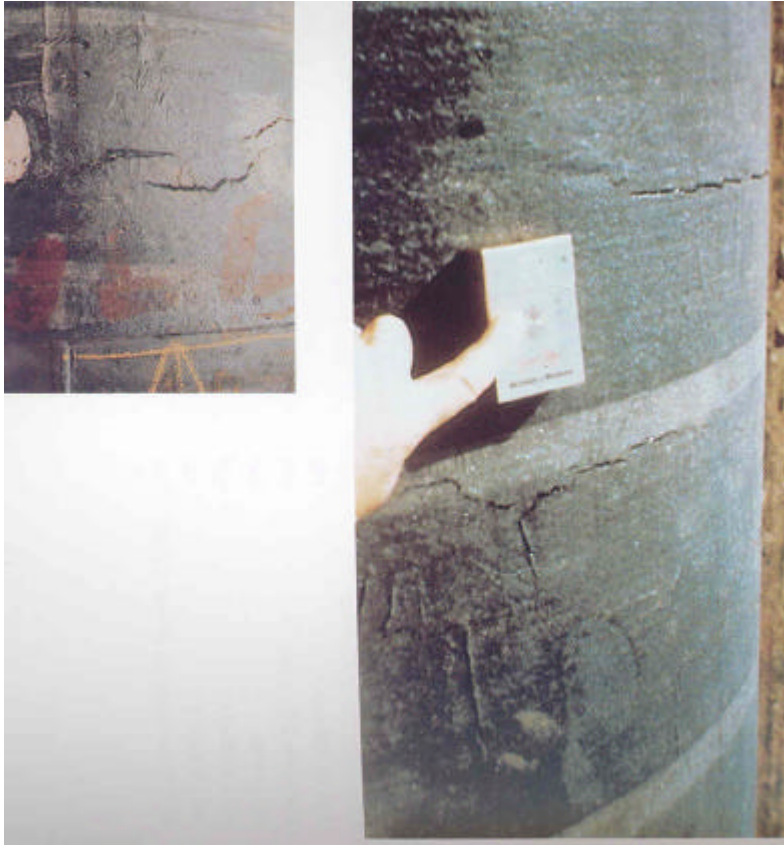
## **COLD BEND CRACKS**

Irregular, circumferential cracks extending through the thickness of the coating.

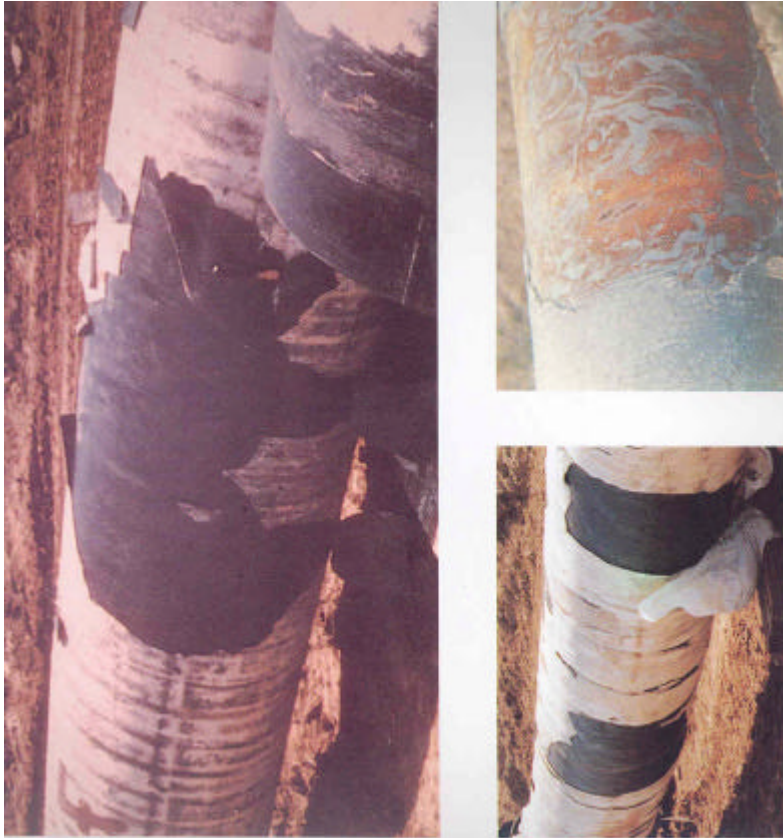
## **COLD BEND DELAMINATION**

Complete loss of adhesion over large areas of the pipe surface.

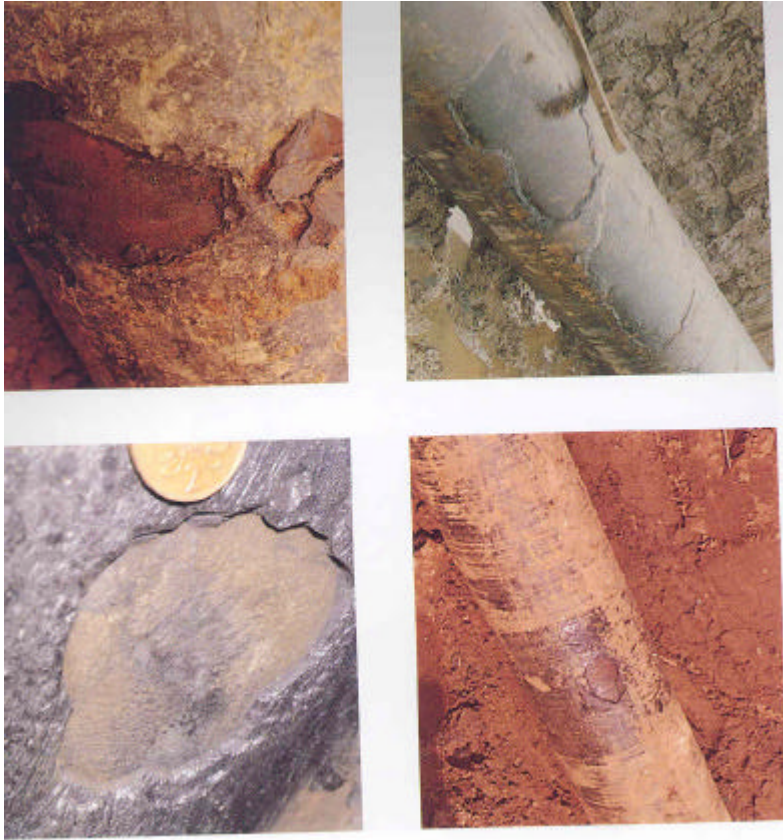
## IMPACT DAMAGE

Complete loss of adhesion around the point of impact.

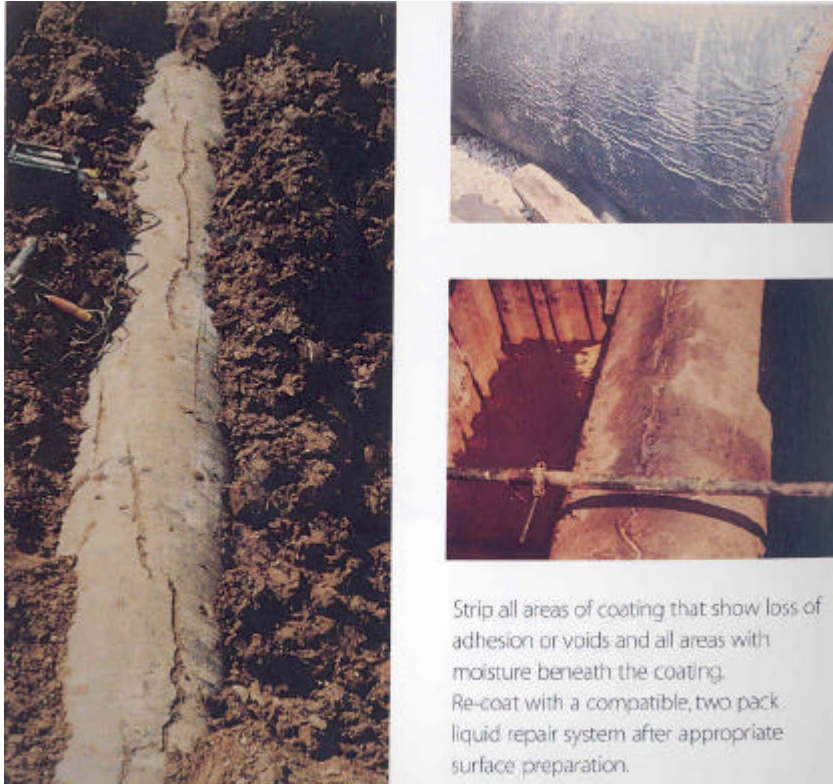
### SOIL LOADING

Irregular cracking of the coating on the crown of large diameter pipe that extends through to the metal. Linear wrinkles, parallel to the pipe axis, as the 3 o'clock and 9 o'clock position. The wrinkles may be filled with water.

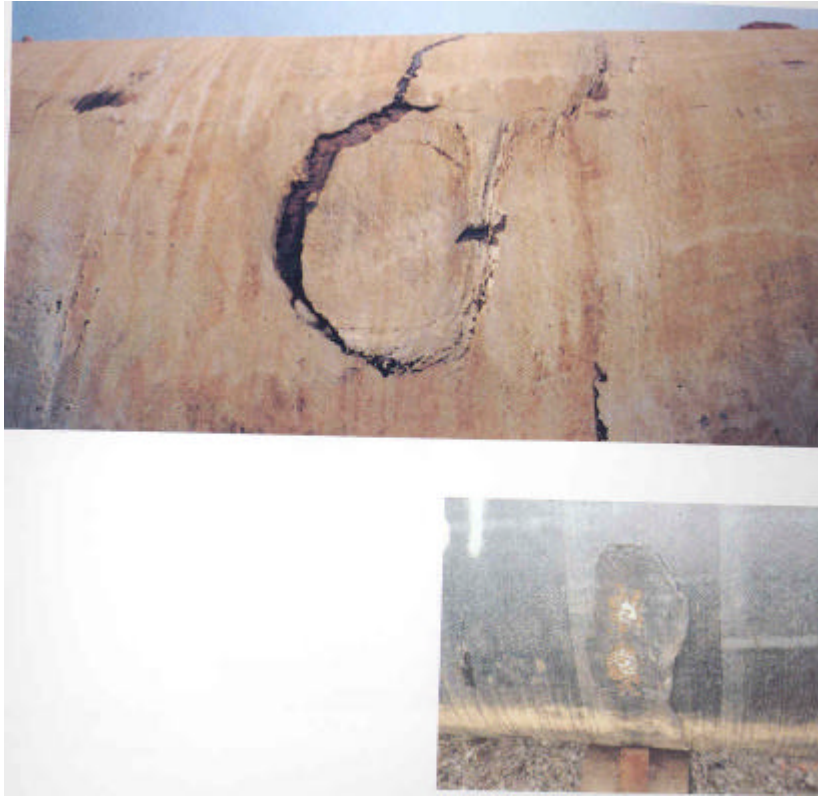
## **SUSTAINED LOADS**

Deformation of the coating due to compression and / or creep.

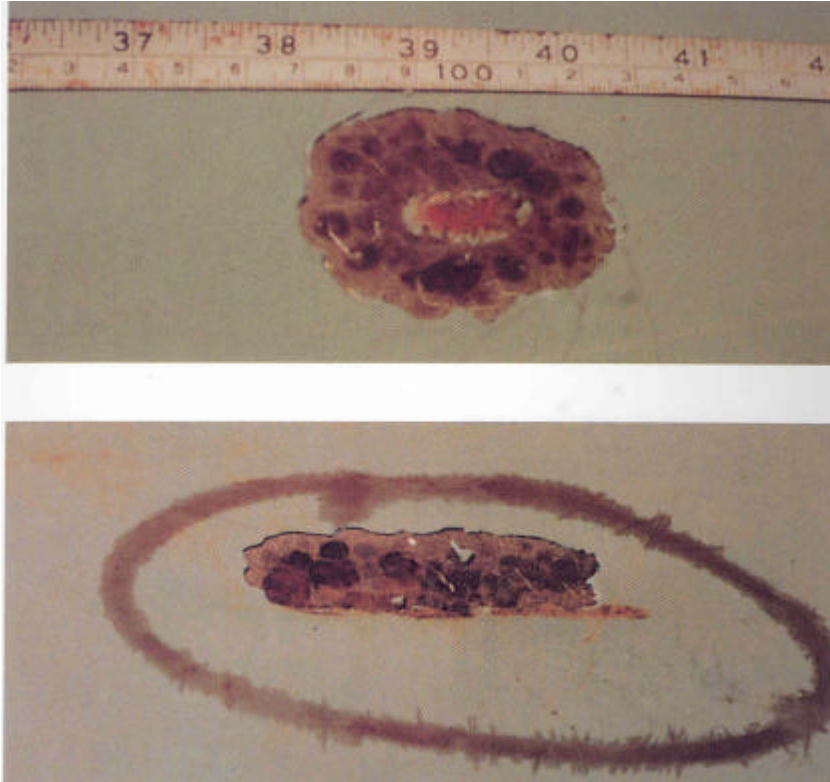
### LEOPARD SPOTTING

Rust spotting beneath delaminated or disbonded coating around pinholes in the coating.

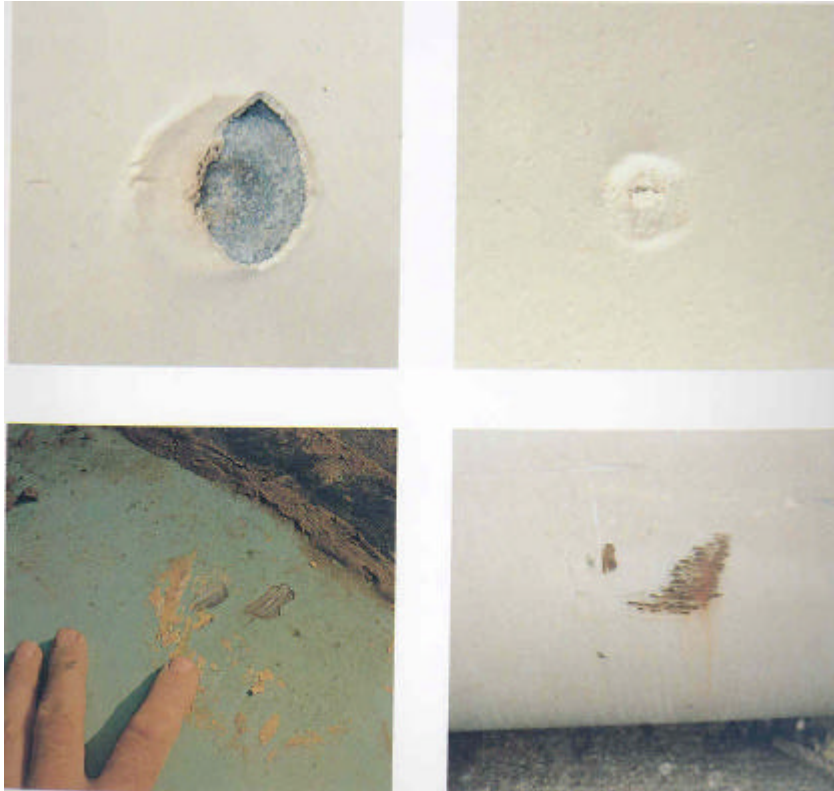
### MECHANICAL DAMAGE

Irregular shaped areas where the coating has been lost.

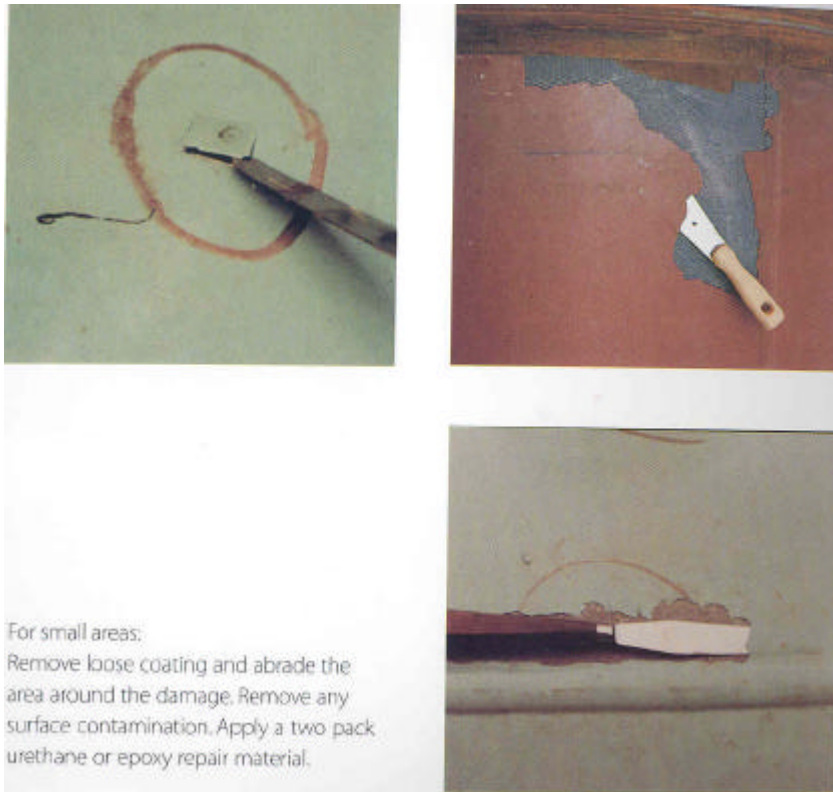
### POOR ADHESION

Coating has lost all adhesion, or can be easily peeled from the substrate.

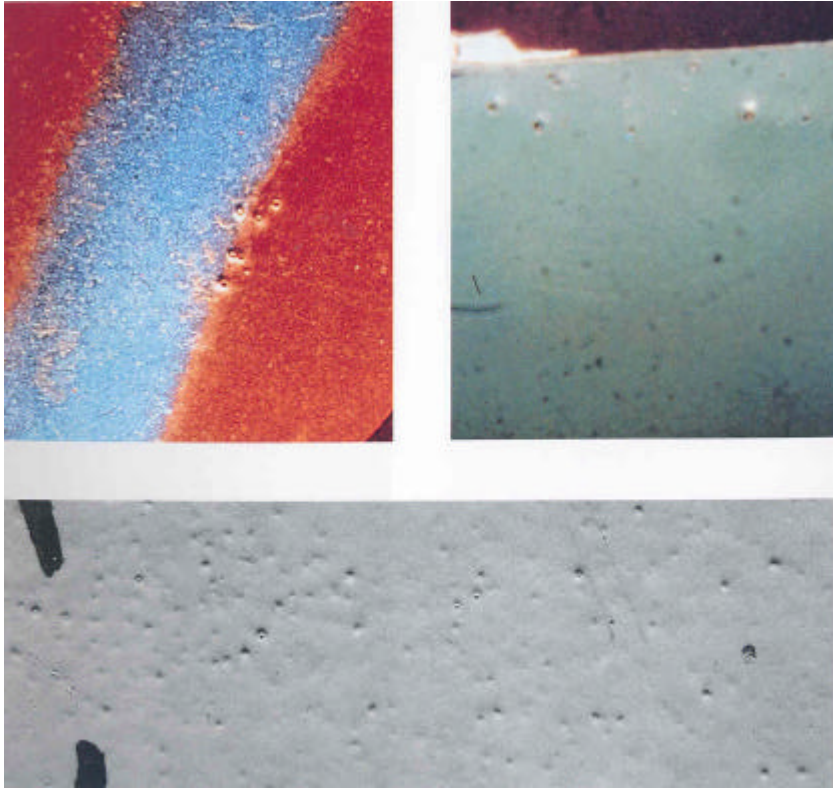
### ROUGHNESS/PINHOLES

Broken blisters showing at the coating surface. On badly affected pipe this may appear as general roughness on the surface of the coating.

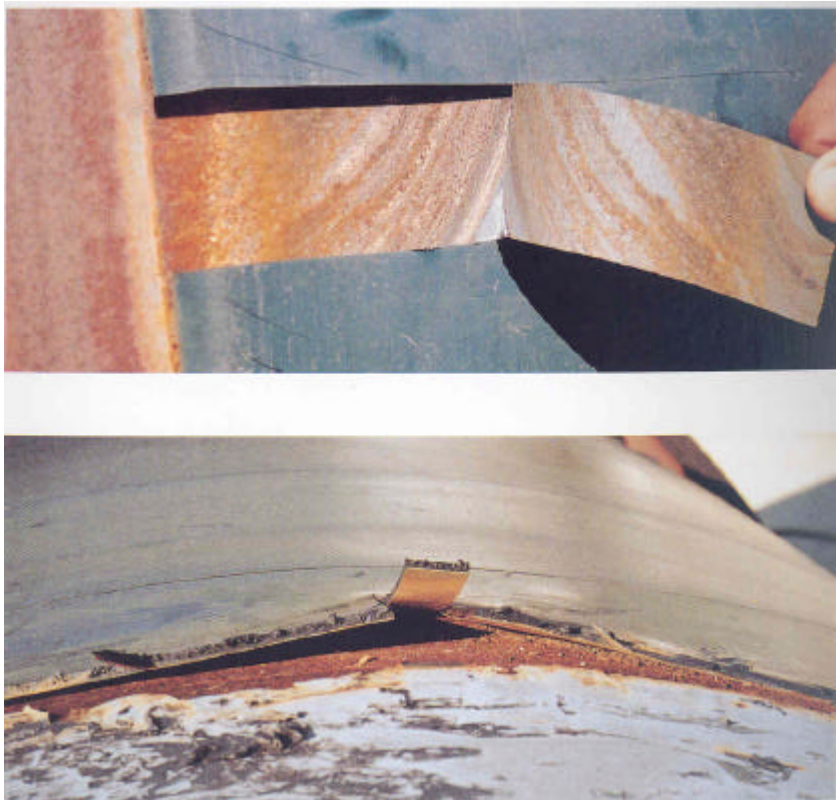
### ADHESION LOSS AT CUT BACK

Complete loss of adhesion, during storage, of the coating next to the cutback at the bevel ends of pipe or fittings. Corrosion may be present beneath the affected coating .

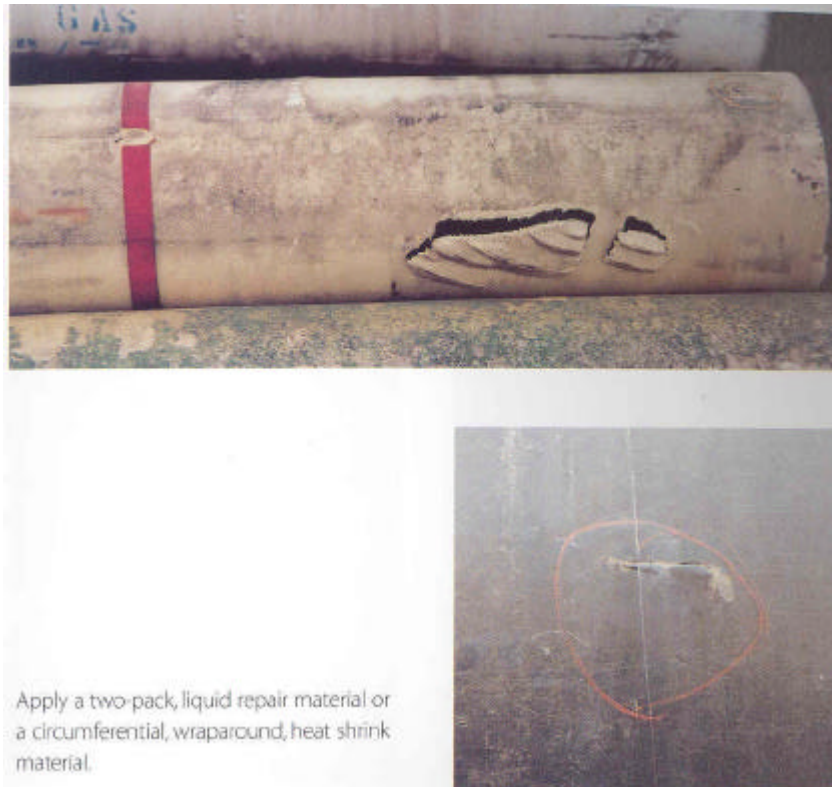
### MECHANICAL DAMAGE

Irregular shaped tears or damage to the coating that exposes the pipe surface or allows water to penetrate to the pipe surface.
