## Manufacturing: ERW Pipe Defects

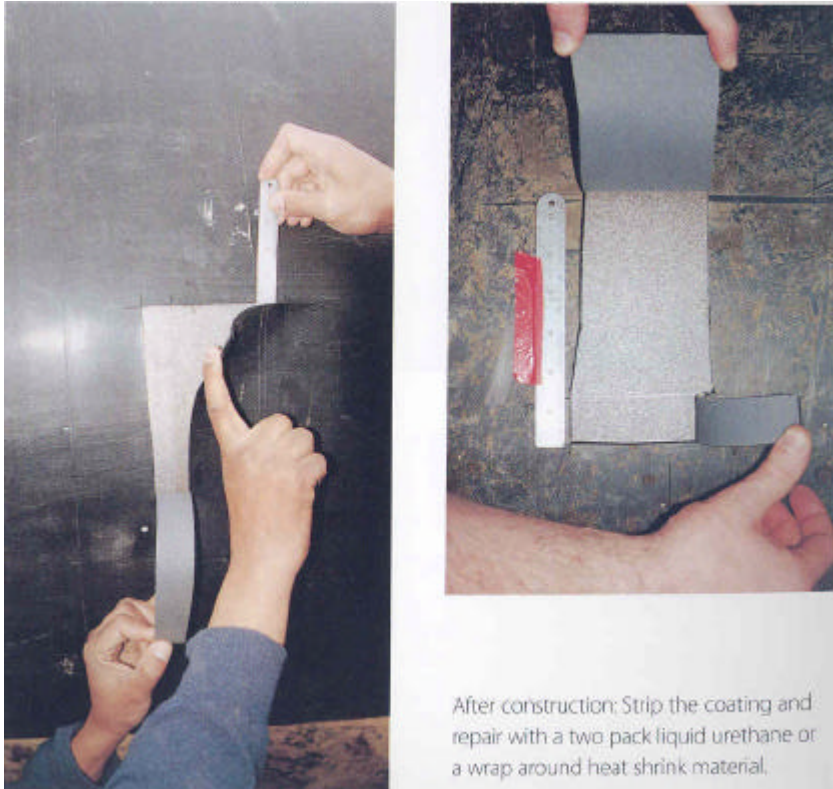
### POOR ADHESION

Loss of bond to the substrate such that all layers of the coating may be removed cleanly from the metal substrate.

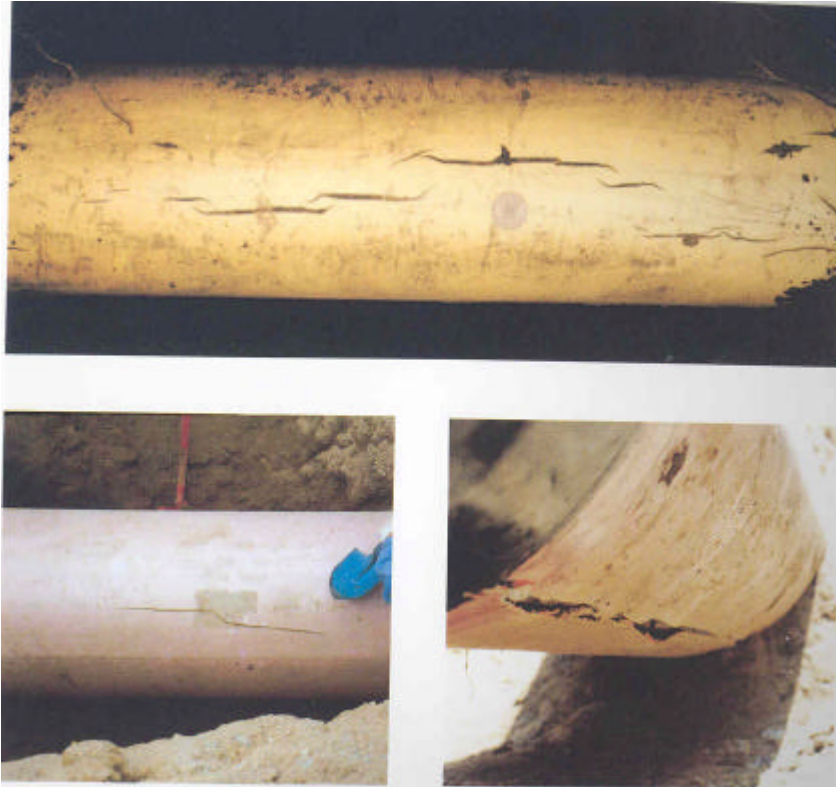
### STRESS CRACKING

Irregular cracks penetrating through the polyolefin layer. Cracks are predominantly longitudinal on pipes with a diameter larger than 150 mm, and may be circumferential on small diameter pipe.

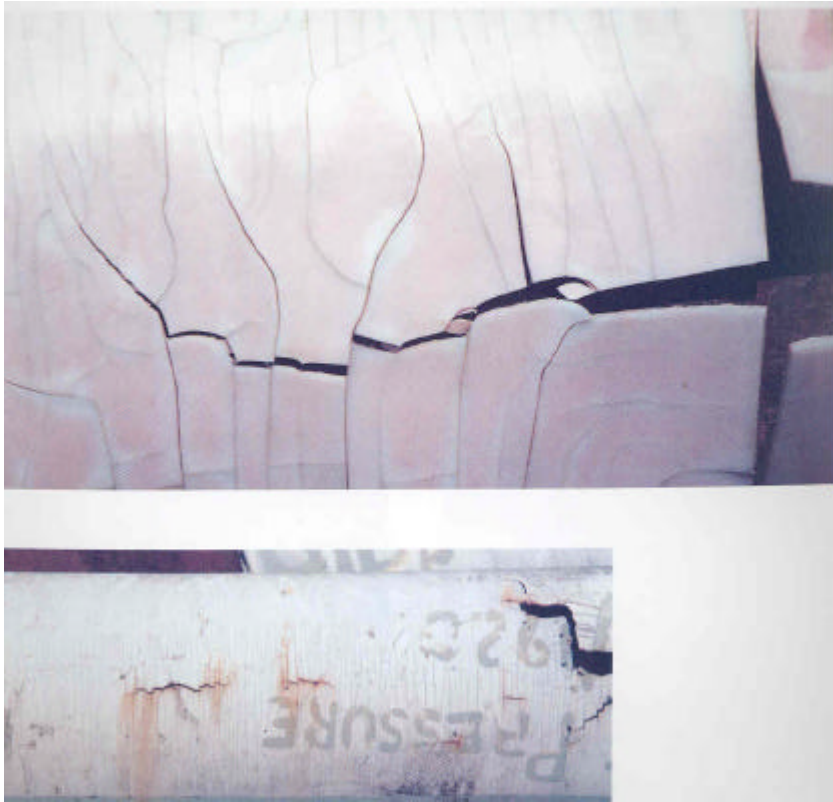
### UV DEGRADATION

Crazing and cracking of the polyethylene.

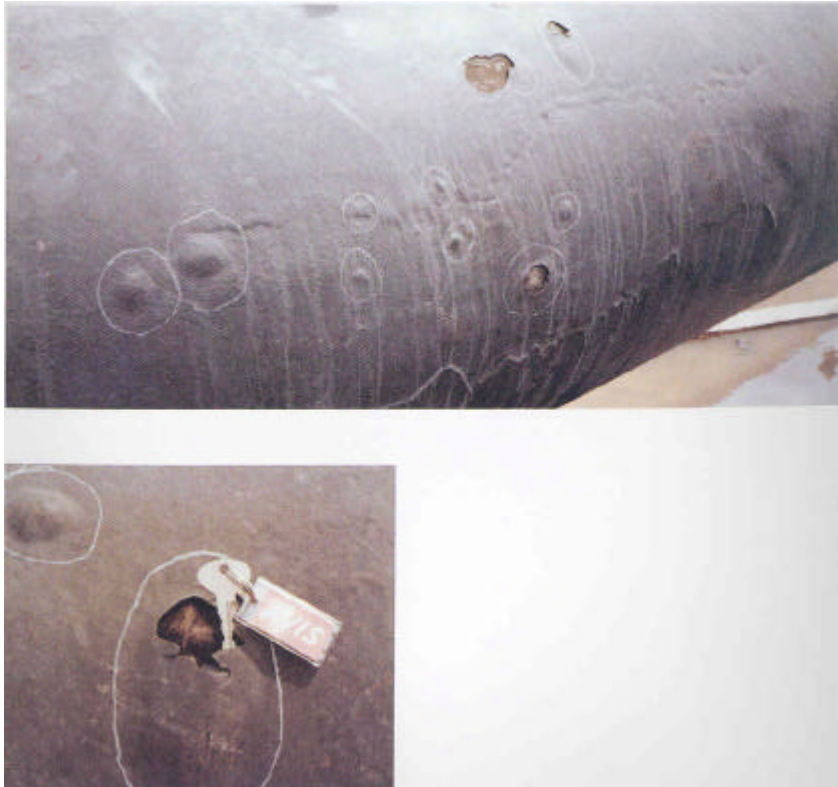
### MIS METERING

Mis-metering is characterized by blisters in the coating and soft areas of incomplete cure.

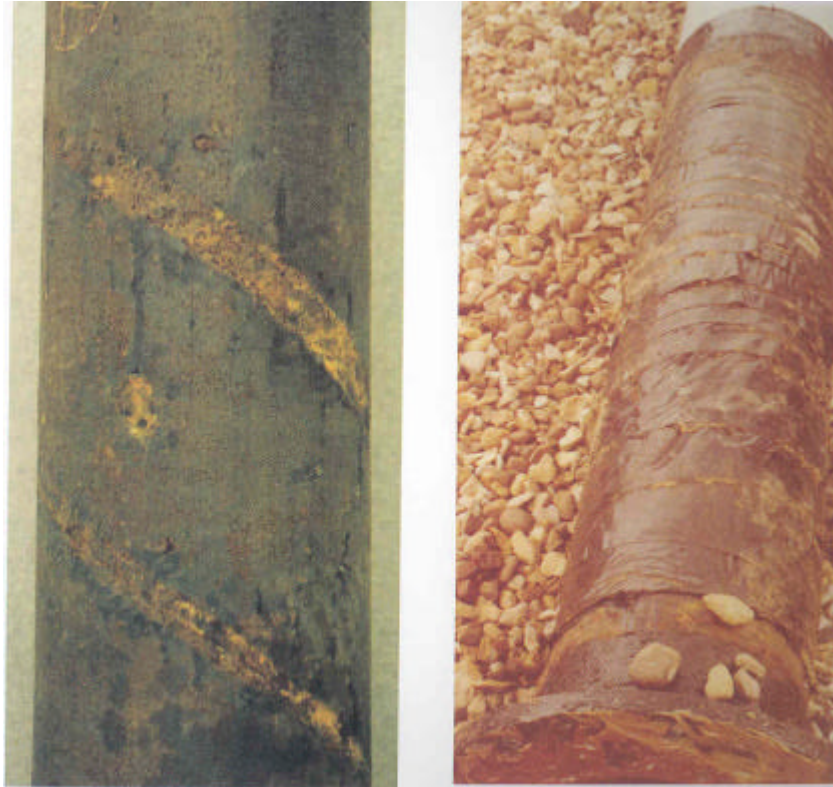
### ADHESION LOSS AT OVERLAP

Spiral pattern of corrosion following the line of overlap between successive turns of tape.

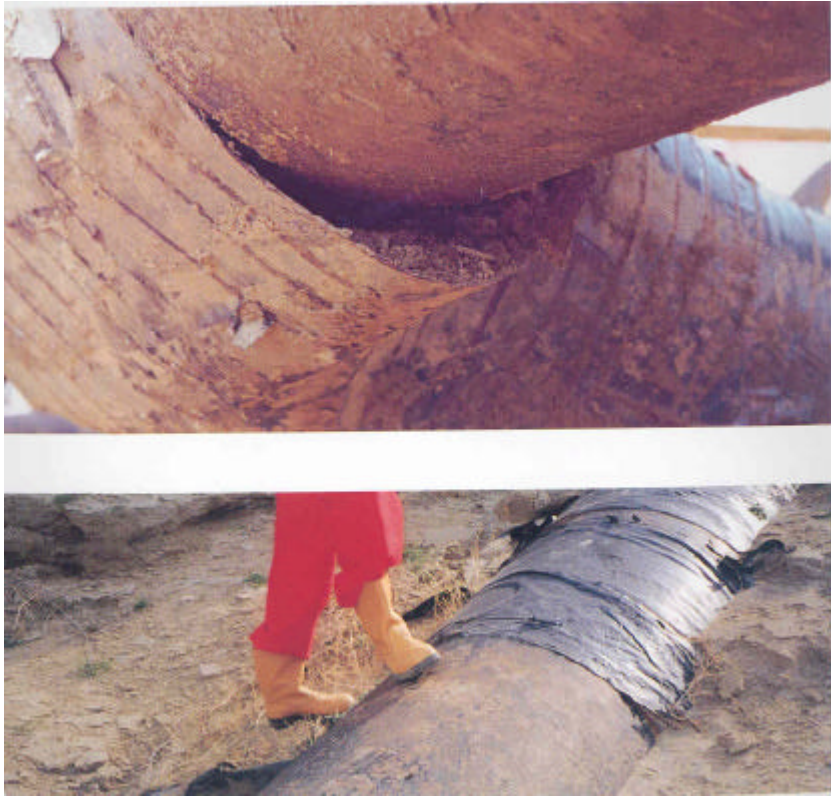
### LOSS OF ADHESION

Tape becomes detached from pipe surface and water enters behind the coating. Where soil is washed in the coating may sag under the weight.

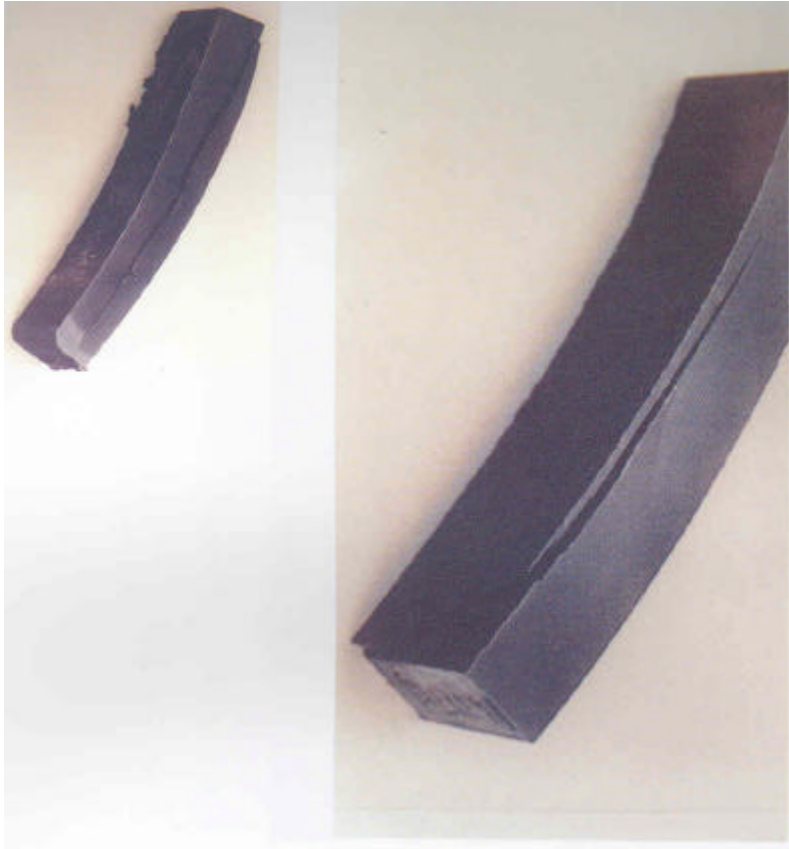
### LAMINATIONS

A discontinuity lying parallel to the pipe surface, usually marked by a concentration of non-metallics.

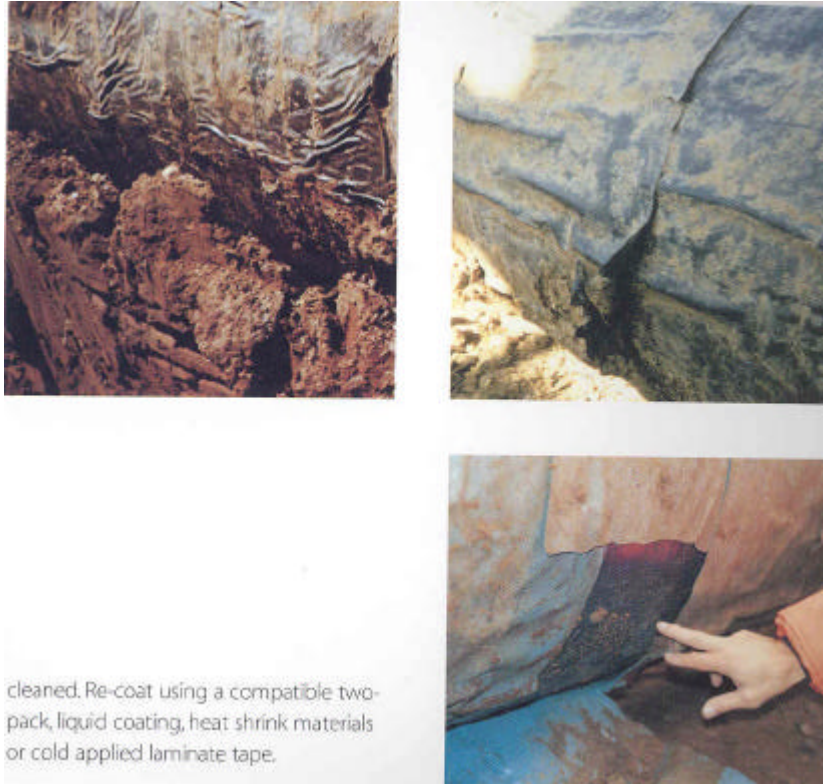
### SOIL LOADING

Loosening, cracking and tearing of the coating with associated loss of adhesion. Linear wrinkles parallel to the pipe axis, usually at 3 o'clock and 9 o'clock. The wrinkles may be filled with water.

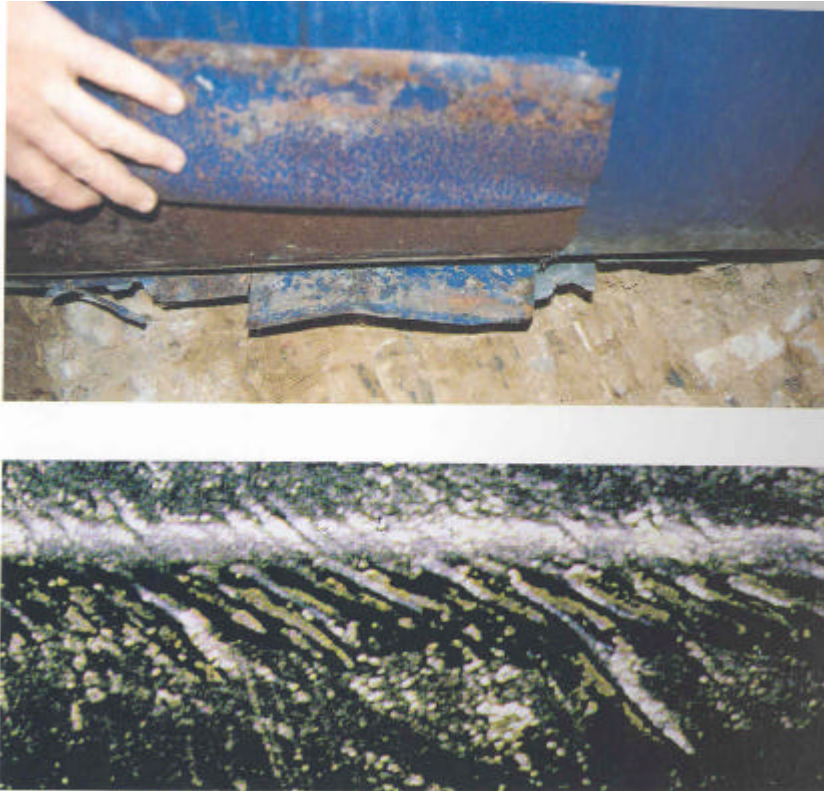
### TENTING OR BRIDGING AT SEAM WELD

Air or water filled voids beneath cold applied laminate tape on either side of the seam or spiral weld bead.

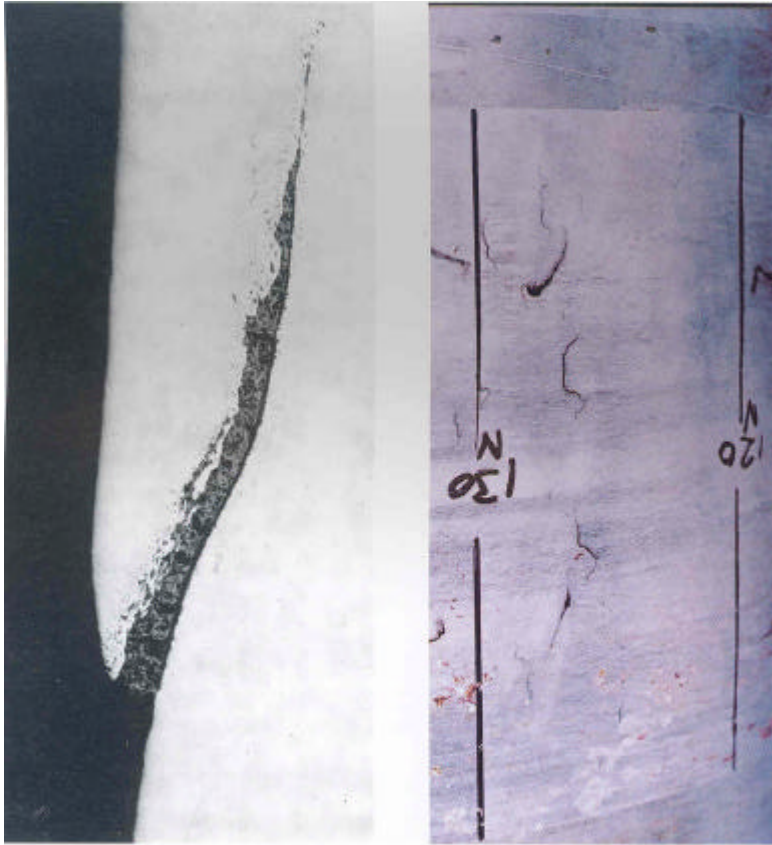
### LONGITUDINAL SURFACE LAPS

A flap of metal lying flat on the pipe surface, usually with a trapped residue of oxide or scale beneath it.

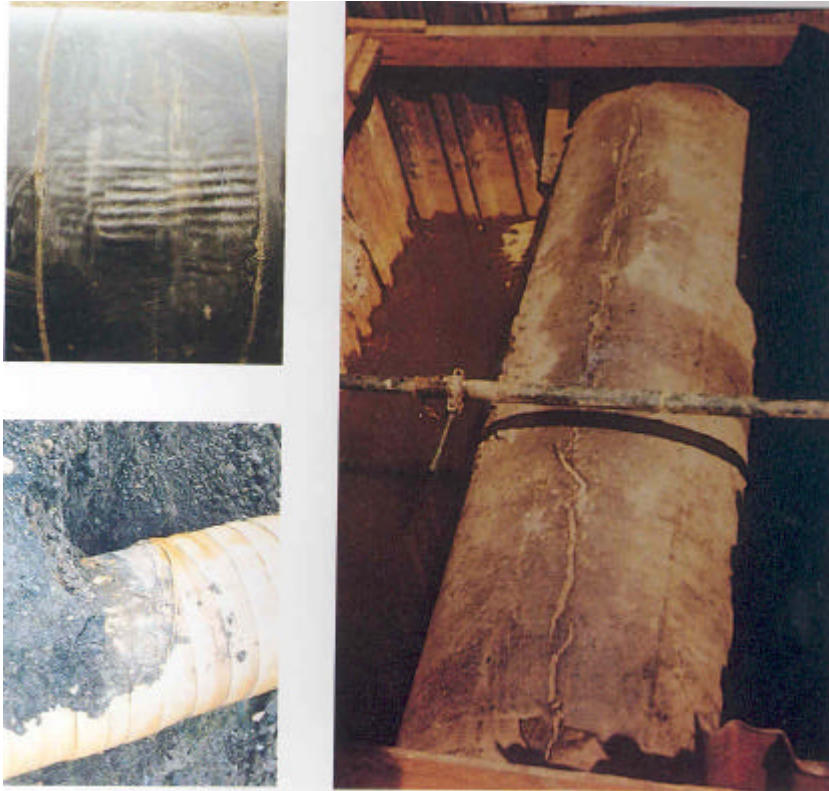
### COATING AND SOIL

Thermoplastic coatings are susceptible to creep under sustained loads, for example from the soil. Defects generated by sustained soil loads can be found in hot enamel coatings, cold applied tapes and heat shrink materials.

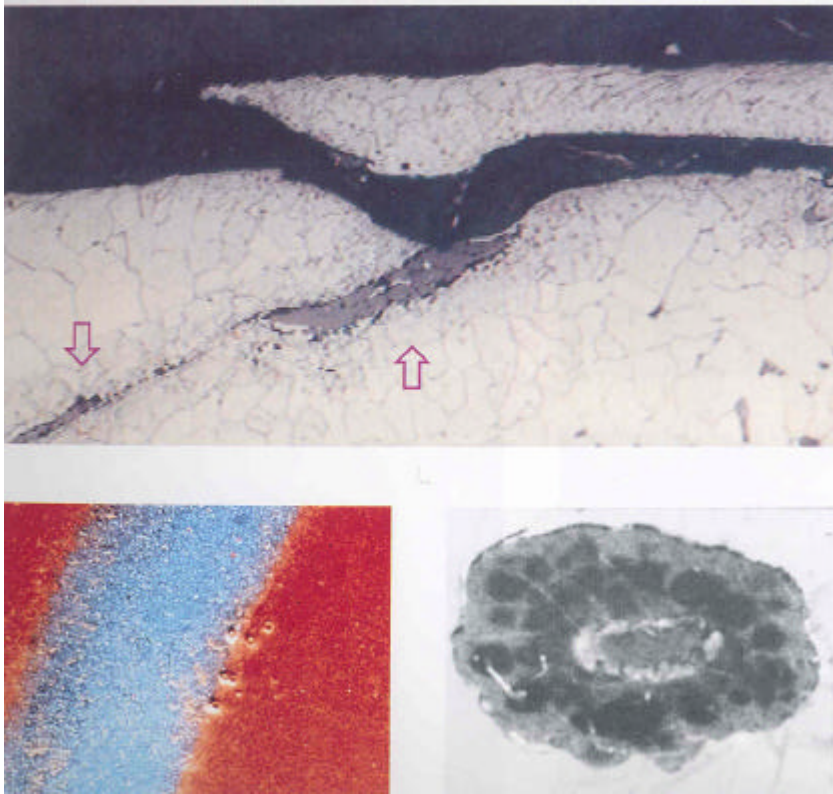
## PIPE SURFACE PREPARATION

Trapped slag exposed at the pipe surface act as a reservoir for moisture and for salts accumulated during transport of pipe by sea and storage on a dockside.

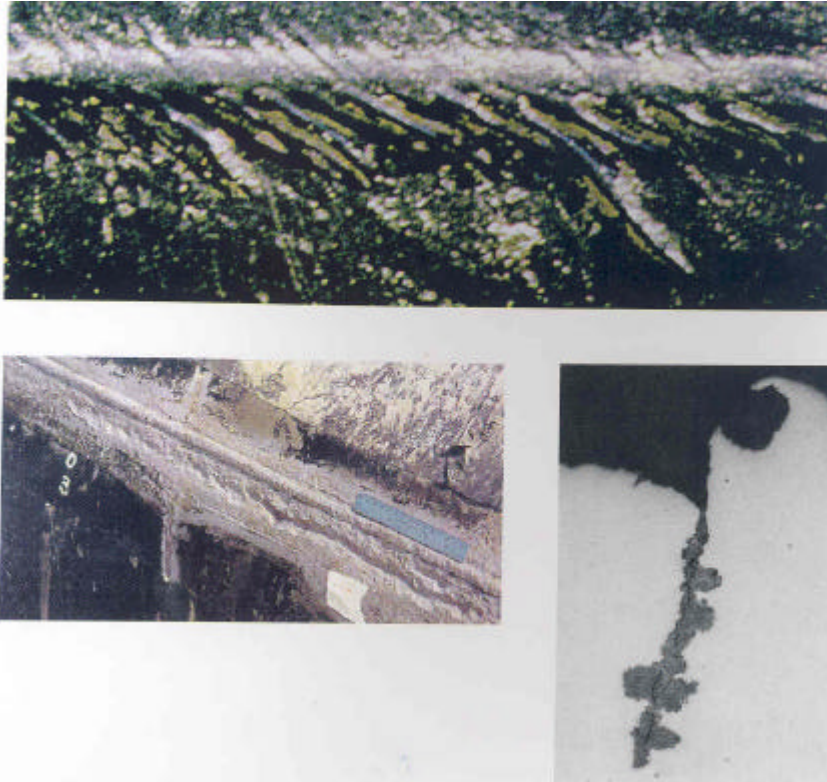
### TAPE – NAEC - SCC

Bridging of cold applied tape over the cap of the seam weld leaves a void on either side of the weld line. When water gets into this void a corrosion risk is created. The applied cathodic protection current cannot control this corrosion risk because the pipe is shielded from the CP current by the insulating coating.

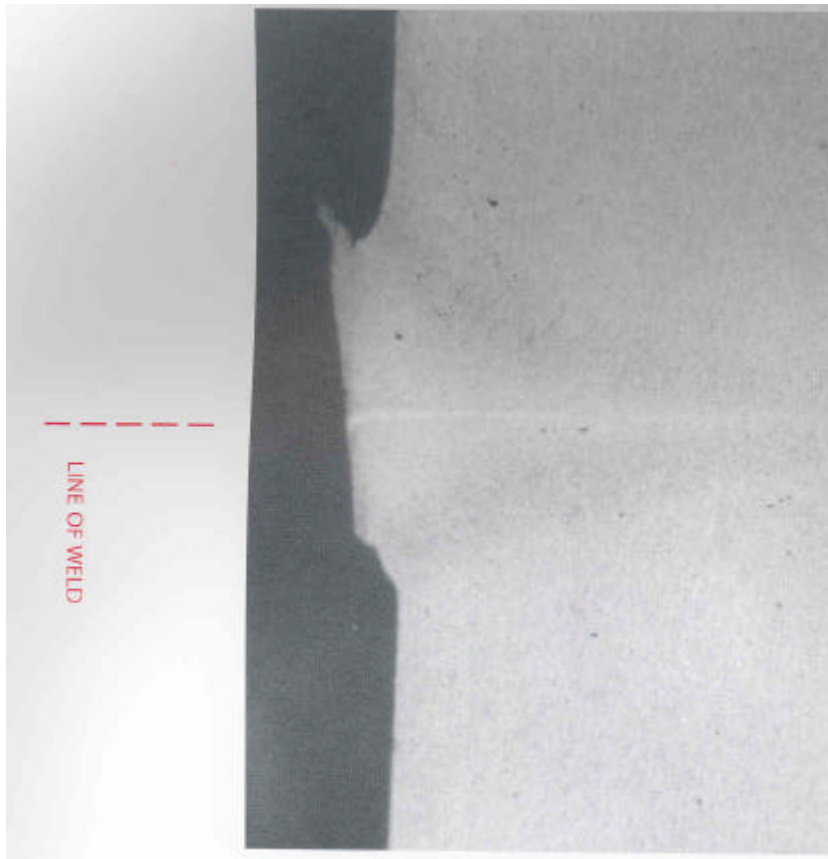
### SEAM UNDERTRIM

Linear feature standing proud of the pipe surface on the line of the seam weld.

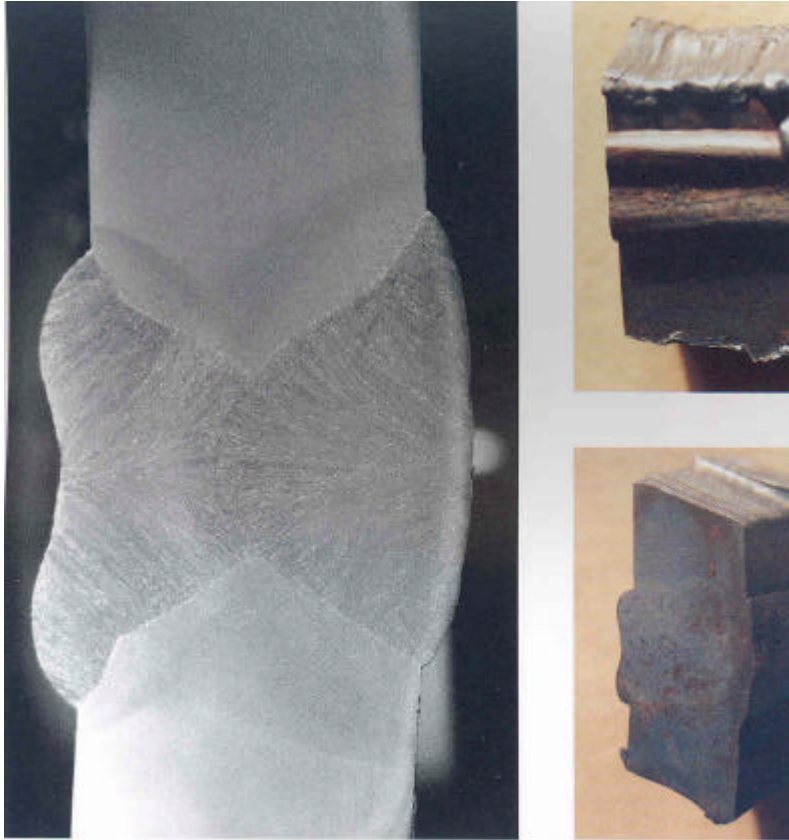
### CONCAVE CAP

Concave profile in the weld cap.

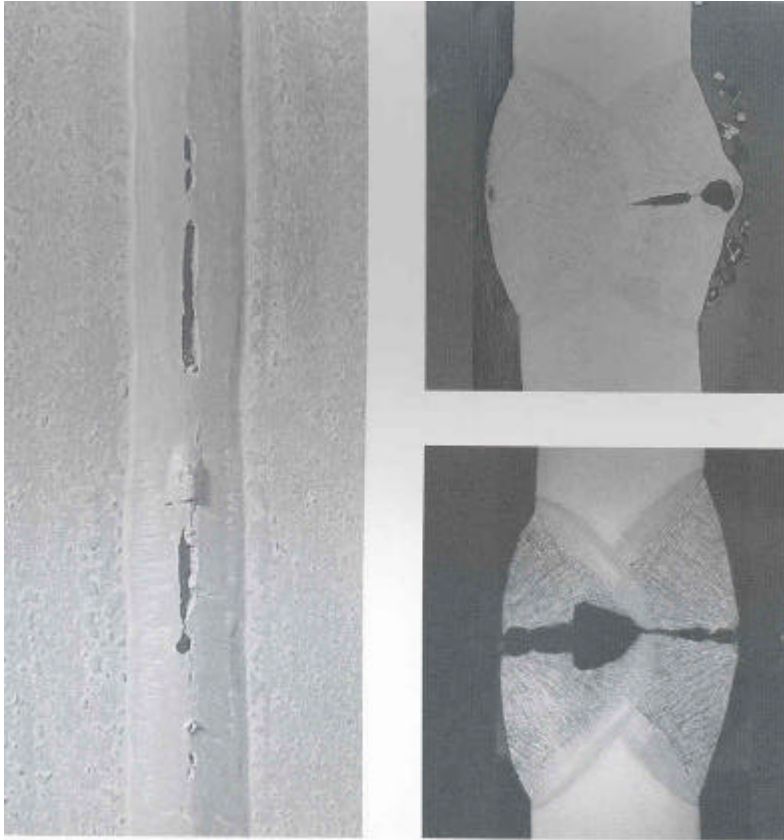
### **POROSITY**

Void in the weld metal which can be isolated, clustered or in the form of piping.

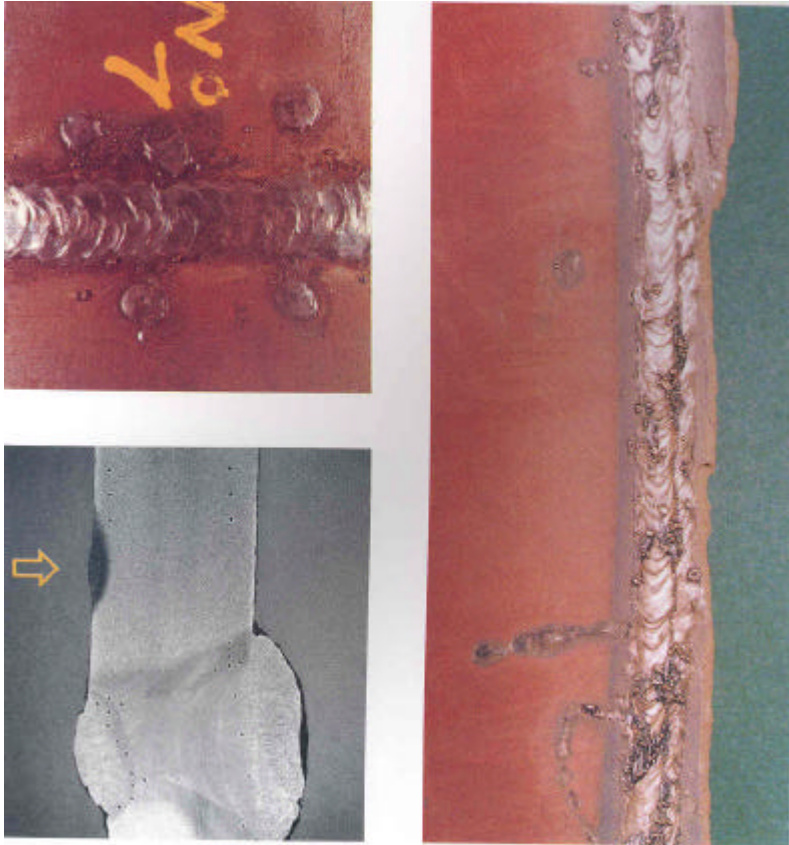
### ARC STRIKES

A localized heat affected zone on the surface of the pipe. An arc strike may produce hardening, and in high strength hardenable steels cracking may occur.

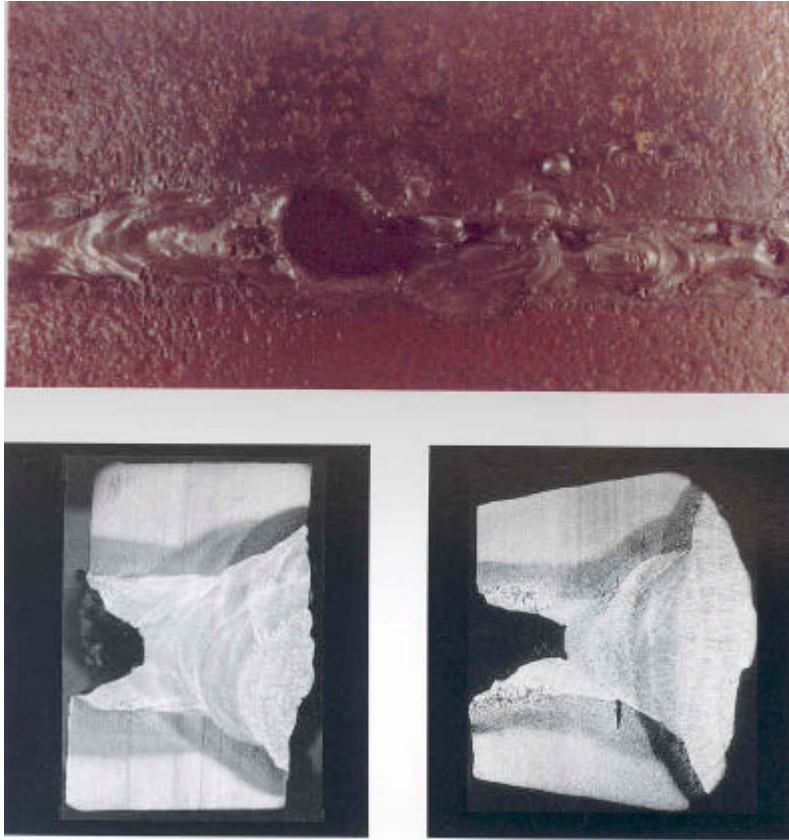
### ARC STRIKES

Local area where the root bead is missing. Often covered by the next pass. Also known as 'window'.

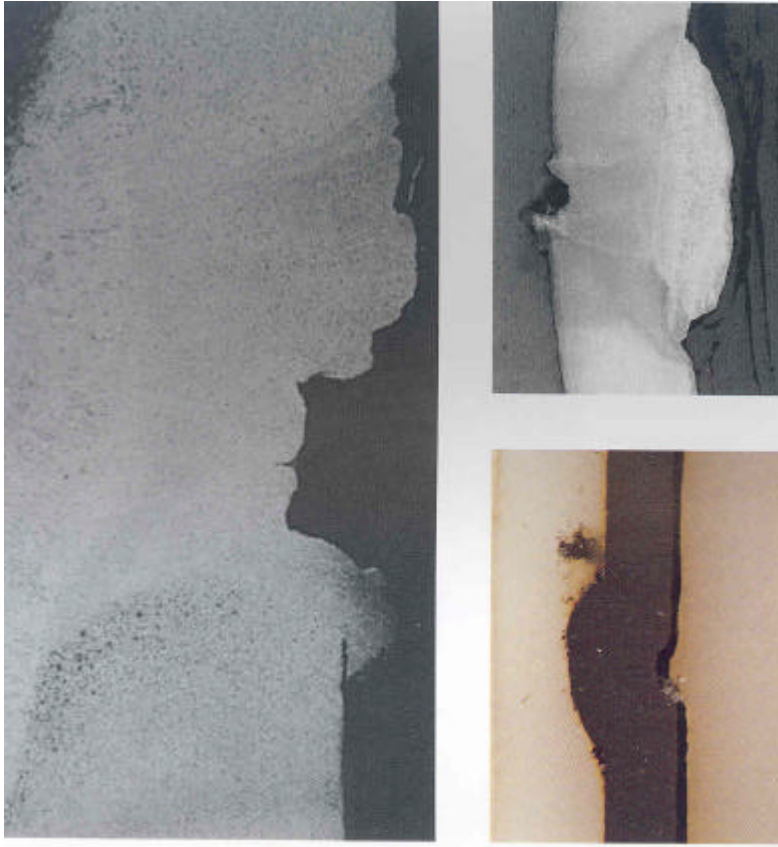
### CONCAVE ROOT

Concave profile of the root run.

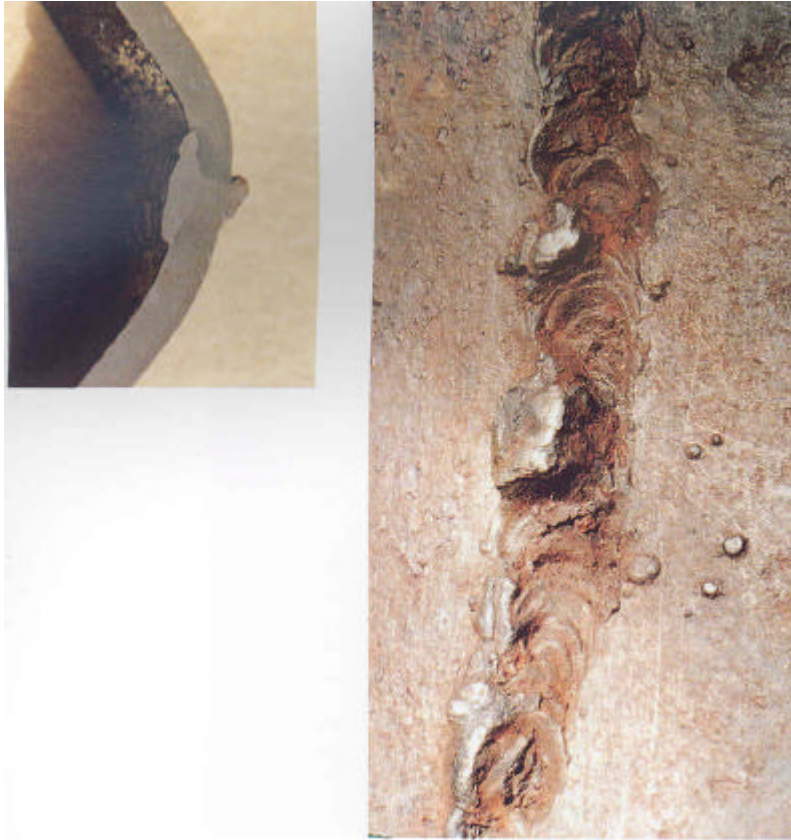
## EXCESS PENETRATION

Excess weld metal in the root of the weld, usually more than 3 mm.

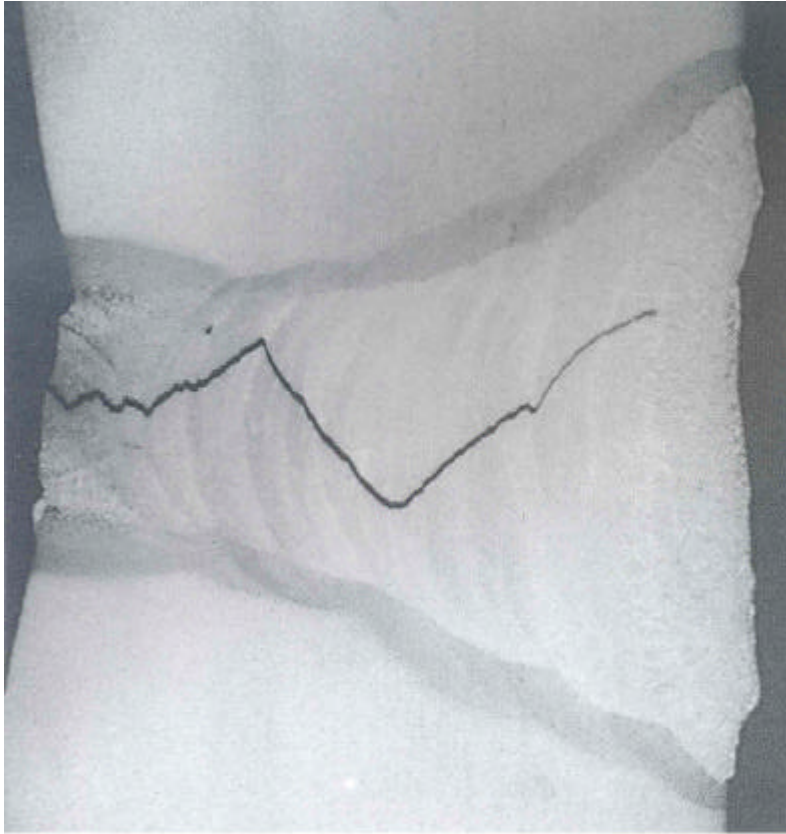
### H CRACKING, WELD METAL

Cracking in the weld metal. Often transverse to the weld axis and lying at an angle of  $45^\circ$  to the weld surface.

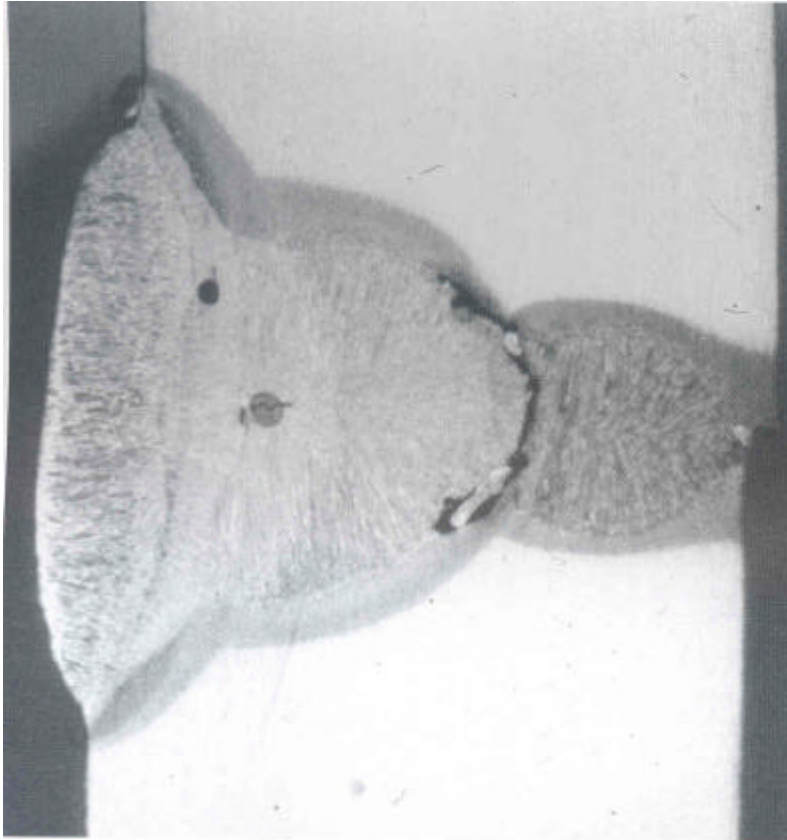
### LACK OF FUSION

Lack of fusion between adjacent weld beads. Also known as 'cold laps'.

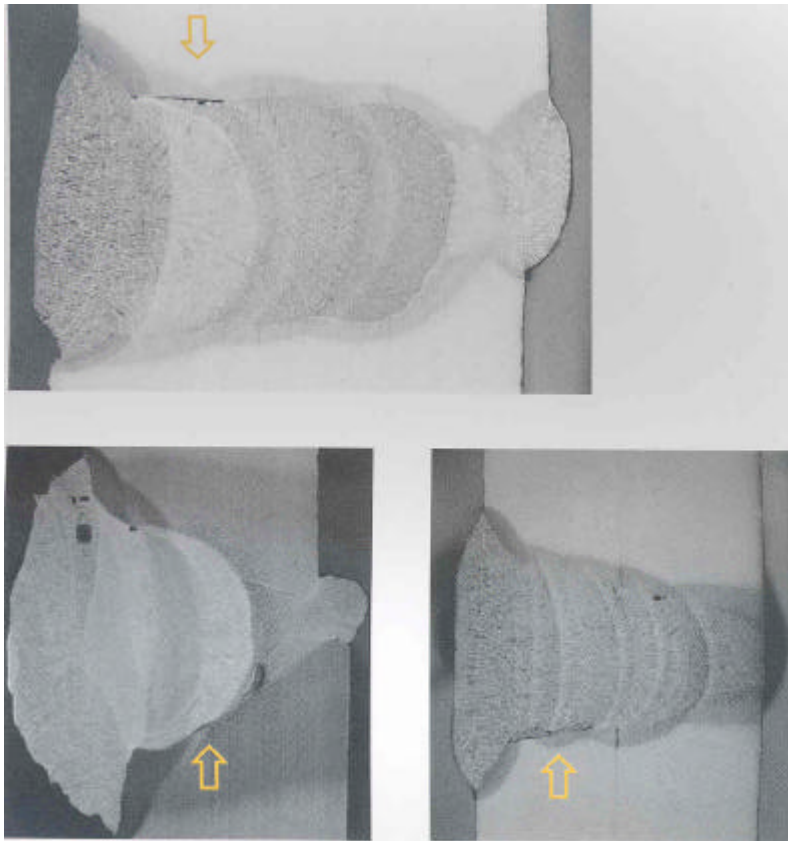
### LACK OF FUSION

Occurs as a planar discontinuities between successive weld passes or between the weld bead and the pipe. Lack of side wall fusion is especially common in mechanized gas metal arc welds.

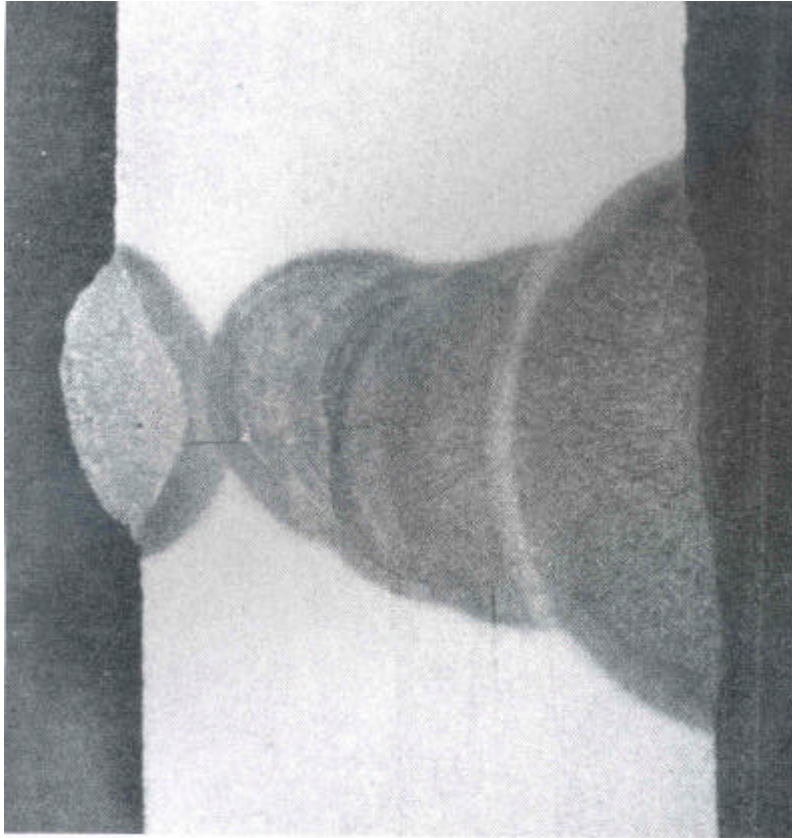
### LACK OF INTER PENETRATION

Failure of inside weld bead and outside weld bead to penetrate, especially in mechanized gas metal arc welds.

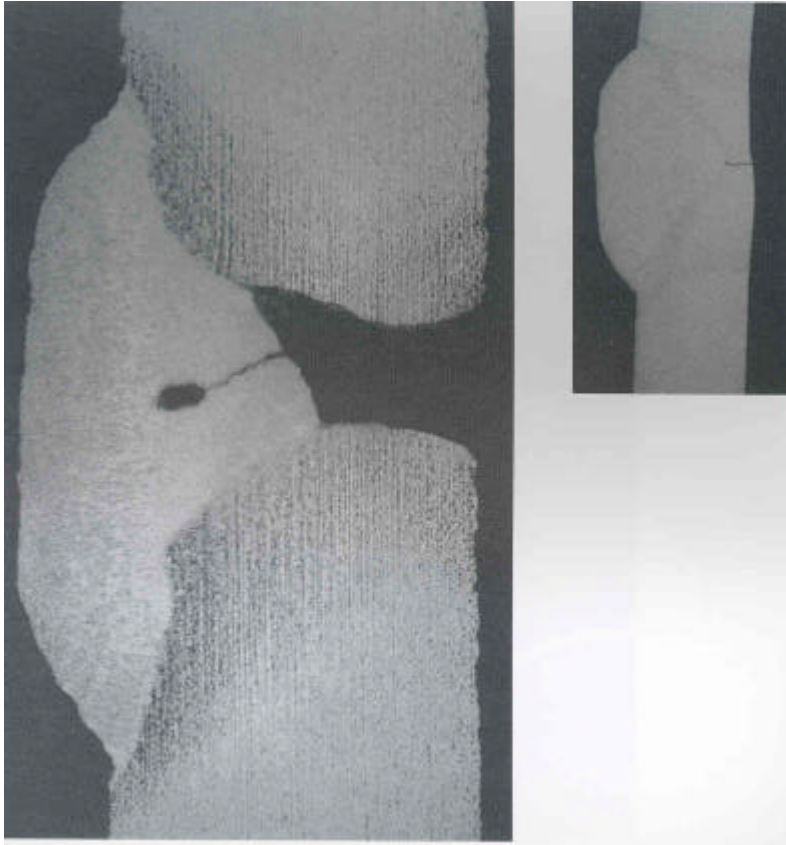
### LACK OF PENETRATION

Incomplete penetration of the weld through the full thickness of the joint to leave an unfused crevice, typically in the root run.

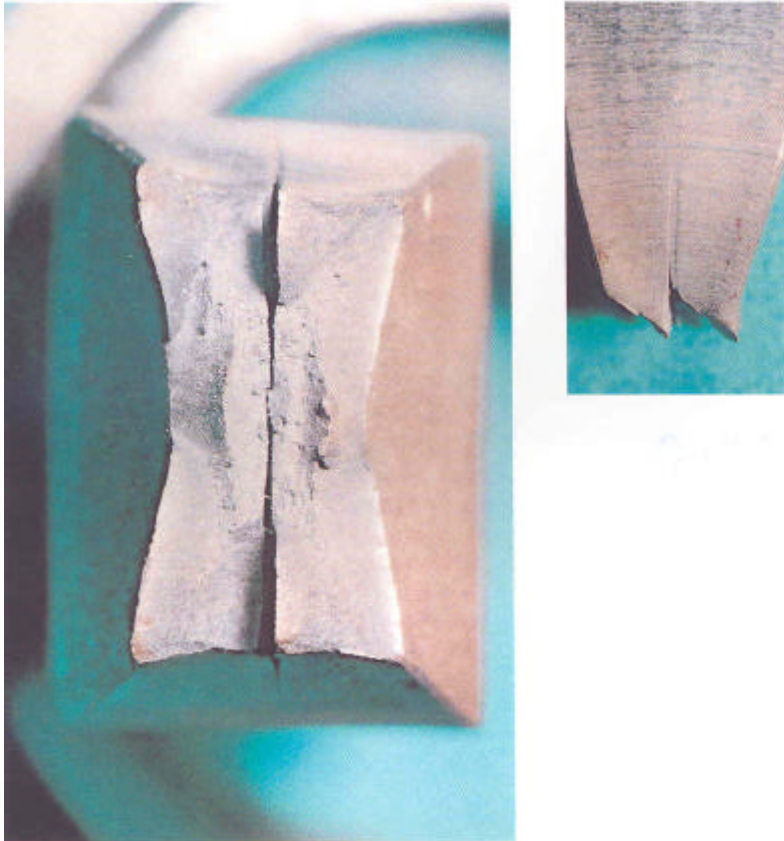
## CENTRE LINE SPLITS

Cracking along the centre line of the plate in test pieces.

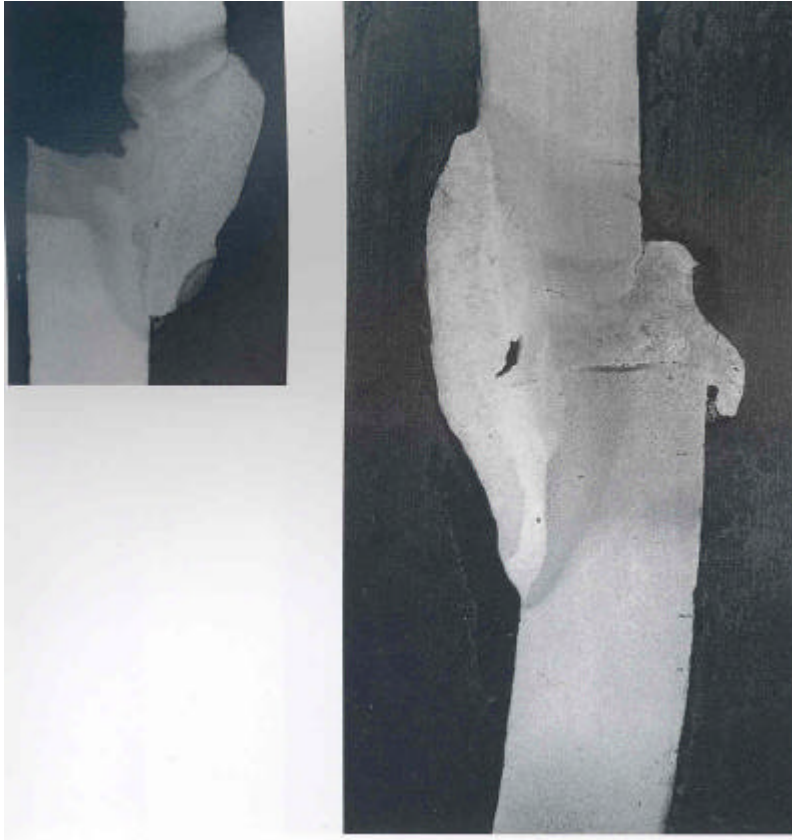
### MISALIGNMENT

Misalignment of the pipe ends across the weld bead to produce an asymmetric weld. Also known as 'Hi-Lo'.

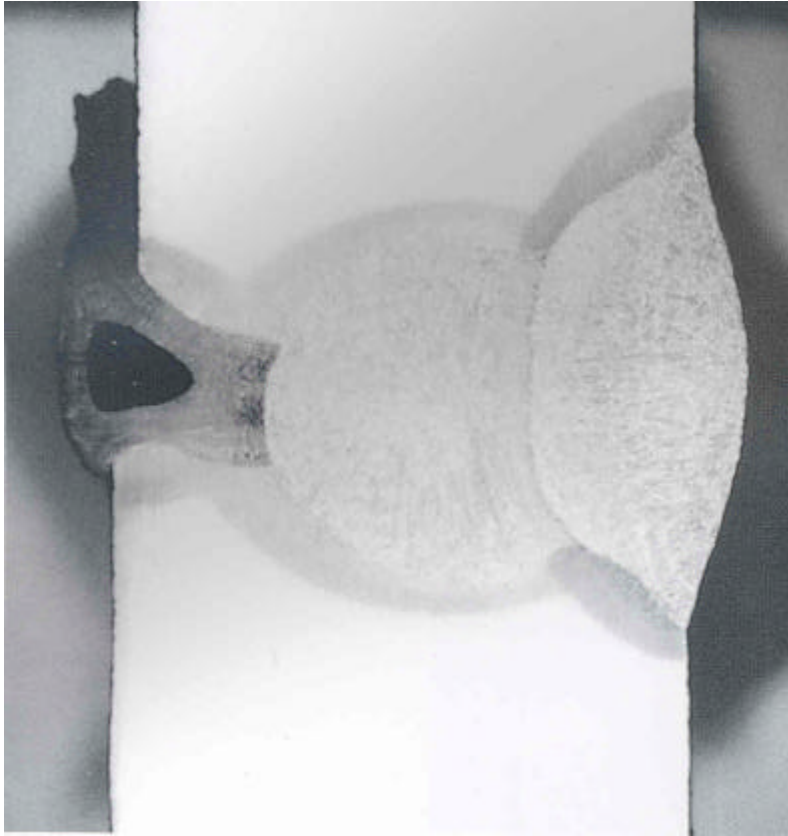
### **POROSITY, ROOT**

A continuous pore in the centre of the root bead. Also known as 'hollow bead'.

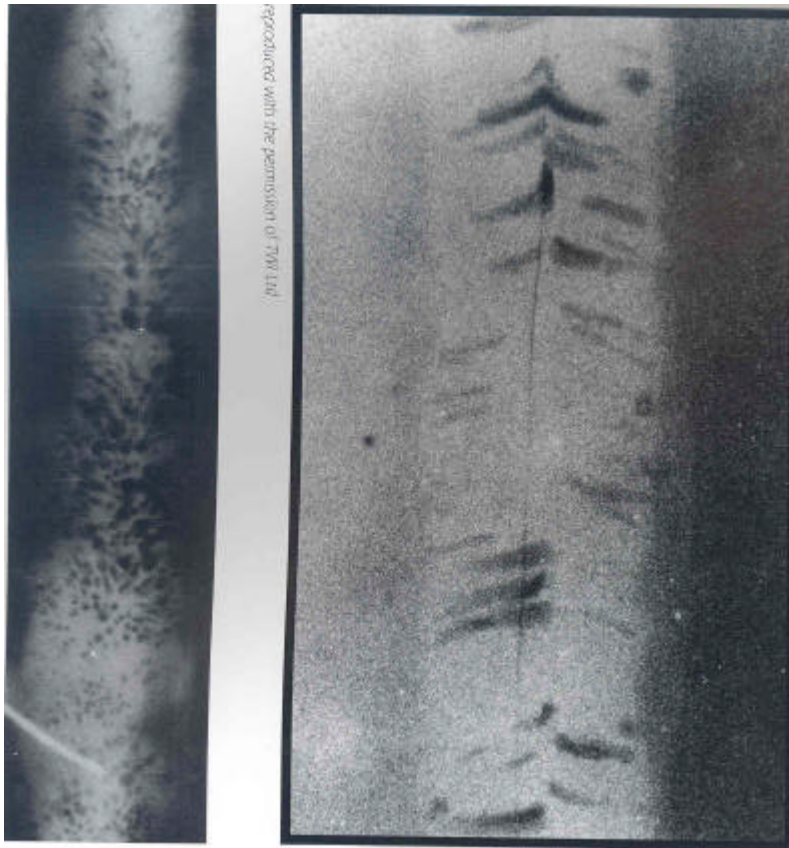
### **POROSITY, PIPING**

Elongated porosity in the weld bead. Also known as wormholes or herring bone porosity.

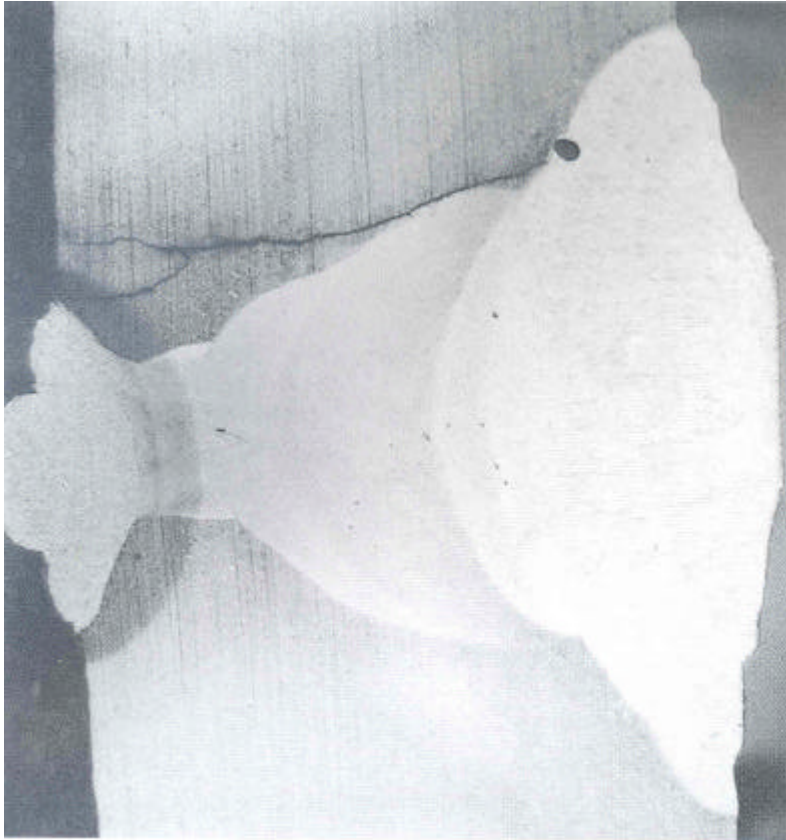
## **REPAIR, WELD CRACK**

Hydrogen cracks associated with repair welds.

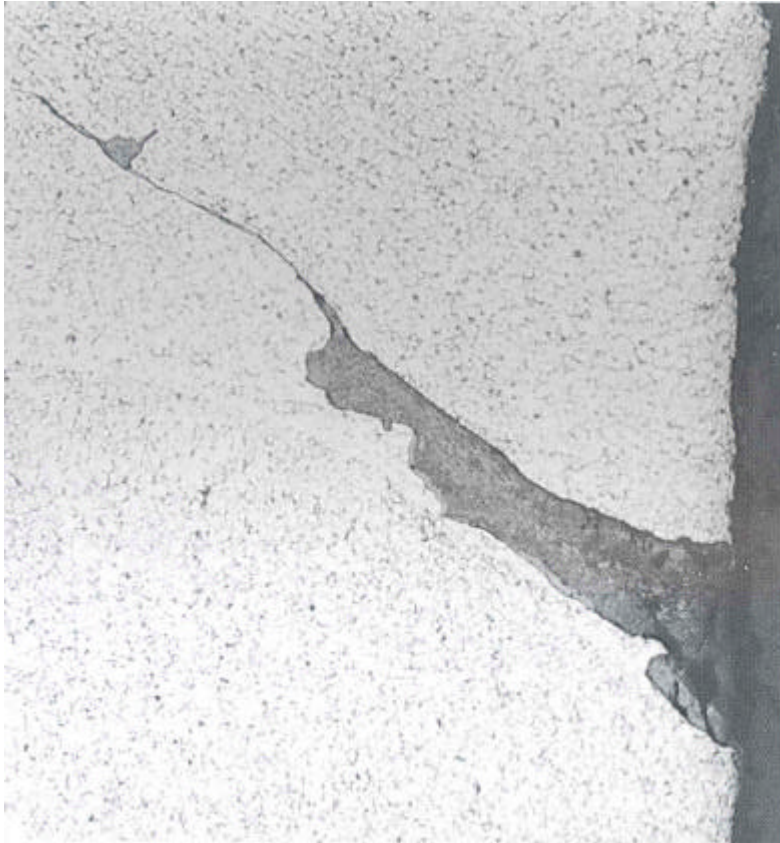
## ROOT BEAD SLAG INTRUSION

Trapped slag at the inside edge of the root weld bead, often associated with a crack lack of fusion defect.

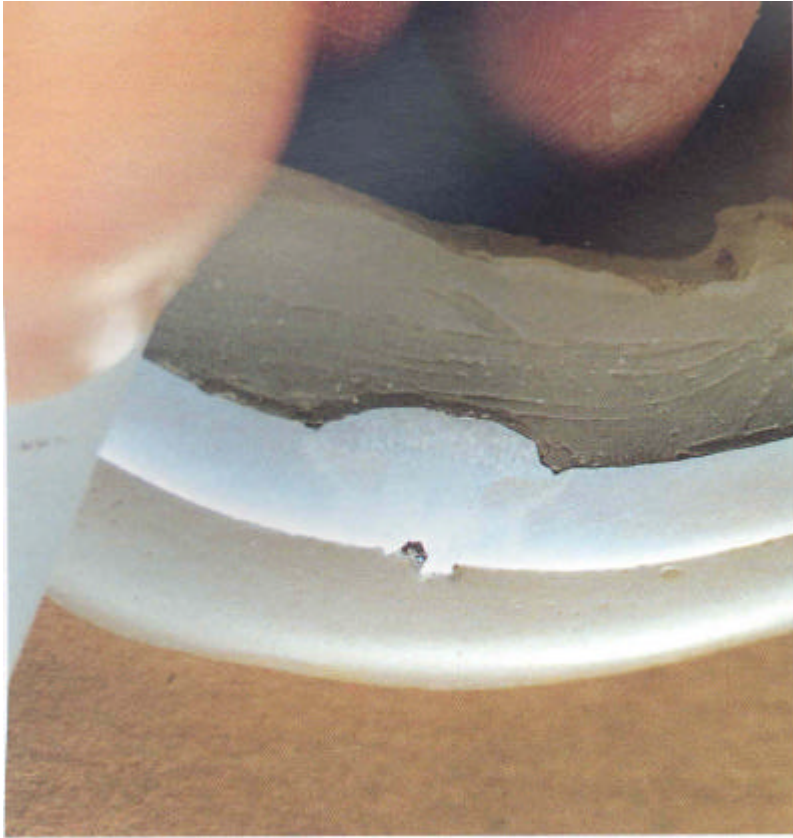
### ROOT UNDERCUT

A groove or channel melted into the pipe metal adjacent to the root or cap run which has not been filled with weld metal.

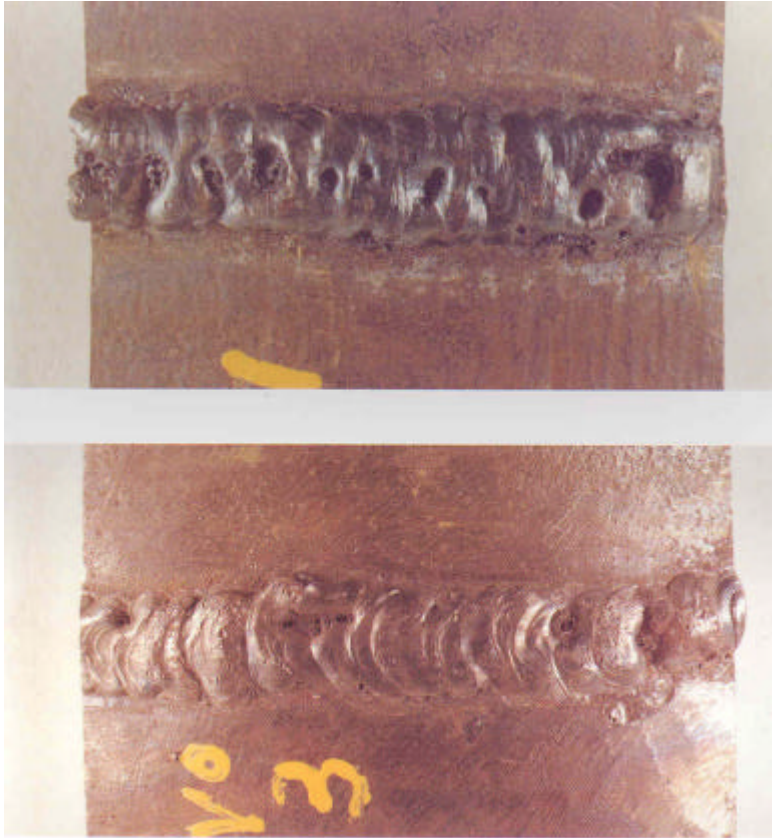
### TRAPPED SLAG

Slag trapped between individual weaves of the weld run. Also known as 'slag holes'.
