## Manufacturing: ERW Pipe Defects

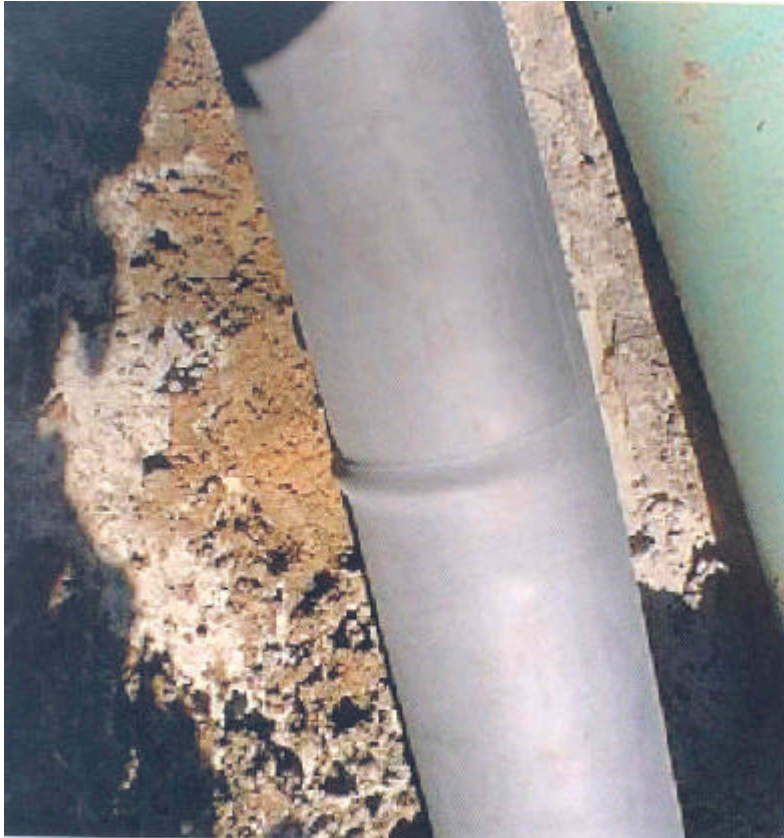
## **COLD BEND KINK**

Circumferential kink or ripple in the pipe that has been subject to cold bending in the field

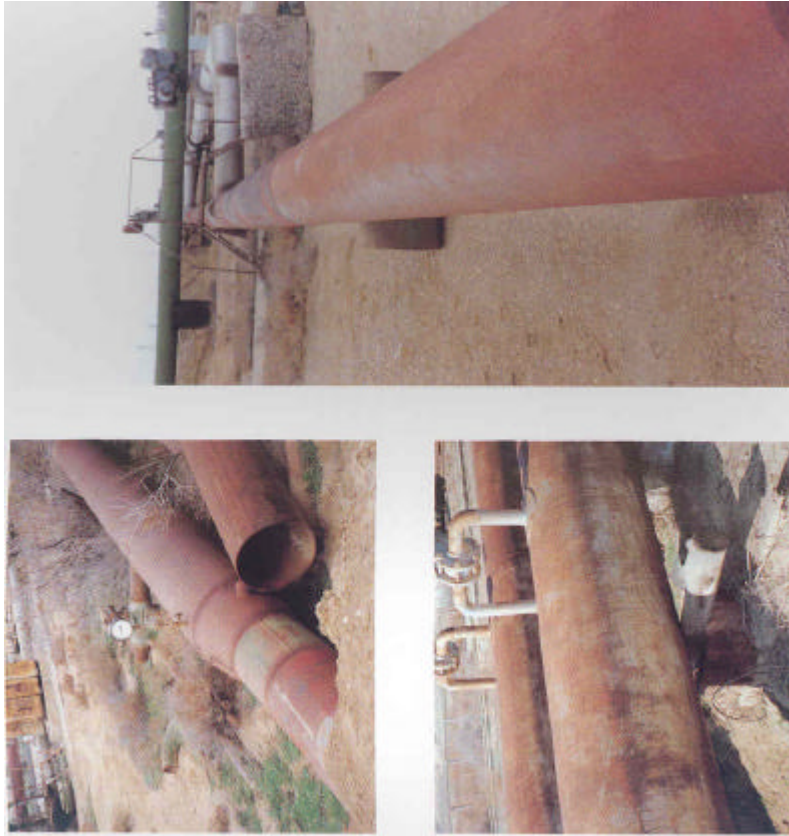
## INCORRECT PIPE SUPPORT

Above ground pipe is supported on objects other than manufactured or shaped pipe supports.

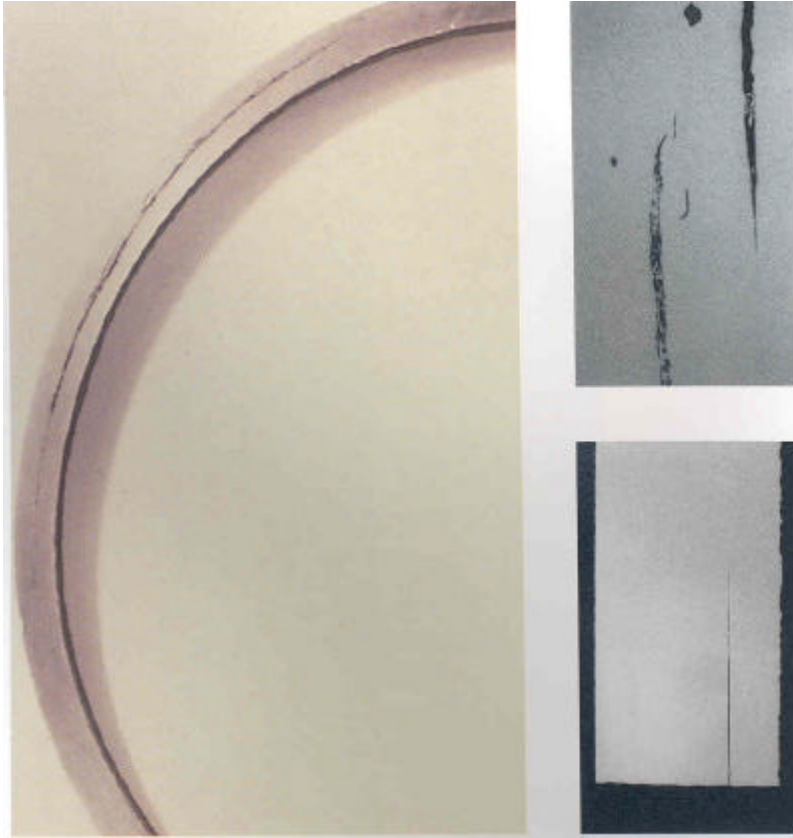
## LAMINATIONS

A discontinuity lying parallel to the pipe surface, usually marked by a concentration of non-metallics.

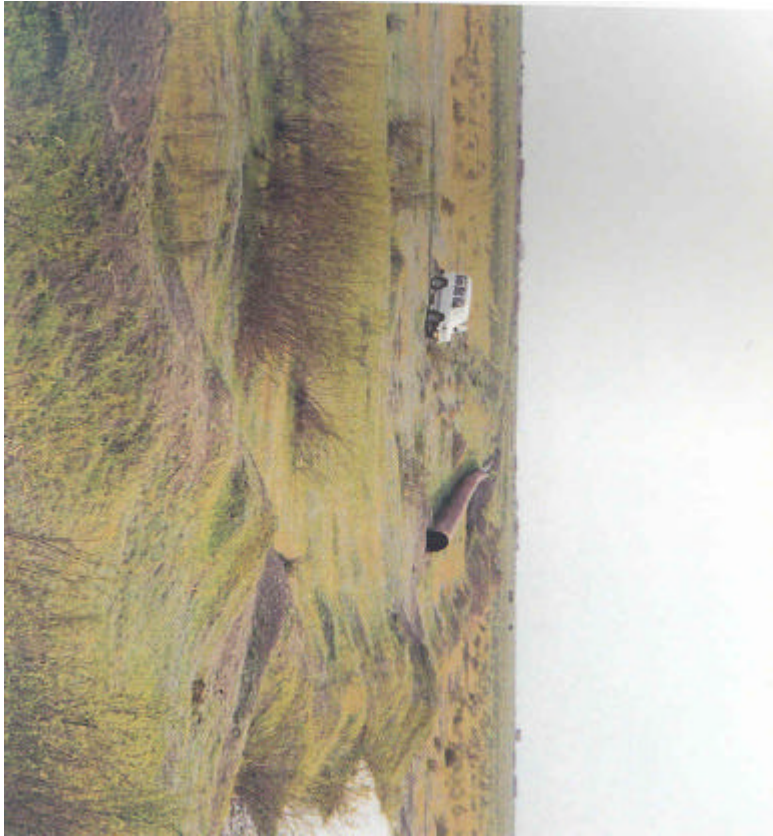
### LACK OF COVER

Shallow depth of burial

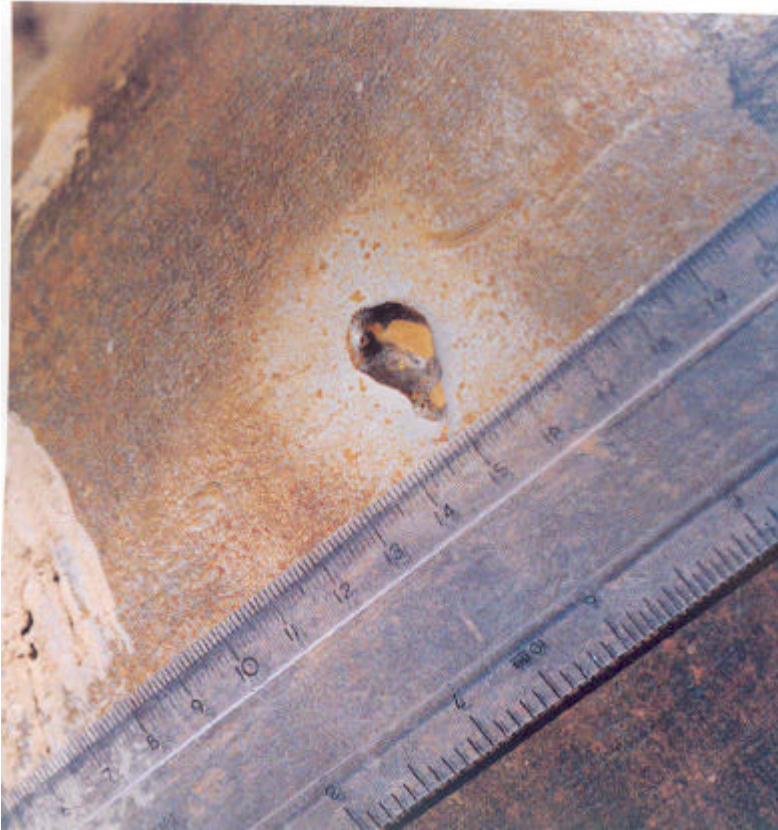
## **ARCING**

Severe, localized metal loss which may show signs of molten material, such as solidified globules.
