Compiled by Ir. Tan Yoke Lee Reference: Failure analysis of machine shafts @ Efficient Plant Magazine

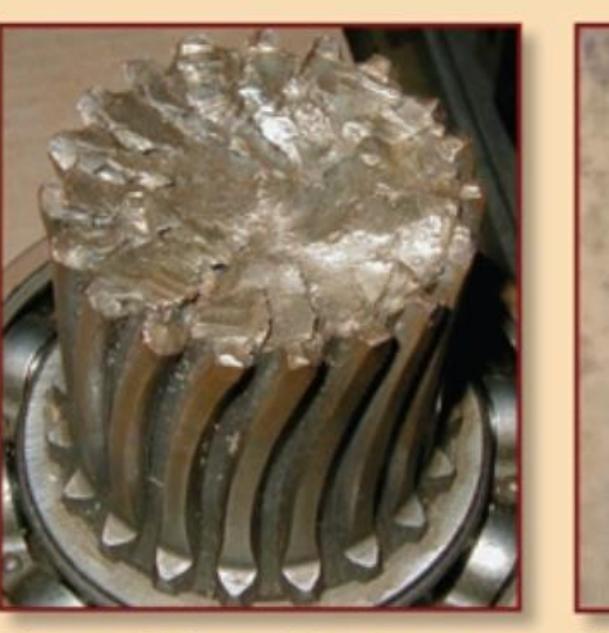
Photo 1. This shaft has been grossly overloaded by a torsional stress.

Photo 2. Occasionally, a ductile shaft will fail in a somewhat brittle manner, as this one did on a 200 hp, 3600 RPM motor that suddenly stopped running.

The shafts used on almost all motors, reducers and fans are low- or medium-carbon steels and relatively ductile. As a result, when an extreme overload is placed on these materials, they twist and distort. The bent shaft shown in Photo 1 has been grossly overloaded by a torsional stress.

There are occasional cases when a ductile shaft will fail in a somewhat brittle manner. Photo 2 shows an example of this situation *i.e., what happened when a 200 hp, 3600 RPM motor suddenly stopped running.* The result was a huge torsional stress and a cracked shaft. But because the material is ductile, the angle of the crack it is not at the 45°position shown in Fig. 1, and there is obvious distortion of the keyway.

When ductile materials are grossly overloaded very rapidly, they tend to act in a brittle manner.

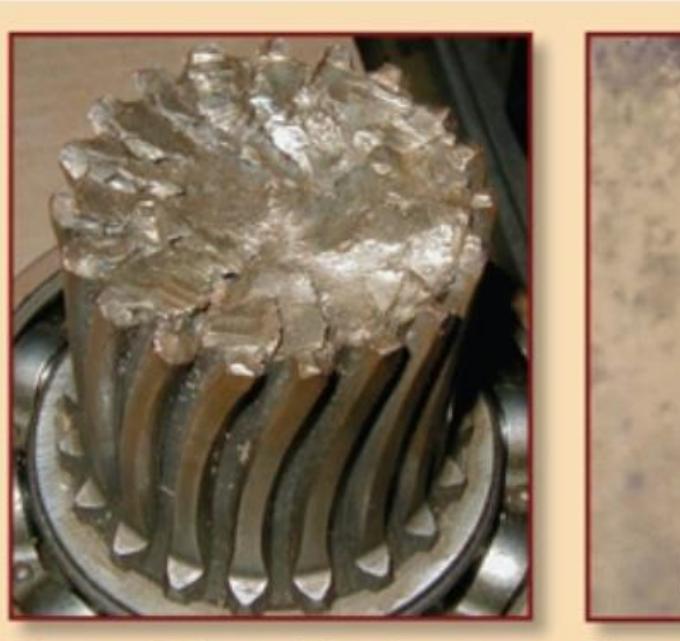
Photo 1. This shaft has been grossly overloaded by a torsional stress.

Photo 2. Occasionally, a ductile shaft will fail in a somewhat brittle manner, as this one did on a 200 hp, 3600 RPM motor that suddenly stopped running.

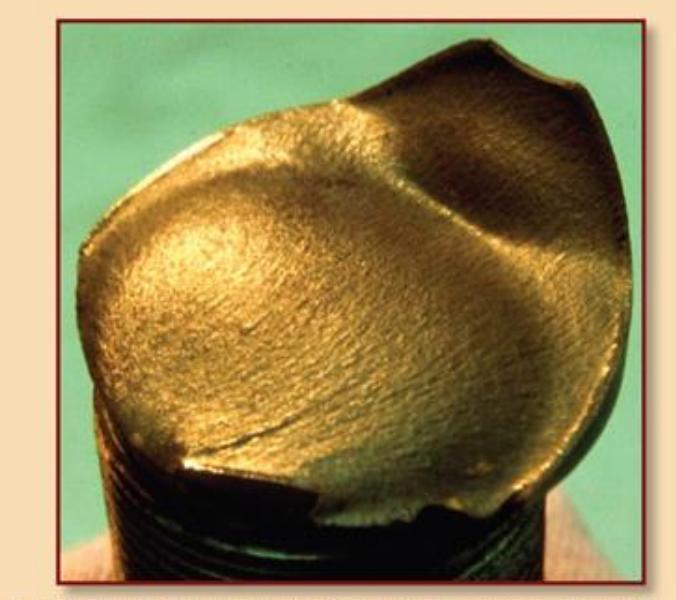
Brittle fractures of machine shafts are extremely rare. Like all brittle fractures, they are characterized by a relatively **uniform surface roughness**—the crack travels at a constant rate, and surface features called "chevron marks" are evident.

Photo 3 shows the brittle fracture of the input shaft of a large reducer that was dropped. The "chevron marks" are the fine ripples on the surface that all point just to the left of the keyway.

Photo 3. This brittle fracture, showing chevron marks just to the left of the keyway, occurred when the input shaft of a large reducer was dropped.

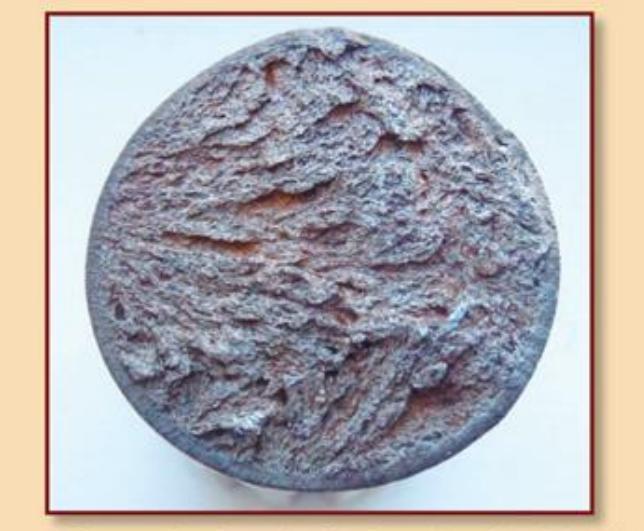
Photo 4 shows the case-hardened splined section of a hydraulic pump shaft, including its hardened case, the ring around the circumference with a very different texture than the majority of the shaft and "chevron marks" that point to the origin of the damage.

Based on how this fracture grew straight across the shaft, the cause could have been related to either bending or tension. Its relatively uniform surface, though, would indicate that this fracture is of a brittle nature— *which also means it was caused by a single force application*.

Furthermore, since it's impossible to put significant tension on a spline, the analyst could safely say that a single bending force caused the failure.

Photo 4. This case-hardened splined section of a hydraulic pump shaft shows evidence of a brittle fracture caused by a single bending force.

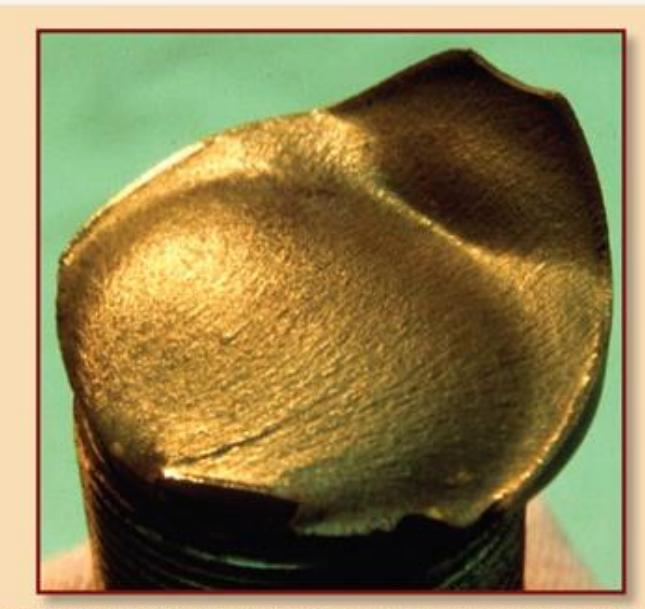
Photo 3. This brittle fracture, showing chevron marks just to the left of the keyway, occurred when the input shaft of a large reducer was dropped.

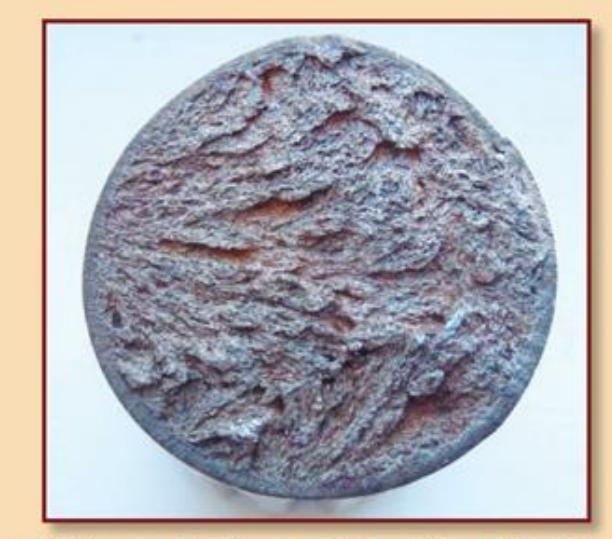
Photo 4. This case-hardened splined section of a hydraulic pump shaft shows evidence of a brittle fracture caused by a single bending force.

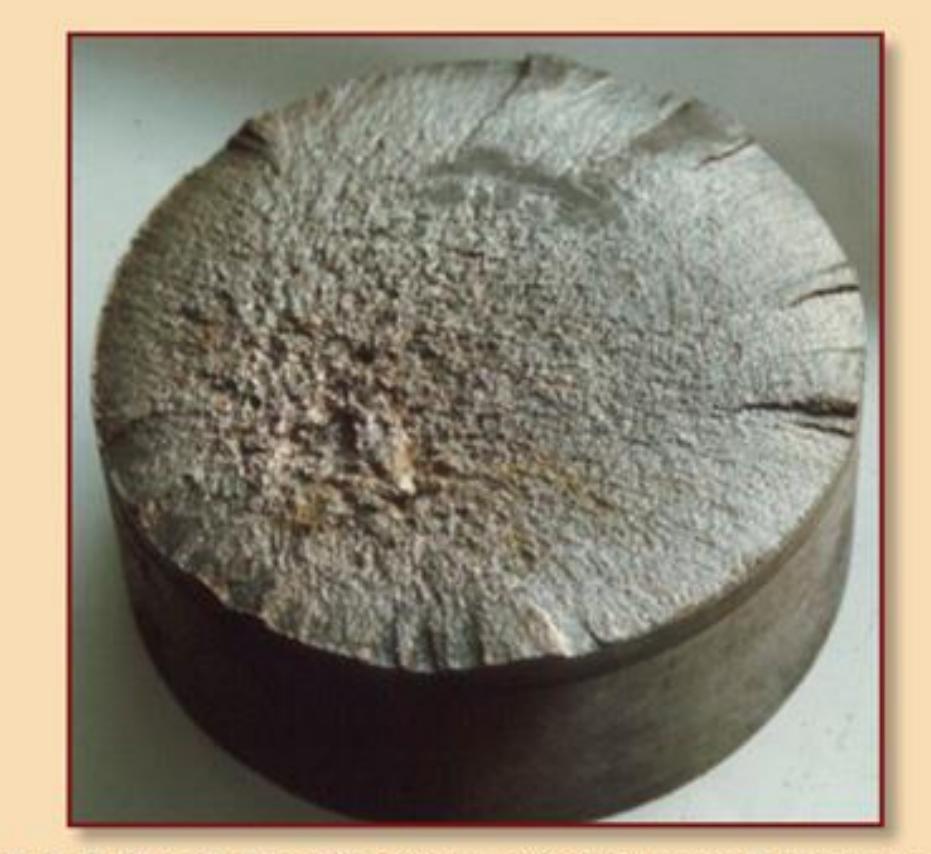
Photo 5 shows a 200 hp, 1180 RPM motor shaft that failed in less than a day. No progression marks means the fatigue load was constant.

The instantaneous zone is relatively large, indicating the shaft was heavily loaded. **Cracking started at numerous locations around the shaft, pointing to rotating bending as the cause.**

So many ratchet marks concentrated on the top and bottom of the photo make us suspect the shaft may not have been straight.

Inspection, though, would indicate the root cause was associated with the belt drive. In fact, the sheaves were worn so badly that the belts were riding in the bottom of the grooves. This situation approximately doubled the shaft bending stress.

Photo 5. The shaft on this 200 hp, 1180 RPM motor failed in less than a day as a result of badly worn sheaves on the belt drive.

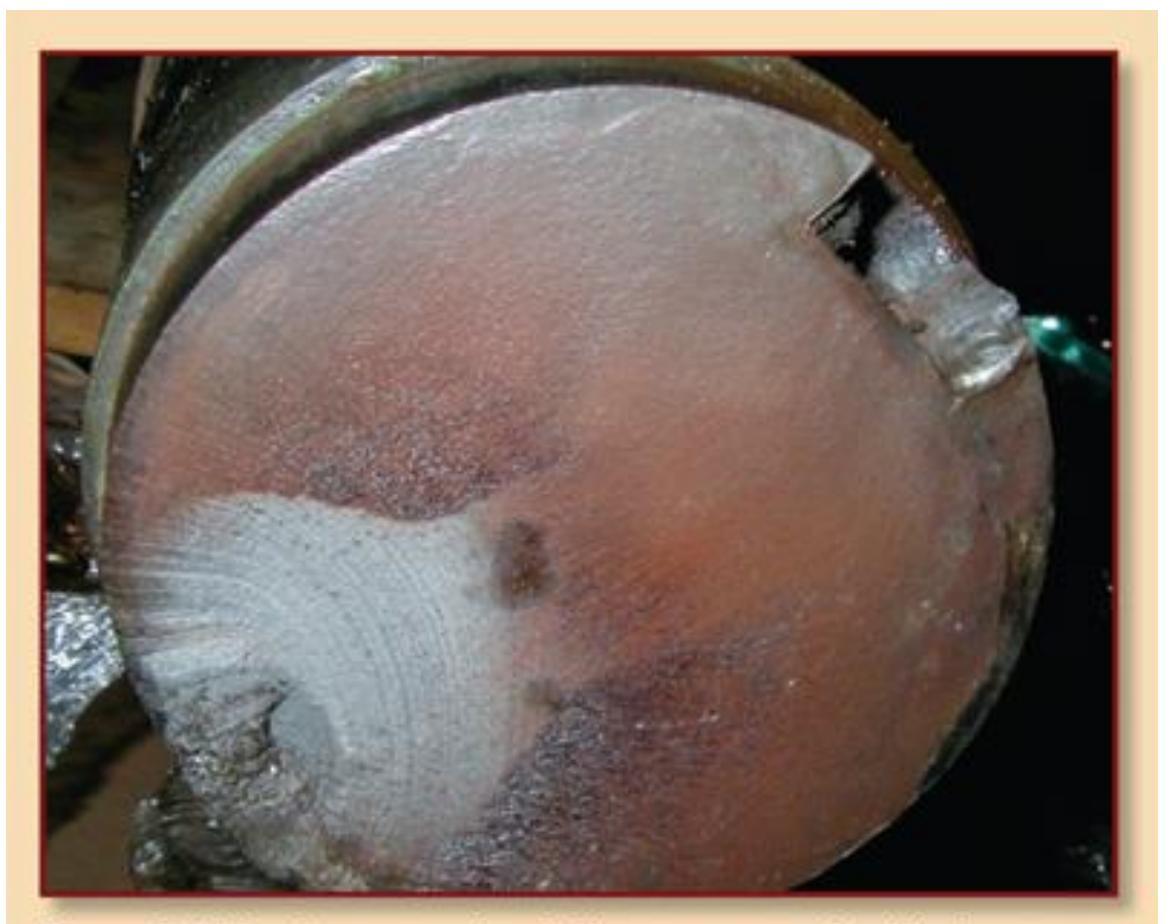
The drive shaft in Photo 6 was on a steel-mill elevator. The surface is smoothest near the root of the keyway and became progressively rougher as the crack grew across the shaft.

Numerous progression marks surrounding the tiny IZ and the change in surface condition about 40% of the way across the shaft from the IZ suggest something changed during the crack growth or that the elevator was not used for an extended period.

These features are indicative of a slow-growing failure—and the fact that fretting corrosion may have substantially reduced the fatigue strength.

Photo 6. This slow-growing failure on a steel-mill elevator drive was initiated by fretting corrosion that substantially reduced the fatigue strength on the shaft.

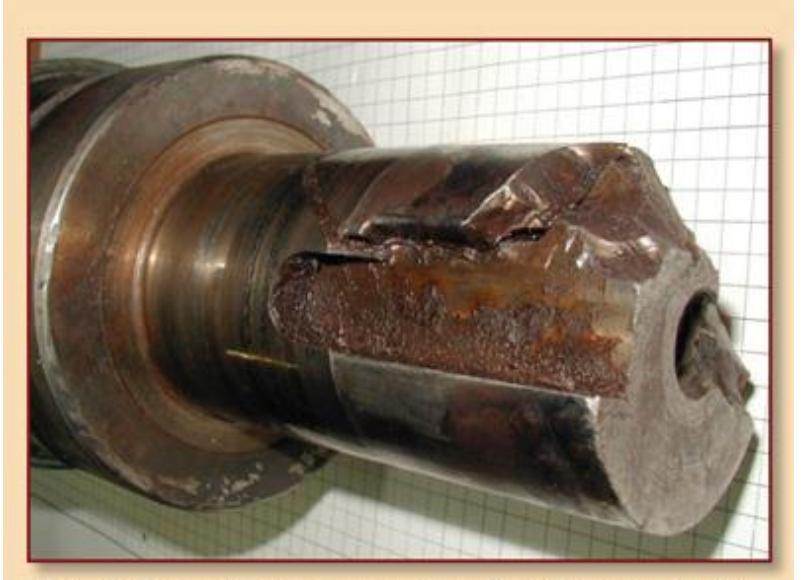
Photo 7 reflects the battered end of a motor shaft with a terrible (loose) coupling fit that let the hub repeatedly drive the key against the side of the keyway until a fatigue crack developed.

Photo 7. The terrible (loose) coupling fit on this motor shaft allowed the hub to repeatedly drive the key against the side of the keyway until a fatigue crack developed.

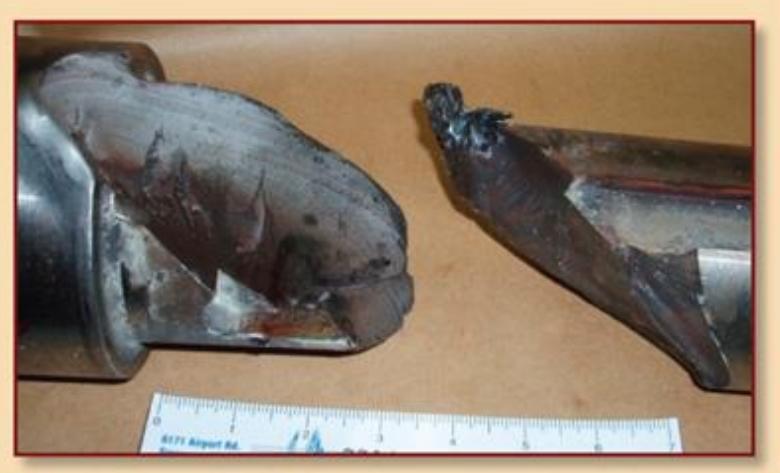
Photo 8 shows both halves of the torsional-fatigue failure of a fan shaft in a plant that had recently changed to a VSD. The 45° angle to the central axis is a sure sign of torsional stresses, and the change in surface roughness across the shaft indicates the cause was fatigue forces.

Photo 8. The torsional fatigue failure of this fan shaft occurred shortly after the installation of a variable speed drive.

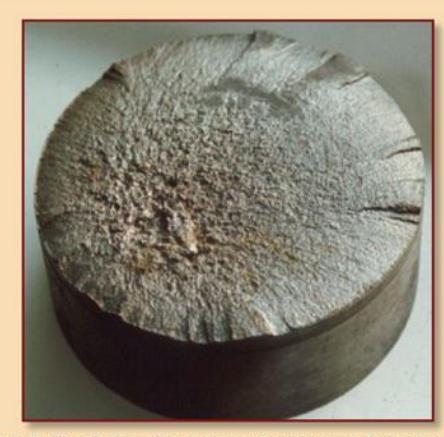
Photo 5. The shaft on this 200 hp, 1180 RPM motor failed in less than a day as a result of badly worn sheaves on the belt drive.

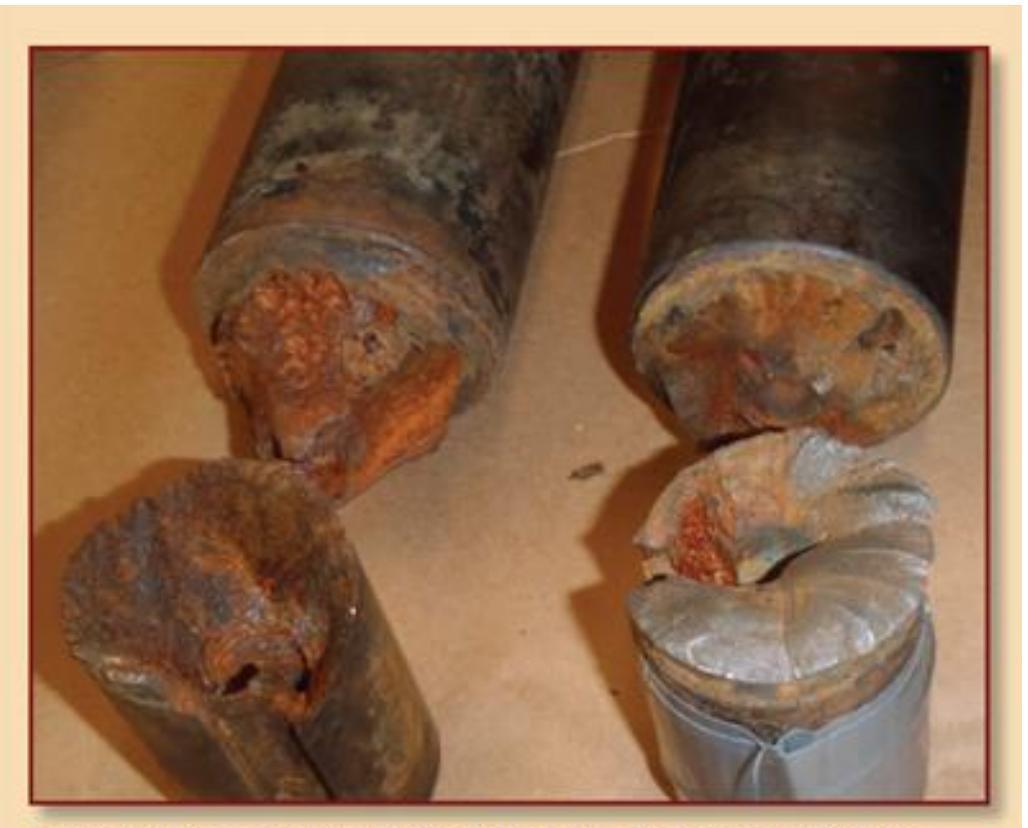
For example, both of the pump shafts shown in Photo 9 failed due to torsional fatigue aggravated by a reduction in strength caused by corrosion. Some might look at the fracture face of the shaft on the right and think it was caused by rotating bending. Closer examination of the many ratchet marks shows they are at a 45° angle to the centerline of the shaft—*a positive indication of torsional fatigue stresses with numerous origins*. (Note that the ratchet marks seen in Photo 5 have straight sides, an indication that they were caused by bending forces.)

Photo 9. These pump shafts failed due to torsional fatigue aggravated by the reduction in strength caused by corrosion, not because of rotating bending.
