Storage tank - maintenance:

API 653: Tank lifting as an option to repair

Prepared by: DSc Dževad Hadžihafizović (DEng)

API 653: TANK INSPECTION CODE:

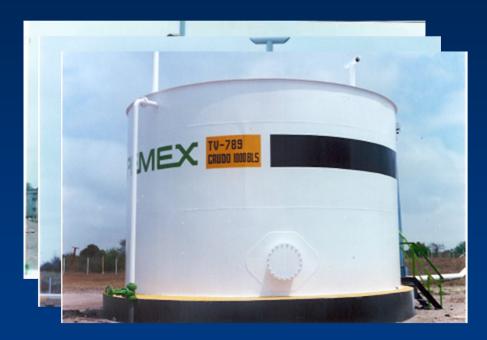
External corrosion can lead to thinning of the tank walls and potential leaks

- Grit blast steel
- Fill in pitting if necessary
- Apply Belzona 6111 Liquid Anode for steel protection
- Apply two coats of Belzona 5111
 Ceramic cladding

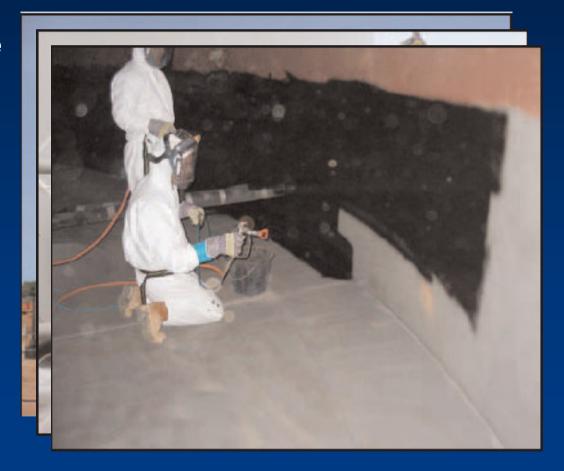
- Corrosion in the tank base
- Only the problem areas were coated saving time and money
- Belzona 1521 was chosen for it's resistance to hydrocarbons, spray capabilities and performance in hot water/ hydrocarbon situations

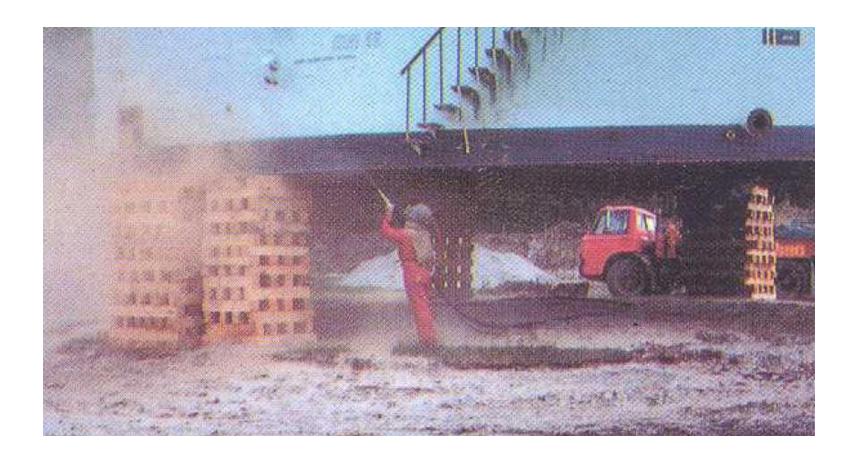
This tank had leaked twice at SRC Singapore and the floor was to be replaced. After lifting it was found that the MFL Scan was in error and there was only two holes in the floor due to stones the rest of the floor had the heat numbers still visible in perfect condition!

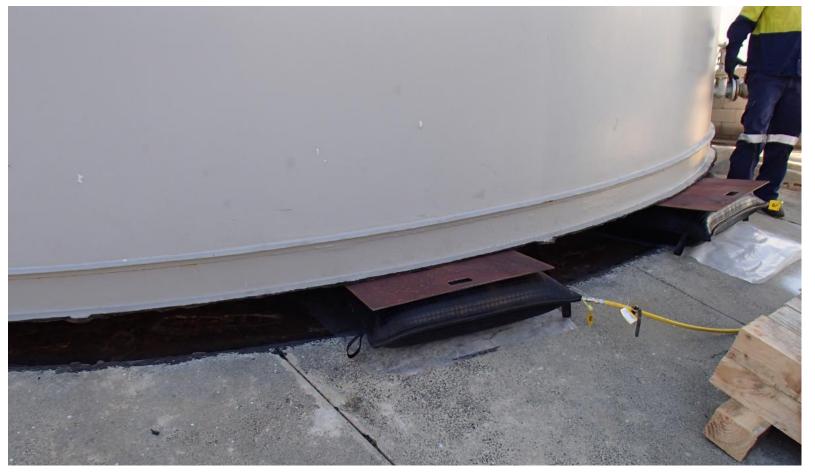
Tank 21 at ALMC had suffered planar tilt outside the limits stated in API 653 Appendix B. The tank was built in 1938 and had leaked through external floor corrosion.

The job was to correct the differential settlement, install a secondary containment liner under the tank and change the floor in the tank.

The tank was lifted from the ground using airbags inserted under the tank

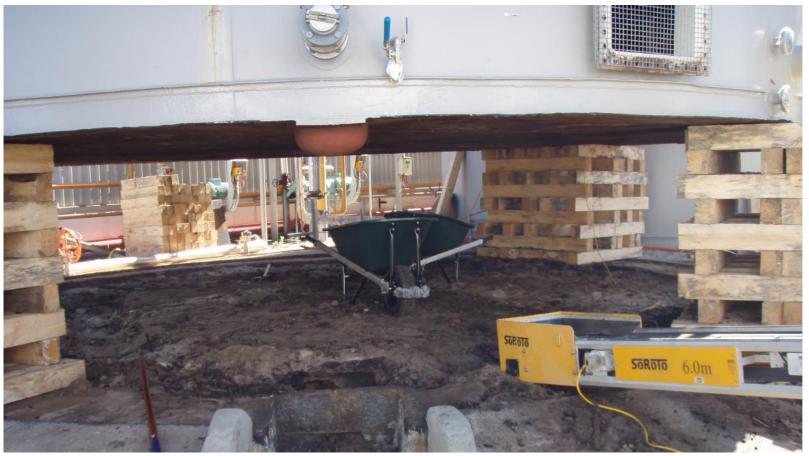
Upon attaining access height under the tank the lifting cribs are removed and the basecourse foundation cap is taken out. This particular tank dihedral of the floor was changed from Cone-Up to 1:120 Cone Down....hence further excavation was required. The concrete ring beam was not level which accounted for the tank differential settlement.
