# Tornado Protection

Selecting Refuge Areas in Buildings

FEMA P-431, Second Edition / October 2009

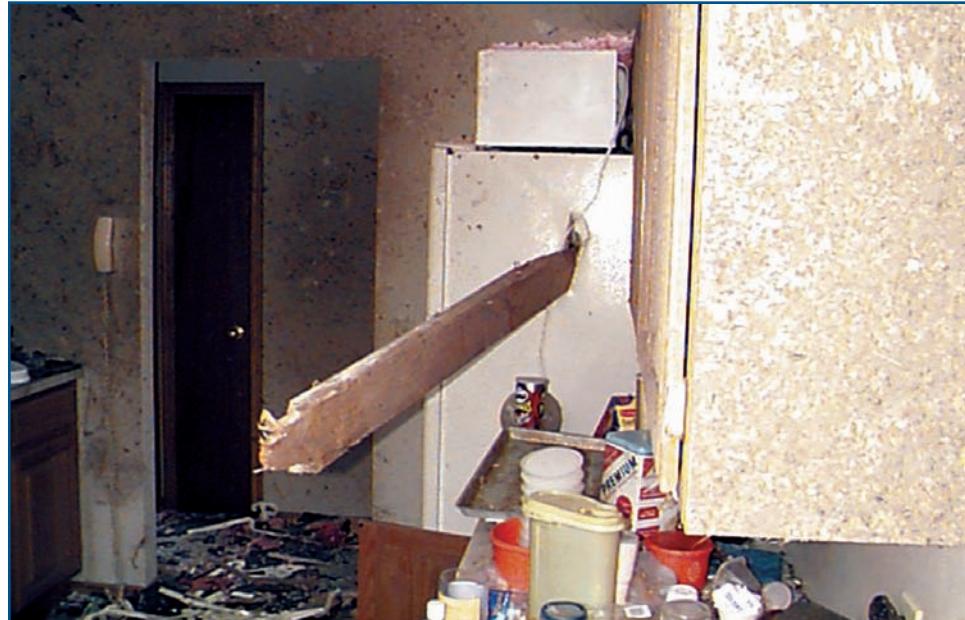
Figure 2-3

*Example of severe damage from a windborne missile. This metal door was pushed inward by the impact of a heavy object.*

The extreme winds in tornadoes pick up and carry debris from damaged buildings and objects located in the path of the winds (see Figures 2-2 and 2-3). Even heavy, massive objects such as cars, tractor trailers, and buses can be moved by extreme winds and cause collateral damage to buildings. Light objects become flying debris, or missiles, that can penetrate doors, walls, and roofs; heavier objects can roll and cause crushing-type damage.

Damage was also caused by the impact of windborne missiles. Figure 2-3, in Chapter 2, shows a steel door that appeared to have been opened by the impact of a heavy object. This door led into an area where the roof was missing. The opening created by this breached door may have allowed wind to enter the building and create internal pressure that increased the load on the building envelope. Figure 3-22 shows damage to a laminated glass window hit by a table.

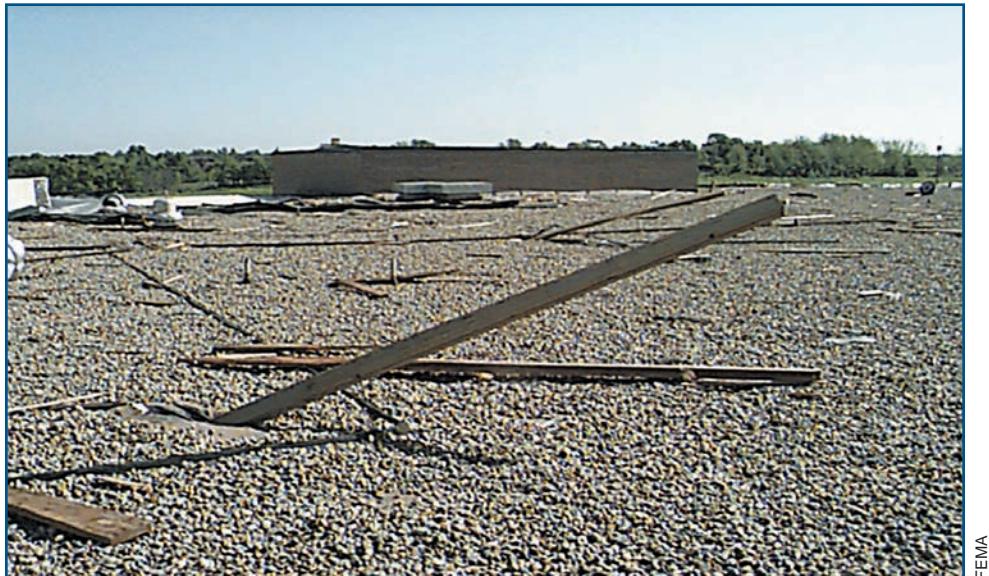
Figure 2-4

*Example of damage from windborne missiles. Medium and small missiles penetrating through the roof of a high school. The missile protruding from the roof in the foreground is a double 2-inch by 6-inch wood board. The portion sticking out of the roof is 13 feet long. This missile penetrated a ballasted ethylene propylene diene monomer (EPDM) membrane, approximately 3 inches of polyisocyanurate roof insulation, and the steel roof deck. The missile lying on the roof just beyond it is a 2-inch by 10-inch, 16-foot-long wood board. The missile protruding from the roof in the background is a 2-inch by 6-inch, 16-foot-long wood board.*

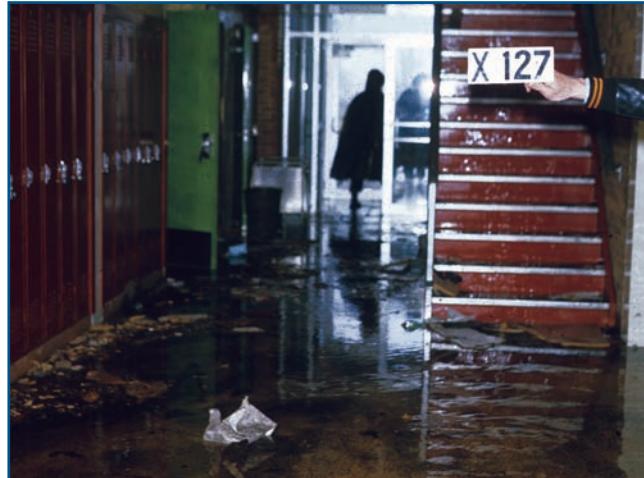
*Surviving interior hallway. This is an example of the type of area that may provide refuge for building occupants during a tornado.*

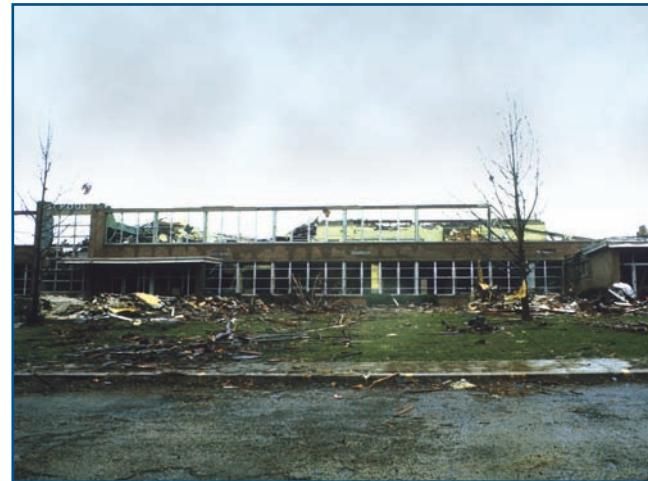
**Figure 3-5**  
*Loss of lightweight roof over the original two-story building.*

The enclosure walls failed on the west and south sides, allowing the winds to enter the building. The roofs collapsed over the three large spans—the auditorium, the boys' gym, and the girls' gym. The lightweight roof over the original two-story building was torn off by the extreme winds.

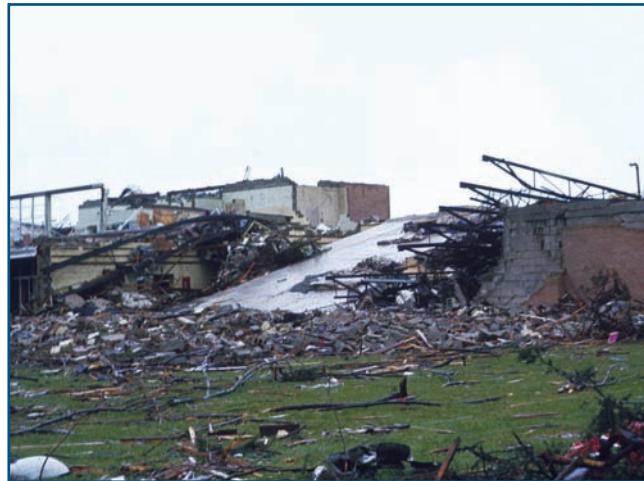
**Figure 3-7**  
**Collapsed gymnasium walls and roof, where open-web roof joists were supported on unreinforced masonry walls.**

All **windows** on the west and south sides were blown into the interior. The high single-story, **loadbearing masonry walls** of the **long-span** rooms failed, allowing the roofs to fall in. The unbaffled west entrances allowed the east-west corridors to become **wind tunnels**.

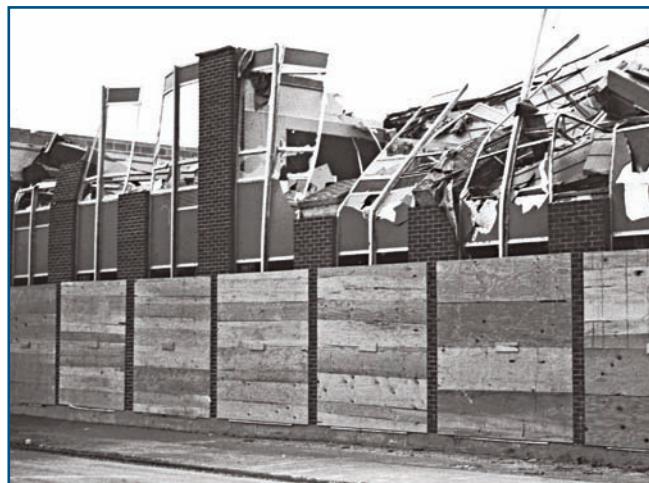
**Collapsed second floor of St. Augustine Elementary School building.**

The tornado winds lifted part of the roof and collapsed the second-floor piers in one wing of the school building (Figures 3-8, 3-9, and 3-10). The wind and windborne debris blew in most of the windows, and windborne debris was found in the classrooms (Figure 3-11). The exterior solid-core wood doors stayed in place and kept the debris out. Wired glass windows near the exterior doors remained intact. The interior doors to the classrooms remained in place although the hinges were damaged. The school was damaged to an extent where demolition was required.

The structural system of **unreinforced masonry piers** collapsed and almost one-third of the second-floor **lightweight roof structure** was lifted. Roof removal occurred over the classrooms as well as over the corridor. Most of the **skylights** in the corridors were removed by wind or broken by windborne debris. Almost all the **windows** on both floors were broken. Windborne debris and broken glass were found in the classrooms.

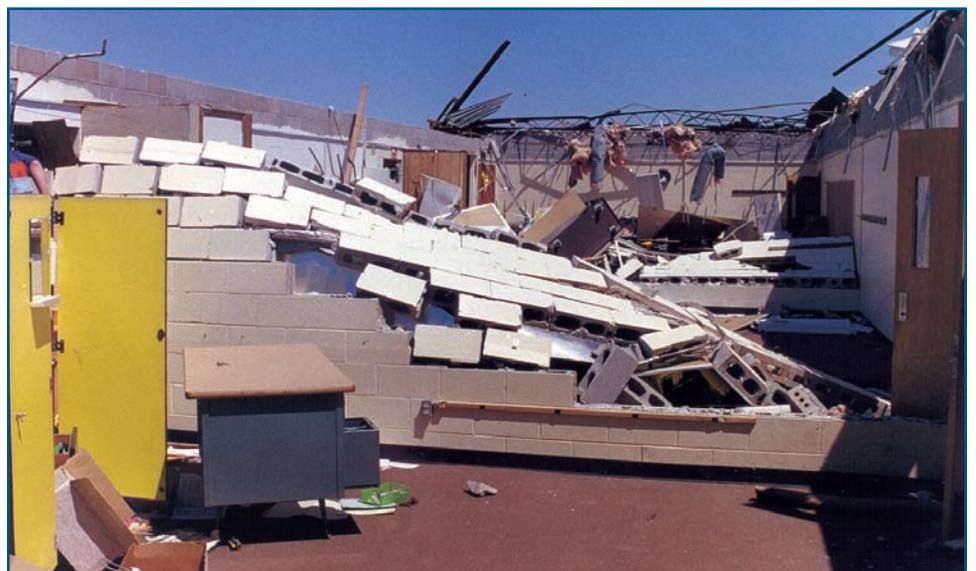
**Figure 3-17**  
*Interior and exterior unreinforced masonry walls were damaged when reinforced bond beams failed.*

Unreinforced masonry walls failed when the roof system was lifted or removed by tornado winds (Figures 3-17, 3-18, and 3-19). Figures 3-17 and 3-19 show failed interior and exterior walls, respectively. Figure 3-18 shows the separation of the reinforced bond beam (indicated by circles) from the upper part of a corridor wall. The inclusion of clerestory windows in some corridor walls contributed to their failure under loads imposed by tornado winds (Figure 3-20).

**Unreinforced masonry** walls failed when the reinforced bond beams at the tops of the walls failed.

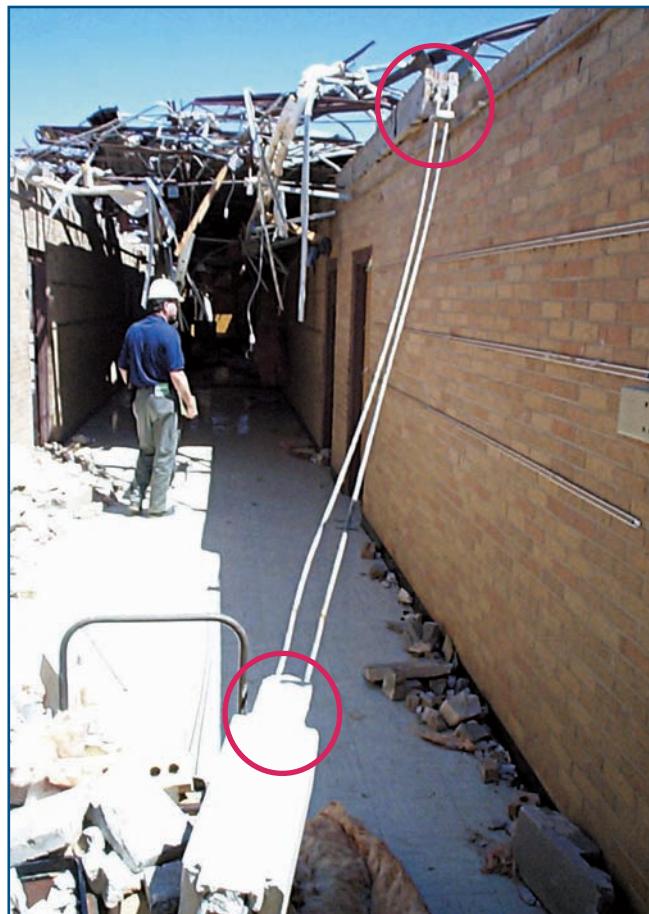
**Figure 3-18**  
*Corridor area. Separation of reinforced bond beam (indicated by circles) from supporting wall.*

Wall and roof structures, including those of designated areas of refuge, failed under the combination of uplift and lateral loads caused by the tornado winds. Connections between bond beams, joists, and walls were adequate for gravity loads, but could not resist the high uplift loads caused by the wind.

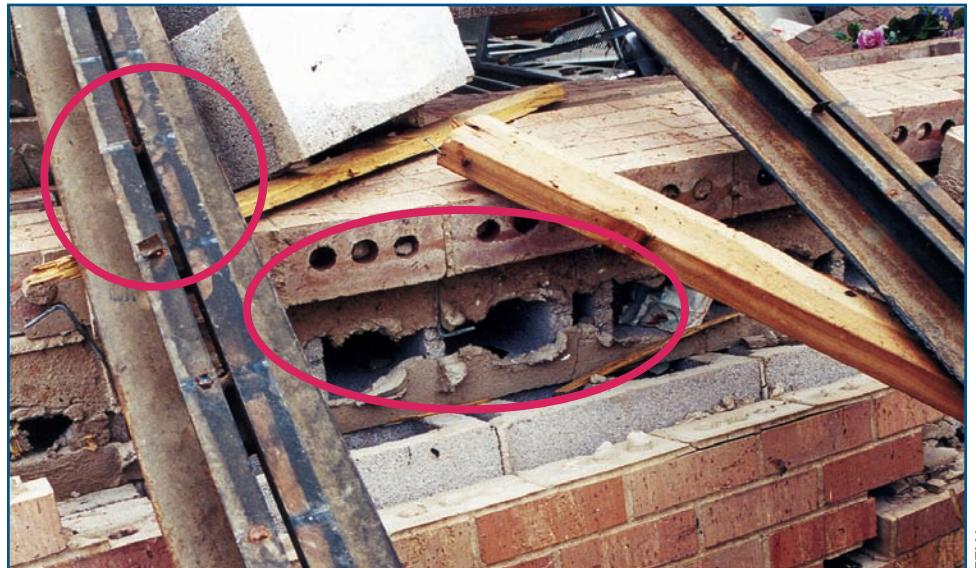
**Figure 3-21**  
**Failed roof structure showing broken welds between metal roof deck and tops of joists (upper circle) and lack of vertical reinforcement (bottom circle).**

Inspection of the roof damage revealed that the roof decking failed at the points where it was welded to the tops of the steel trusses. Although the spacing of the welds appeared to be consistent with standard practice, the welds were not strong enough to resist the wind uplift forces (Figure 3-21).

**Welds** between the roof decking at the tops of the metal joists failed because they were **not strong enough to resist the uplift**.

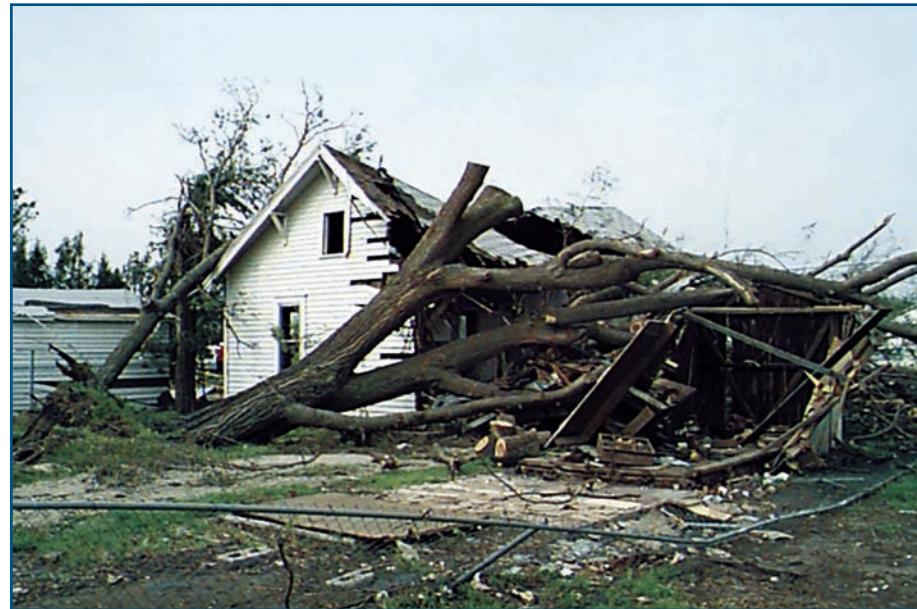
*Two trees toppled by tornado winds damaged this house in Haysville, Kansas.*

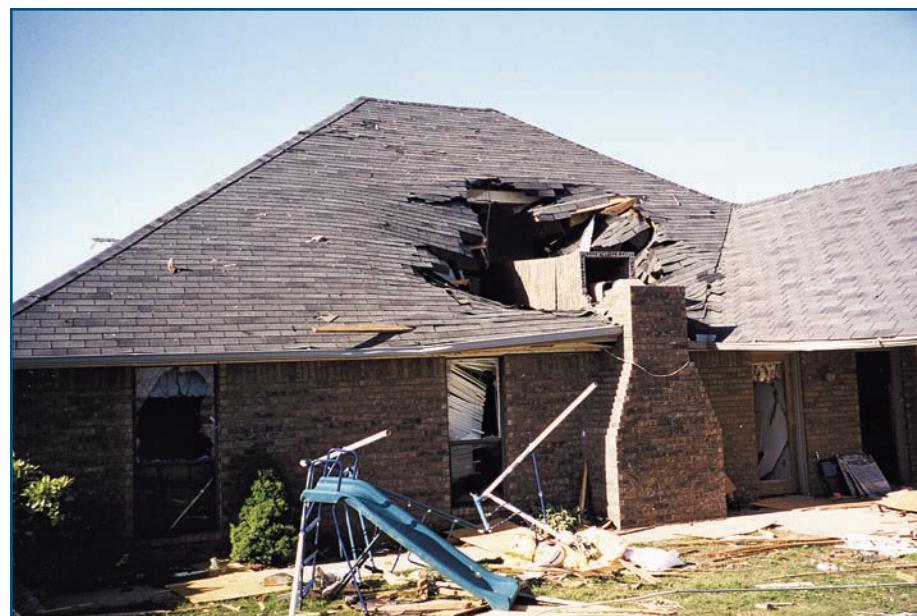
*Failure of brick chimney under tornado winds damaged the room of this house in Moore, Oklahoma.*

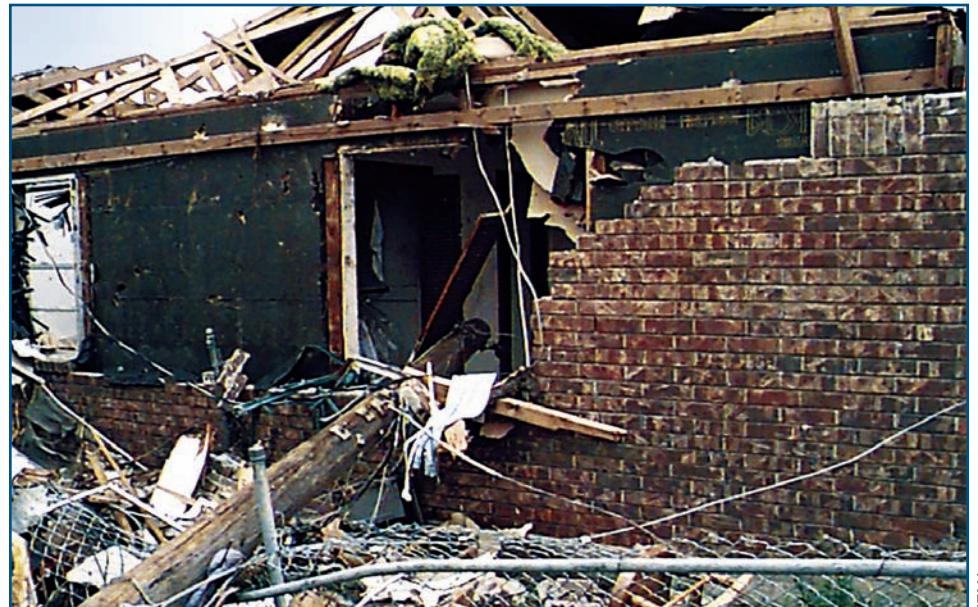
**Figure 4-4**

*This power pole penetrated a window and extended several feet into the house after being blown 40 feet from its original location.*

For most building locations, there will be many nearby sources of small and large windborne missiles. Missile examples include aggregate roof surfacing, rooftop HVAC equipment, components from nearby damaged buildings (e.g., roof decking, studs, joists, trusses, hot water heaters, kitchen appliances, building furnishings), tree limbs, trees, trash containers, propane tanks, poles, automobiles, buses, and trucks. Missiles can be propelled horizontally and vertically (see Figures 2-2, 2-3, 2-4, and 4-5). Therefore, in selecting the best available refuge areas, it is typically prudent to assume that the building being evaluated will be bombarded with both small and large missiles, traveling horizontally and vertically.

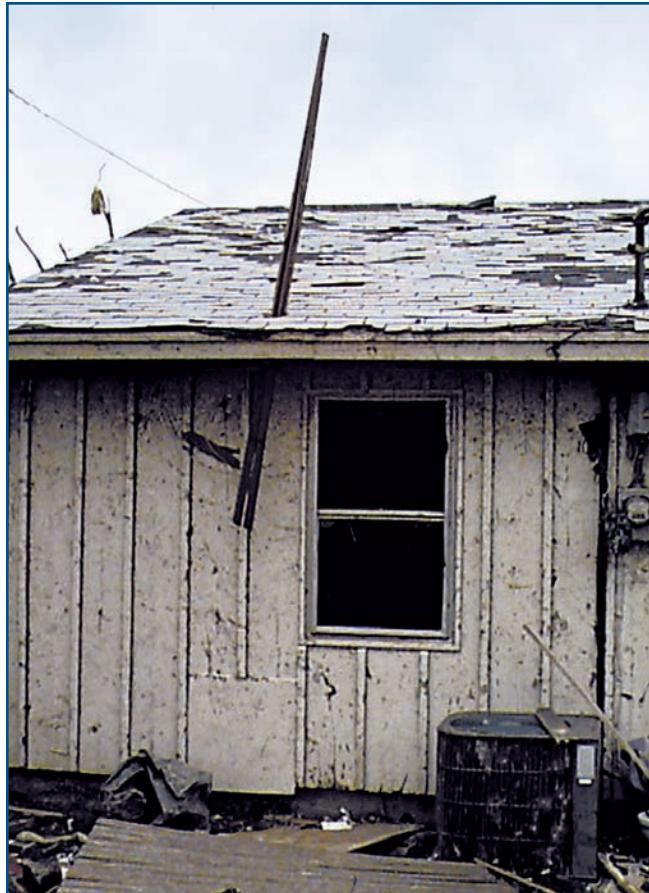
**Figure 4-5**

*This photograph illustrates the importance of overhead protection in refuge areas. The missile shown here fell nearly straight down.*

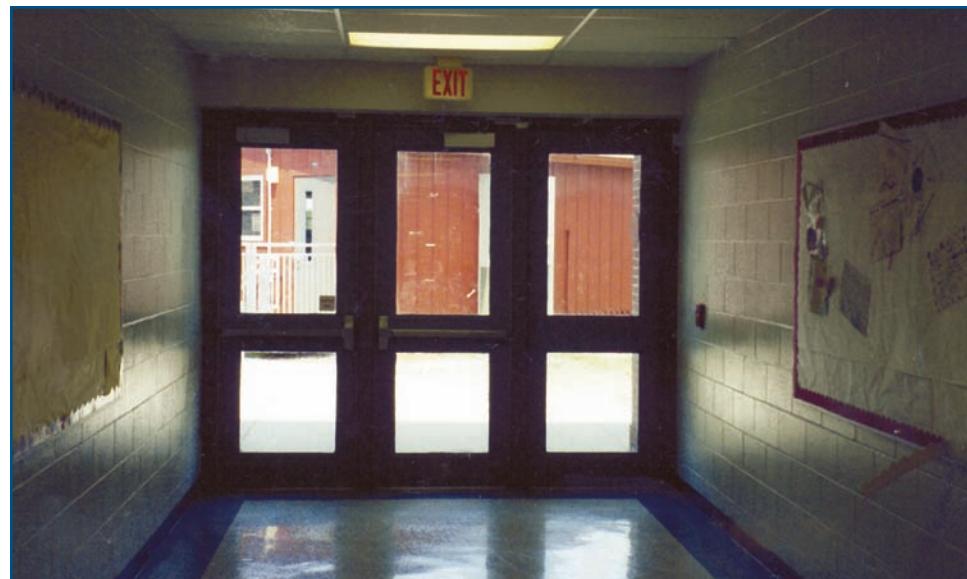
*Figure 4-14  
Exterior corridor doors in the example school.*

The exterior windows in all eight buildings have aluminum frames and tempered glass. The exterior doors—including the exterior corridor doors in Buildings 200, 400, 600, and 800 (Figure 4-14)—are insulated metal-framed units with large windows. The doors from the corridors to the classrooms in these four buildings are wood with small windows (Figure 4-15).
