Coastal Construction: *Maintaining the Building*

Course No: S01-007

Maintaining the Building

This chapter provides guidance on maintaining the building structure and envelope.

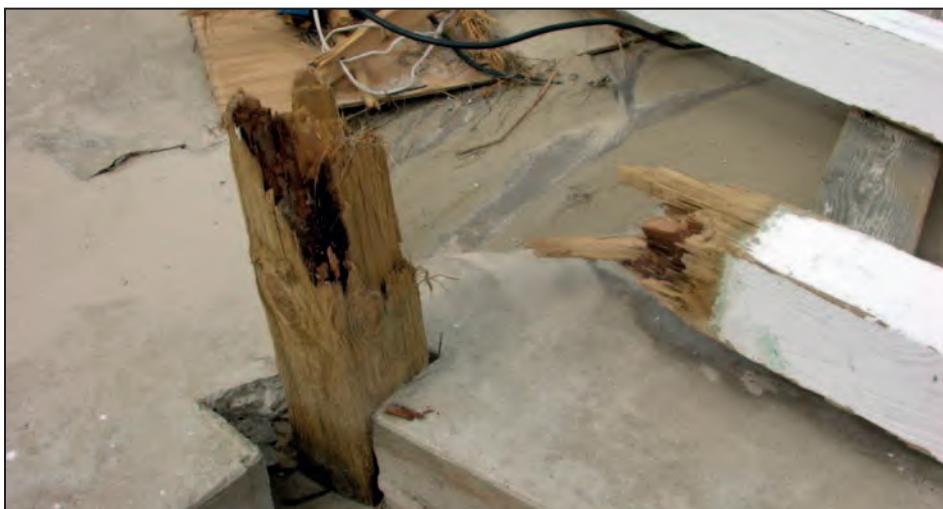
Figure 14-1.
Pile that appears acceptable from the exterior but has interior decay

acceptable condition but is weakened by interior decay, which can be determined only through a detailed inspection. This post failed under the loads imposed by a natural hazard event.

For maximum performance of a building in a coastal area, the building structure and envelope (i.e., exterior doors, windows, skylights, exterior wall coverings, soffits, roof systems, and attic vents) must not be allowed to deteriorate. Significant degradation by corrosion, wood decay, termite attack, or weathering increases the building's vulnerability to damage from natural hazards. Figure 14-1 shows a post that appears on the exterior to be in

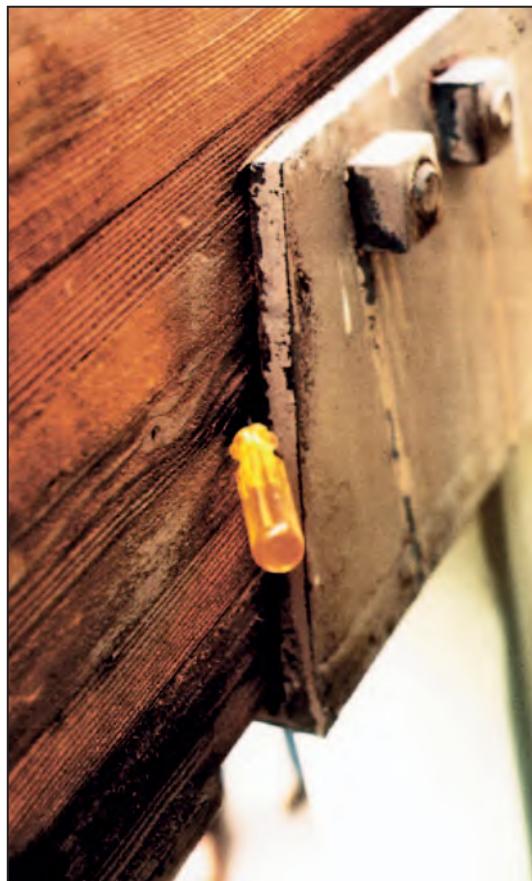
Figure 14-2.
Wood decay behind a
metal beam connector

There are many sources of exterior moisture from outside the home in the coastal environment. Whenever an object absorbs and retains moisture, the object may decay, mildew, or deteriorate in other ways. Figure 14-2 shows decay behind the connection plate on a beam.

Connectors should be designed to shed water to prevent water from accumulating between the connector and the material the connector is attached to. Trapped moisture increases the moisture content of the material and potentially leads to decay. Moisture is most likely to enter at intersections of materials where there is a hole in the building envelope (e.g., window, door) or where two surfaces are joined (e.g., roof to wall intersection). If properly installed, the flashings for the openings and intersections should not require maintenance for many years. However, flashings are frequently not properly installed or installed at all, creating an ongoing moisture intrusion problem.

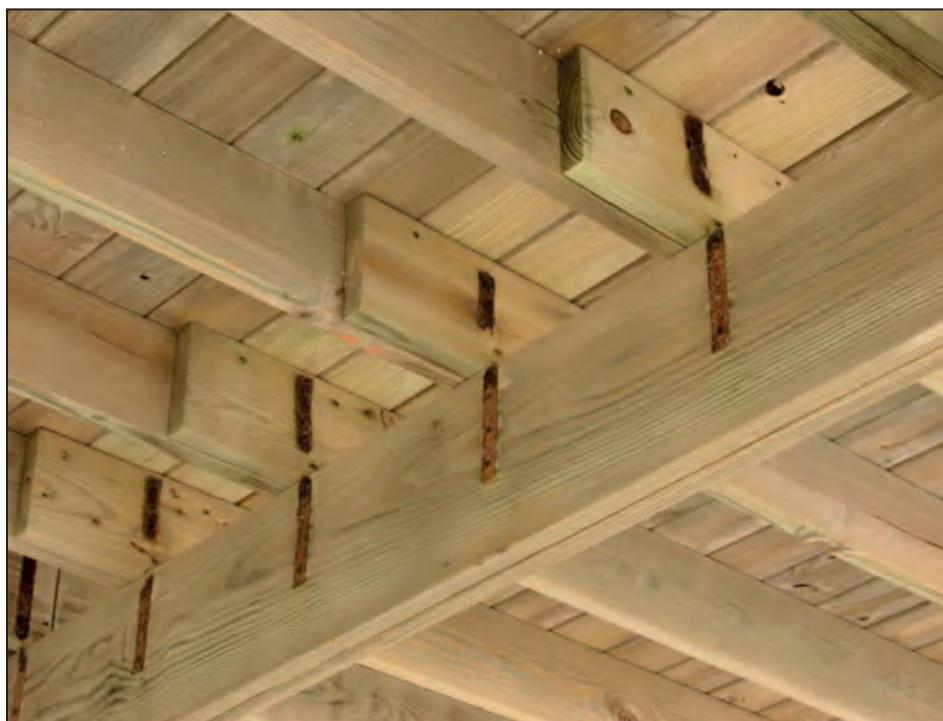
Figure 14-3.
Severely corroded deck connectors

been consumed and the corrosion rate of the unprotected steel can be expected to accelerate by up to a factor of 50 times. Figure 14-3 illustrates severe corrosion under an exterior deck.

- Sheet-metal connectors can be susceptible to rapid corrosion and are frequently without reserve strength. During routine inspections, any sheet-metal connectors found to have turned rust red or to show severe, localized rusting sufficient to compromise their structural capacity should be replaced immediately. However, the replacement of sheet metal connectors is usually difficult for a number of reasons: the connection may be under load, the nails or bolts used to secure connectors are usually hard to remove, and the location of a connector often makes removal awkward.
- Salt-laden air can increase corrosion rates in building materials. Covering exposed connectors with a sheathing material reduces their exposure and therefore increases their life expectancy.

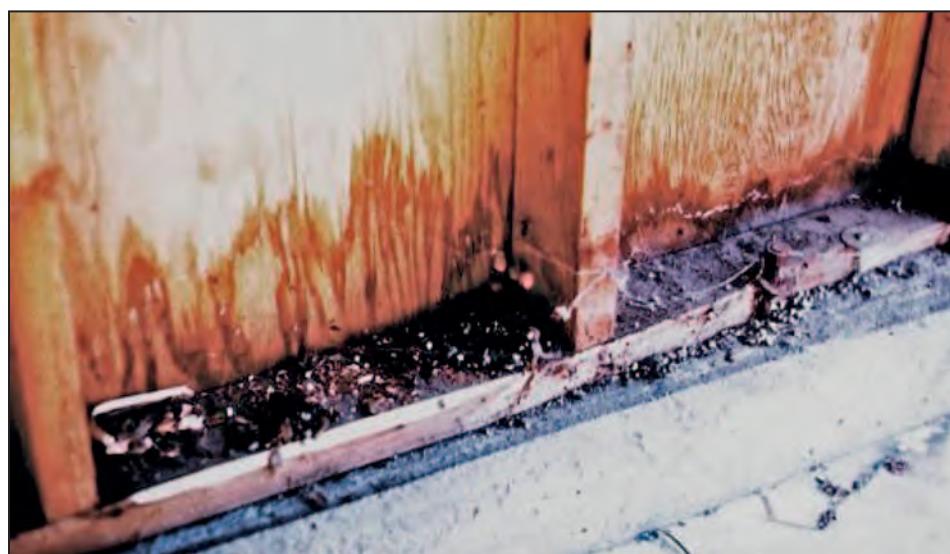
Figure 14-4.
Deteriorated wood sill plate

Shearwall sill plates bearing directly on continuous footings or concrete slabs-on-grade, if used in coastal construction, are particularly susceptible to decay in moist conditions. Figure 14-4 shows a deteriorated sill plate. Even if the decay of the preservative-treated sill plate is retarded, the attached untreated plywood can easily decay and the shearwall will lose strength. Conditions that promote sill and plywood decay include an outside soil grade above the sill, stucco without a weep screed at the sill plate, and sources of excessive interior water vapor. Correcting these conditions helps maintain the strength of the shearwalls.
