Sydney Catchment Authority

# **Annual Water Quality Monitoring Report**

## **2012-13**

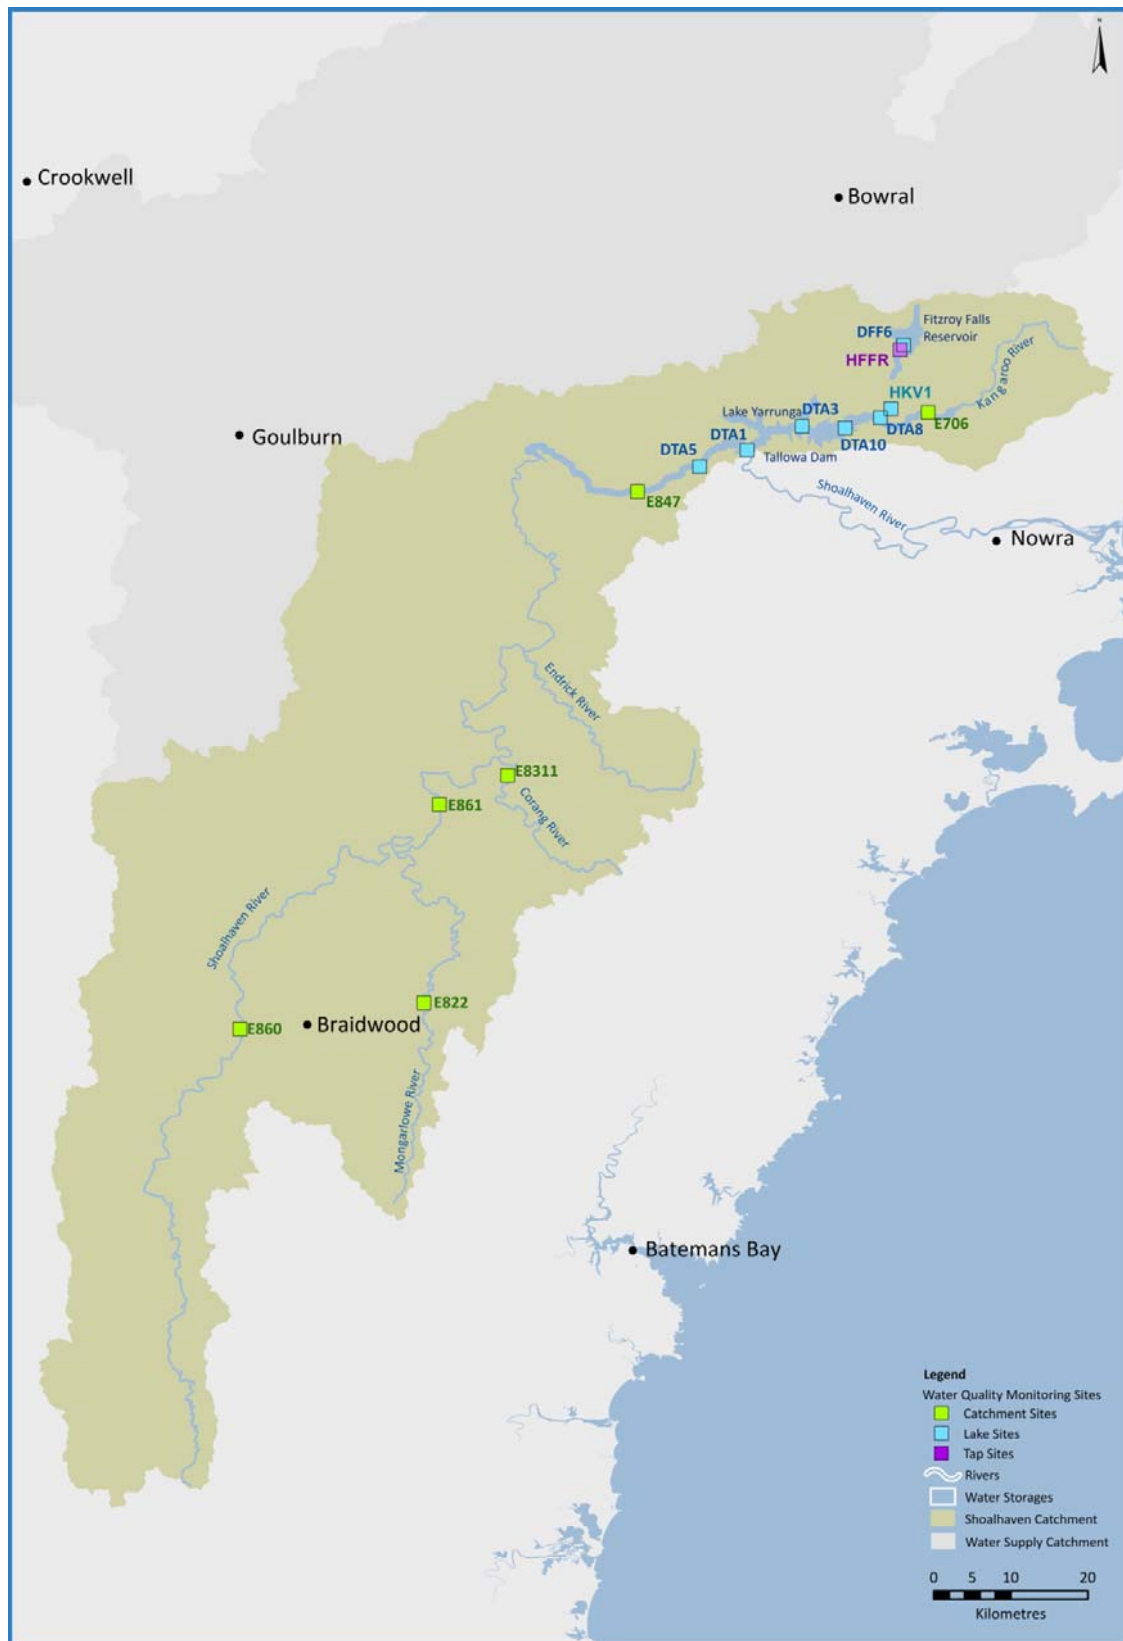
**Figure 5.5 Sampling sites in the Shoalhaven system**

Sampling sites in the Shoalhaven system are shown in Figure 5.5 below.

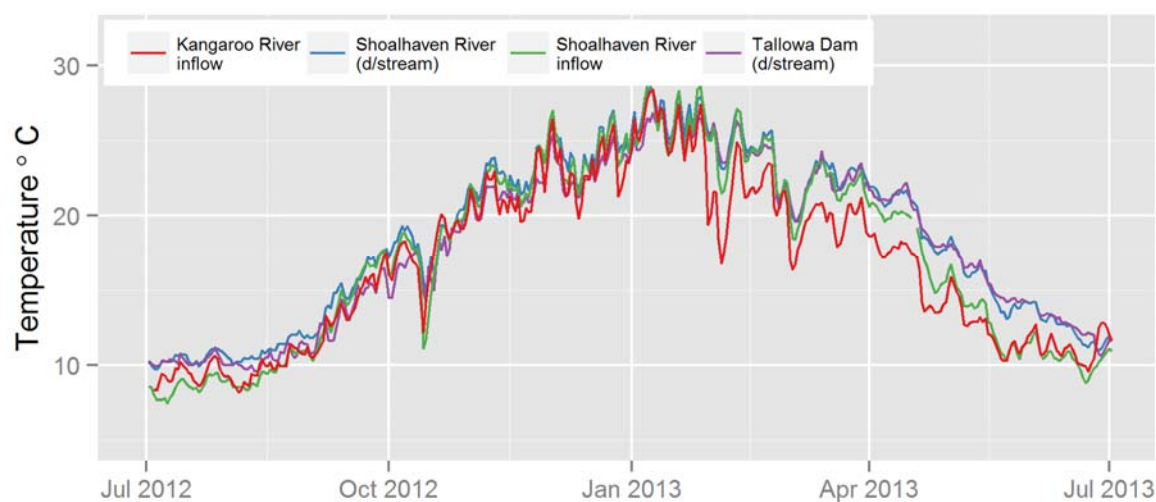
Figure 6.12 below shows that temperatures at both downstream sites closely match those of the upstream Shoalhaven reference site. The similarity between the two downstream sites suggests the environmental releases are very near ambient condition.

**Figure 6.12 Shoalhaven system temperature profile**

The site at Tallowa Dam is immediately downstream of the environmental releases and provides a good measure of the release temperature. Grassy Gully is approximately 20 km downstream of the Tallowa Dam.
