# AFA WORKSHOP ON Process Waste Heat Boilers Integrity and Reliability

Hotel Sharq Village & SPA

Qatar: 01 - 03 December 2014

# **Failure of the New RG Waste Heat Boiler of Ammonia 5 at Qafco**

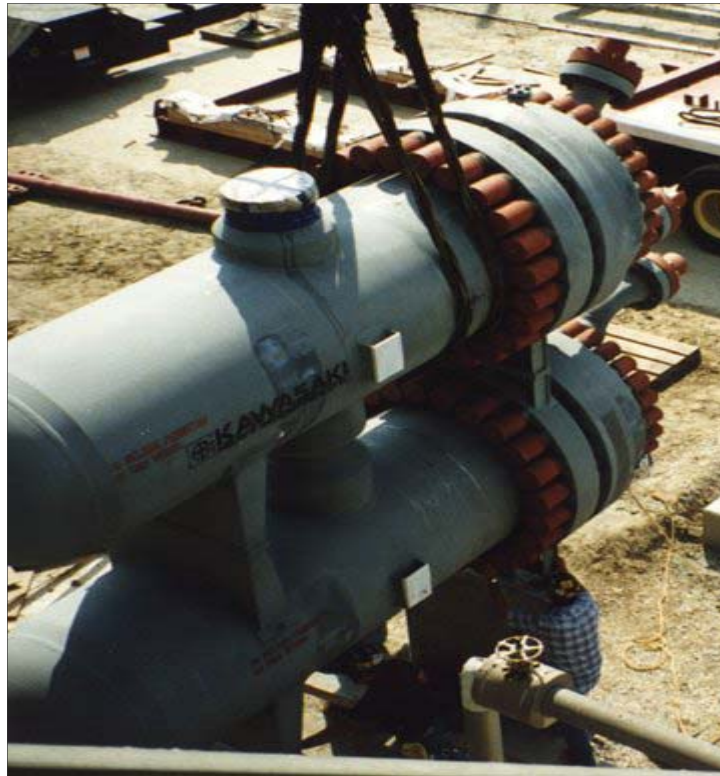
FIGURE-3: Ammonia Converter exit waste heat boiler

Rather than using a complex waste heat boiler, KBR uses two shell and tube exchangers in series (see FIGURE-3) in the syn-loop to generate high pressure steam. These exchangers use a removable U-tube configuration having special details where water is placed inside the tubes. This configuration is more tolerant to transient operating conditions in this severe service, thus provides high reliability. Other configurations including fixed tube-sheet designs or inverted U tubes with hot gas inside having an integral steam drum are more prone to failure as seen in operating plants. A portion of the boiler feed water required in the common steam drum is fed through this exchanger to the common steam drum. A significant portion of water is vaporized and the two-phase stream of steam plus water is routed to the common steam

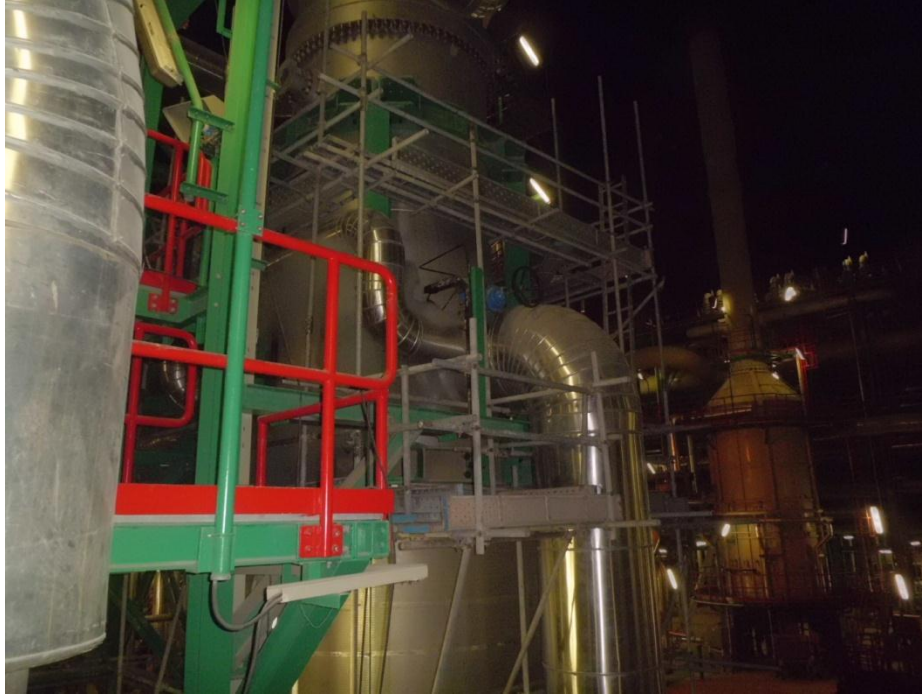
The fire was put-off shortly after by operational staff using a trolley mounted dry chemical powder extinguisher. It was observed that process gas was leaking from E0309 channel flange (process gas temperature was 370 deg C). Nitrogen and steam was applied with hoses on the leak spot in order to dilute the leaking gas. Meanwhile key people from Contractor and Company were contacted and briefed about the leakage and fire. Upon arrival of this key personnel, the situation of the leakage was reviewed and it was jointly decided to shut down the plant and attend to the leak. Shutdown activities started at 23:30hrs on September 8<sup>th</sup> and at 04.00hrs September 9<sup>th</sup> primary reformer shut down was completed.

*Figure 1: Leaking Process gas bypass valve of E0309*

- 5) **Leakage from SSH E0309 gas bypass valve TV03175:** One of the field operators observed a heavy steam/gas leak and loud sound coming from temperature control valve TV03175 (process gas bypass of steam super heater E0309), which lead to the decision to initiate shut down of the primary reformer. This leakage from the flange bonnet seems to have occurred when above mentioned sudden front-end pressure increase happened due to the BFW entering the system, as it was discovered at the same time. Note that it was found later that the bonnet gasket was damaged and that the bonnet joint bolts were loose i.e. not properly tightened.

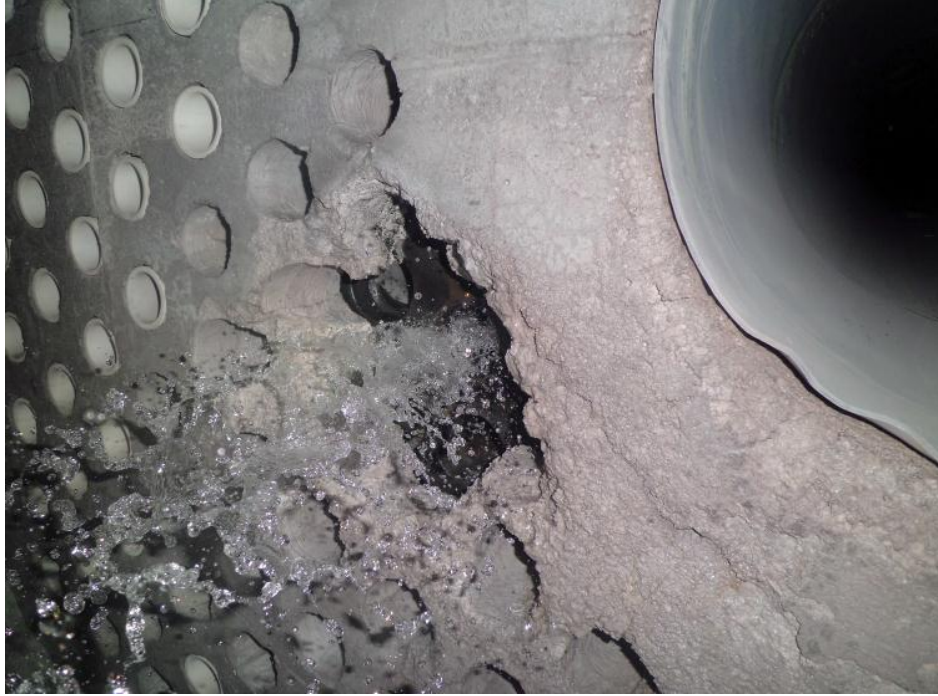
Heavy water leakage was observed from 2 tube-tube sheet joints at the inlet tube sheet (Figure 2). The process gas bypass (center pipe) was found slightly deformed at the inlet tube sheet (also Figure 2).

*Figure 2: Heavy water leakage was observed at the inlet tube sheet*

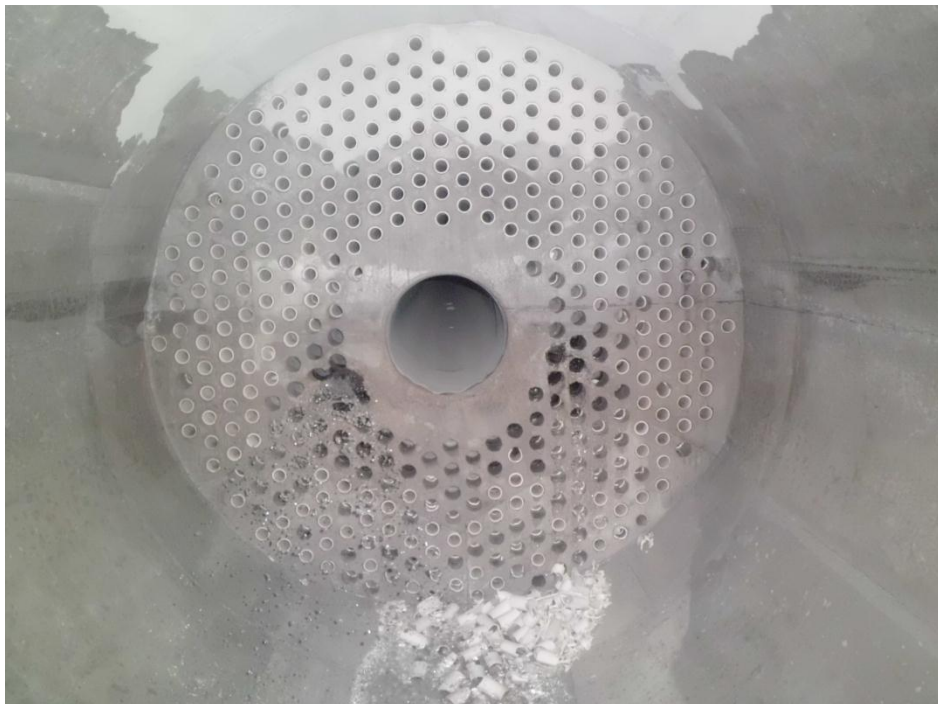
Most of the ferrules were found in damaged condition. Debris of ferrules and refractory was found at E0308 inlet compartment (Figure 3).

*Figure 3: Most of the ferrules were found damaged and debris of ferrules and refractory was found at the entrance in front of the tube sheet.*

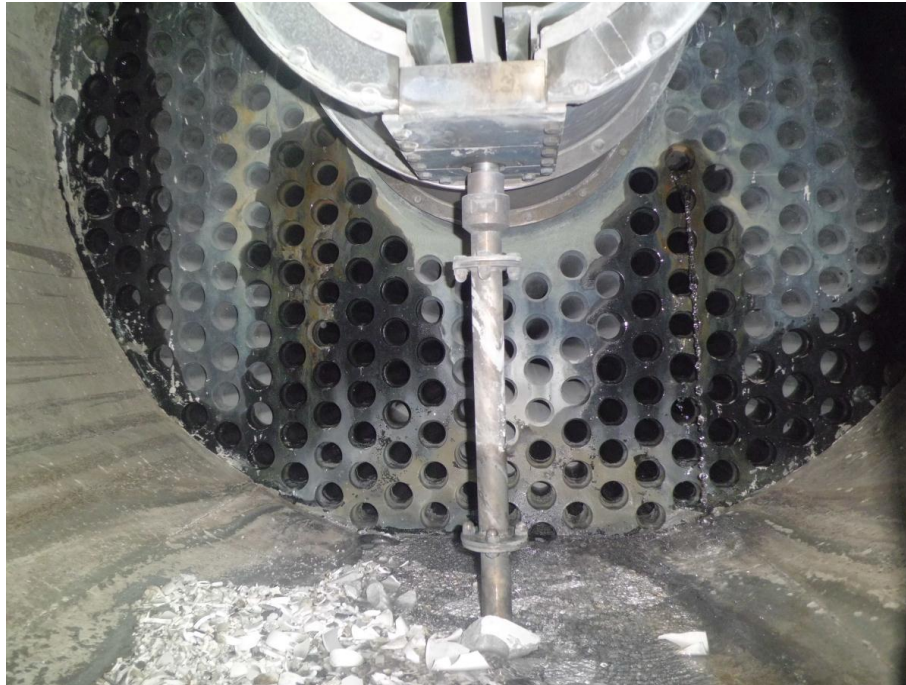
Also broken ferrule pieces went through the pipes to the outlet compartment and water had traveled from E0308 to E0309. (Figure 4)

*Figure 4: Water and debris was found at the outlet compartment*

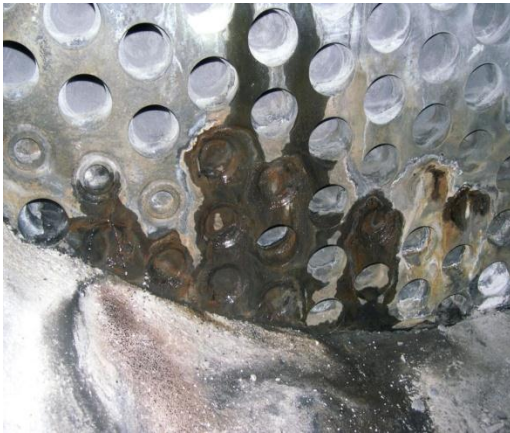
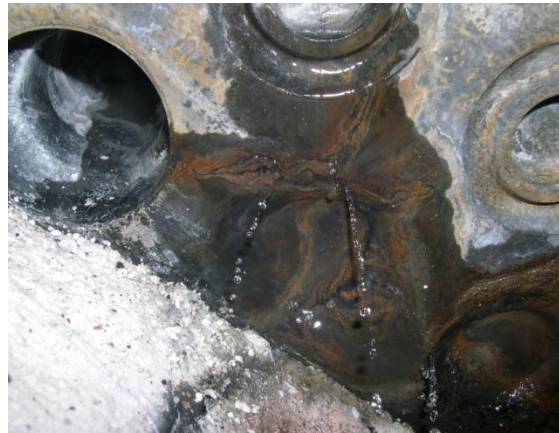
This 2nd failure of the WHB was found to be due to stress corrosion in areas around welded tube plugs with high remaining stresses and local (phosphate) deposition in crevices.

*Figure 9 and 10: Cracks in outlet tube sheet*

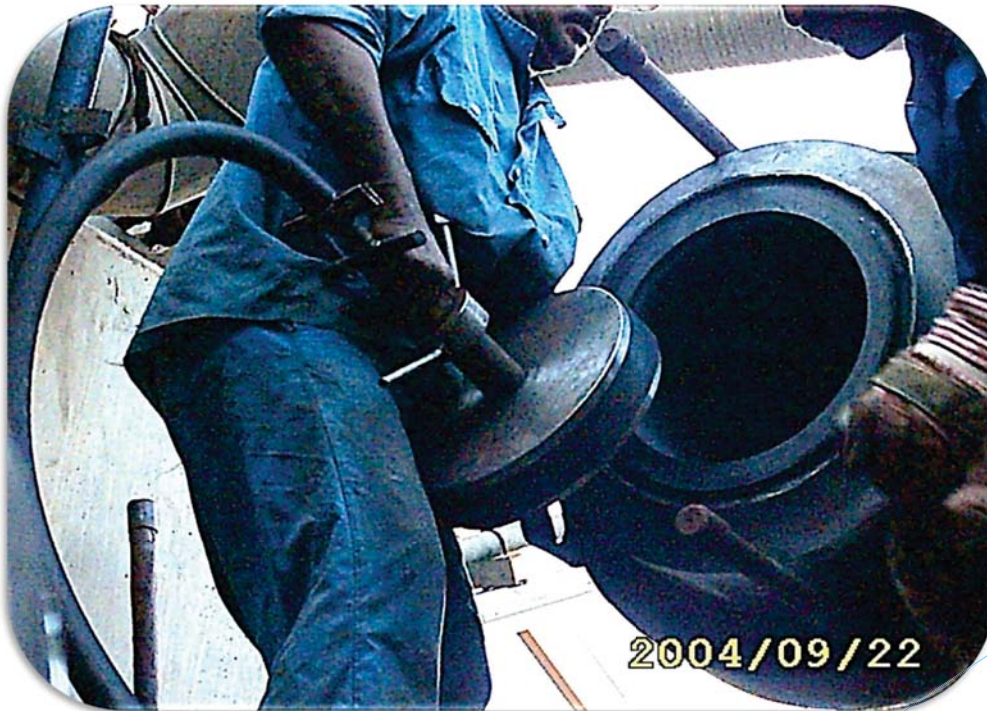
## **Repair Procedure:-**

- ✚ Detecting the defected tubes in the waste heat boiler specially the hot inlet side by filling.
- ✚ Removing the ferrules of the failed tubes.
- ✚ Enlarging the Secondary tube sheet to insert the plugs.
- ✚ Insert the tube plugs up to the primary tube sheet.
- ✚ Preheating before welding and weld plugs to the primary tube sheet.
- ✚ Annealing for the welded plugs tube sheet.

- The cutters and welders should wear special safety clothes.
- Cut about 3-4 Cm of the welding and take measurements for H<sub>2</sub> & NH<sub>3</sub>.
- If the measurements are Ok open more than one N<sub>2</sub> hose and continue cutting to 30-40 Cm and stop for more measurements.
- Then continue cutting.
- Remove the internal expansion joint connected to the cone, and erect a blind flange inside the waste heat boiler on the gas header outlet the converter.
- Erect N<sub>2</sub> hose with PI indicator on the gas header outlet the converter to adjust the N<sub>2</sub> pressure at 0.3 bars inside Ammonia converter.

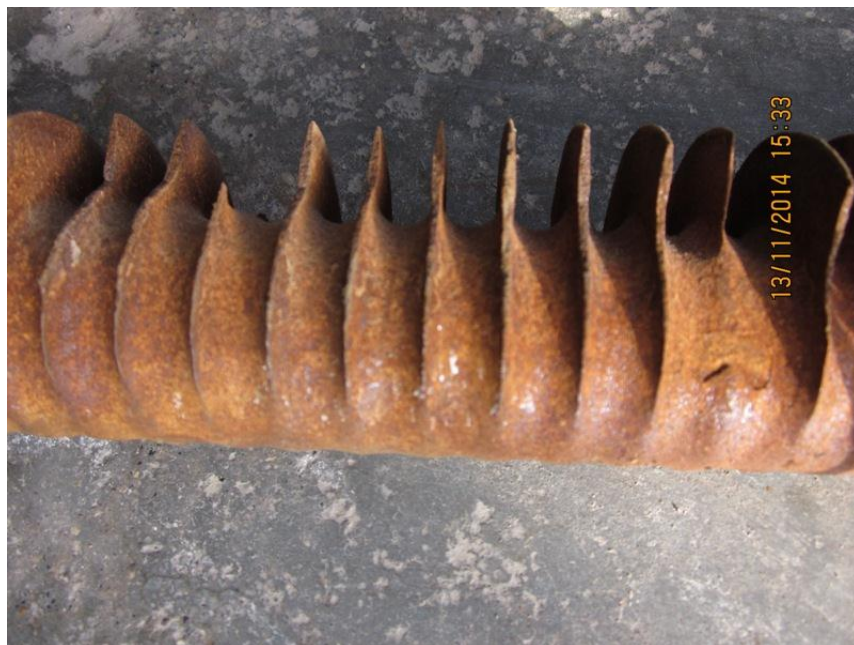
end of the finned tube economizer were facing severe acid corrosion (see figure 1) and tube failures were occurring within weeks of repair/replacement

Figure 1: severe acid corrosion of economizer tube

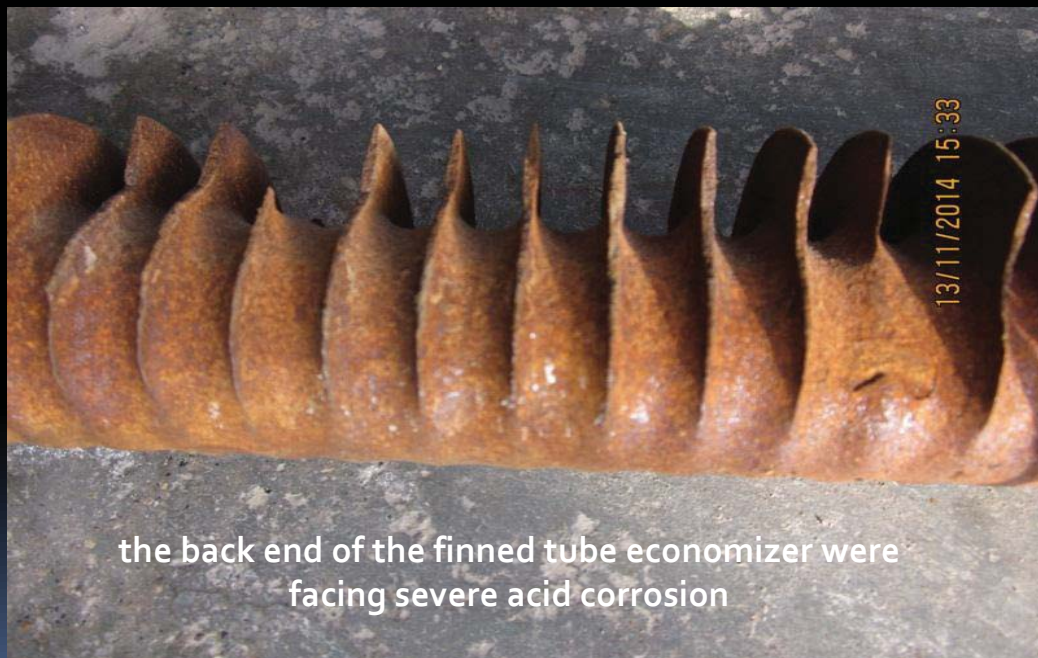
## PROBLEM

- Boiler unit No.2 (SG4-Boiler) has a design capacity of 110 t/h process steam at 64 bar, 478°C. The boiler with first commissioning at 1982 was completely replaced in 2004. The economizer which made of carbon steel, it started facing repetitive tubes and bends ruptures in its lower part one year after commissioning
- Severe fouling occurring on the economizer heating surfaces, preventing efficient heat transfer to the economizer tubes, which resulted in a high flue gas exit temperature and hence a reduction in boiler efficiency and increase in fuel consumption.
