47TH TURBOMACHINERY & 34TH PUMP SYMPOSIA HOUSTON, TEXAS | SEPTEMBER 17-20, 2018 GEORGE R. BROWN CONVENTION CENTER

Troubleshooting of Sub-synchronous Torsional Interaction Phenomena on an Electric Motor-Driven Centrifugal Compressor

Southwest Research Institute

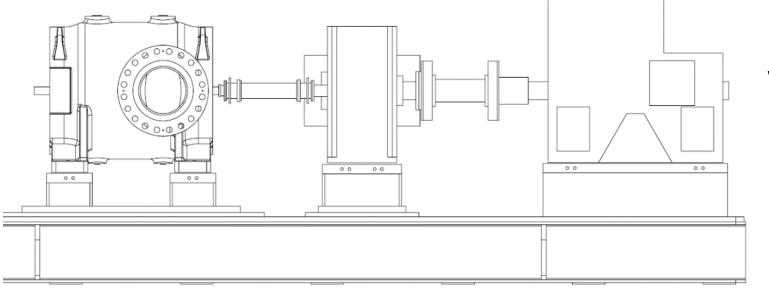
VFD EMD Compressor Facility used in Case Study

5-stage centrifugal **compressor**, max speed 16,500 rpm

single-stage, single-helical, 7.792 gear ratio, 14,025 rpm output speed **gearbox**

4040 HP, 1800 rpm, 60 Hz induction **motor**

VFD controlled

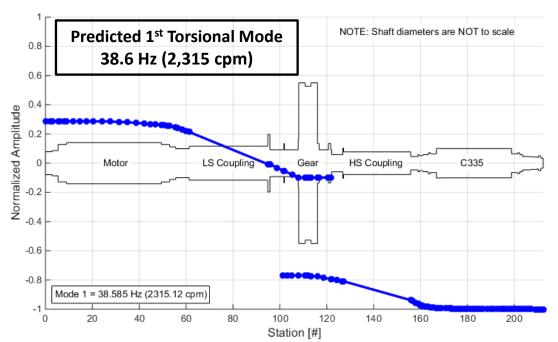
Torsional Rotordynamic Model

- Campbell diagrams show no interference with 1st mode with mechanical 1x and 2x energy orders (next slides)
- VFD non-integer excitation data not provided by VFD manufacturer

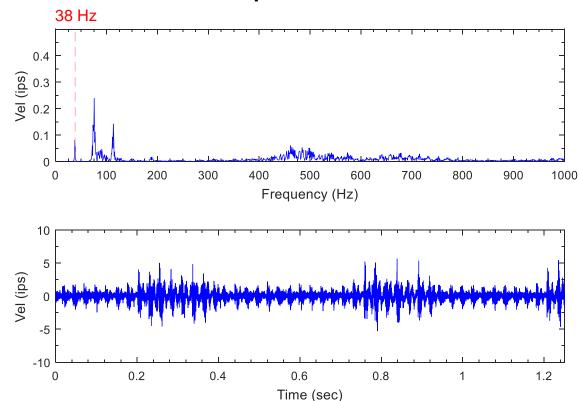
Gearbox Low-Speed Shaft Accelerometer

During high-pressure, high-speed testing, high vibrations were observed on the gearbox at the drivetrain's torsional frequency (38 Hz) between the speeds of 9,800 - 11,000 rpm.

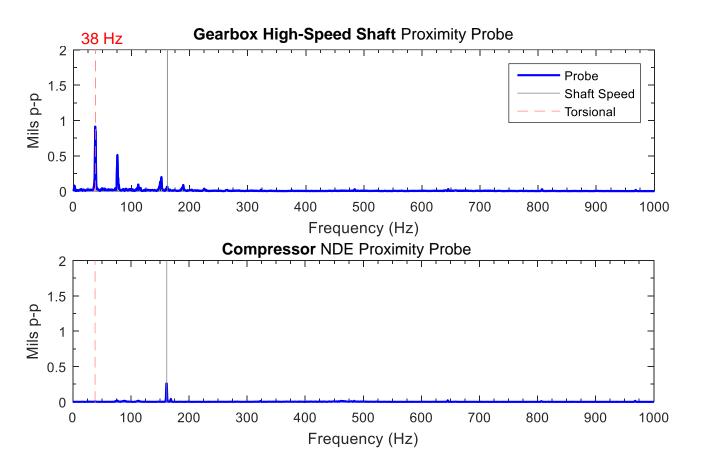
Response observed on the gearbox shafts with proximity probe, but little response observed on the compressor shaft

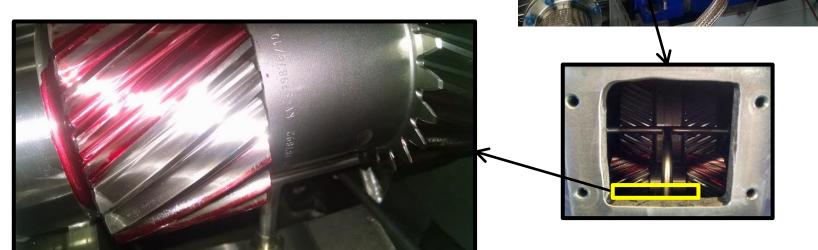
1. **Audible noise** during operation (steady state, accelerations, and decelerations) from gearbox *No noise when deceleration occurred via emergency stop on VFD*

2. **Visual wear** on gearbox teeth in post-test inspection

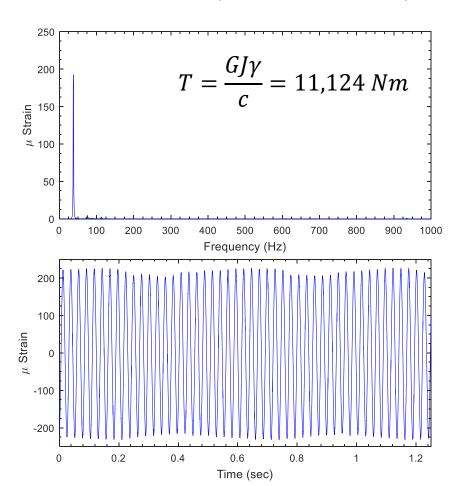
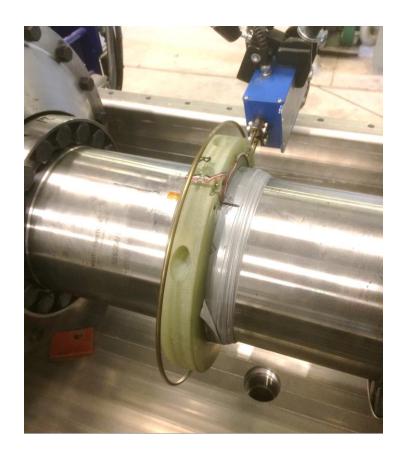
Dynamic Torque Measurements

Low Speed Coupling Measurements

Coupling Spacer

Motor Shaft

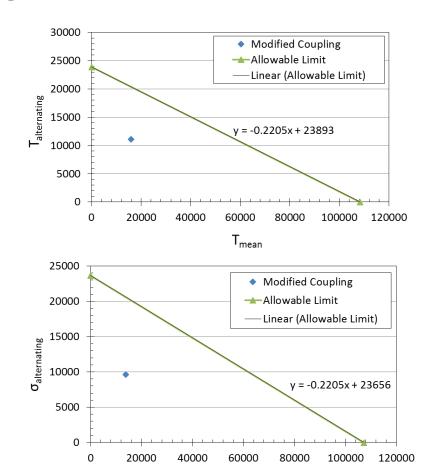
- Measured dynamic torque was applied to the torsional model to determine stress at various critical locations in the machine.
- The stress was plotted on a Goodman diagram to determine if low-cycle fatigue had occurred.

σ_{mean}

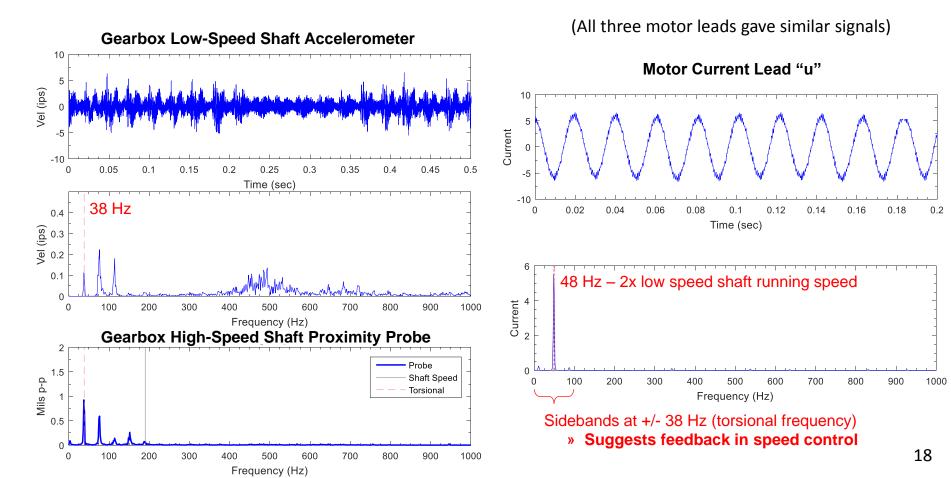
Motor Current Monitoring: 11,400 rpm V/F Mode

- V/F Mode is open loop speed control method
- There is a steady state relationship between speed reference and output frequency/voltage determined by parameterization.
- Motor speed is free to seek motor/load-torque equilibrium within a slippage window around synchronous speed.
- Choices of PWM frequency didn't seem to provide any benefit

- Operate VFD in Sensorless Vector Mode opposed to V/F Mode
- Tuned settings (filter constants and gains) to improve performance (power availability and stability) without inducing response

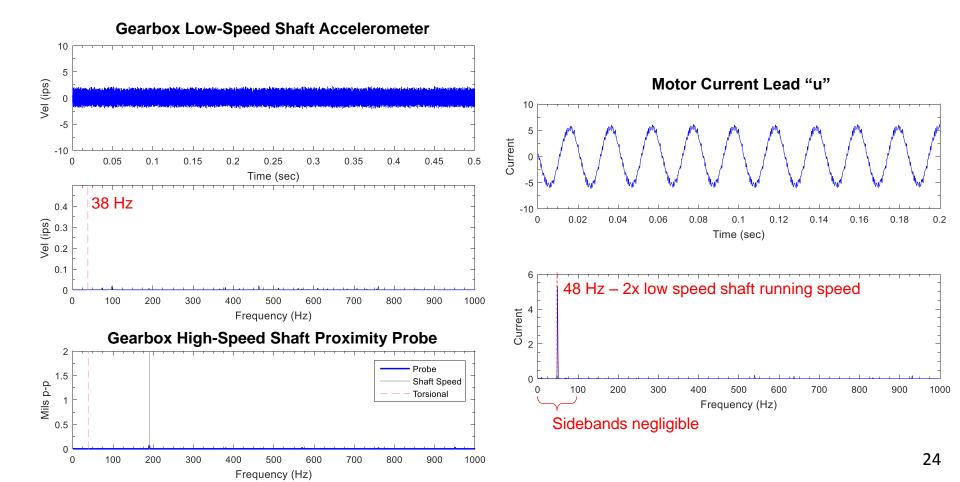
11,400 rpm Sensorless Vector Mode

- Sensorless vector mode is closed loop control
- Provides various means of tuning with filter gains and constants
- This operating mode also controls motor excitation precisely, which may be beneficial to the present issue, given the observed effects of adjusting the V/F characteristic.

- Torsional excitation and response of the compressor train was unrelated to integer and non-integer VFD harmonics
- Slip associated with speed control in V/F Mode suspected to cause torsional response
- Sensorless Vector Mode did not eliminate response, but significantly reduced the magnitude of the response
- Torsional vibration monitoring recommended to detect problems and avoid unanticipated coupling/shaft failures
- This solution differs from other instances in the literature
- No 'typical' solution for all VFD-excited torsional vibrations; may need to involve VFD manufacturer and utilize coupled mechanicalelectrical dynamic model
