# **Evaluating the Long-Term Performance of Composite Wear Rings in Centrifugal Pumps**

**By Robert Aronen Boulden International  
and Martin Russek, Sunoco**

# Long Term Results: 2000—2009

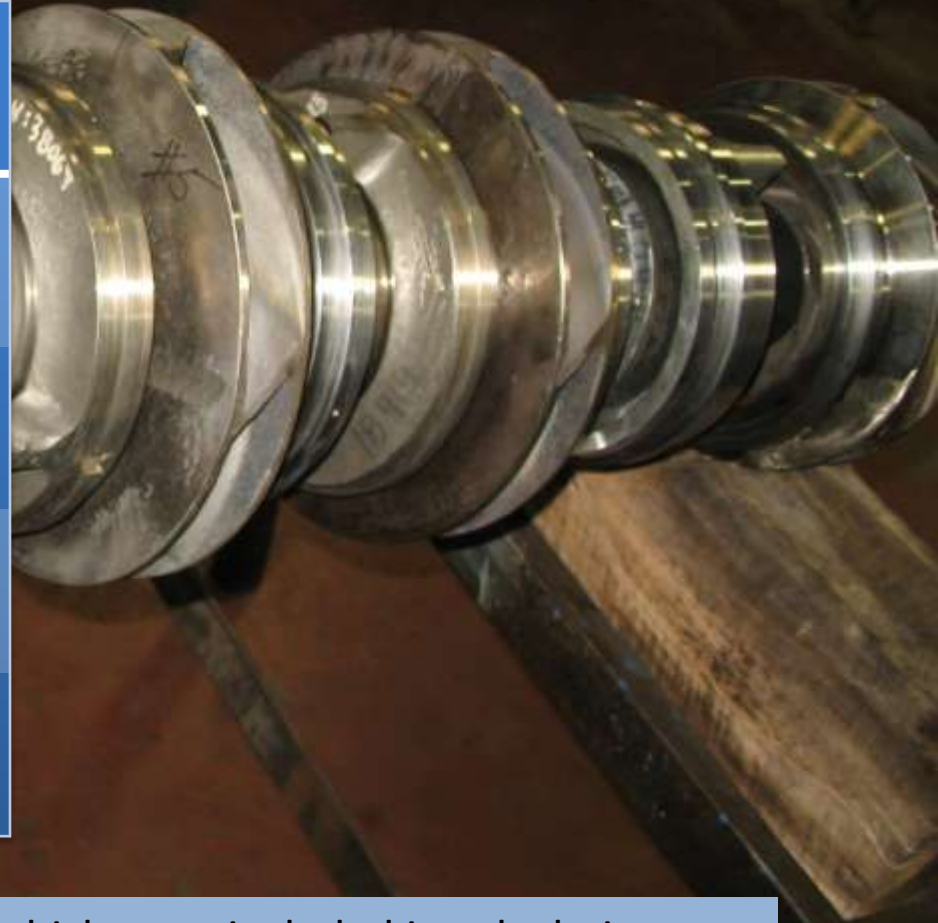
# Boiler Feed Water

| Pump Type | BB3<br>3 Pumps |
| Operating Temperature | 230—250 °F<br>(110—120 °C) |
| Speed | 3550 RPM |
| MTBR Before | 15 Months |
| MTBR After | 41 Months* |

\* One pump had 3 lube oil system failures which were included in calculation, otherwise MTBR would have increased to 163 months

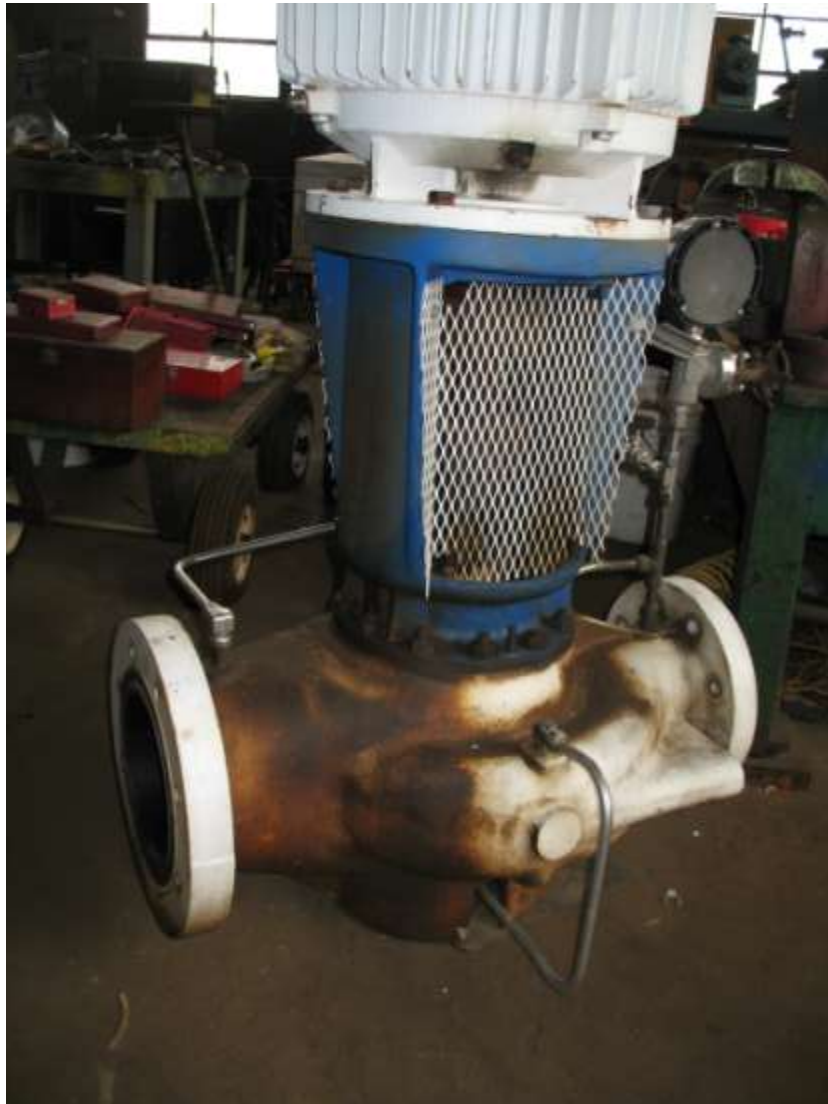
# Gasoline Transfer

| Pump Type | OH2<br>4 Pumps |
| Operating Temperature | Ambient |
| Speed | 3550 RPM |
| MTBR Before | 17 Months |
| MTBR After | 120 Months |

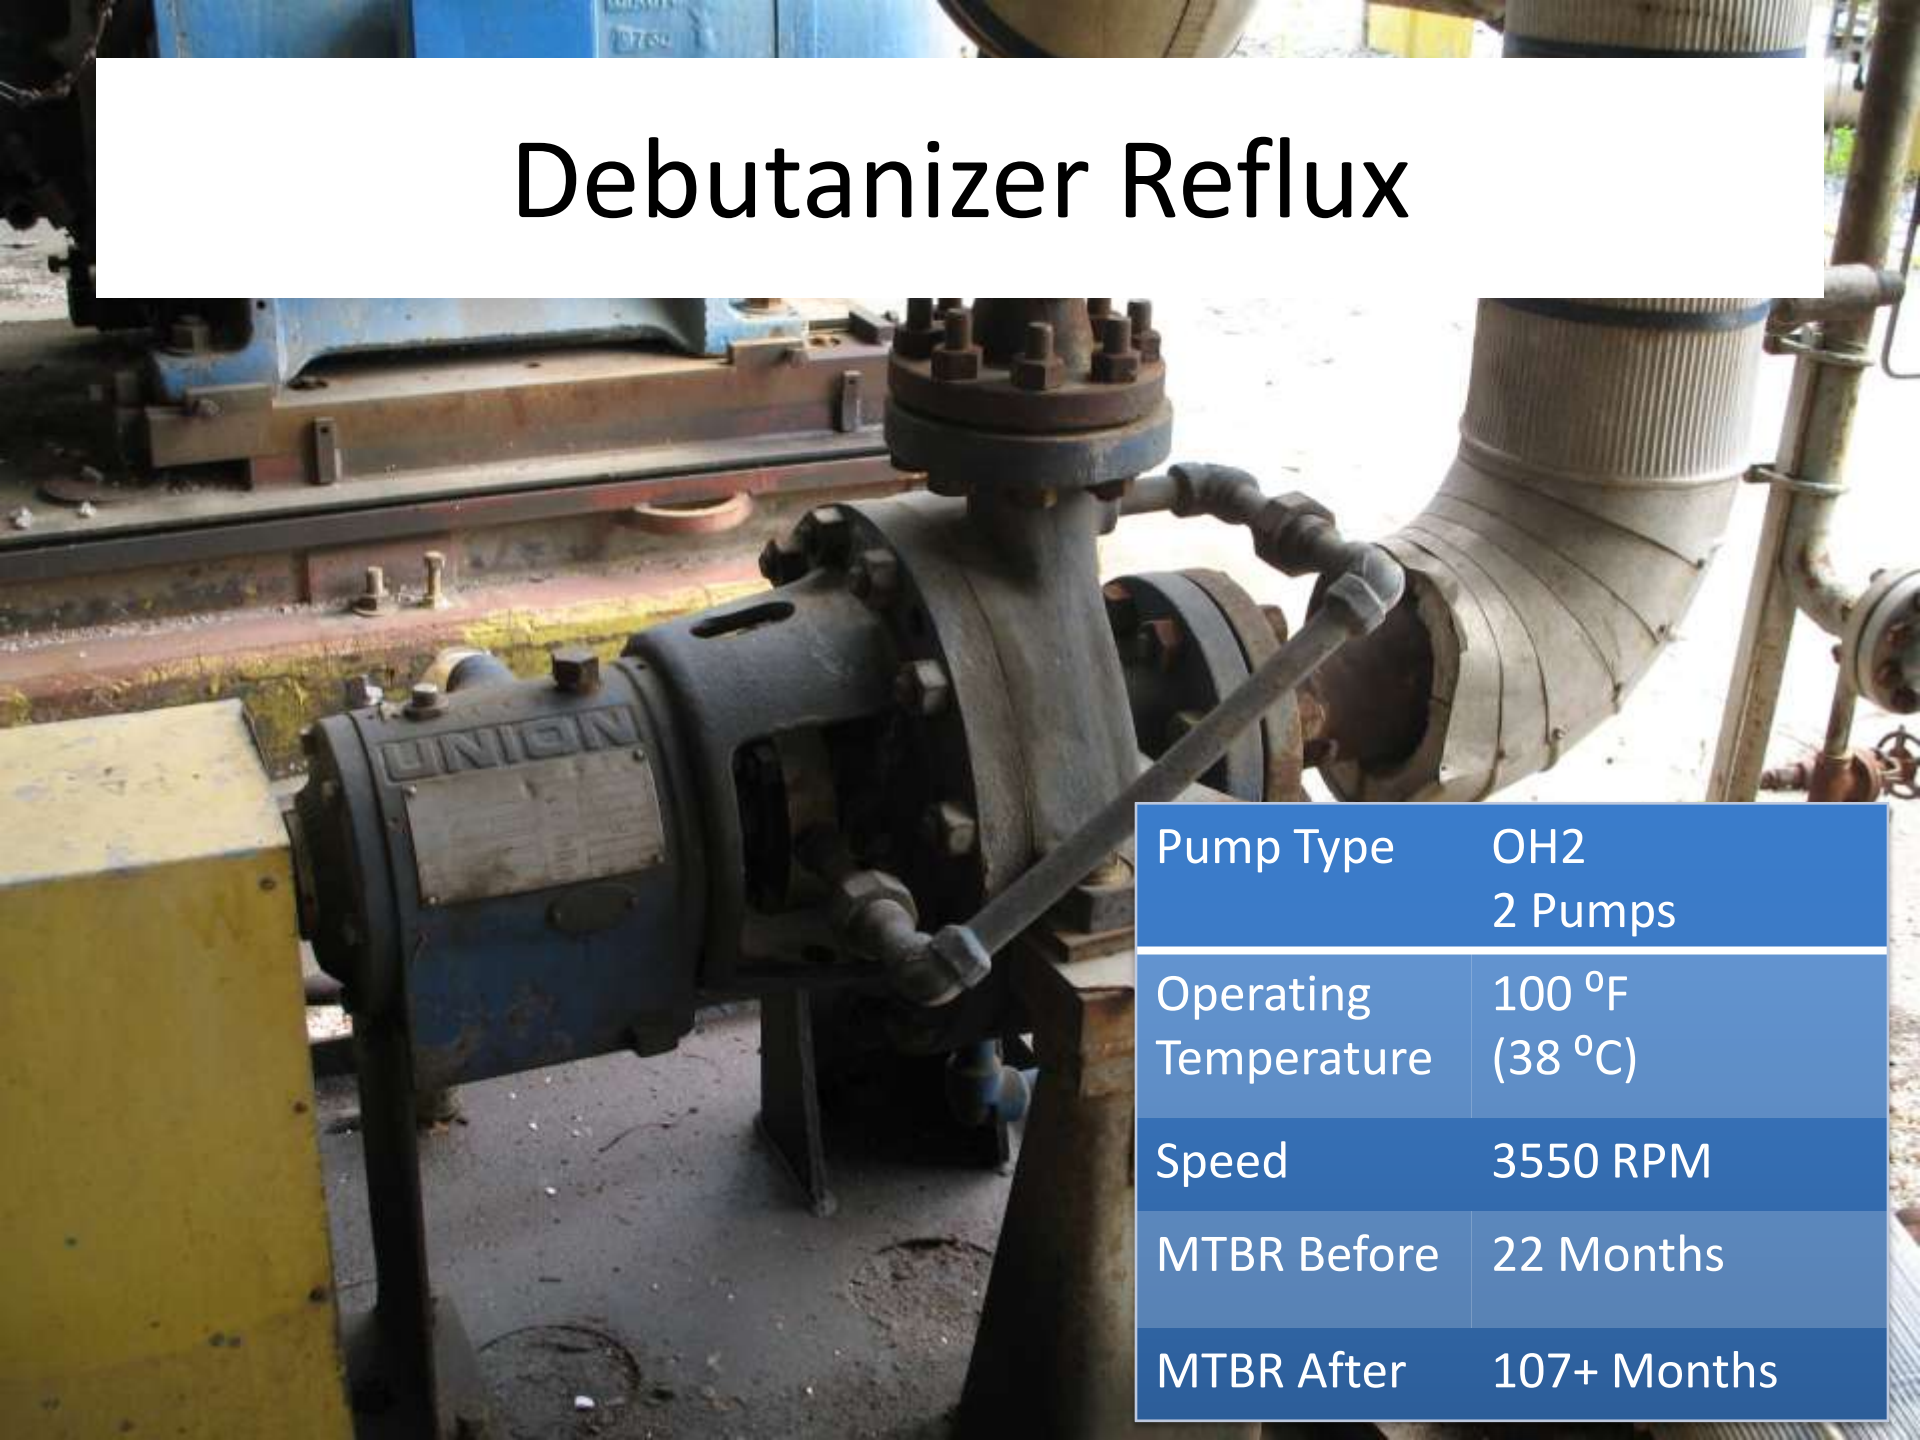
# Debutanizer Reflux

| Pump Type | OH2<br>2 Pumps |
| Operating Temperature | 100 °F<br>(38 °C) |
| Speed | 3550 RPM |
| MTBR Before | 22 Months |
| MTBR After | 107+ Months |
