RCA: Improving Pump-Motors Reliability by Changing Structural Stiffness

Nayef A. Al-Dossary
Reliability Supervisor
2012 Rotating Equipment
Roundtable Meeting

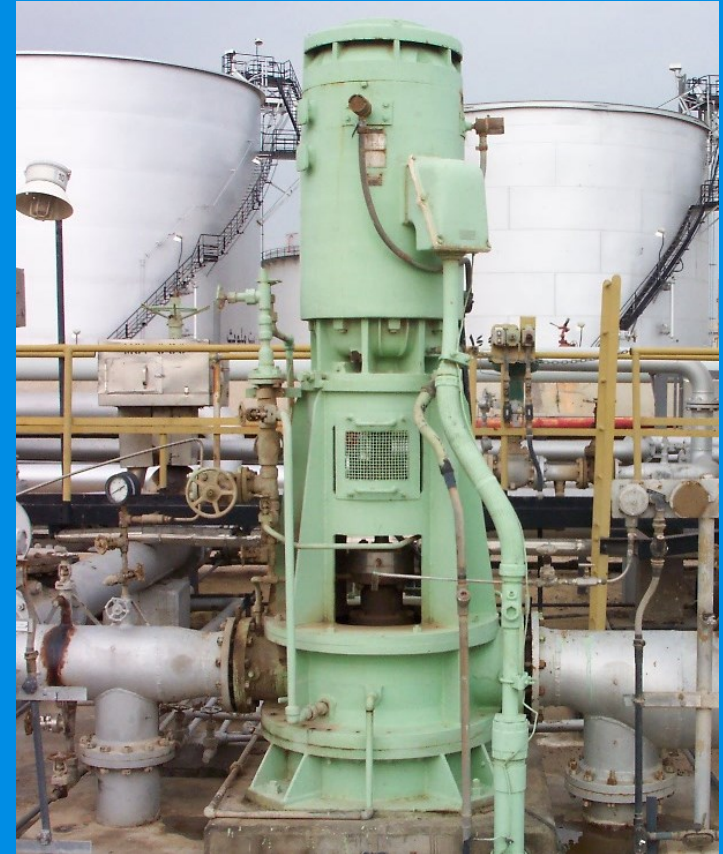
Crude Booster Pump-Motor

- **Motor speed 1800 RPM**
- **250 HP**
- **Experience a high vibration specially in summer**

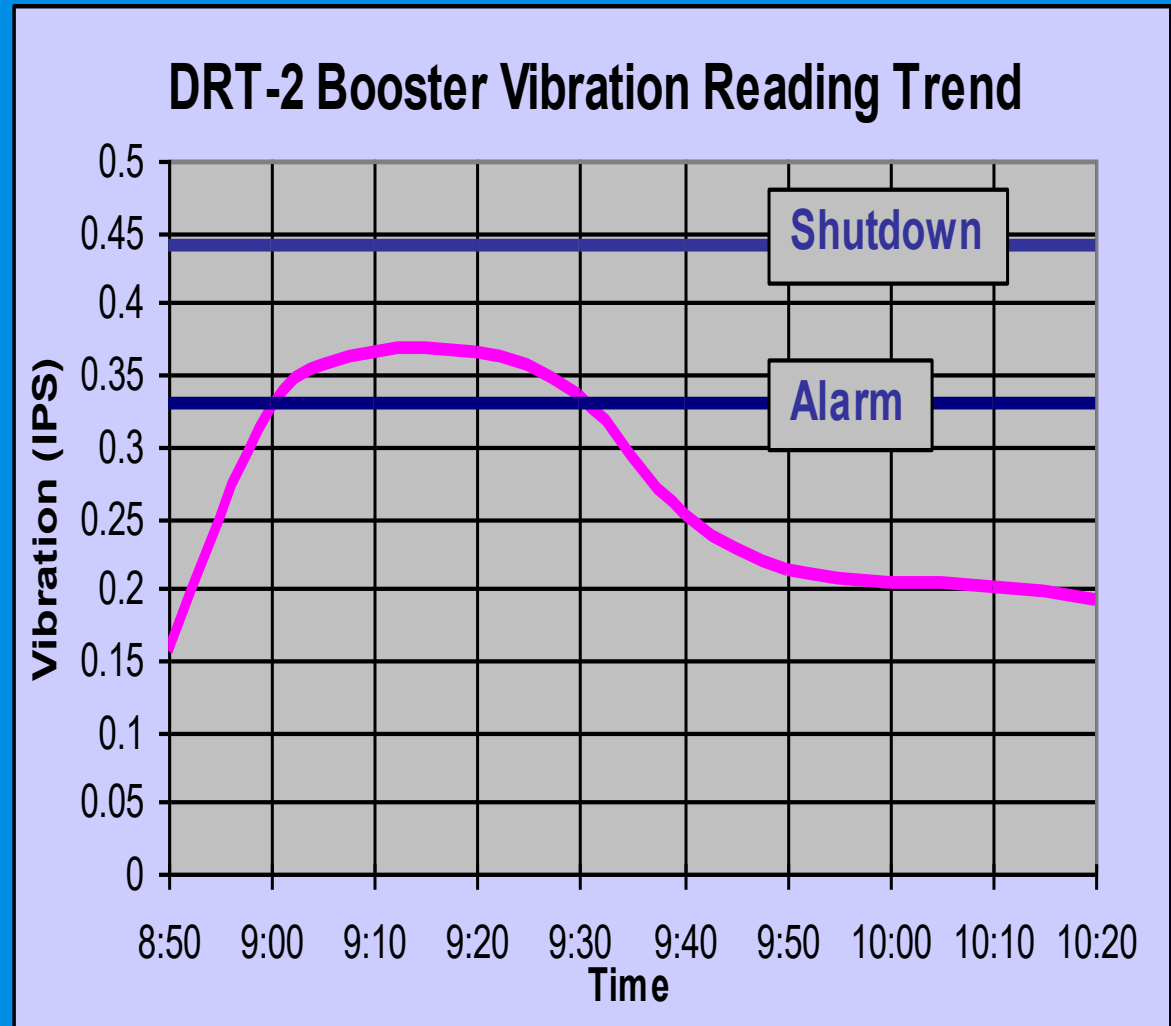
Vibration Problem Discussion

The vibration problem happened at the startup of DRT-2 booster motor. The vibration levels increased gradually to 0.38 in/s over a period of half an hour.

The vibration then decreased to 0.17 in/s over the next 30 minutes. The level remained constant there after. The alarm setting point is 0.33 IPS and the shutdown setting point is 0.44 IPS.

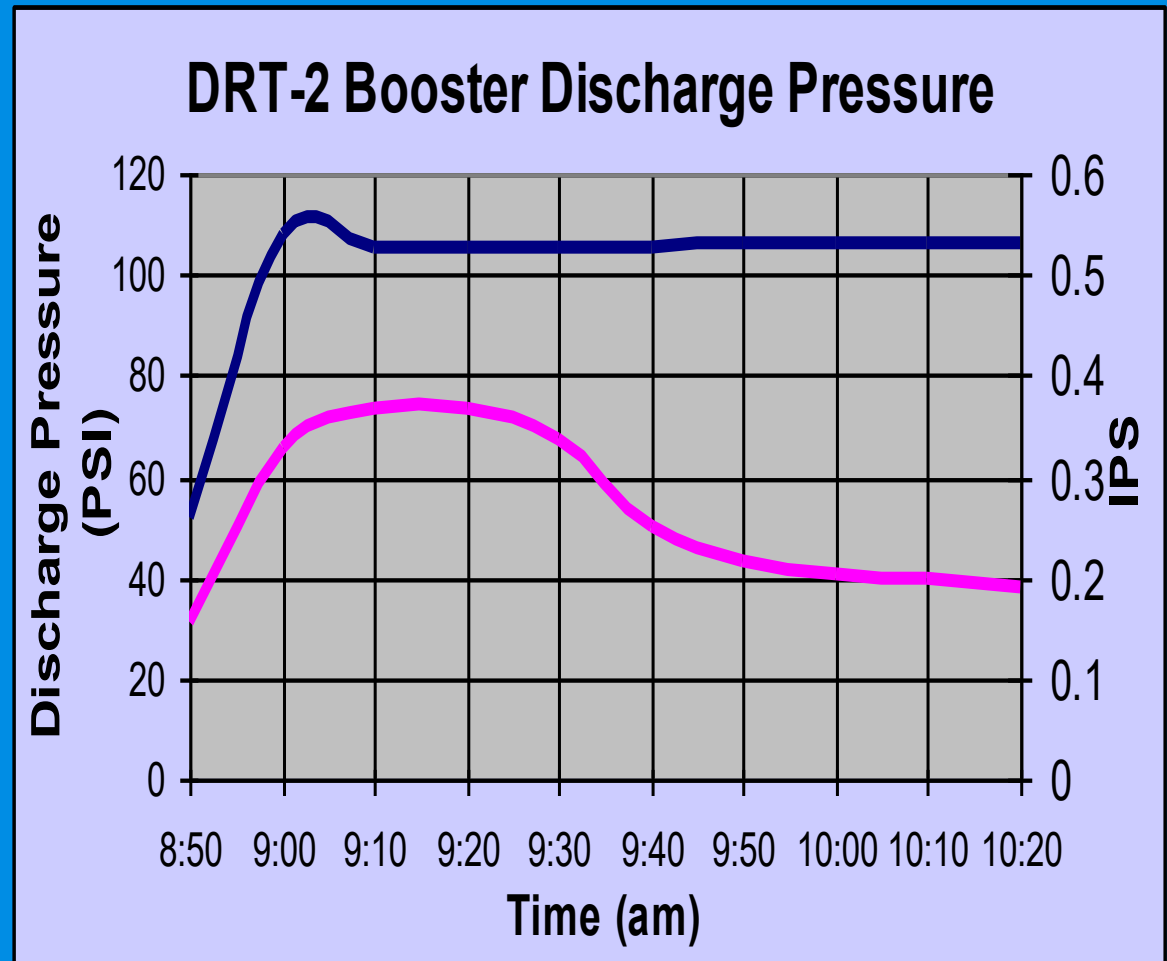
Possible Process Defect

It has noticed that during DRT-2 high vibration problem, the discharge pressure was constant at 105 PSI.

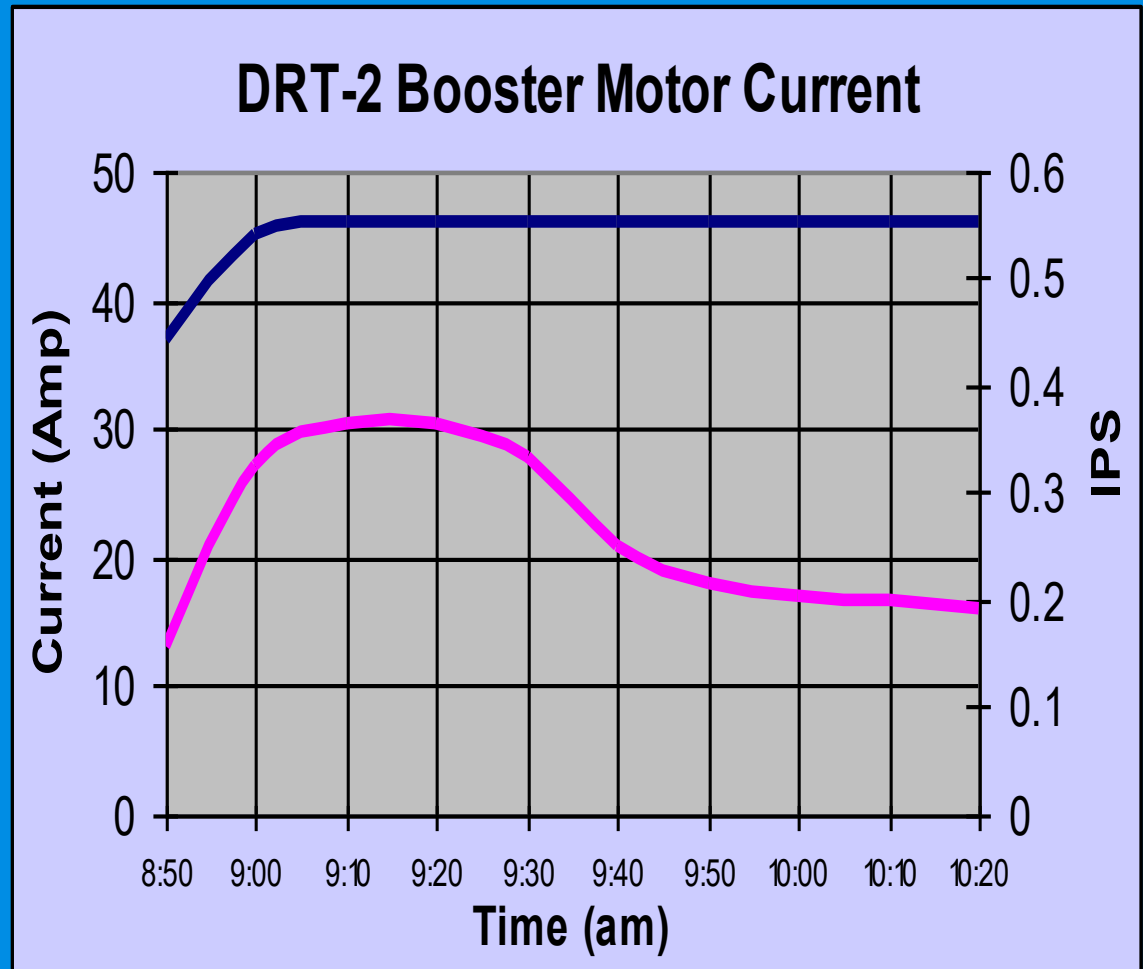
Possible Process Defect

During DRT-2 high vibration problem, motor current stays constant at 46 Amp.

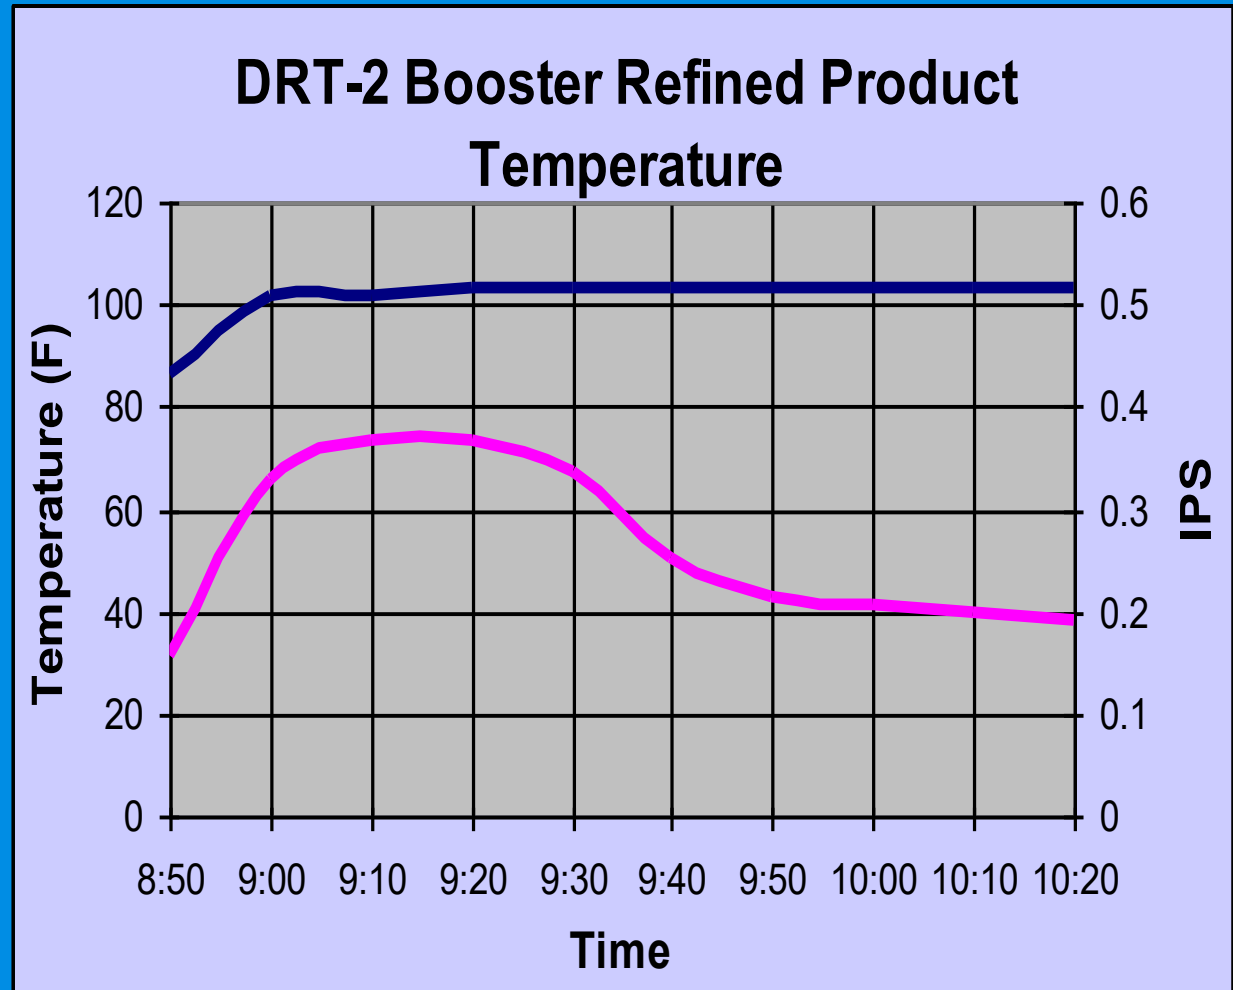
Possible Process Defect

- During DRT-2 high vibration problem, refined product temperature stay constant at 106F.

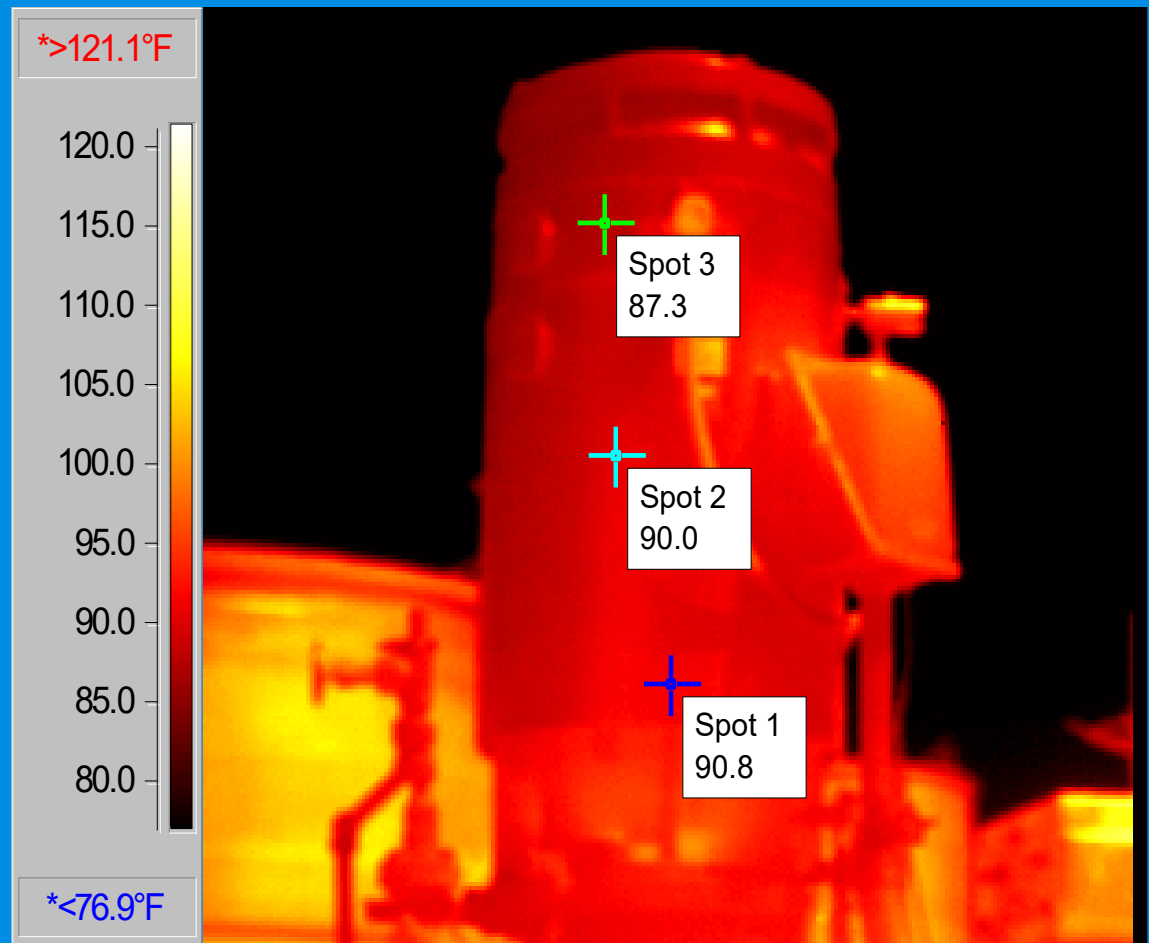
Thermography Readings of DRT-2 Running at High Vibration

Thermography survey is to see the temperature distribution on the DRT motor. motor top bearing temperature and bottom bearing.

Temperature distribution of DRT#2 booster at different operating conditions: The thermal images were recorded on DRT#2 booster when it was stopped, running at low vibration and running at high vibration.

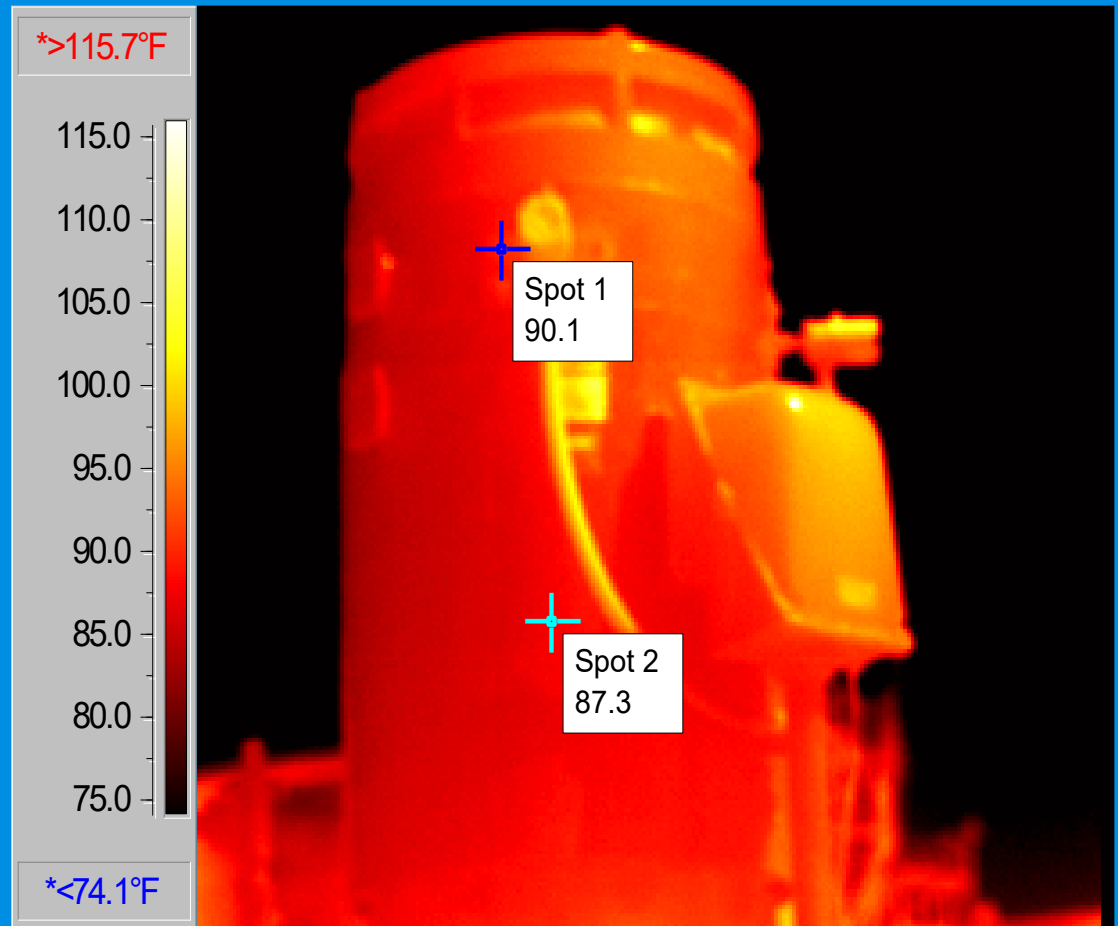
Thermography Readings of DRT-2 at Reduced Vibration

As you can see and compare between those imagers, the thermography images didn't indicate a significant change on DRT#2 booster temperatures at different operating conditions that can be related to the high vibration problem.

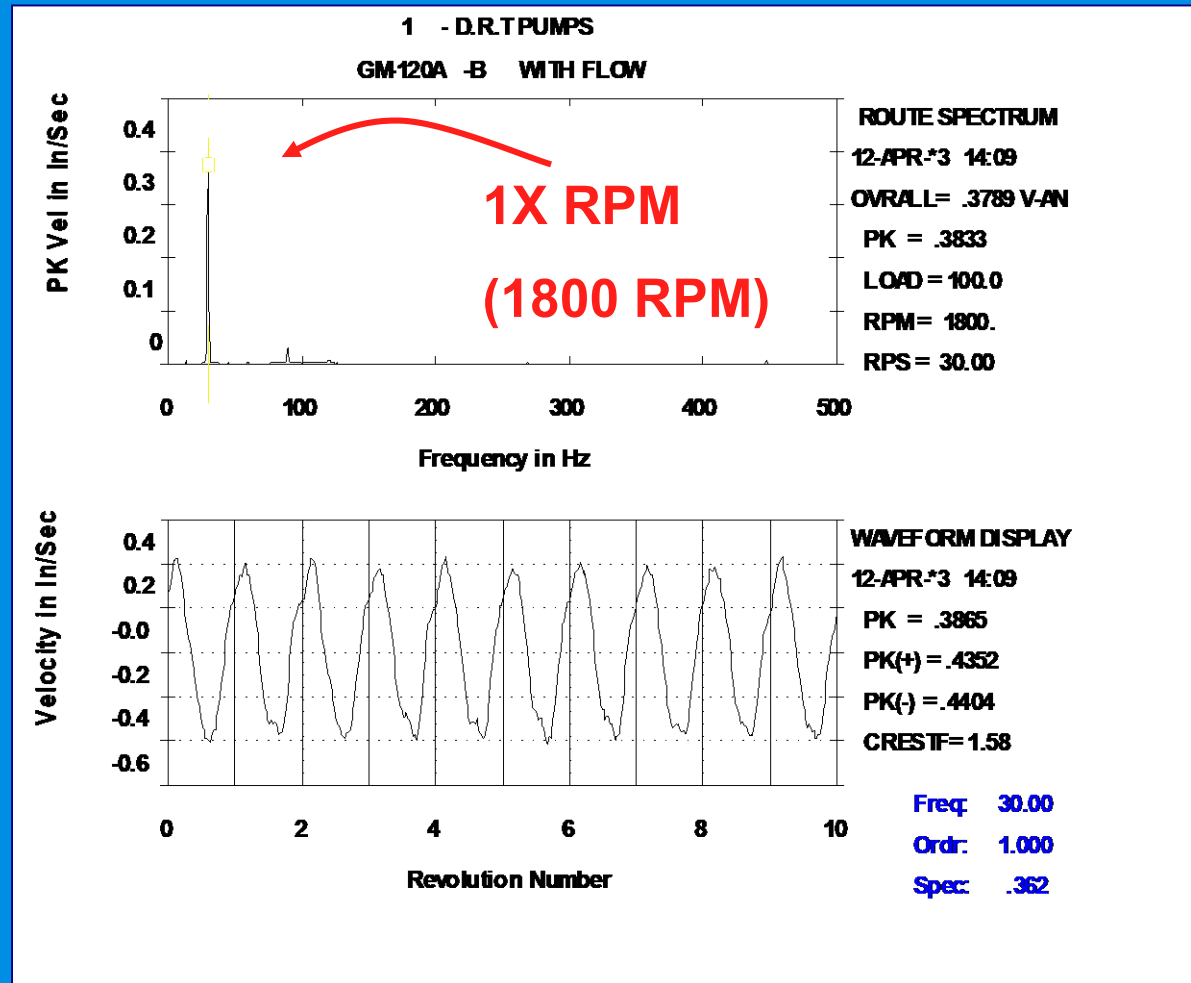
High Vibration Reading For DRT-2

The vibration data spectrum recorded indicated a real vibration and most of the overall vibration is fallen at one-time running speed.

There are no predominant frequencies on the vibration spectrum other than 1X RPM.

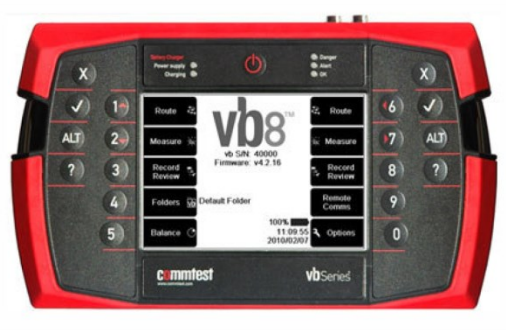
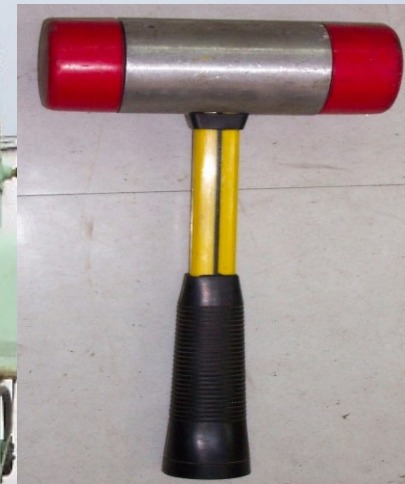
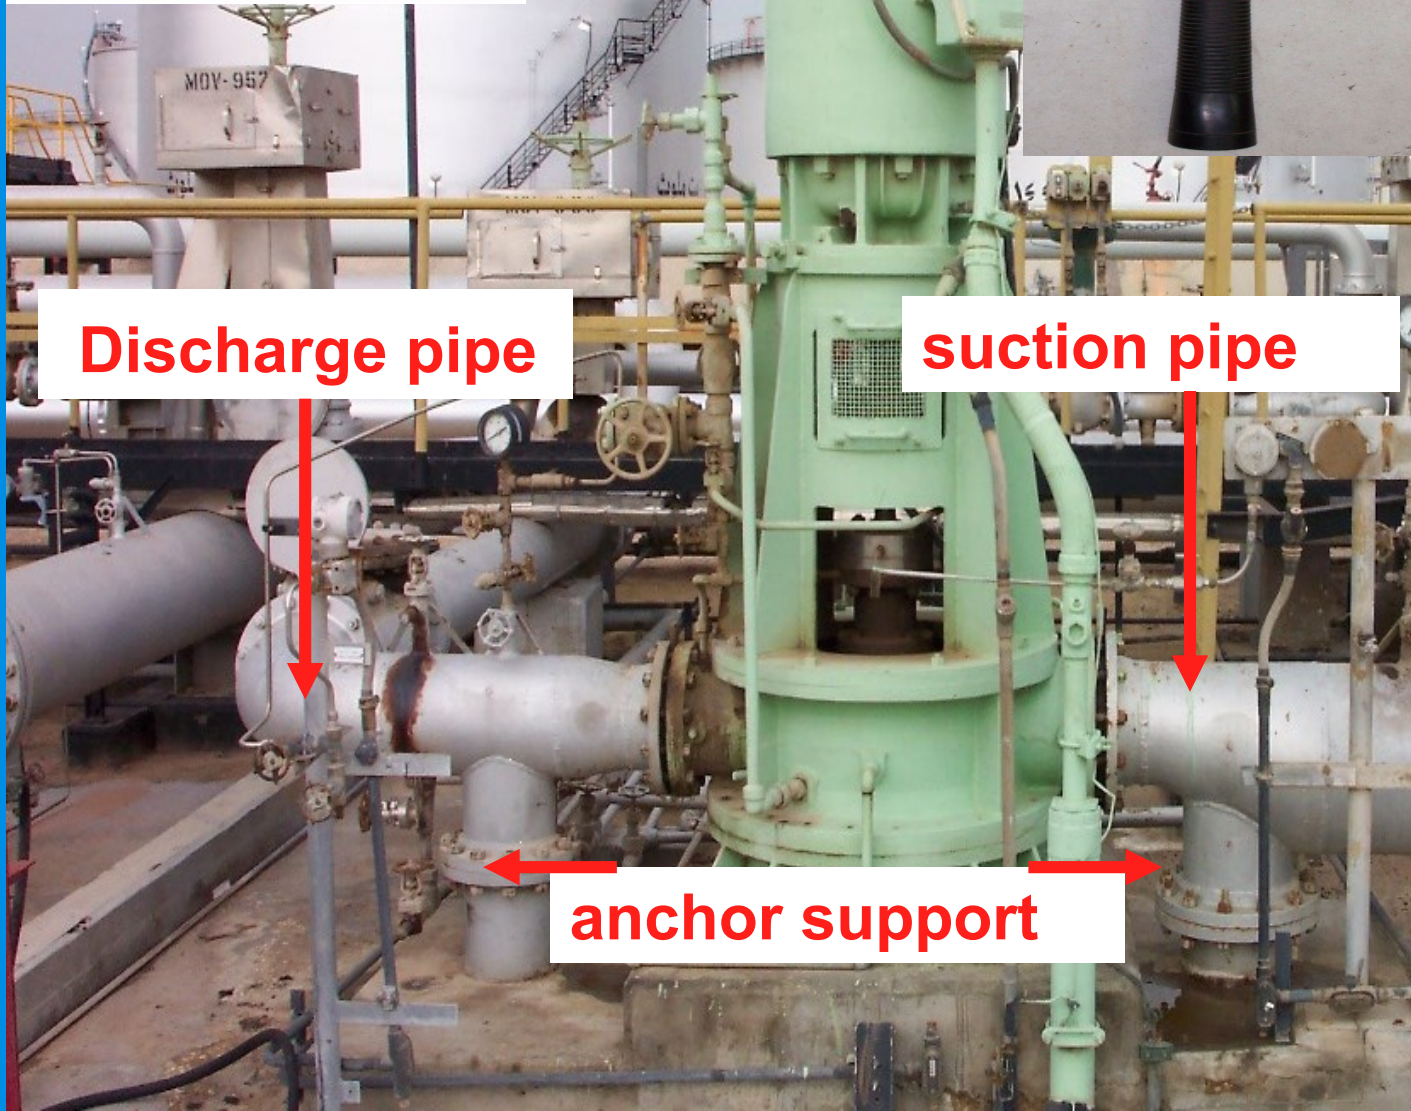
Discharge pipe

suction pipe

anchor support

Resonance
Impact test
carried out to
obtain
information
about the
dynamic
characteristics
of DRT#2
booster and
its structural
support and
piping.

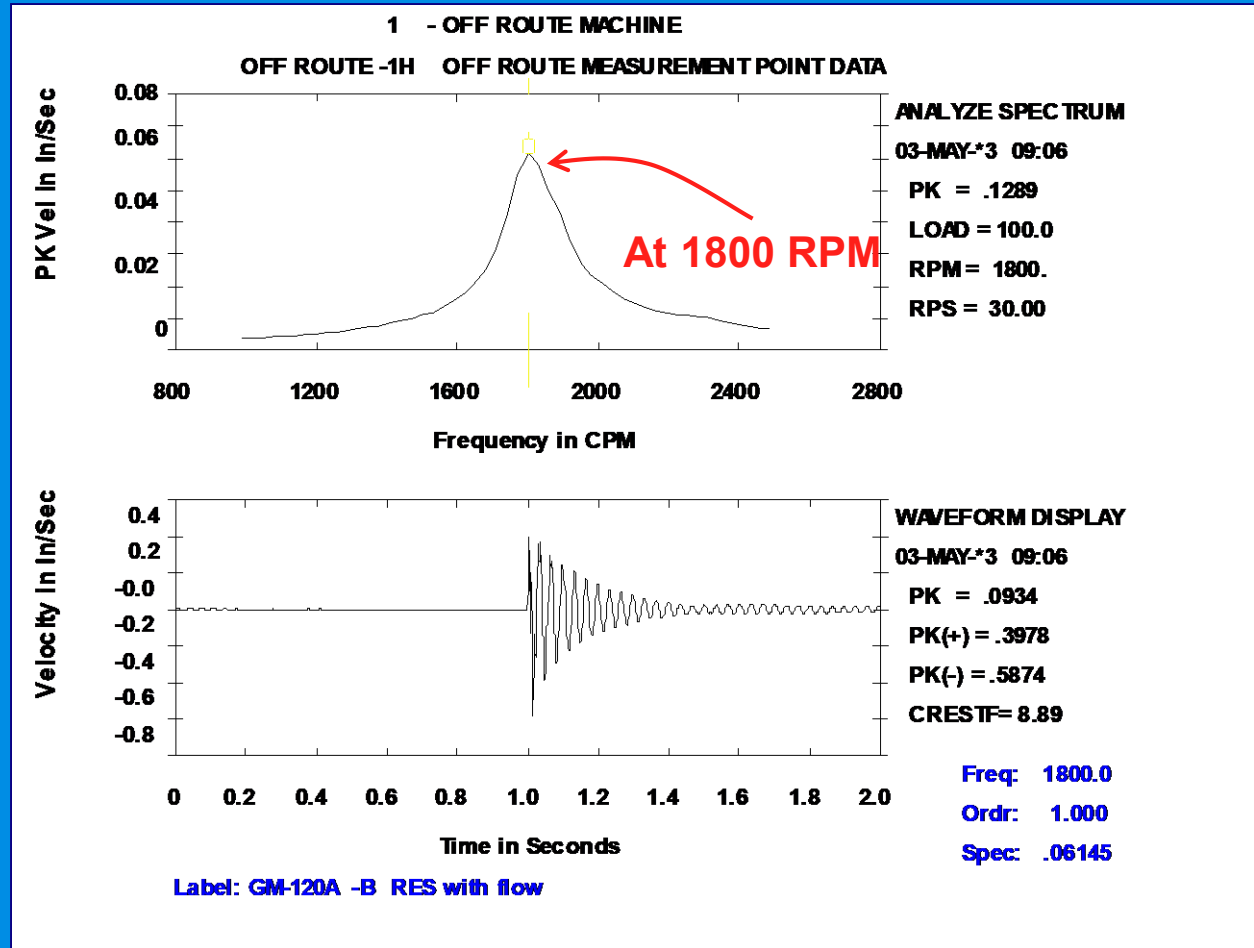
Resonance Test For DRT-2

The results of the test indicated that the natural frequency of DRT#2 booster pump structural occurs at 1800 rpm, which is the same as the rotating speed of the motor.

Operating any machine close to its natural frequency will amplify the vibration operating speed.

- **Changing DRT-2 Pump-Motor system stiffness by shifting the natural frequency away from motor speed.**

The changing of system stiffness was conducted by disconnecting the suction and discharge pipe anchor support. After changing the system stiffness the natural frequency of the pump-piping system changed to 1710 rpm which is less than induction motor speed 1800 rpm [actually 1780 RPM.

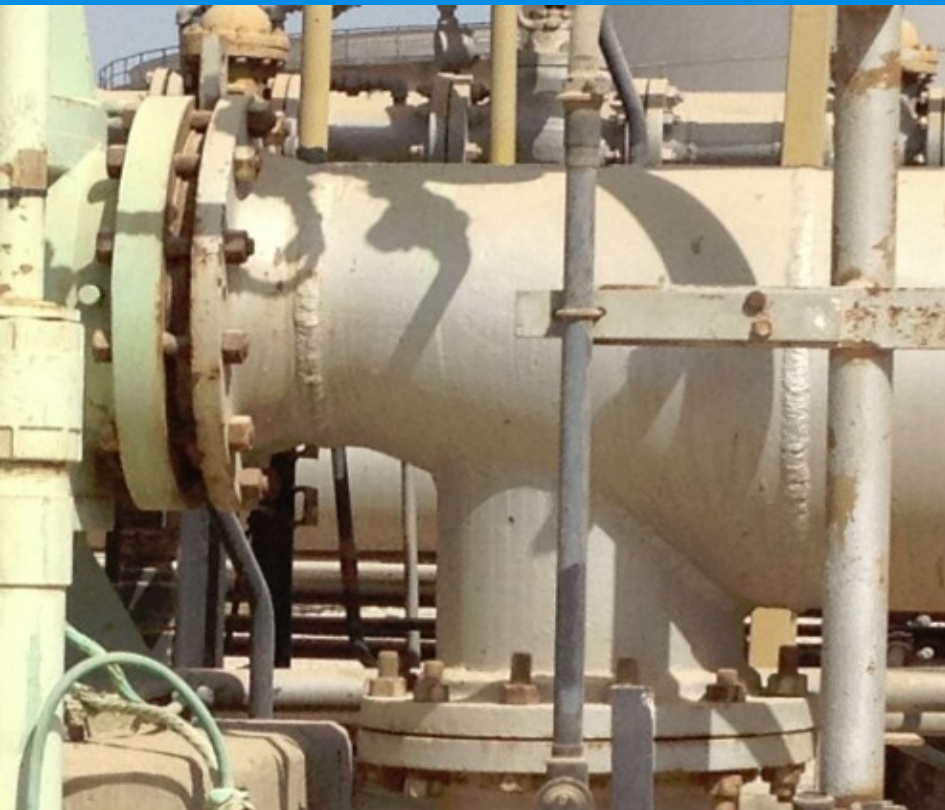
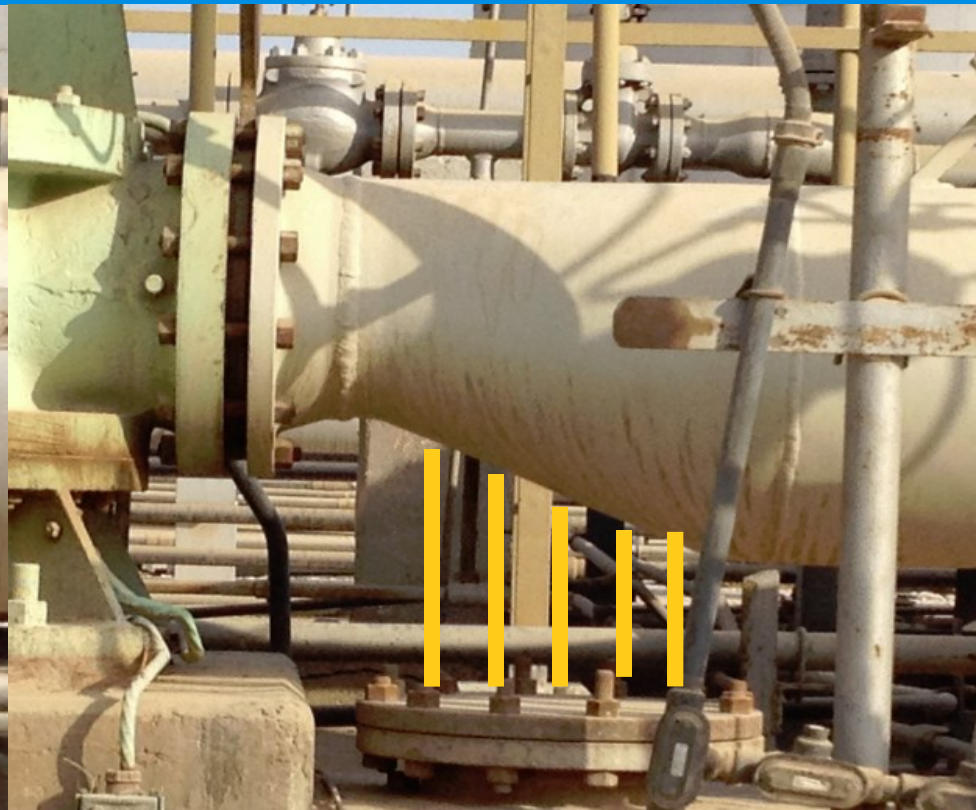
Before

After

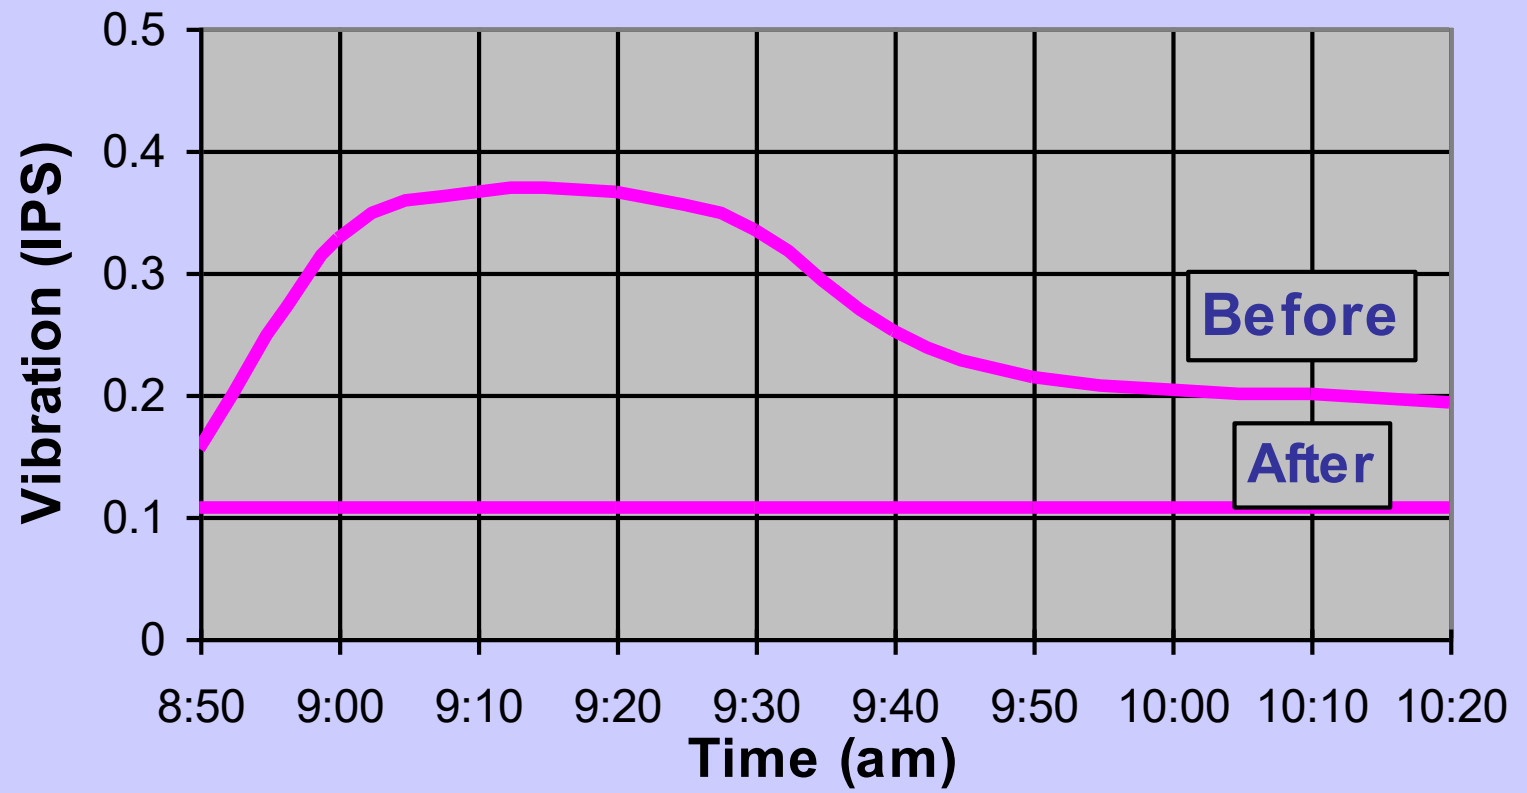
DRT-2 Booster Vibration Reading Trend Before and After Repair

- **Problem identified in early stage**
- **Correct diagnosing and analysis save motor & pump from repair cost.**
- **Vibration went back to acceptable level of 0.10 in/s RMS.**
