# A GENERAL GUIDE TO THE PRINCIPLES, OPERATION AND TROUBLESHOOTING OF **HYDRODYNAMIC BEARINGS**

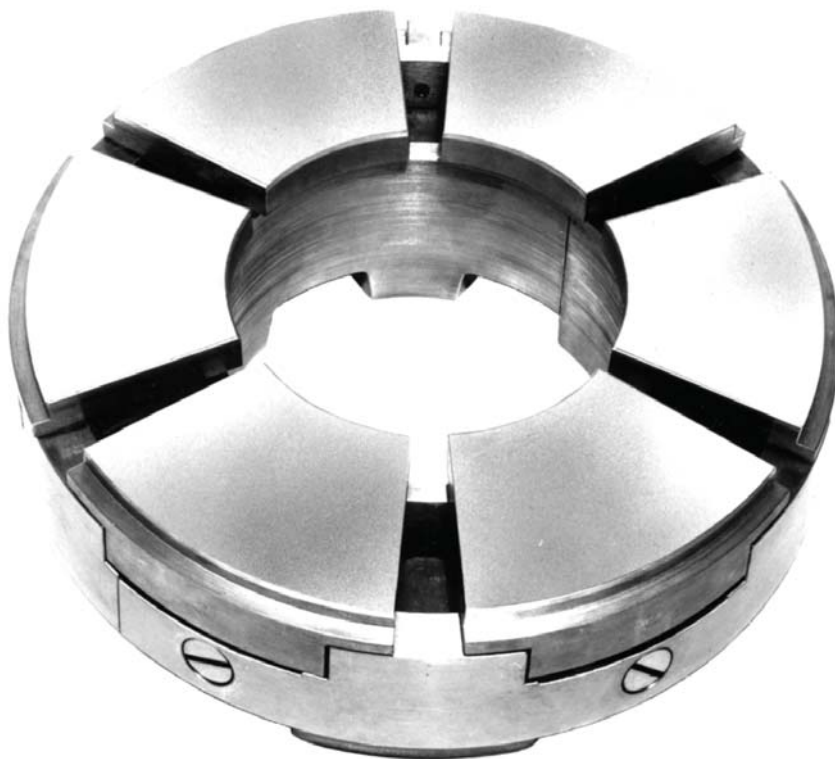
Figure 1 Hydrodynamic, Equalizing Tilting Pad (Pivoted Shoe) Thrust Bearing

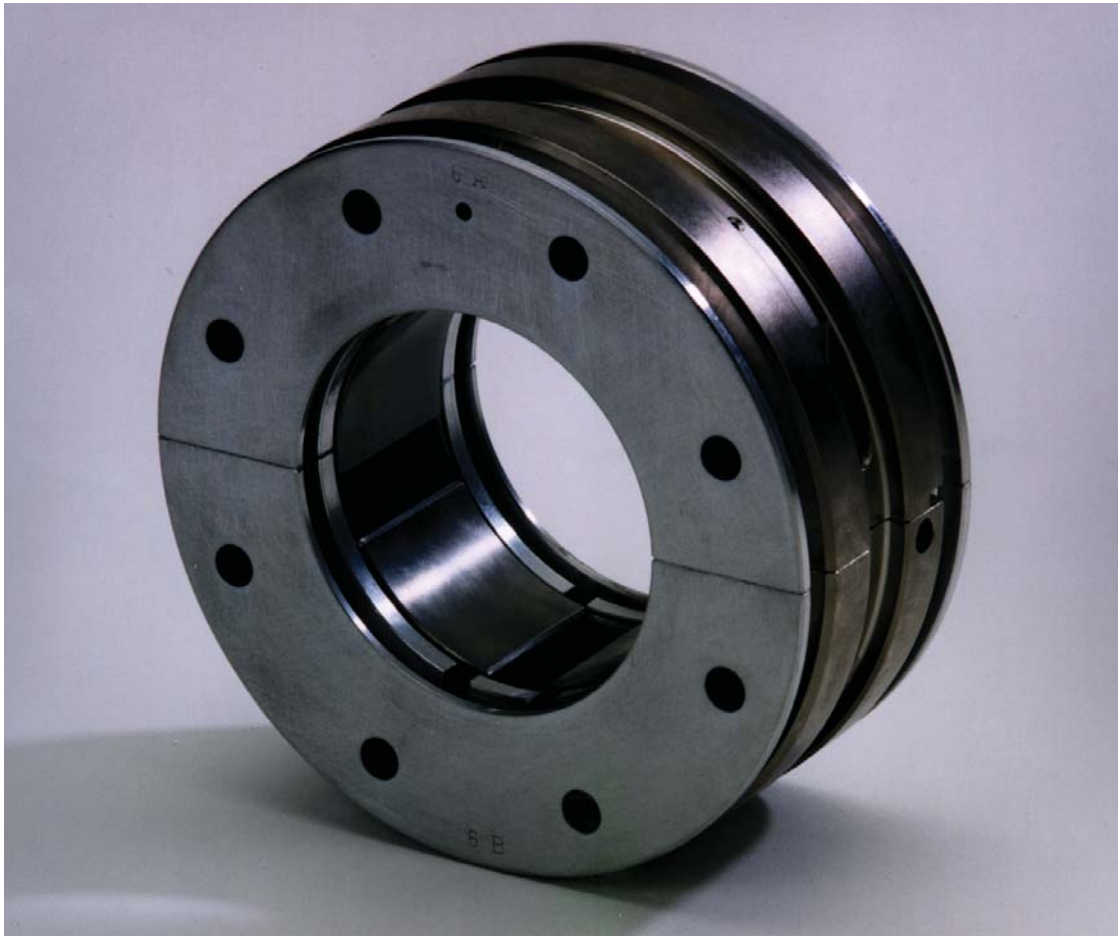
**Figure 2 Hydrodynamic Tilting Pad Journal Bearing**

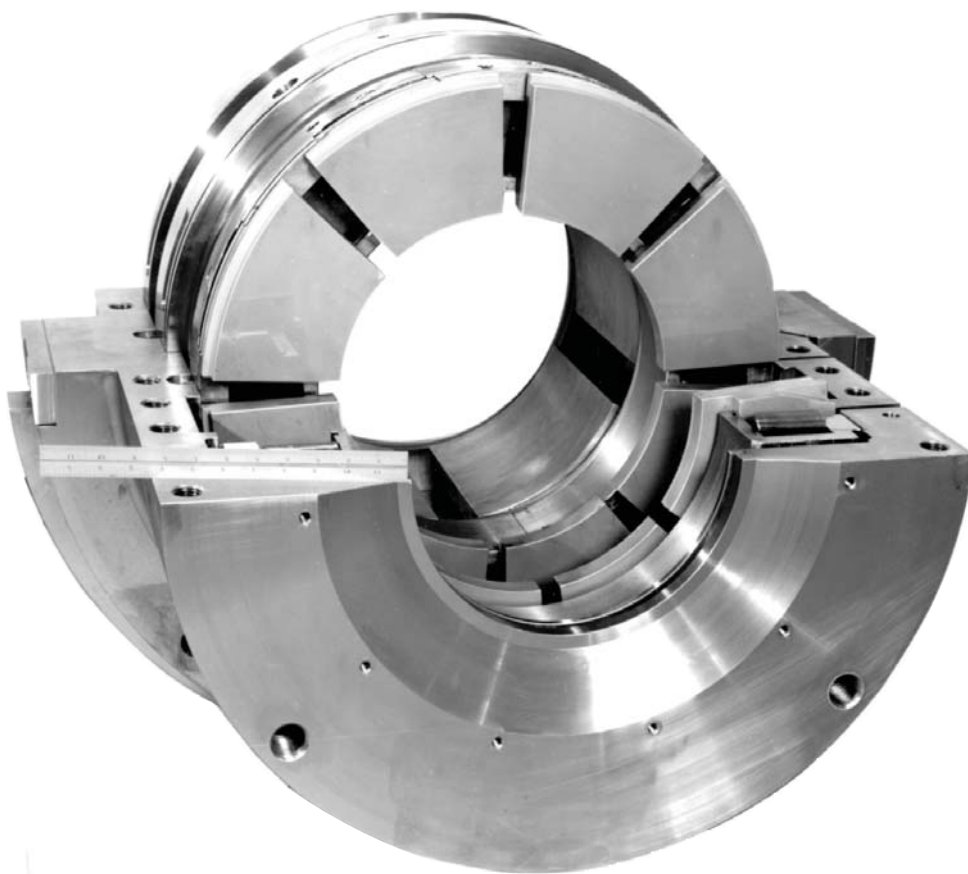
**Figure 3** Hydrodynamic Tilting Pad Thrust and Journal Bearing

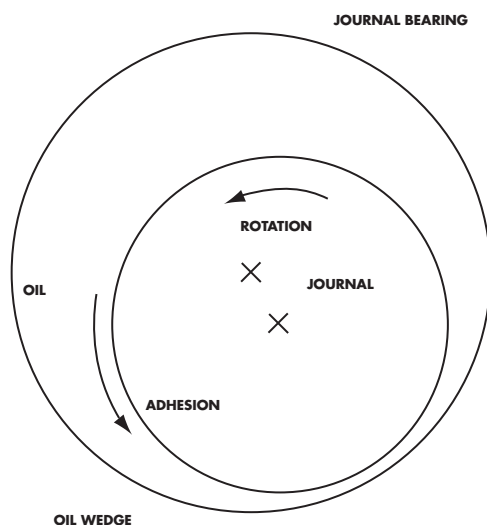
Figure 4 Hydrodynamic Principle

Based on his theoretical investigation of cylindrical journal bearings, Professor Osborne Reynolds showed that oil, because of its adhesion to the journal and its resistance to flow (viscosity), is dragged by the rotation of the journal so as to form a wedge-shaped film between the journal and journal bearing (Fig. 4). This action sets up the pressure in the oil film which thereby supports the load (Fig. 5).

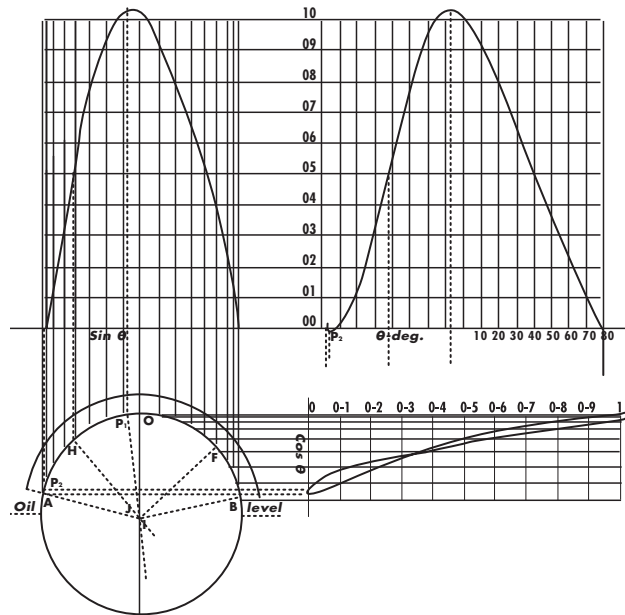
Figure 5 A figure from Reynold's Paper "On the Theory of Lubrication" showing oil film pressure distribution

showed that "if an extensive flat surface is rubbed over a slightly inclined surface, oil being present, there would be a pressure distribution with a maximum somewhere beyond the center in the direction of motion."

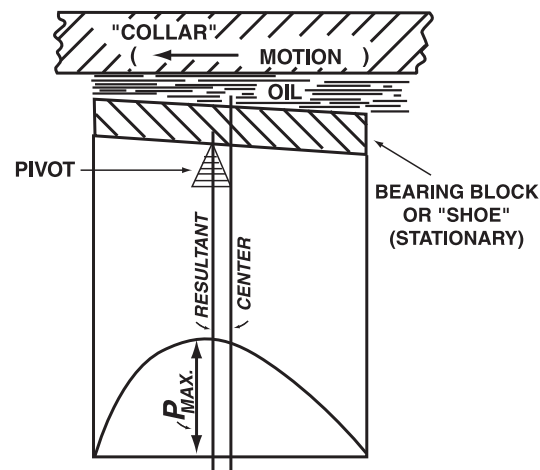
Figure 6 Illustration from a page from Albert Kingsbury's Paper "Development of the Kingsbury Thrust Bearing"

Applied to hydrodynamic tilting pad thrust bearings (Fig. 6) Albert Kingsbury stated: "If a block were supported from below on a pivot, at

about the theoretical center of pressure, the oil pressures would automatically take the theoretical form, with a resulting small bearing friction and absence of wear of the metal parts. In this way a thrust bearing could be made with several such blocks set around in a circle and with proper arrangements for lubrication.” The same concept applies to the tilting pad journal bearing.

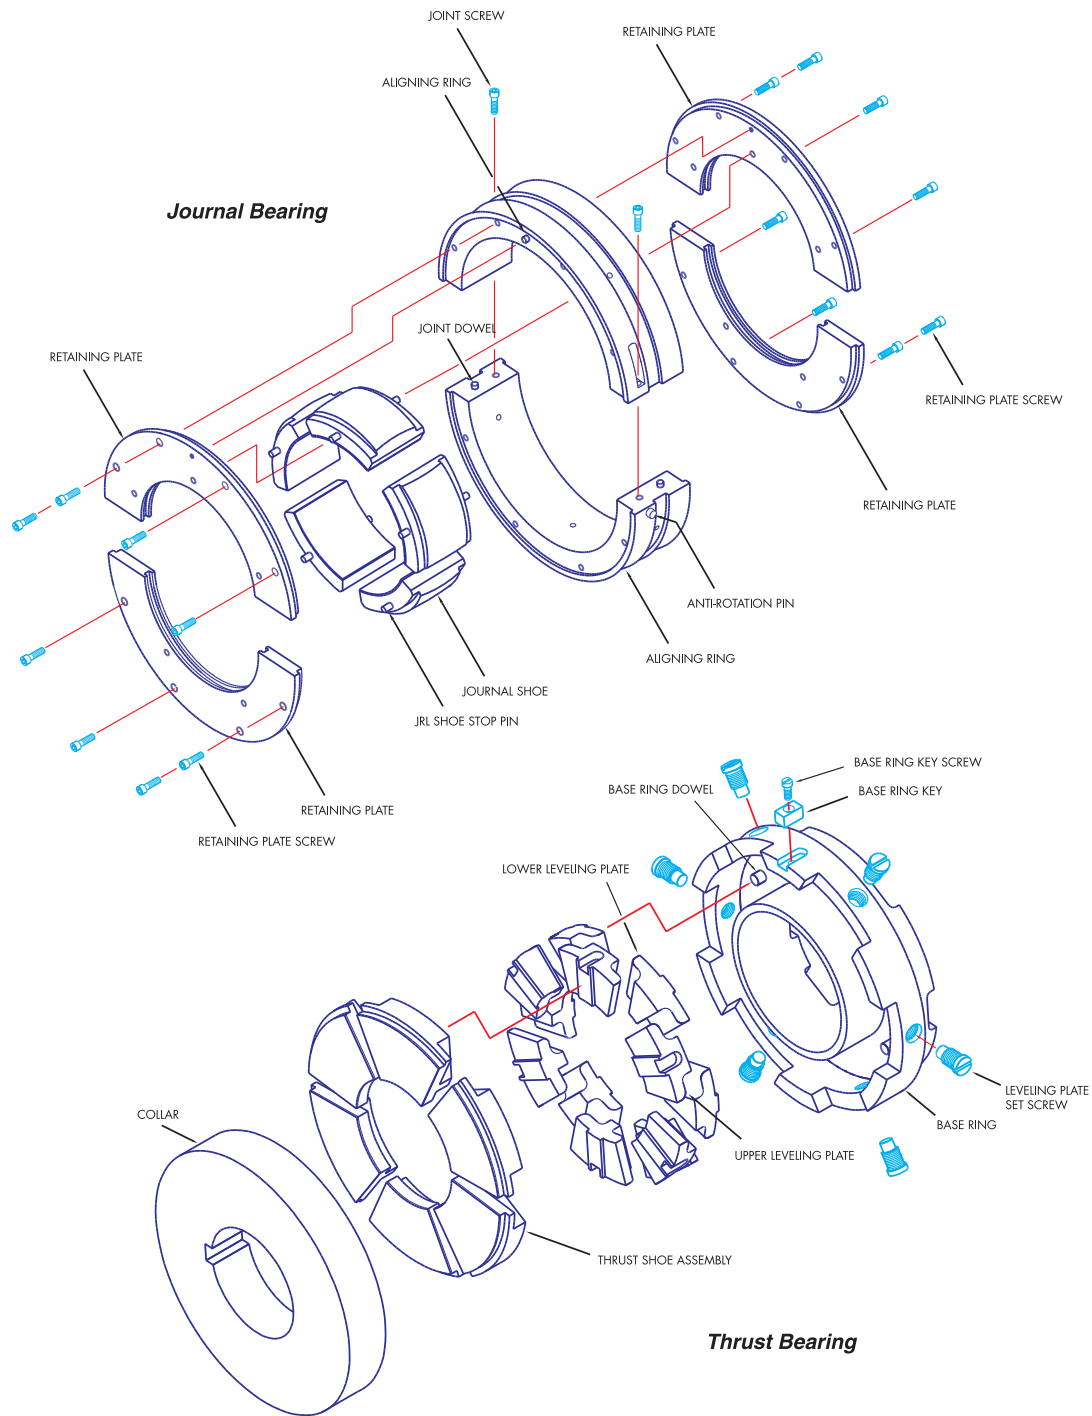
**Figure 7 Thrust and Journal Bearing Part Schematic**

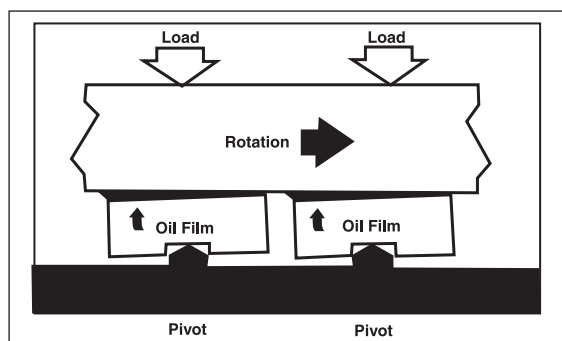
Figure 8-1 Pivoting Shoe Hydrodynamic Film Formation

The lubricant is another important “element” of the bearing (See Fig 8-1). The loads are transmitted from the shaft to the bearing through the lubricant which separates the parts and prevents metal-to-metal contact. The lubricant also serves to carry heat caused by friction out of the bearing.

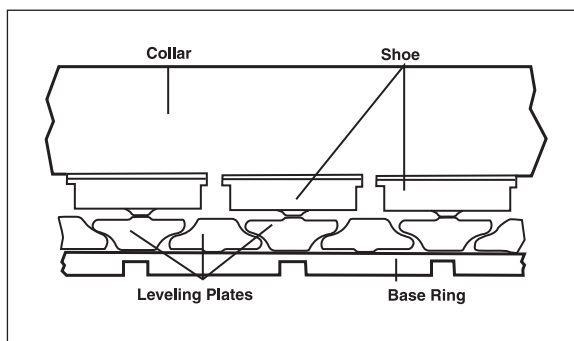
Figure 8-2 Thrust Bearing Load Equalization and Alignment Features

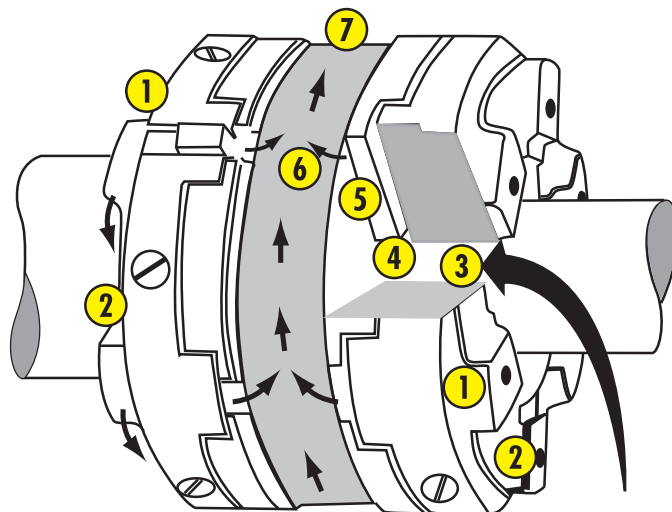
- 1 – Oil enters annulus in base ring.
- 2 – Oil passes through radial slots in back face of base ring.
- 3 – Oil flows through clearance between base ring bore and shaft.
- 4 – Oil flows to inner diameter of rotating thrust collar.
- 5 – Oil flows between shoes and into the films.
- 6 – At the collar rim, oil is thrown off into space around the collar.
- 7 – Oil exits tangentially through the discharge opening.

**Figure 10 Thrust Bearing Typical Oil Flow Path**

Various methods are applied to provide lubricant to the bearing surfaces. The bearing cavities can be flooded with oil such as vertical bearings which sit in an oil bath. The bearings can also be provided with pressurized oil from an external lubricating system. The flow path of a horizontal, flooded **tilting pad** thrust bearing is shown in Figure 10.

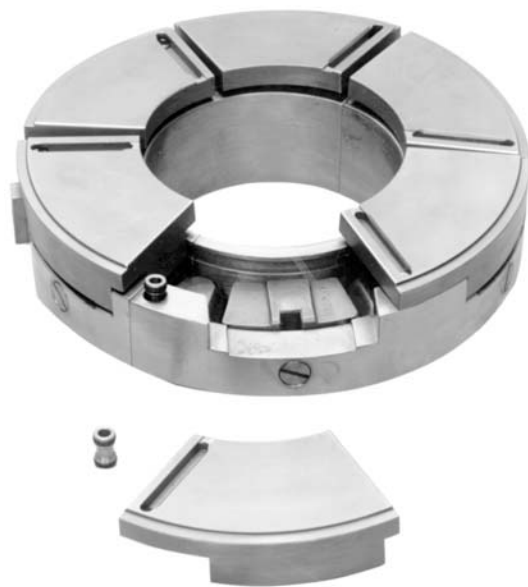
**Figure 11 Leading Edge Groove (LEG) Thrust Bearing**

In 1984 Kingsbury introduced its Leading Edge Groove (LEG) Thrust Bearings (Fig. 11), another technology developed for high tech machines. In addition to reducing oil flow and power loss, LEG lubrication greatly reduces the metal temperature of the shoe surface. This effectively reduces oil flow requirements and power loss while improving the load capacity, safety and reliability of the equipment. Rather than flooding the bearing or wetting the surface, the LEG design introduces cool oil directly into the oil film (Fig. 12), insulating the shoe surface from hot oil that adheres to the shaft. The same technology is applied to tilting pad journal bearings (Fig. 13).

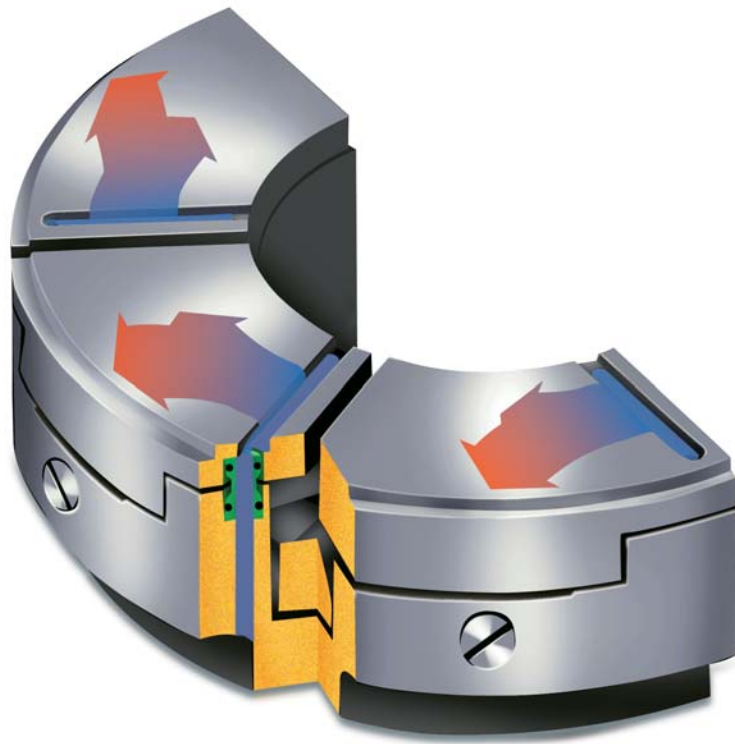
**Figure 12**      **Leading Edge Groove  
Lubricant Flow Path.**

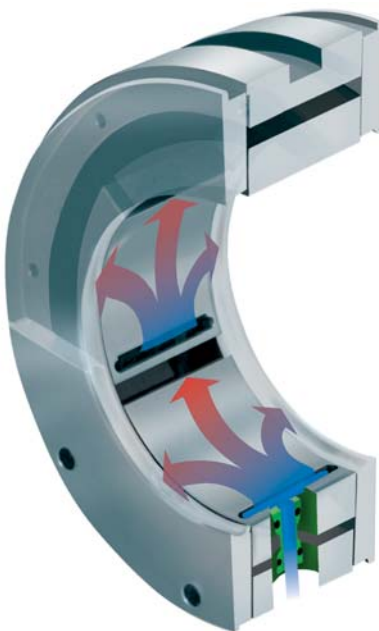
**Figure 13**      **Leading Edge Groove  
(LEG) Journal Bearing**

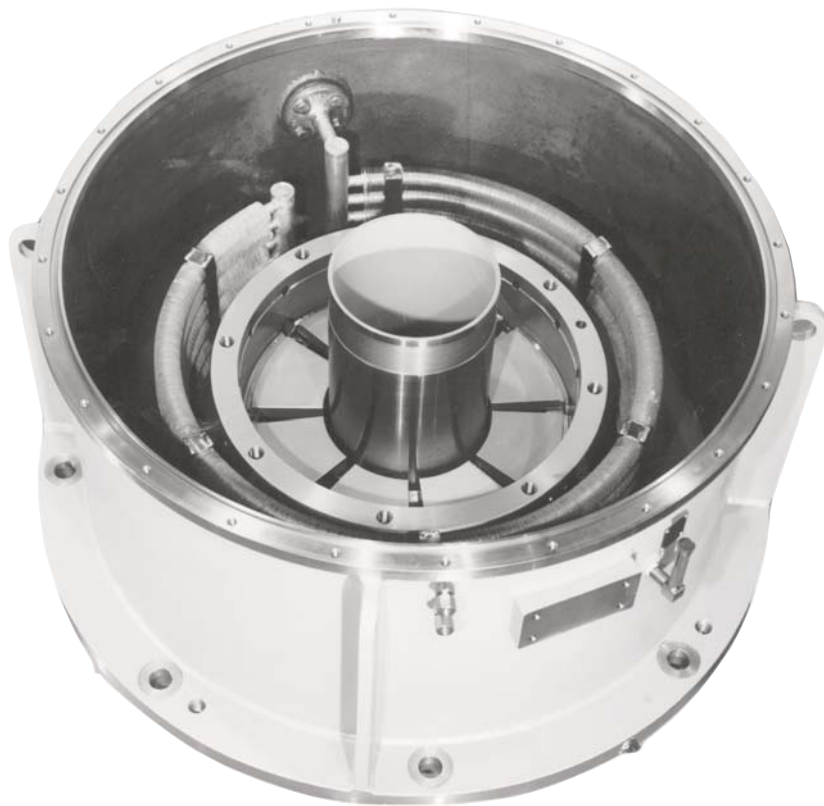
**Figure 14** Vertical Thrust Bearing Oil Sump and Cooling Coils

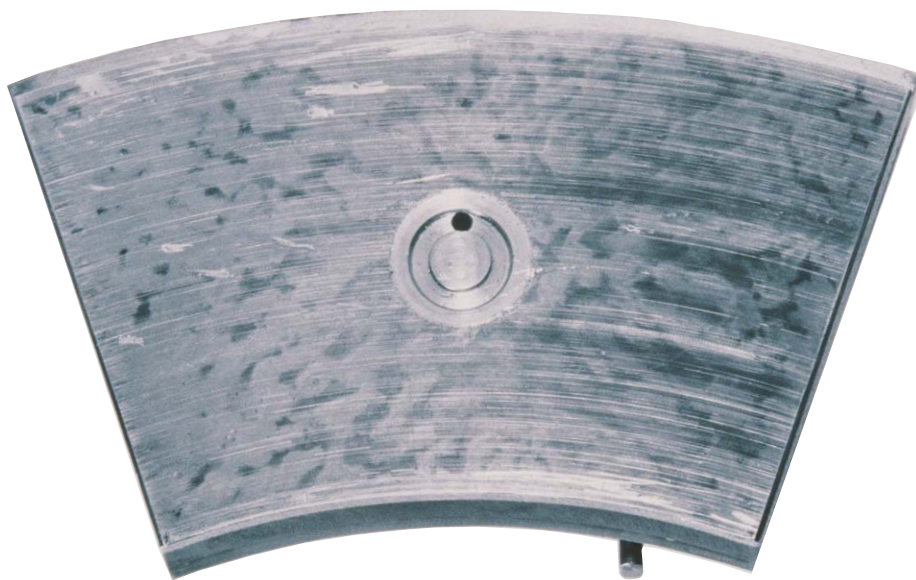
**Figure 15 Thrust Shoe Surface Abrasion**

A bearing surface exhibiting circumferential scratches is the result of abrasion damage (Fig. 15). Abrasion is caused by hard debris, which is larger than the film thickness, passing through

the oil film. The debris may embed itself in the soft babbitt, exhibiting a short arc on the shoe surface, ending at the point where the debris becomes embedded. Depending on the debris size, the scratch may continue across the entire shoe surface.

Abrasion damage becomes worse with time. Surface scratches allow an escape for lubricating oil in the oil wedge, decreasing the film thickness. This will eventually lead to bearing wipe.

In order to eliminate abrasion damage, the lubricating oil must be filtered. If the oil cannot be filtered or has degraded, it should be replaced. It is important to evaluate the filtering

In addition to filtering/replacing the oil, the entire bearing assembly, oil reservoir and piping should be flushed and cleaned. The original bearing finish should also be restored. Journal shoes typically must be replaced, but if the correction leaves the bearing within design tolerance, the bearing may be reused.

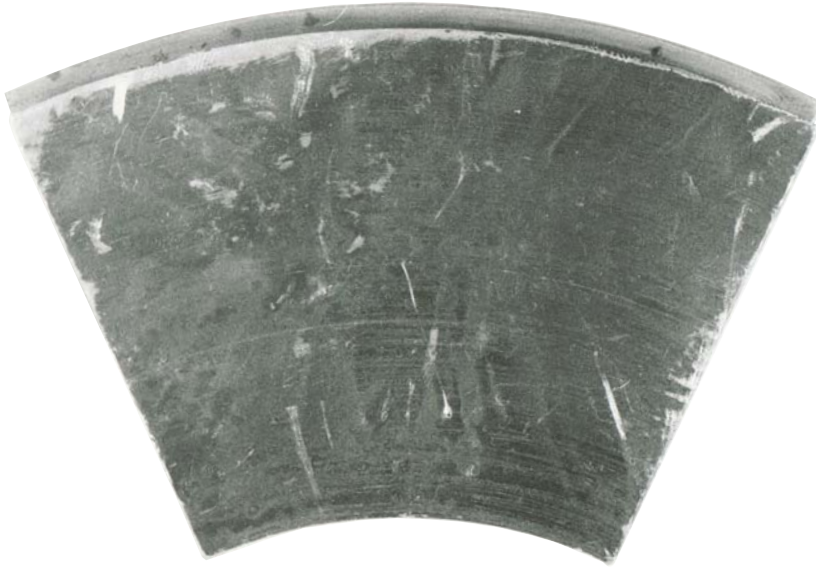
**Figure 16 Tin Oxide Damage**

This is one of several electrochemical reactions which eliminate the embedability properties of a fluid-film bearing. Tin oxide damage (Fig. 16) is recognizable by the hard, dark brown or black film that forms on the babbitt.

Tin oxide forms in the presence of tin-based babbitt, oil and salt water, beginning in areas of high temperature and pressure. Once it has formed, it cannot be dissolved, and its

hardness will prevent foreign particles from embedding in the bearing lining. This allows abrasion damage to occur. Pieces of tin oxide may break off during operation and score the journal, collar, or runner. The formation of tin oxide will also eliminate bearing clearance.

This damage may be stopped by eliminating some or all of the contributing elements. The lubricating oil must be replaced. A reduction in oil temperature may also discourage the formation of tin oxide.

In addition to replacing the oil, the entire bearing assembly, oil reservoir and piping should be flushed and cleaned with mineral spirits. The bearing shoes should be replaced. The condition of the rotating journal, collar or runner surfaces must also be evaluated. They must be restored to original condition, either by lapping, hand stoning or replacement.

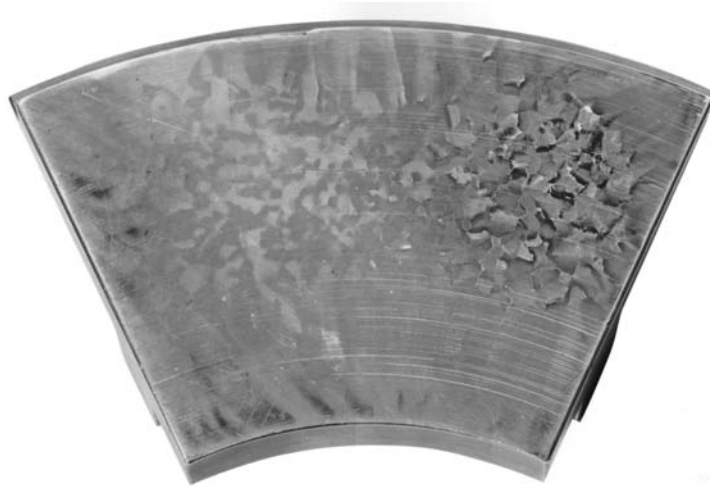
**Figure 17 Thermal Ratcheting**

Overheating damage may represent itself in many ways, such as babbitt discoloration (Fig. 18), cracking, wiping or deformation. Repeated cycles of heating may produce thermal ratcheting (Fig. 17), a type of surface deformation that occurs in anisotropic materials. These materials possess different thermal expansion coefficients in each crystal axis.

If thermal ratcheting has occurred, examine the shoes for the existence and depth of cracks. Remove the cracks and restore the original shoe surface. If this cannot be done, replace the shoes. Journal shoes typically must be replaced, but if the correction leaves the bearing within design tolerance, the bearing may be reused.

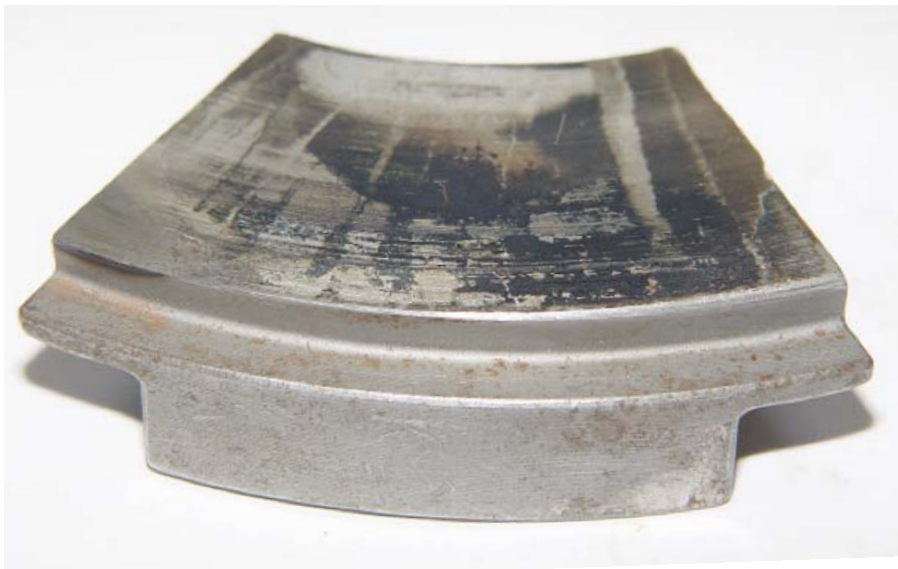
**Figure 20 Outer Edge Babbbitt Erosion**

In Fig. 19, the babbbitt has been completely removed from the shoe surface. If there had been any oil flow to the bearing, it would have sufficiently cooled the region to allow the molten babbbitt to at least solidify and accumulate between the shoes. With no oil coming in at the leading edge of the shoe, this area typically shuts down, resulting in the babbbitt being eliminated in the corner near the outer diameter in Fig. 20.

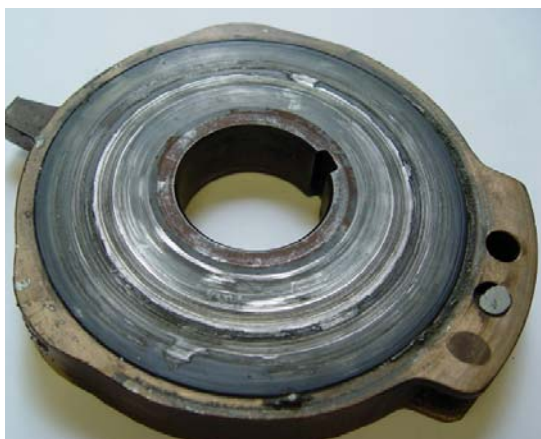
**Figure 21 Oil Circulator Fused To Collar**

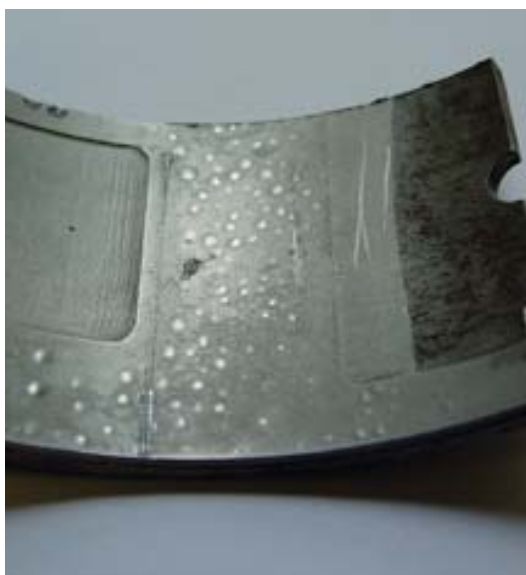
**Figure 22 Hydrogen Blisters In The Babbitt**

In certain occasions, hydrogen gas becomes trapped during the casting or forging of parts made of steel. If the steel base is babbitted and the gas eventually migrates to the surface, blisters can form in the area, significantly weakening the babbitt bond (see Fig. 22).

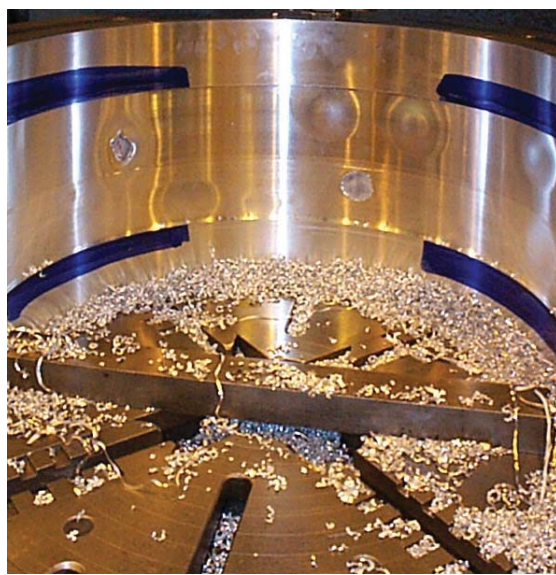
**Figure 23 Large Hydrogen Blisters**

Thermal annealing has been proven to prevent blisters from forming by diffusing out hydrogen before the part is babbitted. In Figure 23, the annealing process was accidentally missed and large hydrogen blisters emerged during the machining process.

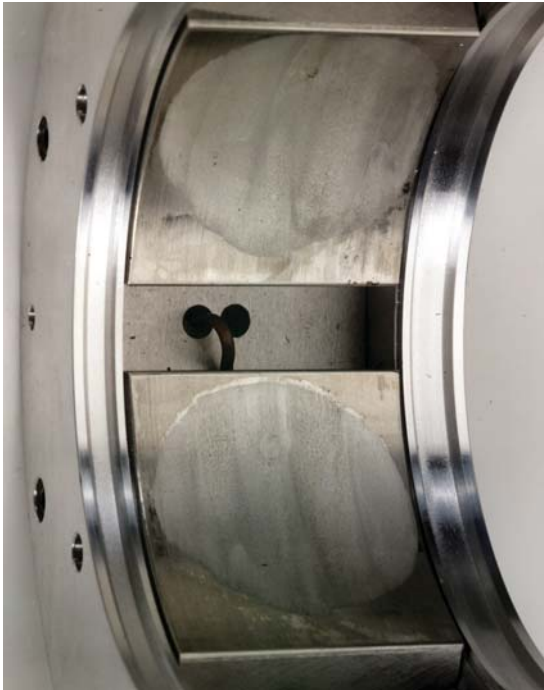
**Figure 24 Stray Shaft Currents/  
Electrical Pitting (Frosting)**

Electrical pitting (Fig. 24) appears as rounded pits in the bearing lining. The pits may appear frosted, or they may be blackened due to oil deposits. It is not unusual for them to be very small and difficult to observe with the unaided eye. A clearly defined boundary exists between the pitted and unpitted regions, with the pitting usually occurring where the oil film is thinnest. As pitting progresses, the individual pits lose their characteristic appearance as they begin to overlap. Pits located near the boundary should still be intact. The debris that enters the oil begins abrasion damage. Once the bearing surface becomes incapable of supporting an oil film, the bearing will wipe. The bearing may recover an oil film and continue to operate, and pitting will begin again. This process may occur several times before the inevitable catastrophic bearing failure.

Electrical pitting damage is caused by intermittent arcing between the stationary and rotating machine components. Because of the small film thicknesses relative to other machine clearances, the arcing commonly occurs through the bearings. Although the rotating and other stationary members can also be affected, the most severe pitting occurs in the soft babbitt.

The lubricating oil must be filtered or replaced. Pitting damage often blackens the oil and fills it

The original bearing finish should also be restored. Journal shoes typically must be replaced, but if the correction leaves the bearing within design tolerance, the bearing may be reused. The condition of the rotating journal, collar or runner surfaces must also be evaluated. It must be restored to original condition, either by lapping, hand stoning or replacement.

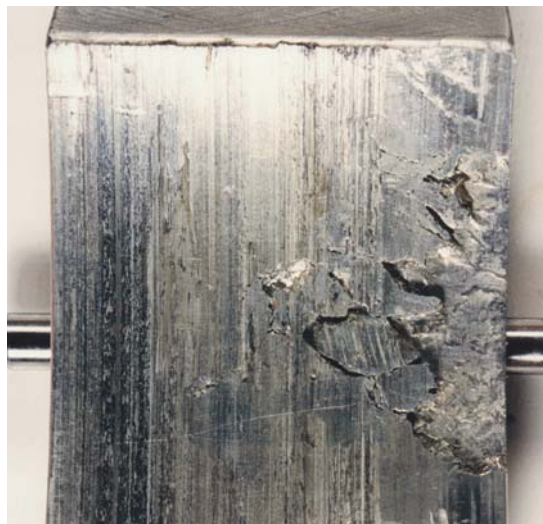
**Figure 25 Edge Load Tilting Pad  
Showing Babbitt Mechanical Fatigue**

A combination of causes contribute to fatigue damage, but concentrated cyclic loading is usually involved. The fatigue mechanism involves repeated bending or flexing of the bearing, and damage occurs more rapidly with poor bonding.

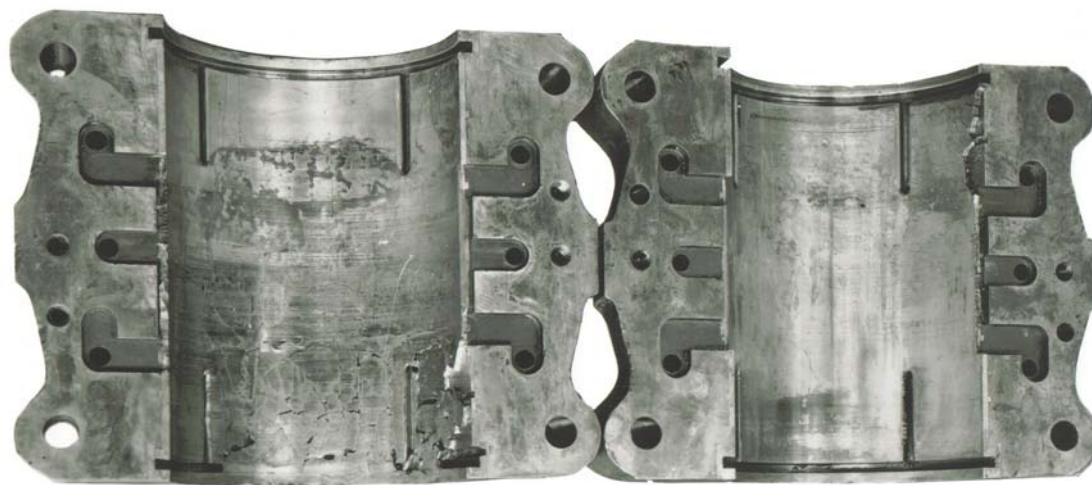
**Figure 26 Edge Load Journal Shell With Babbitt Mechanical Fatigue**

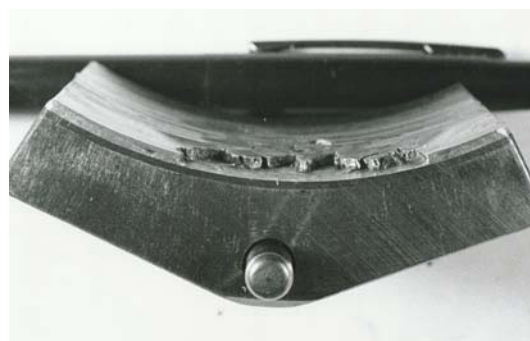
**Figure 27 Fatigue**

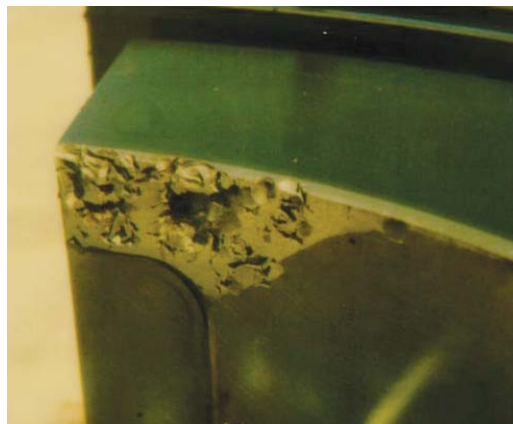
**Figure 29 Eroded Babbitt From Spragging**

shaft. The frequency of motion is usually about half that of the rotating speed of the journal. This self-excited motion is frequently detrimental to the pad, causing a cyclical load on the leading edge that erodes away the babbitt (Fig. 29 and 30). Pads with a smaller arc-length have been found to be much less prone to spragging, so a 5-pad bearing will be less likely to experience this phenomenon than a 4-pad bearing. When a bearing must have less than five pads and there is a relatively light load, the axial length of the bearing can be reduced to exert more force on the pads. In addition, when there is limited preload on the original pads, the bearing manufacturer should consider introducing a relief into the leading edge of the pads in order to eliminate self-excited vibration.

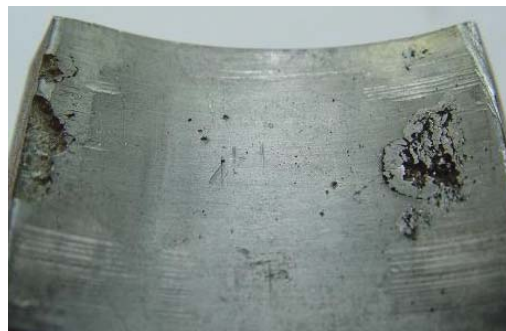
**Figure 30 Spragging Effects On Pad**

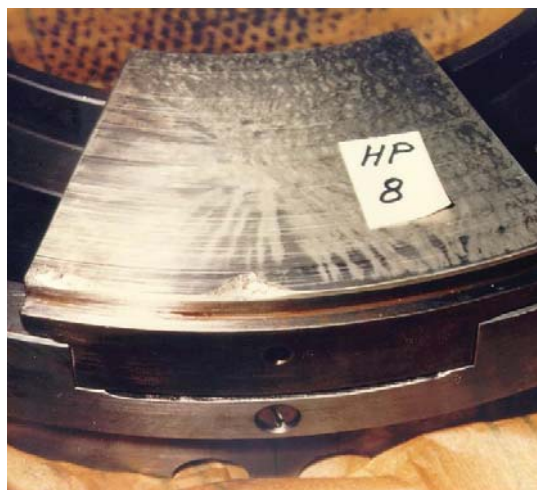
**Figure 32 Thrust Shoe Cavitation Towards Outside Diameter**

Often called cavitation erosion, cavitation damage (Fig. 32 and 33) is caused by the formation and implosion of vapor bubbles in

areas of rapid pressure change. Damage often occurs at the outside diameter of thrust bearings due to the existence of higher velocities. This type of damage can also affect stationary machine components in close proximity to the rotor.

Depending on the extent of damage, voids in the babbitt can be puddle-repaired. The original bearing finish must be restored. Journal shoes may also be puddle-repaired and refinished. If this cannot be done, the shoes must be replaced.

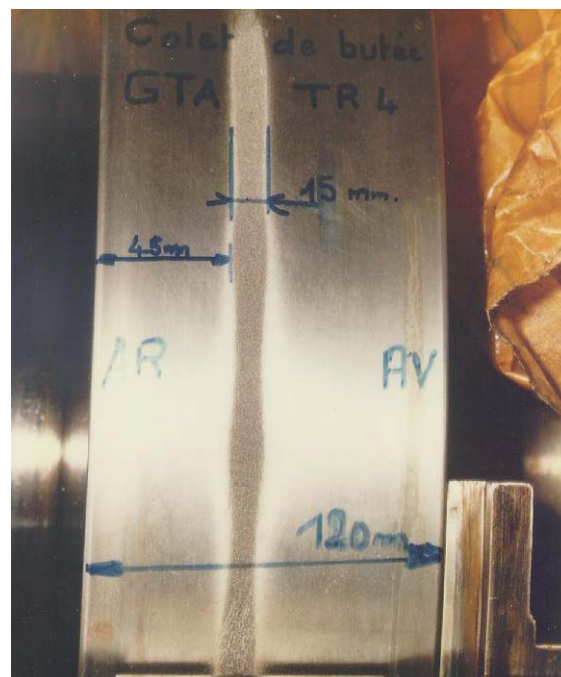
**Figure 33 Cavitation Damage on Outside Diameter of Collar**

Although the babbitted surface is usually damaged more severely, the rotating collar, runner or journal surface must also be evaluated. This

surface must also be restored to original condition, either by lapping or hand stoning.

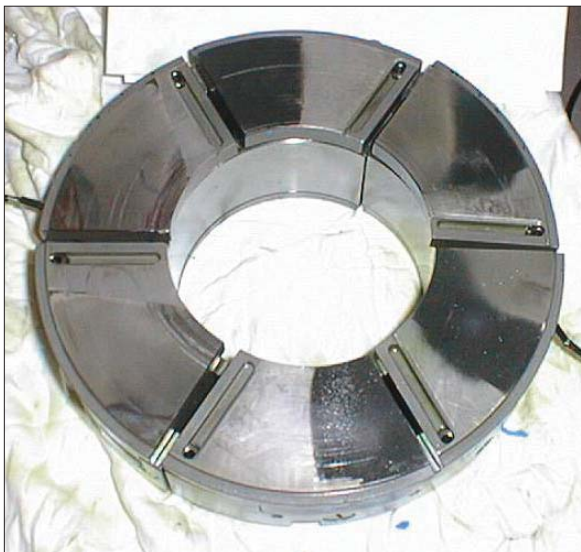
**Figure 34** Example of Bearing Corrosion

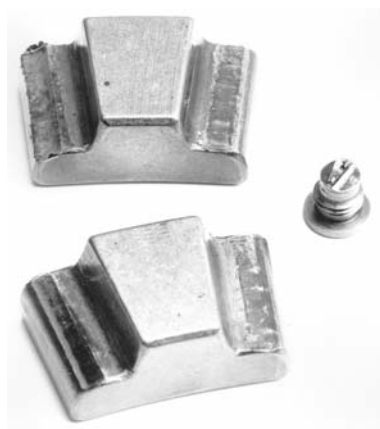
**Figure 36 Leveling Plate Wear Due To Collar Wobble**

If the collar is not within tolerance, the resultant "wobble" (Fig. 36) will force the shoes and leveling plates to constantly equalize, causing rapid leveling plate wear.
