# Earthquake Design Considerations for Non-Residential Buildings

Course No: S04-014

# Primer for Design Professionals

Communicating with Owners and Managers of New Buildings on Earthquake Risk

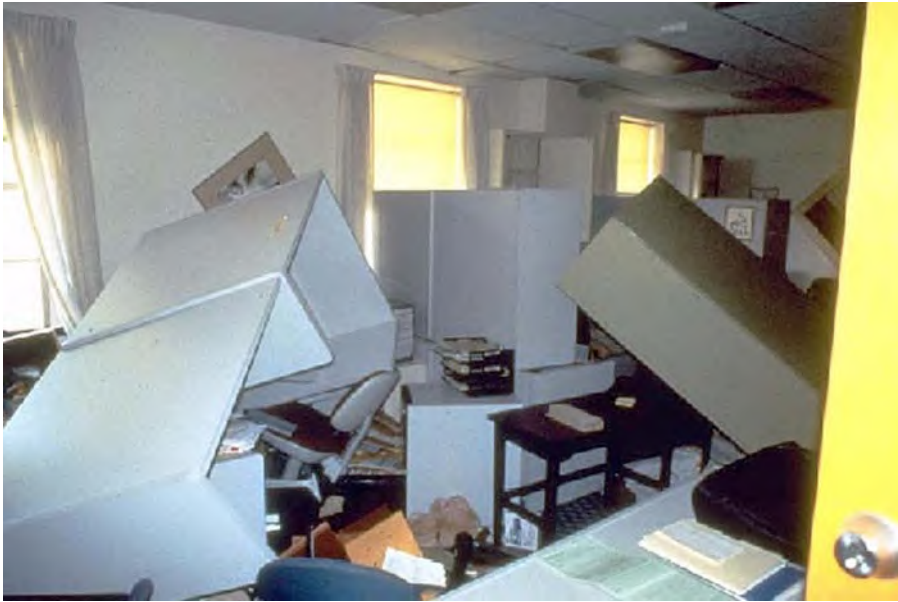
Figure 6-1 Typical earthquake damage to contents and nonstructural components in a modern office building. (photo courtesy of the Earthquake Engineering Research Institute)

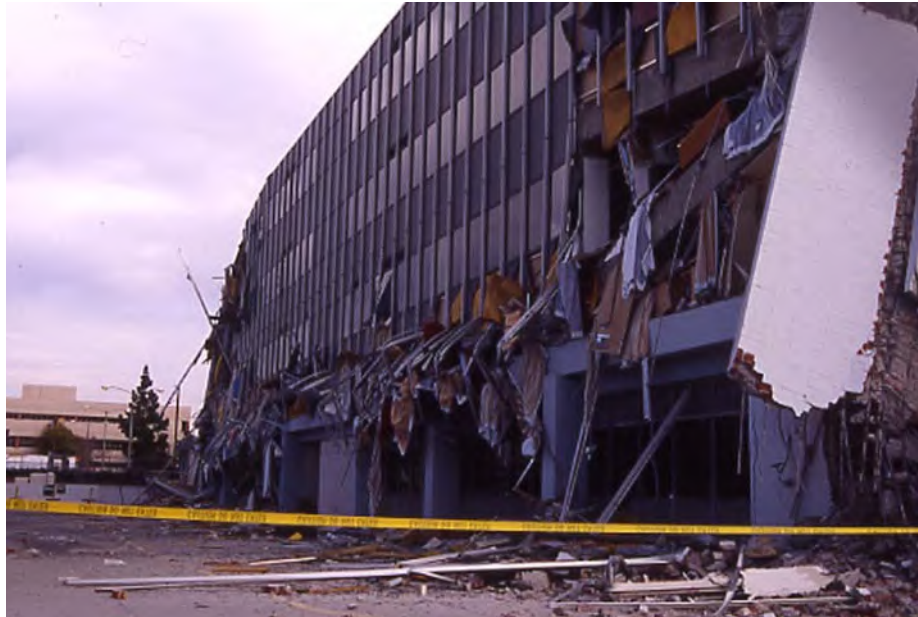
Figure 6-2 Exterior view of medical office building severely damaged by the 1994 Northridge earthquake. (C. Arnold photo)

Where severe structural damage has occurred in commercial office buildings, it has generally been to older buildings, often the result of configuration irregularities. Figure 6-2 shows an older medical office building, which had a vertical irregularity that caused one floor to pancake during the 1994 Northridge earthquake in Southern California; a failure resulting from inadequate attachment of heavy nonstructural walls in an older 5-story office building is shown in Figure 6-3.

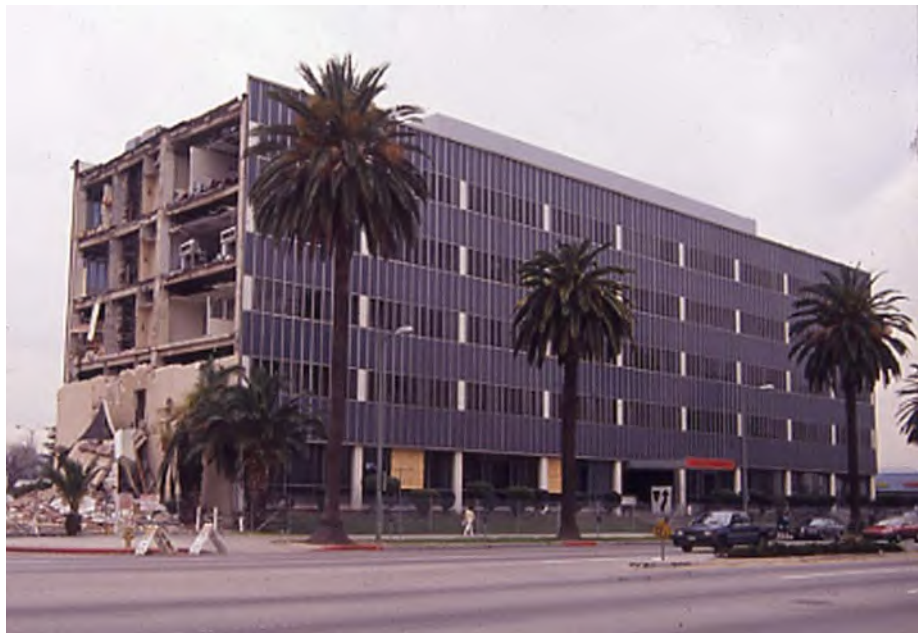
Figure 6-3 Partially collapsed end-wall in 5-story office building caused by severe earthquake ground shaking. (C. Arnold photo)

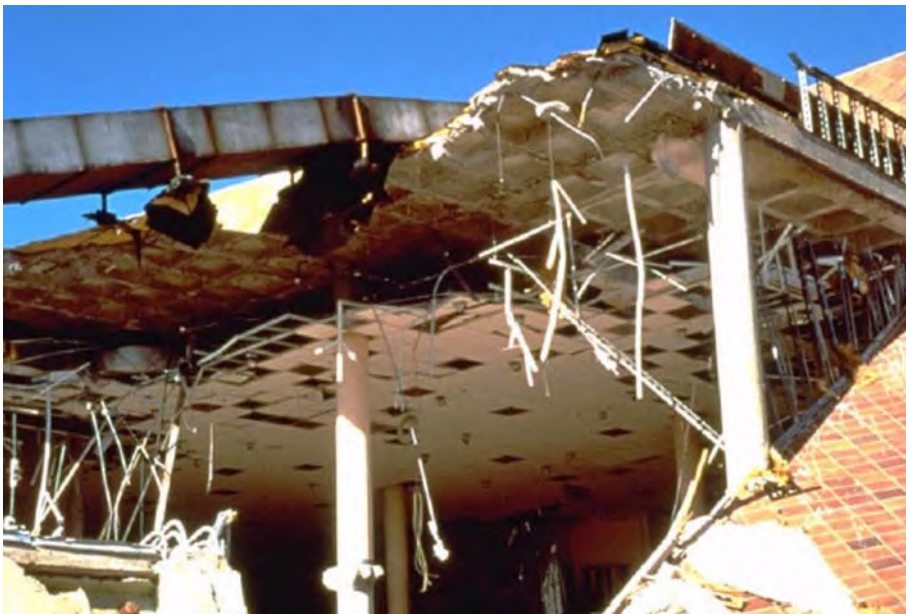
Figure 7-1 Severe damage to a department store severely shaken by the 1994 Northridge earthquake. Shear failure between the waffle slabs and columns caused the collapse of several floors. (photo courtesy of the Earthquake Engineering Research Institute.)

In the Northridge earthquake of 1994 near Los Angeles, a large regional shopping mall with 1.5 million sq.ft. of retail space suffered severe damage and was closed for 18 months. Some 200 mall stores were closed and six department stores under independent ownership received varying amounts of damage. One department store suffered a partial collapse, and was demolished and replaced (Figure 7-1). The

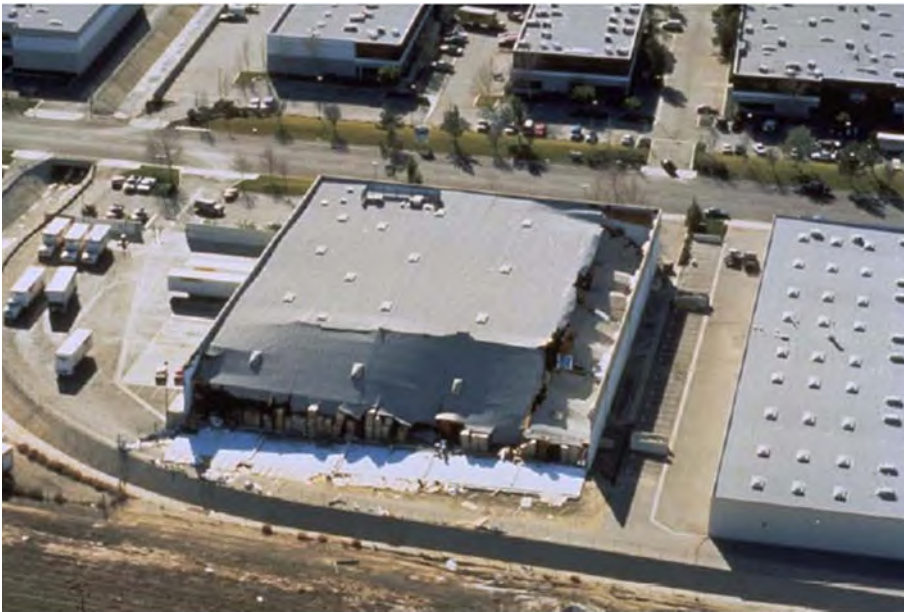
Figure 8-1 Roof and wall collapse of tilt-up building during the 1994 Northridge earthquake. (Photo courtesy of the Earthquake Engineering Research Institute)

Starting in the late 1950s larger light manufacturing buildings have been predominantly tilt-up structures, particularly in California. In seismic regions the perimeter precast walls were used as shear walls and roof structures were generally glued-laminated beams and plywood diaphragms. In the 1964 Alaska earthquake and the 1971 San Fernando (Los Angeles) event, performance of these buildings was poor, with considerable damage being sustained. The most common type of failure was to the wall/diaphragm anchors, but large out-of-plane movement of the panels, out-of-plane bending cracks in pilasters at mezzanine levels, and roof separations were all encountered and many roof collapses occurred. Due to the relatively large size of these buildings roof collapses were localized, rarely extending beyond one or two bays, and the buildings were sparsely occupied, so casualties were few. (Figure 8-1)

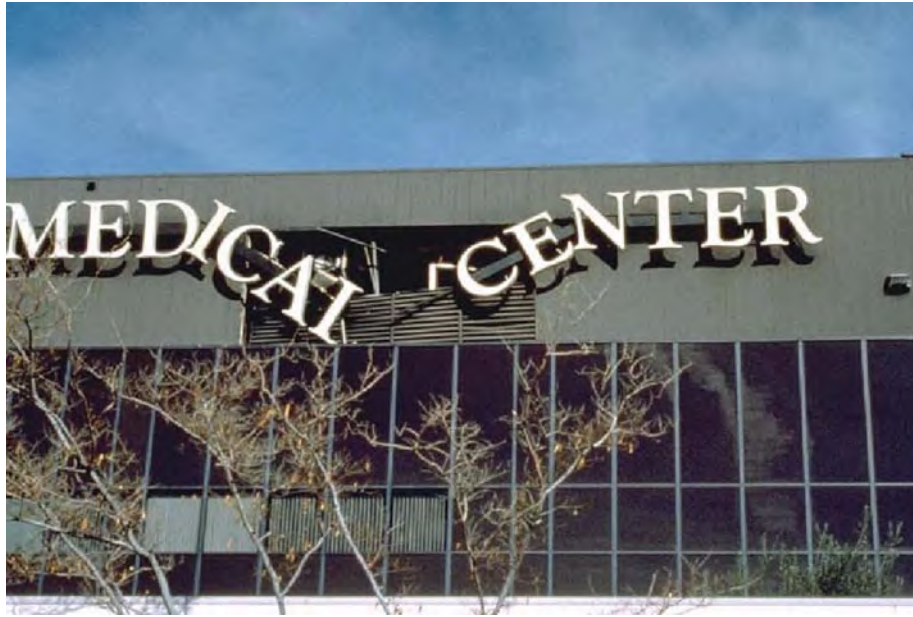
Figure 9-1 Exterior view of Holy Cross Medical Center, which was evacuated after the 1994 Northridge earthquake due to damage to the HVAC system. (photo courtesy of the Earthquake Engineering Research Institute)

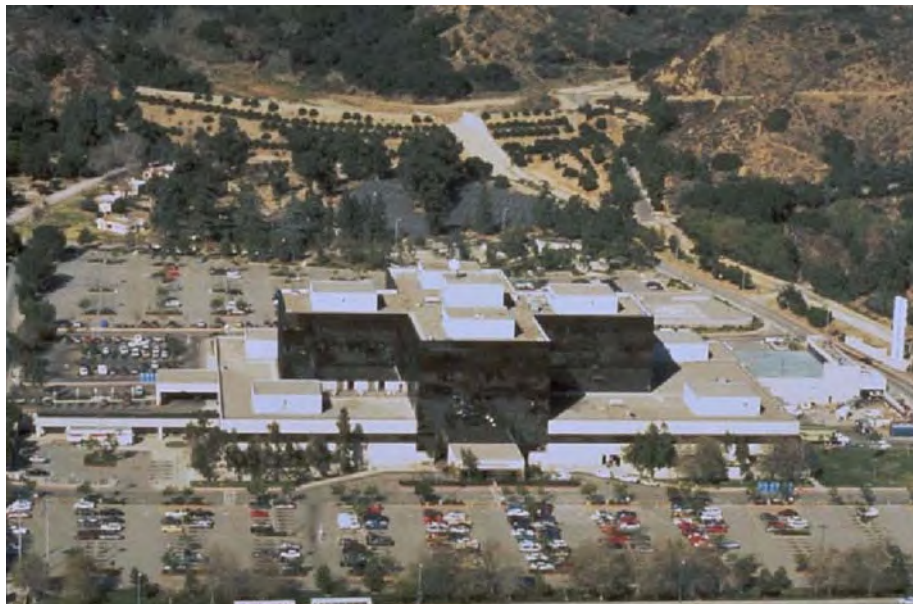
Figure 9-2 Aerial view of Olive View Hospital, which sustained no structural damage during the 1994 Northridge earthquake, but was closed for a short while after the earthquake because of water leakage from broken sprinklers and waterlines. (photo courtesy of the Earthquake Engineering Research Institute)

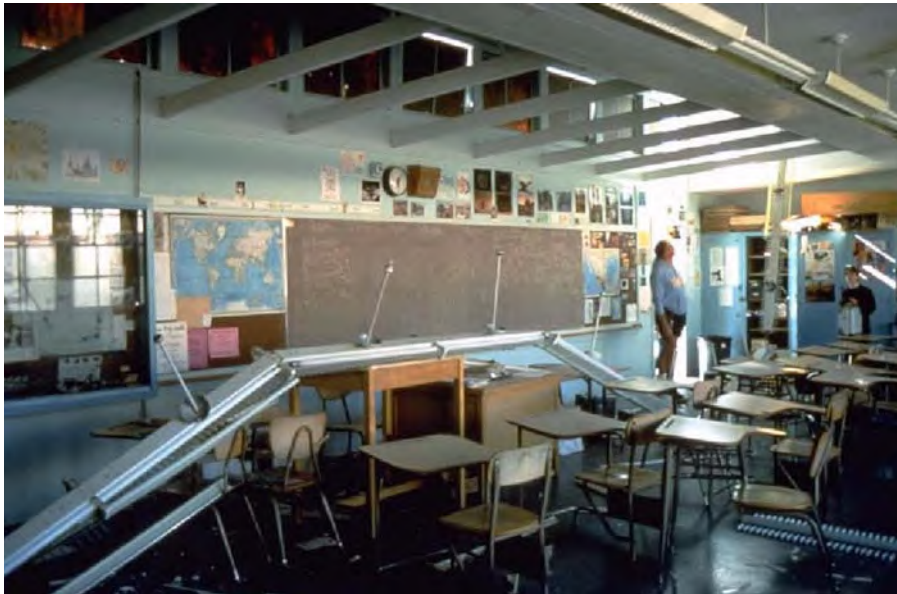
Figure 10-1 Nonstructural damage at Northridge Junior High where lights fell onto desks during the 1994 Northridge earthquake. (photo courtesy of the Earthquake Engineering Research Institute)

Falling nonstructural components and systems present a significant potential for injuries to building occupants as shown in Figure 10-1. In addition to the injury potential and economic loss resulting from repair and clean-up costs, excessive service interruption can result from lighting fixture and water, mechanical, and electrical equipment damage.

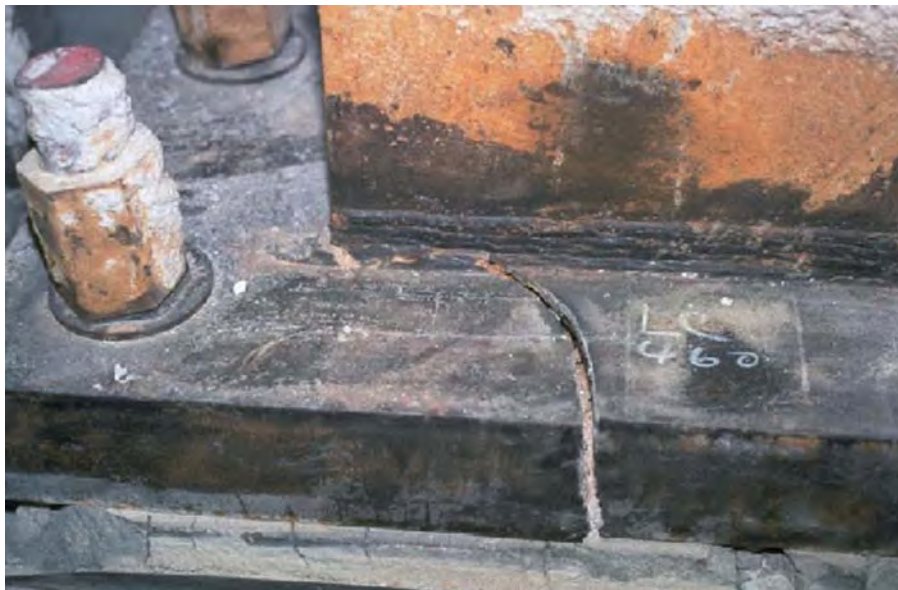
Figure 11-1 Fractured 4-inch-thick steel base plate, university building, Northridge, 1994. (photo courtesy of the Earthquake Engineering Research Institute)
