Fan Bearing Maintenance & Troubleshooting

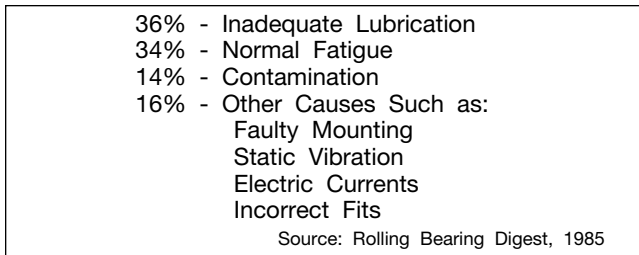
Figure 4. Bearing Failure Causes

The L-10 life discussed earlier is an estimate of the fatigue life of a bearing. However, there are many other factors that determine how long a bearing lasts. Figure 4 shows the results of one study that looked at the reasons for bearing failure. What is interesting about this study is that it shows that normal fatigue is not the normal cause of bearing failure, since only 34% of the bearings failed this way. Half of the bearing failures were due to either inadequate lubrication or contamination. Other sources list fatigue to be the cause of only 10% of bearing failures.

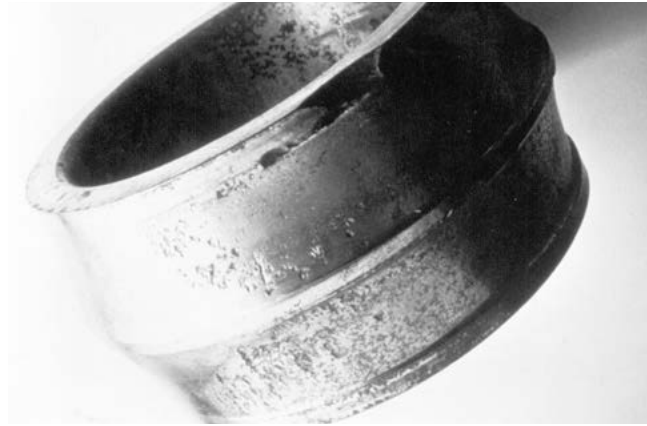
Figure 5. Normal Fatigue Failure

Figure 5 shows an inner race that has had a normal fatigue failure. The repeated loading and unloading of the race every time a roller passes eventually causes microscopic fatigue cracks to form under the surface.

In time, these cracks grow to the point where small portions of the surface flake off. This process is called "spalling" and the flaws left in the surface are called "spalls."

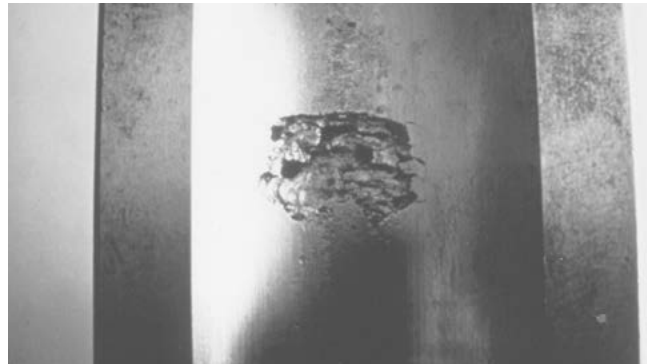
Figure 6. Spall

With continued operation, the spalls grow until the bearing becomes noticeably noisy. Figure 6 shows an inner race that has a severe spall. In addition to being noisy, it is also likely that this bearing would show high levels of vibration. The time required for the spalling to cause catastrophic bearing failure will vary with the load on the bearing and its speed. Usually the bearing will run for a while after it becomes noisy, but once noise is heard, prepare to have the bearing changed before it fails suddenly.

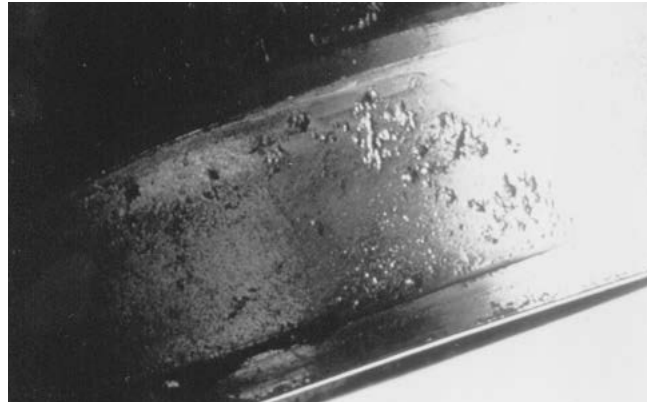
Figure 7. Spalls & Wear Patterns in the Race

Inadequate lubrication can lead to spalling as seen in Figure 7. This bearing also shows signs of excessive

wear due to inadequate lubrication. The rollers have worn a very deep wear pattern in the race.

Material that flakes out of spalls and other contaminants from other sources such as dirty grease or worn seals dents the races when caught between the rollers and races. Figure 13 shows an inner race with severe particle denting. Figure 7 also shows signs of particle denting. Each dent is a stress concentrator, which increases the stress in the area around the dent and accelerates the fatigue failure process.

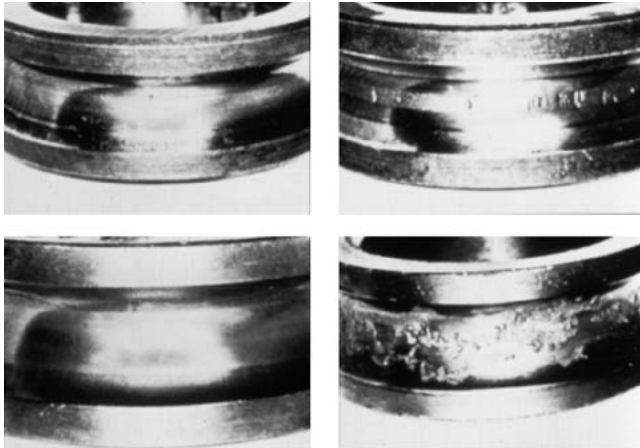
Figure 8. Progressive Failure of a Bearing Due to Inadequate Lubrication

Figure 8 shows the progressive failure of a bearing due to inadequate lubrication. At first there are traces of waviness or a slight roughening of the race. With time small cracks develop, which lead to a modest amount of spalls and eventually the severe amount of spalling shown on the lower right.

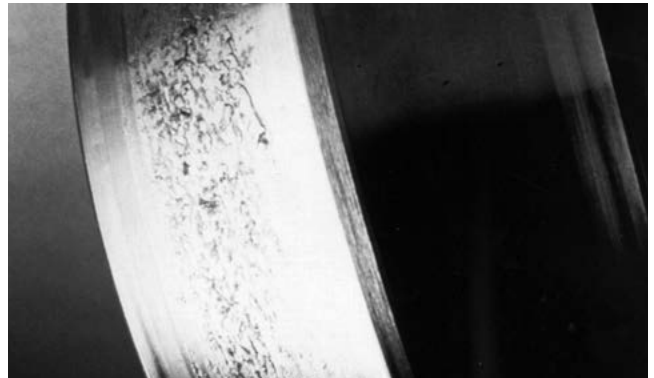
Figure 10. Smearing

Under the right conditions the heat generated by metal-to-metal contact causes the two surfaces to adhere for an instant. Small portions tear out from one surface and adhere to the other surface. This is "smearing" and is shown in Figure 10.

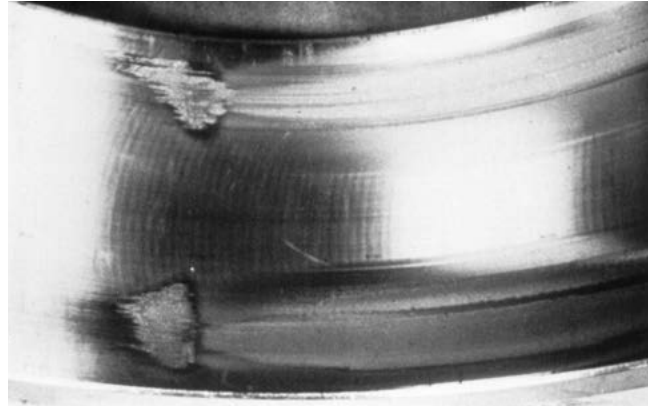
Figure 11. Skid Smearing

"Skid smearing," shown in Figure 11, occurs on lightly loaded bearings. As the rollers come around and enter the lower half of the bearing, they go from being

unloaded to being under load. With the light load it takes them some distance to roll properly and they skid against the race causing smearing.

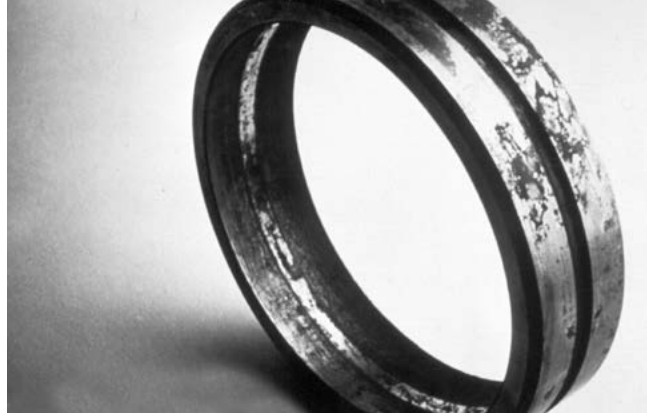
Figure 14. Water Corrosion

Keeping moisture out of bearings is necessary to achieve long life. Figure 14 shows a bearing severely damaged from water corrosion. This much damage was

probably due to seal failure, possibly in a “wash down” environment. High moisture applications require the use of grease that has rust inhibiting properties. Frequent relubrication is necessary, to insure that all bearing surfaces are coated with a protective layer of grease and that the rust inhibitors are replenished. Figure 15 shows a spherical roller bearing roller that has rusty ends from moisture in the lubricant.

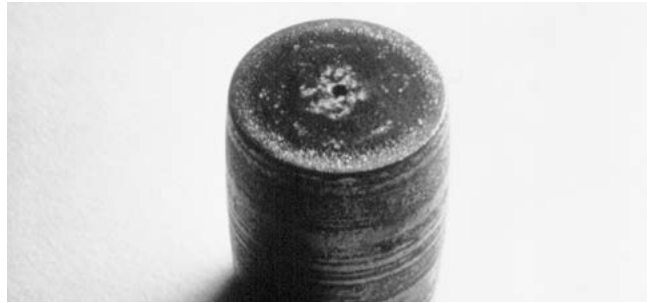
Figure 15. Bearing Roller with Rusty Ends Due to Moisture in the Lubricant

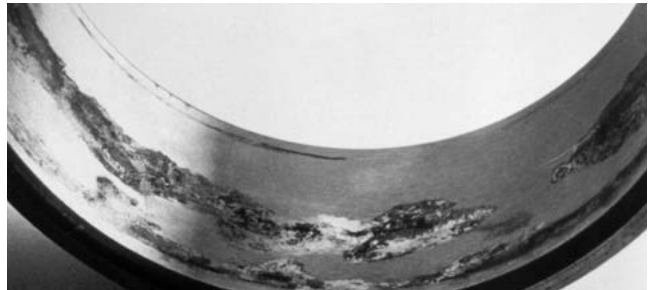
Figure 16. Puddle Corrosion

Water from condensation causes corrosion in idle fans. This is particularly true for fans in high moisture areas, located outdoors or improperly stored outdoors. Figure 16 shows an outer race damaged by puddle corrosion. Moisture or dew condensing in the bearing settles to the bottom of the race in puddles and causes rusting. Clearance packs ball and unit roller bearings completely full of grease prior to shipment. Split pillow block spherical roller bearings are shipped with the bearing insert packed full. This minimizes the chances of having puddle corrosion occur during shipment and storage. This practice covers all components with grease and ensures there are no pockets of air where water can condense. At startup the excess grease purges out of the bearing, which gets a little messy but is better than having a damaged bearing.

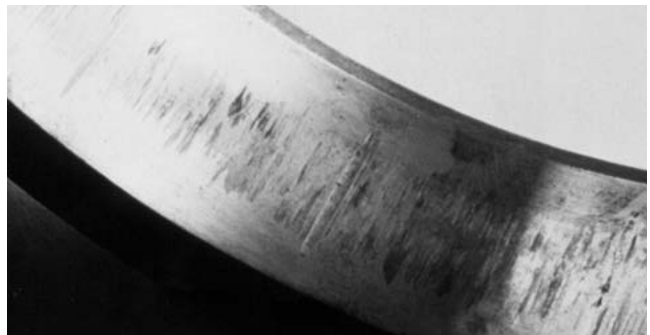
Figure 17. False Brinnelling

Figure 17 shows damage to an outer race from a bearing subjected to vibration while the unit is not rotating. Notice the even spacing of the marks, which correspond to the roller spacing. You can also see marks where the rollers came to rest in different locations. This type of damage, called “false brinnelling,” occurs when small portions of the race get rubbed away. The remaining area is ideal for starting fatigue and the abrasive material rubbed off contaminates the grease, which accelerates bearing wear.

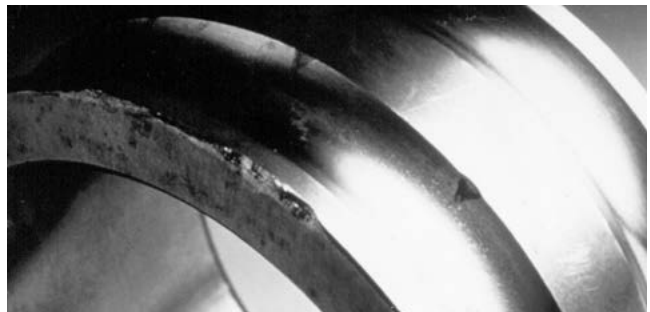
Figure 18. True Brinnelling

“True brinnelling” occurs when a bearing is subjected to impact and the rollers dent the races. Figures 18 and 19 show damage caused by improper mounting. Impact from hammering on the outer race or the bearing housing causes true brinnelling of the races. If it is necessary to tap on a bearing to get it into position, tap on the inner race so that the rolling elements do not carry the load. Dropping a bearing prior to mounting can also cause true brinnelling. Like false brinnelling, the marks are evenly spaced and the damage will eventually develop into spalls. Figure 20 shows spalls resulting from true brinnelling.

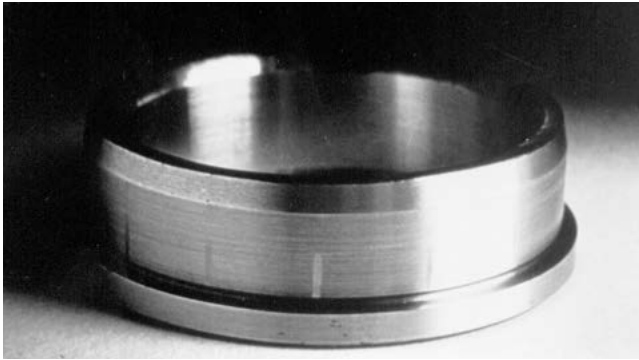
Figure 19. True Brinneling

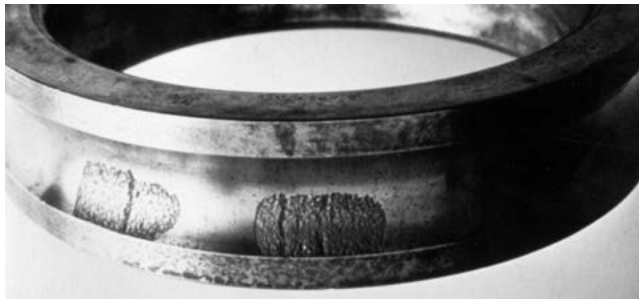
Figure 20. Spalls Resulting from True Brinneling

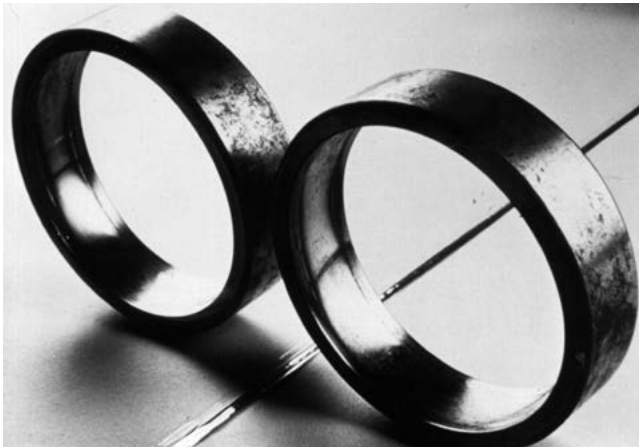
Figure 21. Two Load Zones on the Outer Race

Mounting a bearing pillow block on a warped or crowned surface, or improperly shimming a pillow block can pinch the outer race. As seen in Figure 21, this causes two load zones on the outer race 180° apart.

As the rolling elements pass through the pinched area, the load between them and the races increases. If the severity of the pinch is high, a drastic reduction in the life of the bearing will result.

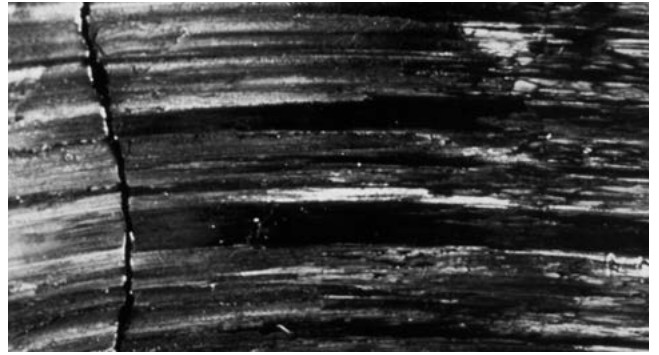
Figure 22. Smearing on a Bearing Race

failures. Figure 22 shows the surface of a bearing bore that had too much clearance. The shaft turned in the bore, smearing the surface.

Insufficient tightening of the set screws on a set screw mounted bearing causes this type of failure. It can also be caused on a tapered adapter mounted bearing by not tightening the adapter lock nut enough. The damage to the surface resulted in a crack.

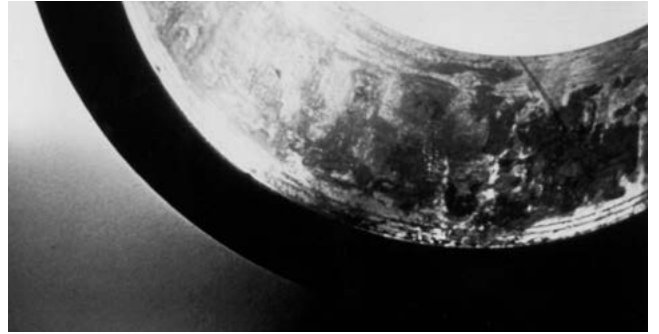
Figure 23. Fretting Corrosion on Bearing Bore

The bore of the bearing shown in Figure 23 shows signs of serious fretting corrosion. Microscopic movement between the shaft and the bore causes the rust colored patches to develop. Small amounts of fretting are common with set screw mounted bearings and are not detrimental to bearing life. Advanced cases, caused by loose mounting, can lead to cracks.

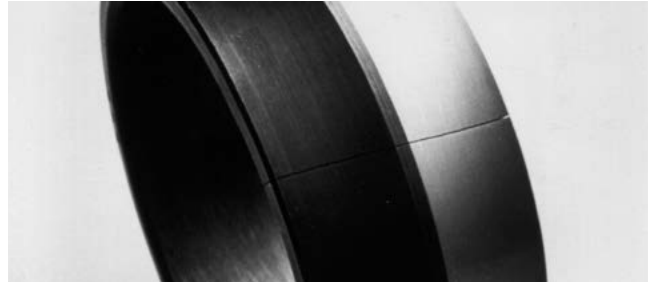
Figure 24. Cracked Inner Race

Tightening the locknut of an adapter mounted bearing too much can crack the inner race as shown in Figure 24 or the outer race as shown in Figure 25.

This also occurs by exposing the bearing on a high temperature fan to excessive temperatures. This easily happens when shutting down high temperature fans when they are hot or by exposing them to high temperatures while idle.

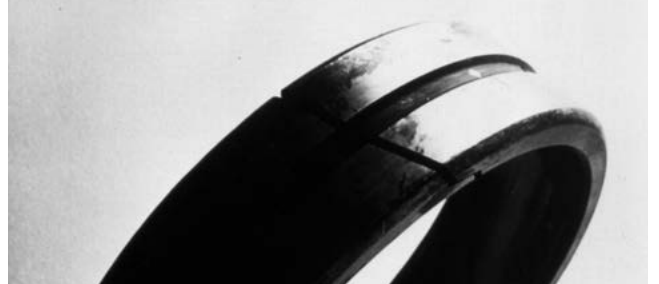
Figure 25. Cracked Outer Race

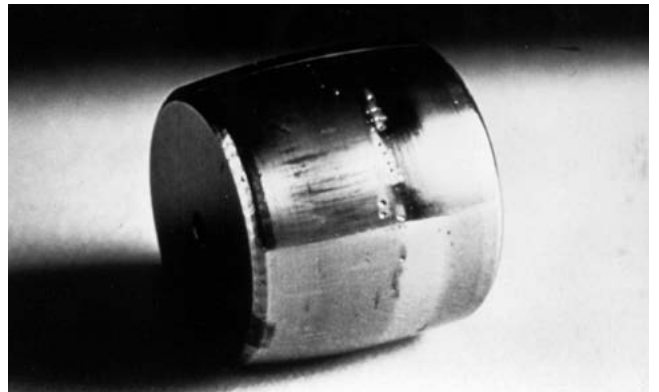
Figure 26. Pits Caused by Electrical Current

Allowing electrical current to pass through a bearing can cause damage. Figure 26 shows a spherical roller with pits in its surface caused by electrical current. This type of damage commonly occurs when welding balance weights on a fan impeller with improper grounding. To avoid having the welding electrical current pass through the bearings, attach the grounding clamp to the impeller or shaft when adding balance weights.
