# A comprehensive review of hazards identification and risk assessment in ammonia plants

*As part of our ongoing efforts to improve safety and reliability in ammonia plants, we develop an extensive risks database using a HAZID type exercise. Based on our own experience, researching a collection of industry case studies and experience from other plants, we built a collection of over 300 potential and past causes of incidents that already happened or might occur in ammonia plants. We want to share part of these risks with the participants at this symposium and include other risks in the Fertilizer Academy online training platform as part of the industry training program developed by the authors of this paper.*

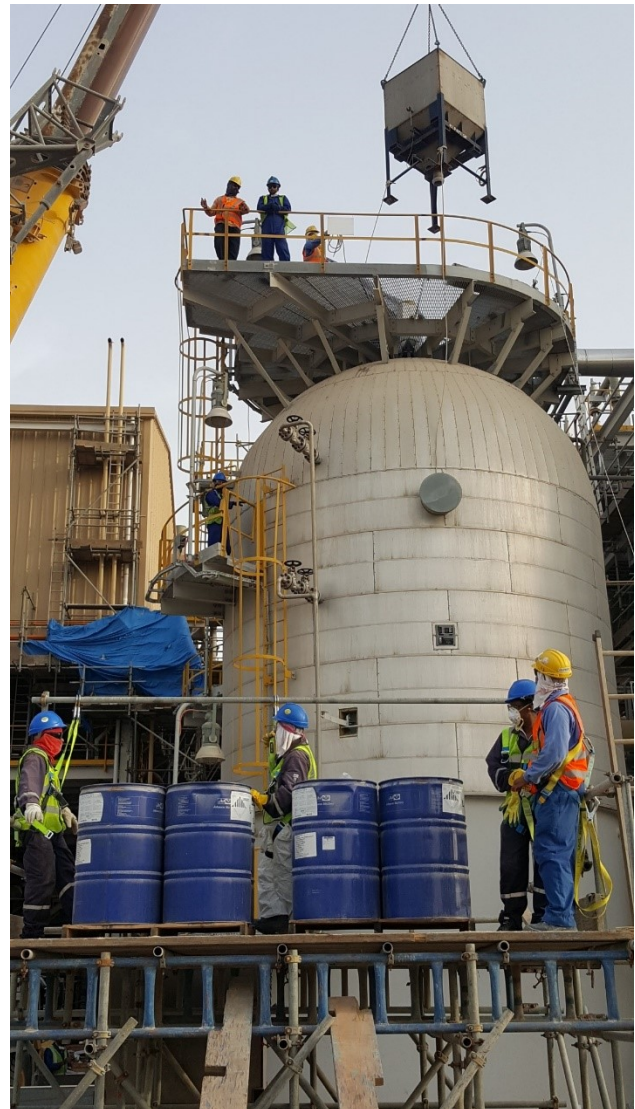
Figure 2. Catalyst loading process.

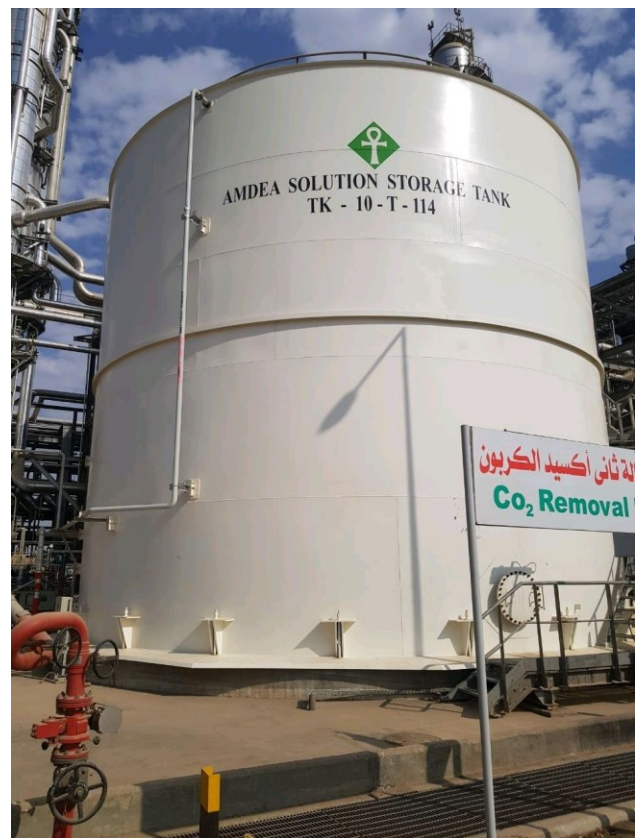
Figure 4. aMDEA Solution Storage Tank

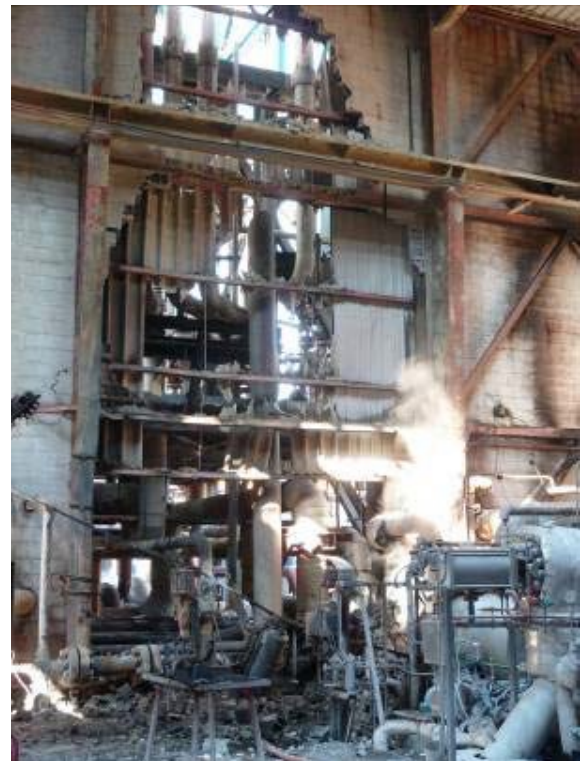
Figure 5. Compressor house after a fire

Critical Event	Loss of containment at syngas compressor from piping, seals, flanges, etc.
Potential Cause(s)	Corrosion, overpressure, surging, mechanical failure, weld defect
Potential Consequence(s)	Release of flammable gas from failed equipment with the potential for fire with associated equipment damage, business

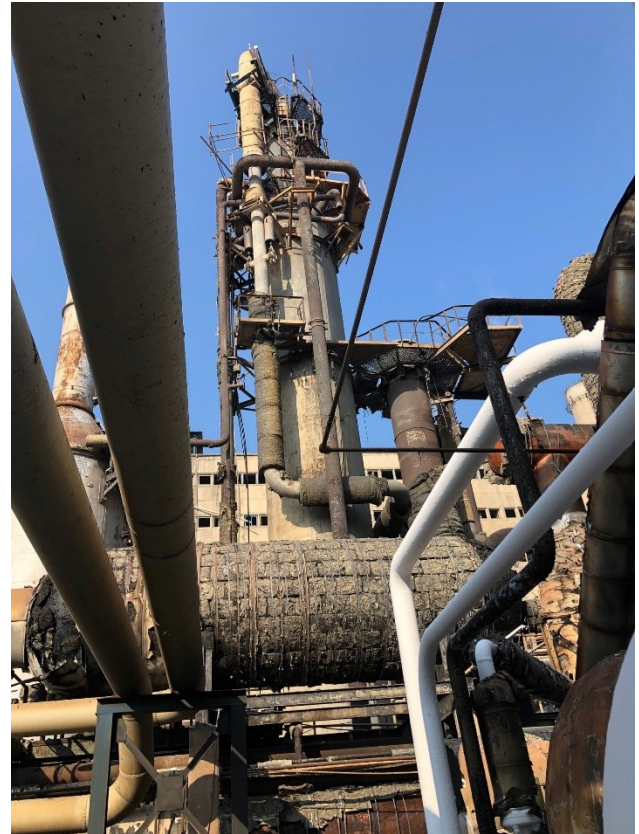
Figure 6. Synthesis loop fire aftermath due to pipe rupture.

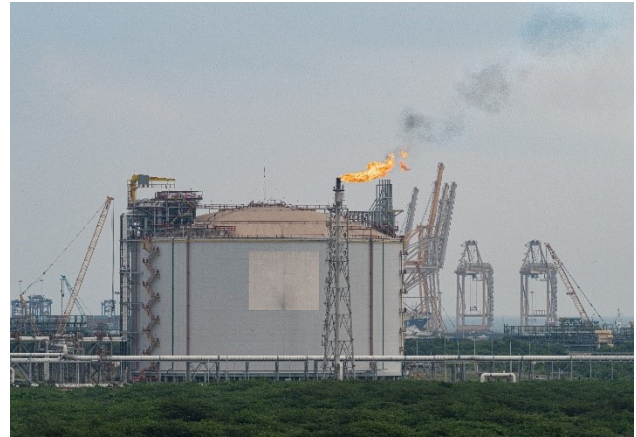
Figure 9. Storage tank flare

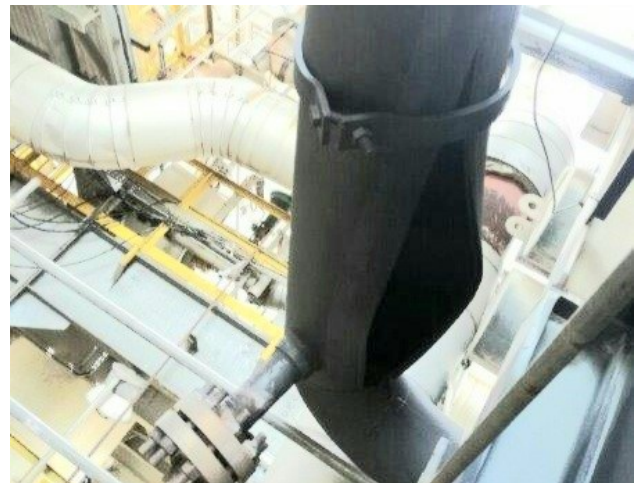
*Figure 2: Photo of ruptured mixed feed piping*

Initial visual inspection revealed a large rupture on the longitudinal weld seam on the first straight run of piping exiting the mixed feed coil. (Figures 2 and 3) The rupture was measured to be 85 in (216 cm) in length and 16 in (40.6 cm) wide at the widest point. The fracture centerline was observed to be positioned at the center of the longitudinal weld seam of the pipe. Two distinct zones were present on the fracture surface of the pipe with a more oxidized surface noted to be from the outer diameter towards the inside of the pipe with an average depth of 0.750 in (1.91 cm). The thickness of the pipe was 1 in (2.54 cm). At certain locations along the ruptured section, the fracture surface showed about 96% of the total piping thickness to be more oxidized.

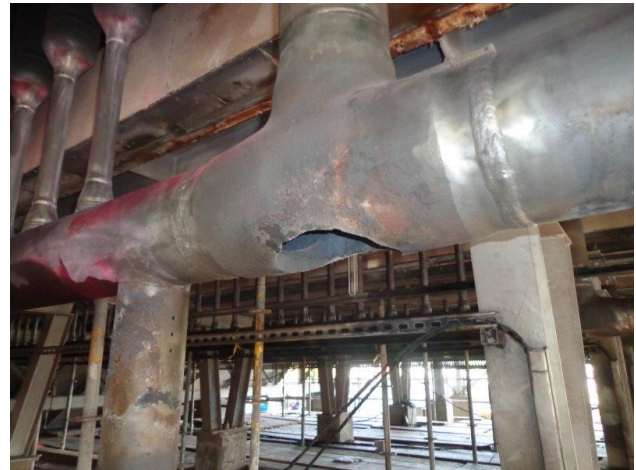
*Figure 4: Photo of outlet header tee showing burn through due to reverse flow*

occurred within a 5 in (12.7 cm) diameter circular area consistent with the inner diameter of a riser.

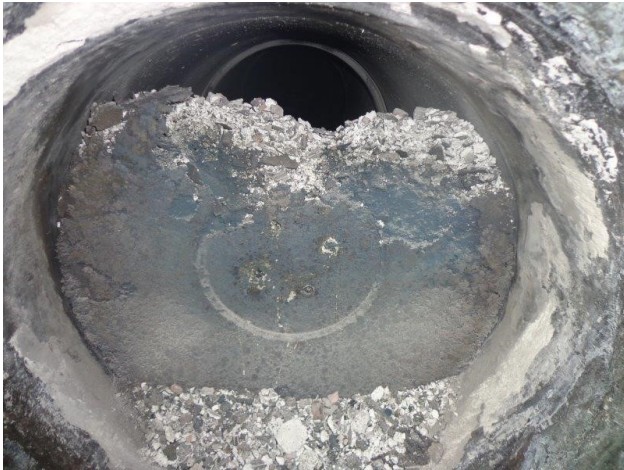
*Figure 6: Photo showing refractory material and solidified molten metal deposited at the flanged end of the transfer line*

See Figure 6. The internal liners of the riser transition assemblies were also damaged. Subsequent inspection of the transfer line showed severe damage to the internal liner components.

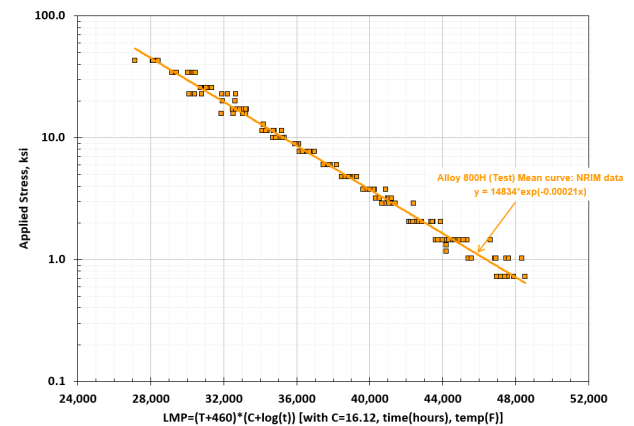
Figure 2. LMP curve constructed from stress-rupture test data for Alloy 800H from NRIM.

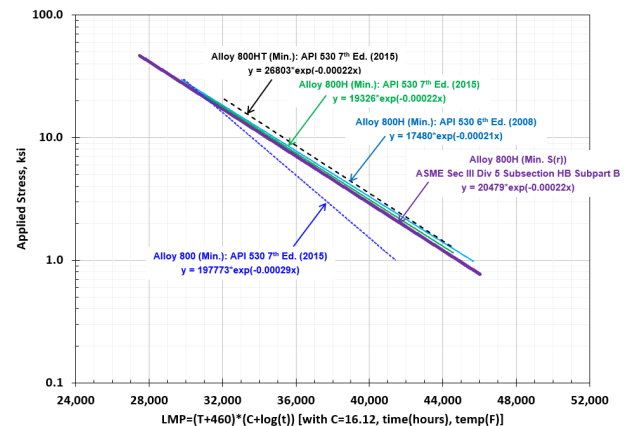
Figure 3. LMP curves constructed for MINIMUM properties of Alloy 800, Alloy 800H, Alloy 800HT, using data from API 530, and ASME Section III.

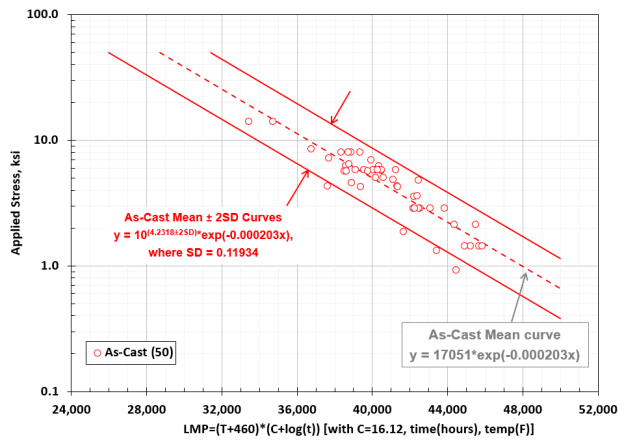
Figure 7. Mean LMP curve (hatched) and mean  $\pm 2$  standard deviation curves, for as-cast Alloy 20Cr32Ni1Nb, constructed from 50 data points. Slope  $C=16.12$ ; refer to Figure 1.

The literature review identified 50 data-points from stress-rupture tests of Alloy 20Cr32Ni1Nb in the as-cast condition, and the data are shown in Figure 7. The hatched line in the figure is the mean curve through the data, and the solid lines indicate the 95%-confidence interval of the data (mean  $\pm$  2 standard deviations [SD]). Four data-points are located below the mean  $- 2$  SD curve.

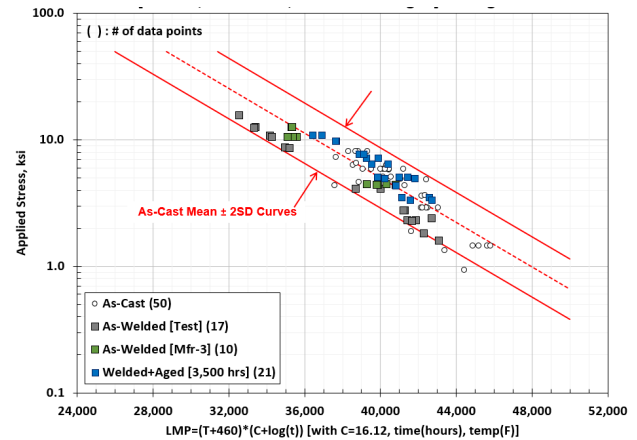
Figure 8. LMP data for Alloy 20Cr32Ni1Nb in as-cast, as-welded and in as-welded + aged conditions, constructed from 48 data points. Slope  $C=16.12$ ; refer to Figure 1.

the laboratory-aged condition with or without SA heat treatment (23 data-points).

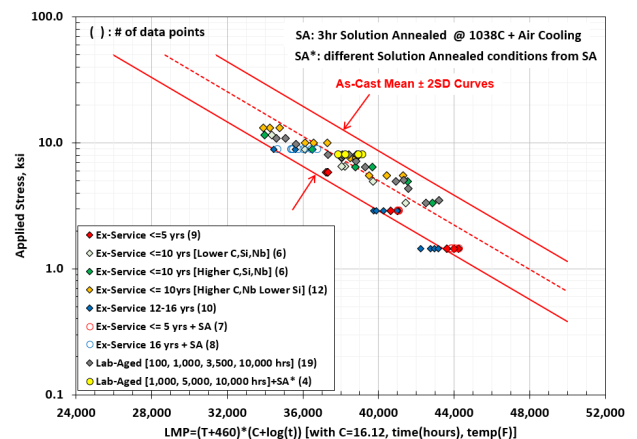
Figure 9. LMP data for Alloy 20Cr32Ni1Nb after laboratory aging (lab-aged) and/or solution annealing (SA), constructed from 38 data points. Slope  $C=16.12$ ; refer to Figure 1.

Figure 9 shows the ex-service data together with the LMP data for Alloy 20Cr32Ni1Nb in ex-service + SA, lab-aged, and lab-aged + SA conditions. With the exception of one data-point for 16 years of exposure + SA, all the data sets for ex-service + SA, lab-aged, and aged + SA are within mean  $\pm 2$  SD of as-cast data.

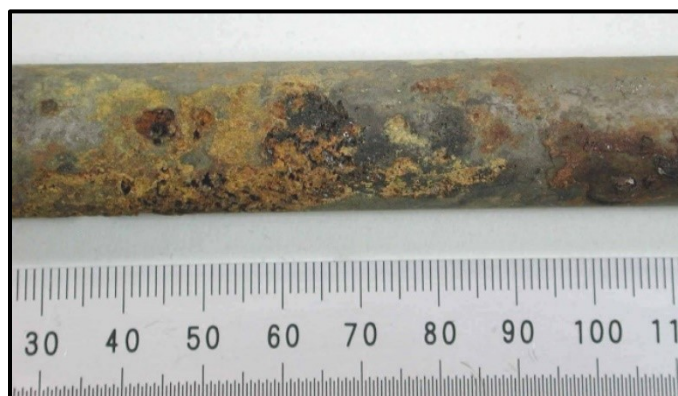
Figure 4. Type 304L stainless steel condenser tube with pits and cracks.

Type 304L stainless steel condenser tubes in a fertilizer plant had developed pits and cracks on the OD shell side after several years of service (see Figure 4). The tube OD was exposed to cooling water below 260°F (130°C). The cooling water contained chlorides and chlorinated compounds. The OD had pits and multiple transgranular cracks typically associated with chloride SCC in austenitic stainless steel (see OD on the left side of Figure 5).

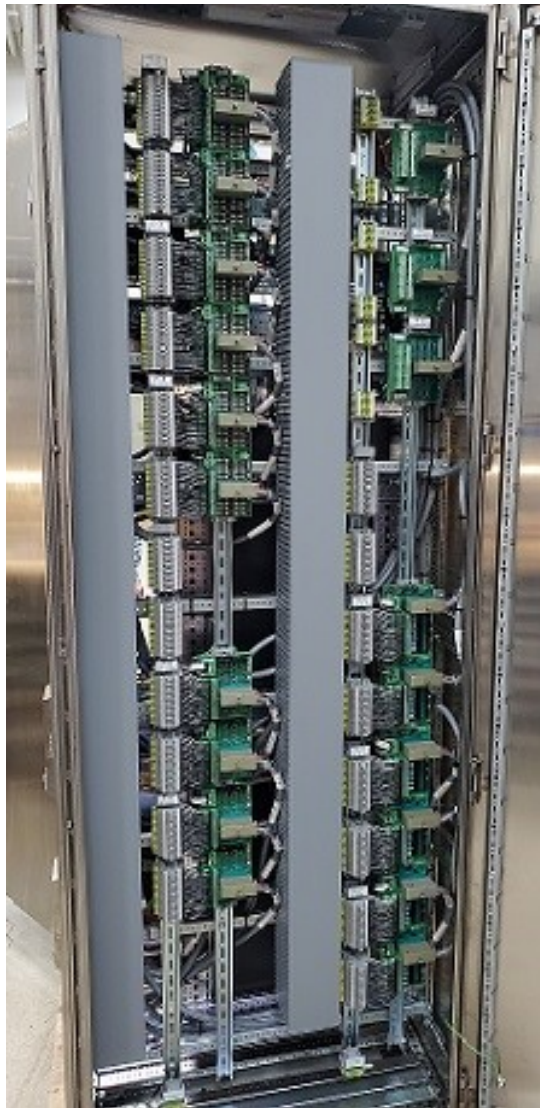
*Figure 2: Back (I/O wiring) side of ESD control cabinet*

install path. If the common cable tray was damaged by work or weather, the operators' view of the process and/or the remote I/O would be interrupted.

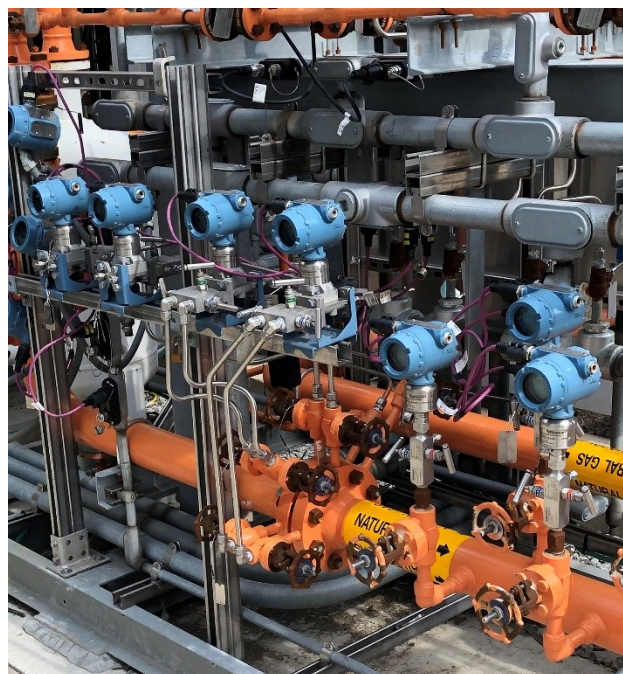
*Figure 4: Pressure and flow input devices*

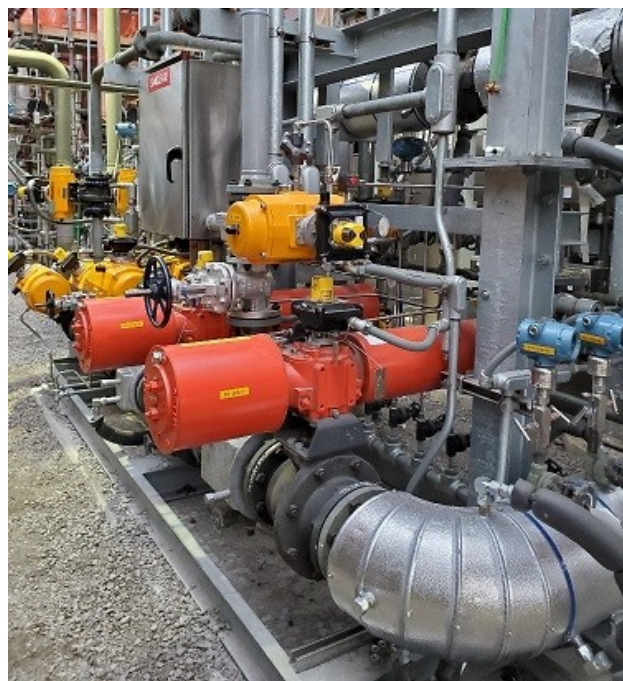
*Figure 5: Input and output devices on a skid*

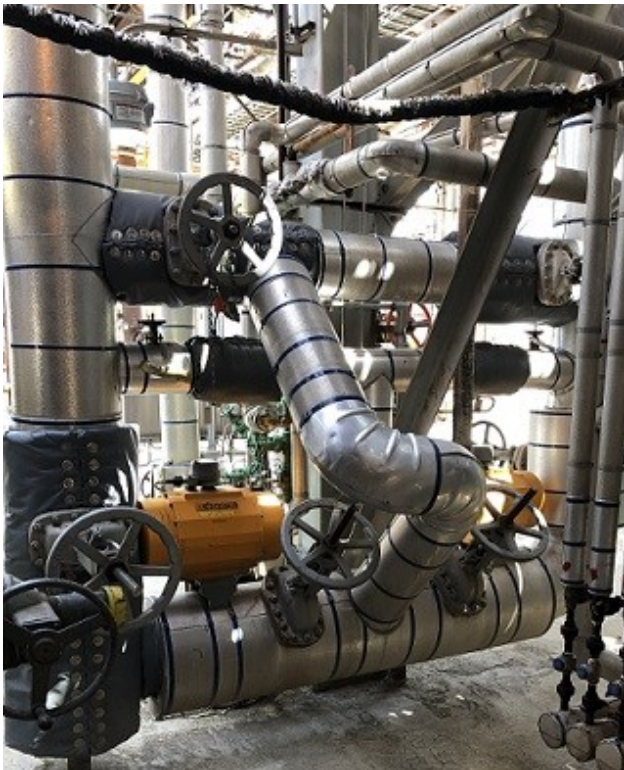
*Figure 6: Reformer fuel isolation valves with online testing bypass*

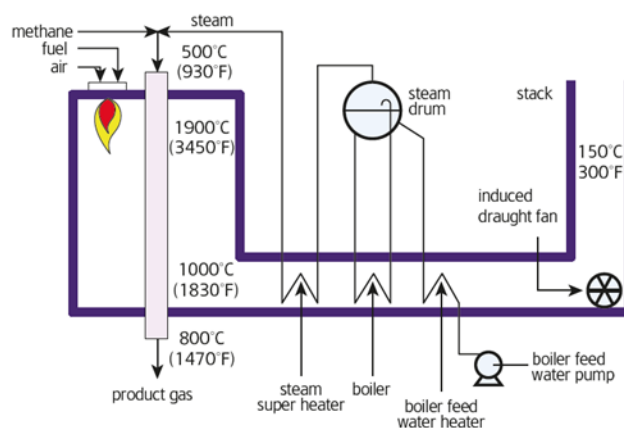
Figure 1. Outline diagram of a steam-methane reformer, showing typical process conditions.

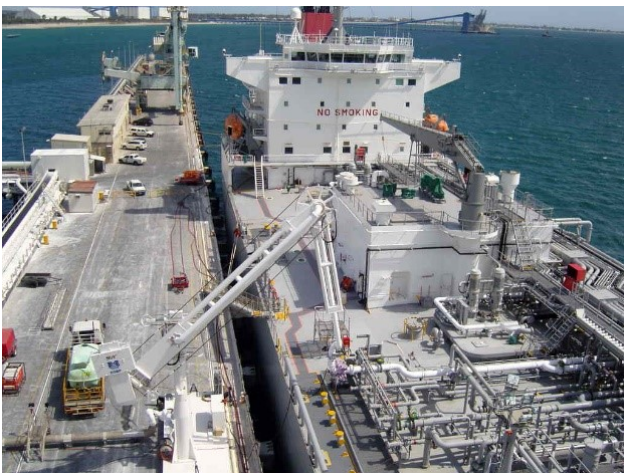
*Figure 2. Ammonia import line connection*

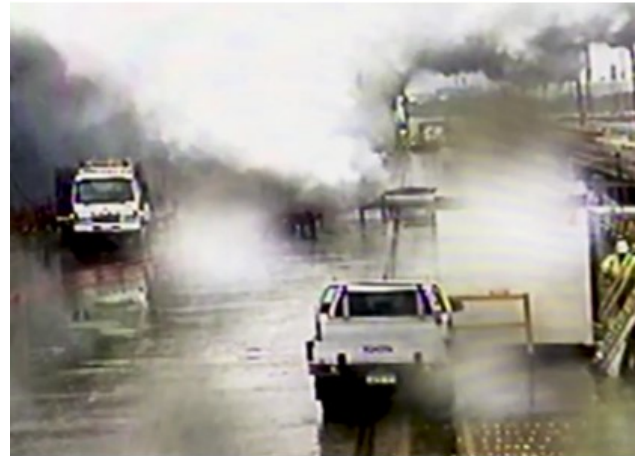
*Figure 3. The ammonia release captured by a port camera*

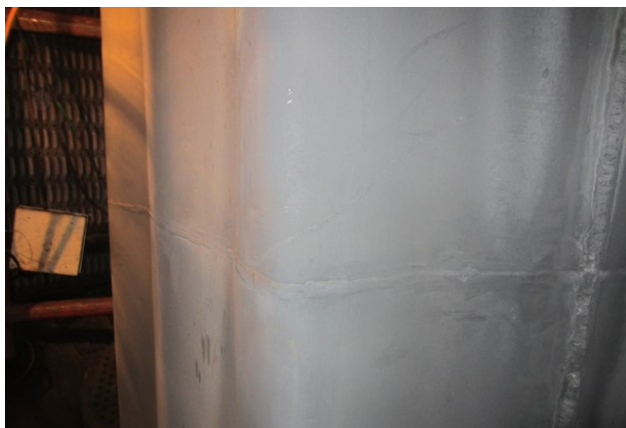
*Figure 2. Deformed course inside an ammonia converter*

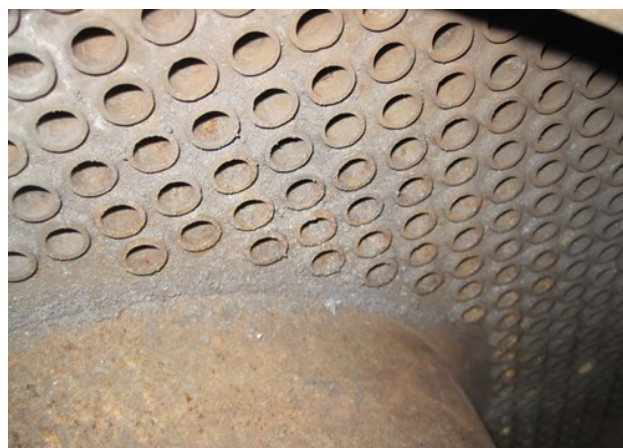
*Figure 8. Oxidized surface of an operated internal exchanger*

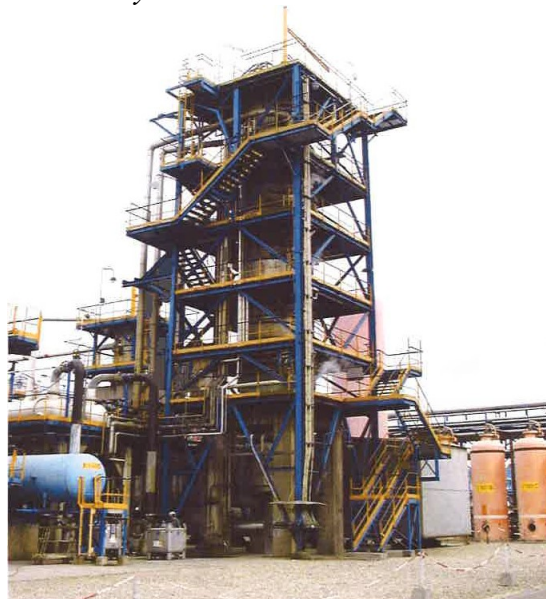
Figure 1. View of Synthesis Reactor

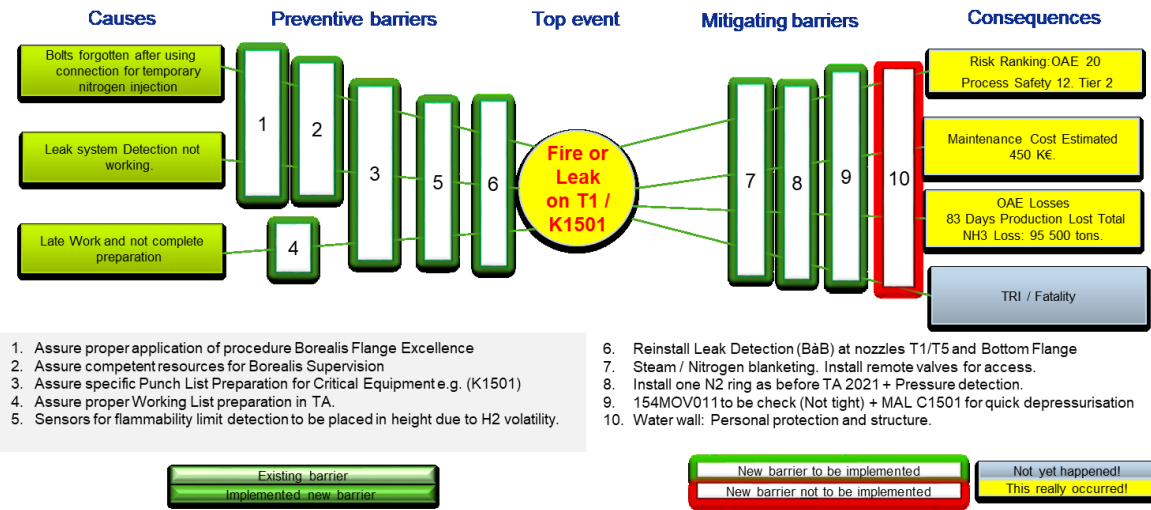
Figure 5. Bow Tie Showing Main Root Causes of Failure.
