47TH TURBOMACHINERY & 34TH PUMP SYMPOSIA
HOUSTON, TEXAS | SEPTEMBER 17-20, 2018
GEORGE R. BROWN CONVENTION CENTER

IMPROVED RELIABILITY OF WASTE WATER PUMP

Existing Industrial waste water Pump

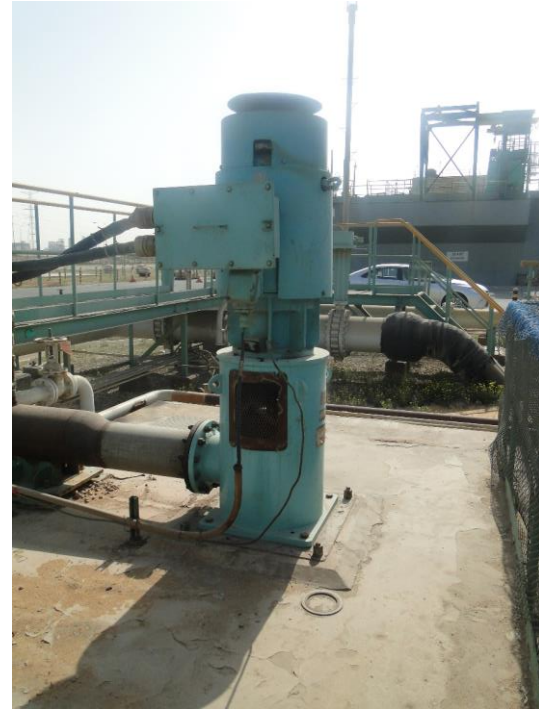
- Nine vertical sump pumps are used to transport Industrial Waste Water (IWW) from the processing plant to outside of the manufacturing complex.
- One normally running while two on stand-by.
- The pumps are self-lubricated by the pumped media (API VS2, 6m Long, 75KW of Power).
- Material Class is API I-1

- Suction Press. : 1.03 kg/cm²A
- Head : 25 m
- Capacity : 500 m³/h
- Liquid : Waste Water
- Lubrication : Self. Lubricated
- Sump Depth : 6.42 m
- Pump length : 6.3 m
- Min. Submergence: 0.7 m

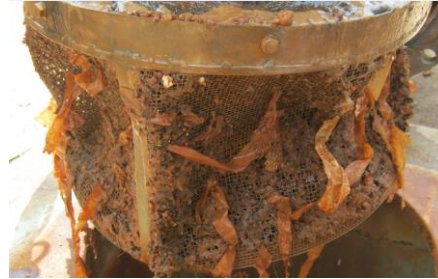
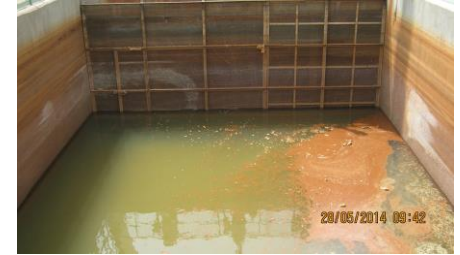
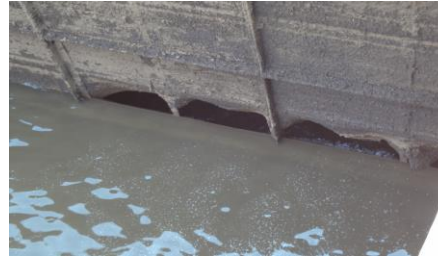
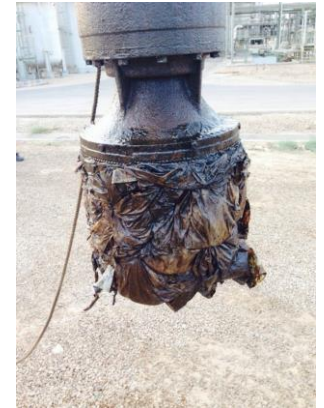
OVSERVATIONS: WASTE WATER POND SCREEN MESH & BLOCKED STRAINER

- The ponds receives foreign items both from upstream processes & atmosphere.
- This leads eventually to blockage of suction strainer.
- 3M pond cleaning and impeller cleaning was not sufficient to eliminate failures

This blocks the pumped water leading to a lack of lubrication for the bearings, as well as impeller cavitation.

2. To re-design the pump suction strainer to 1.2m by 1.2m cage. This is introduced to minimize chances of blockage hence pump cavitation.

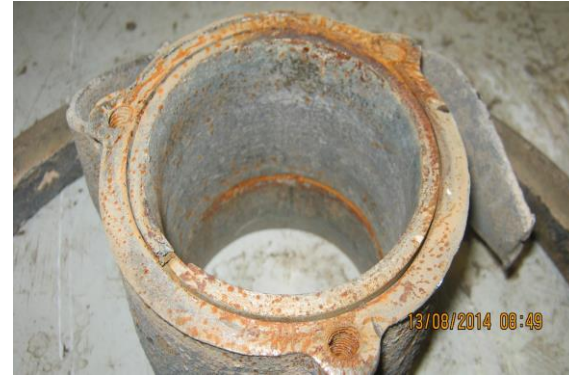
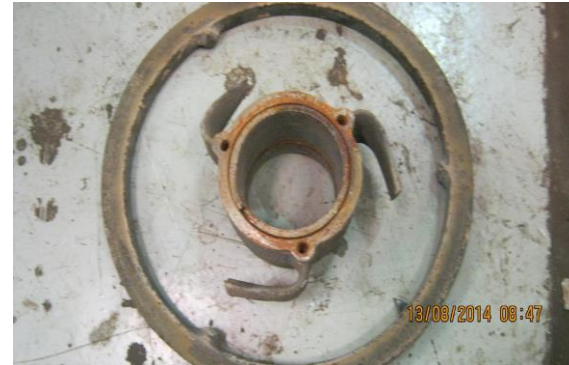
WORN OUT SLEEVE BEARINGS

- The sleeve bearing are severely worn out with a completely wiped out silicon carbide coating.
- This leads to the bearing housing being twisted and separated from the outer ring.

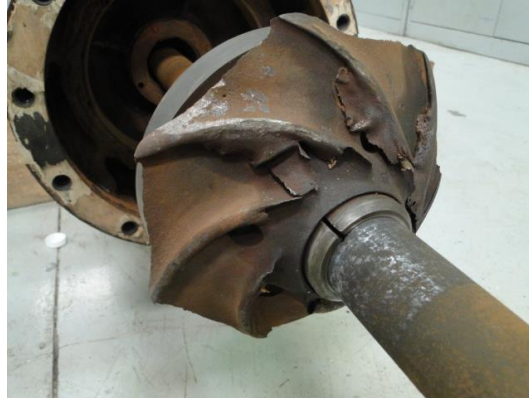
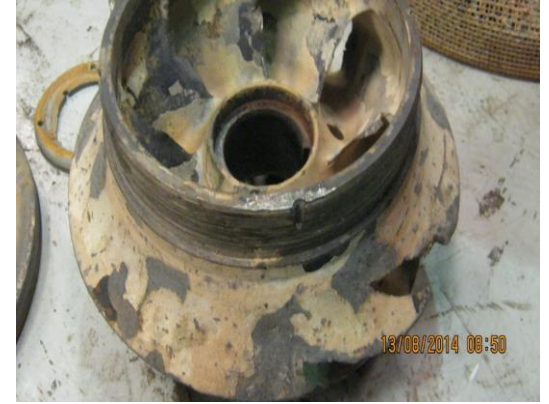
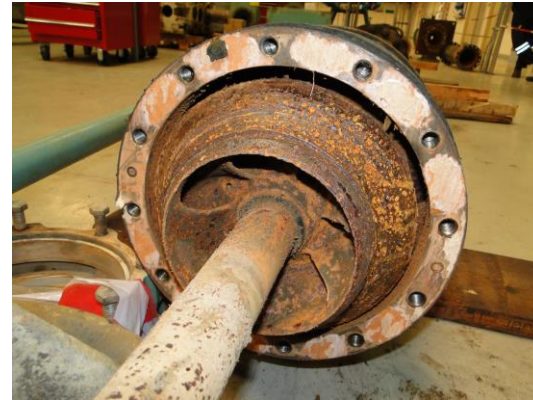
CORRODED IMPELLER

- These are photos of three different impellers at different failures.
- Severe corrosion can be observed with significant thickness reduction.
- Sometimes the impeller is disintegrated into two pieces.

After Lab Sample Analysis with consultation with Metallurgy specialists. It was concluded that severe corrosion was taken place due high dissolved oxygen content accompanied by high flow.

1. To upgrade the pump material to a minimum of API S-8 Material Class.

Pump Parts	Material Class		
	Existing	Proposed Option 1	Proposed option 2
	I-1	S-6	S-8
Casing	Cast Iron	Carbon Steel	Carbon Steel
Inner Casing Parts	Cast Iron	12% CR	316 AUS
Shaft	Carbon Steel	AISI 4140	316 AUS
Impeller	Cast Iron	12% CR	316 AUS

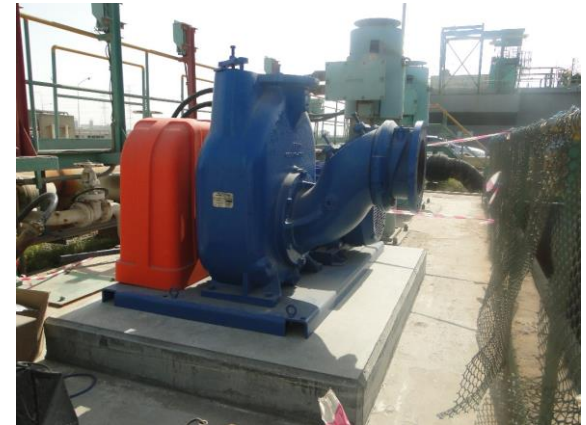
Selected Self-Priming Pump

- Suction Press. : 0.00 kg/cm²A
- Head : 28 m
- Capacity : 500 m³/h
- Liquid : Waste Water
- Lubrication : Oil

- Casing : Ductile Iron
- Impeller : Hi Chrome 27%
- Wear plate : Hi Chrome 27%
- Shaft : 17-PH SST

Easy maintenance (smaller and easily maintainable at site).

Upgraded material suitable for the process

Project capital cost less than cost of material upgrade of the existing pump

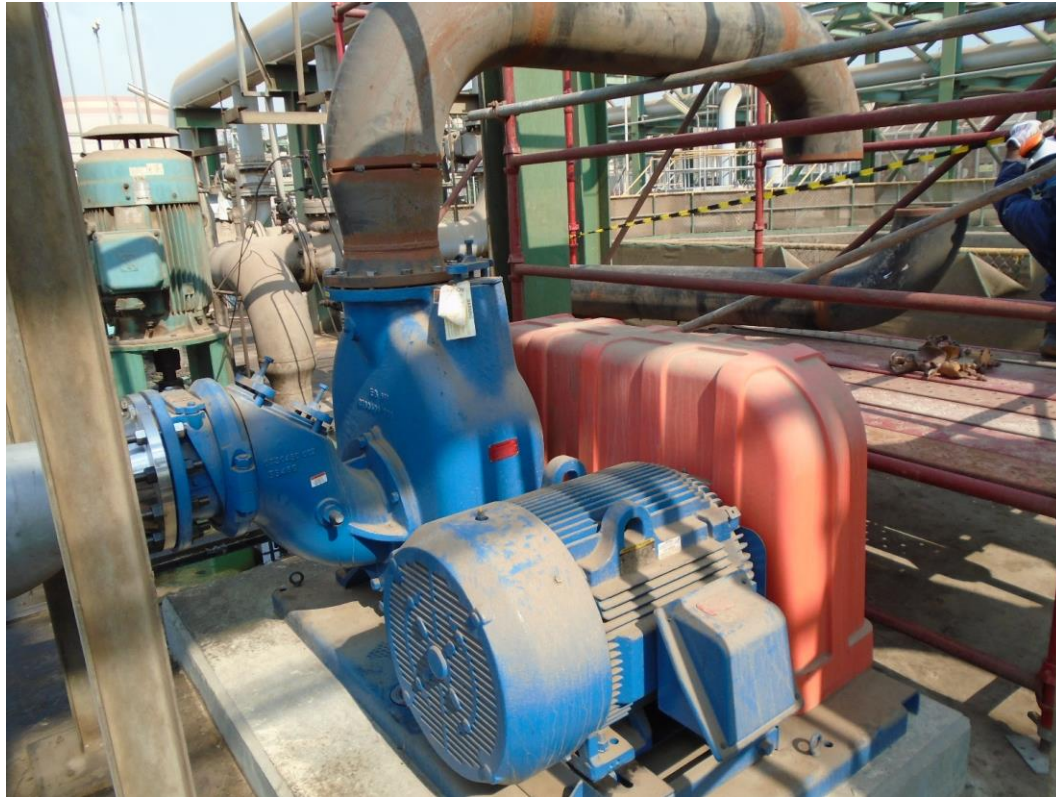
NEW PUMP INSTALLATION

Two pumps were commissioned in Jan 2017

The two pump are running healthy
