47TH TURBOMACHINERY & 34TH PUMP SYMPOSIA
HOUSTON, TEXAS | SEPTEMBER 17-20, 2018
GEORGE R. BROWN CONVENTION CENTER

Investigating & Improving the drooping curve of a two-stage feed pump

Ng Tzuu Bin, Flowserve

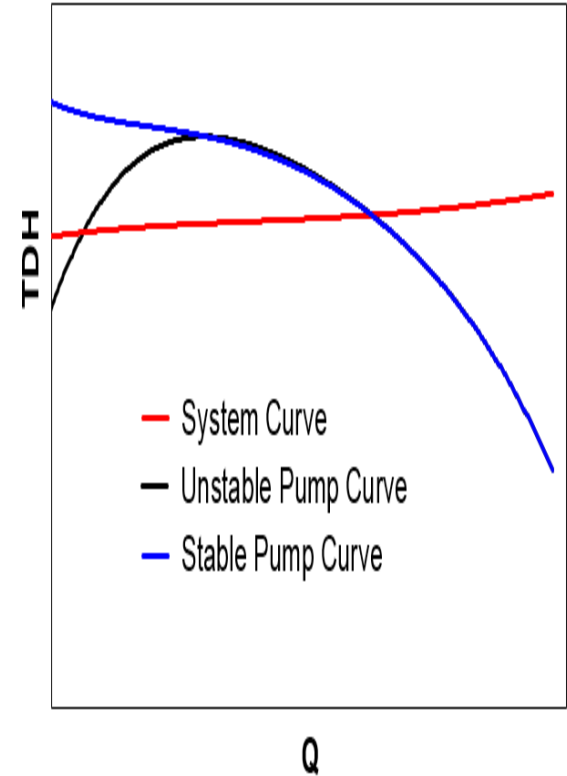
The Definition of Head Droop

- The head droop (ΔH_d) occurs when the pump TDH does not rise continually when moving from BEP to shutoff.
- This could generate the static instability for a pumping system with high static/pressure head & negligible friction head.
- API 610: “pump with continuous HRTSO is preferred for all applications & is required for parallel operation.”

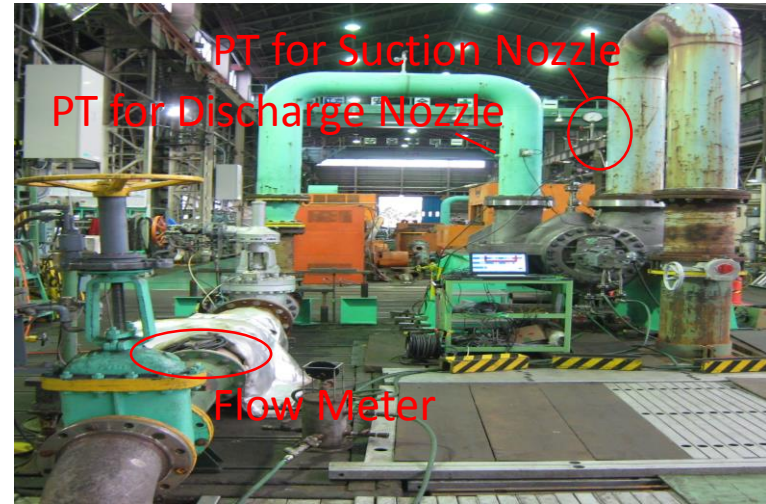
The Initial Test Setup

- Test carried out in accordance with API 610 11th Ed.
- Pressures, flow, speed & motor power were measured.
- Pressure gauges were installed 2D away from pump nozzles.

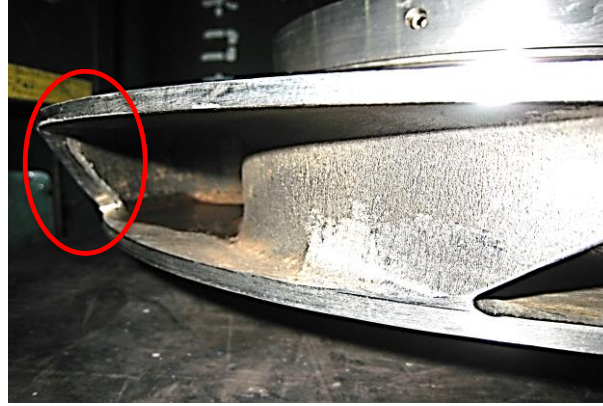
The Rework 2: Impeller Vane Squaring

Stage 1 Impeller

Stage 2 Impeller

- Both Impellers: Cut the exit edge of vanes radially.
- This could reduce the wake shedding area due to traversing flow at the exit. Further trimming is needed, as the rework will rise the TDH at all capacities.

- Impeller V-trim/ oblique cut generated minor recovery on head droop. Higher cut angle could have negative impact.
- Impeller vane squaring showed significant improvement in head droop, but further trim is required for rated TDH.
- Extended inlet guide vanes at stage 2 casing produced very minimal impact on head droop recovery.
- Improvement on the head droop was obtained at the expense of pump efficiency. None of these well known methods could completely remove the head droop here.

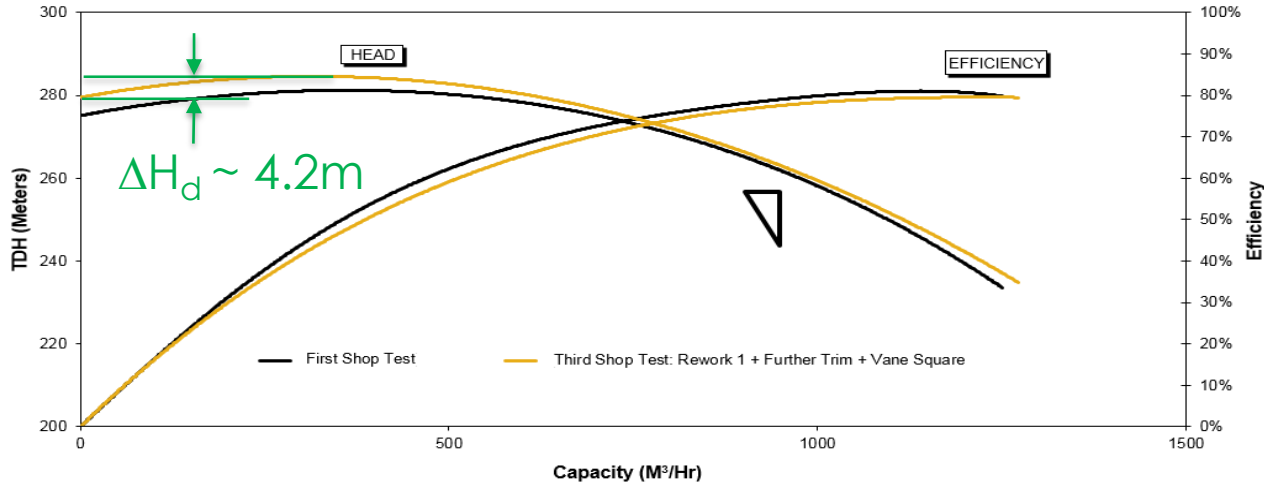
The Third Shop Test Result – Rework 2

- Substantial improvement obtained, but 4.2m of head droop remained in the test.
- Rated efficiency dropped $\sim 1.3\%$ (Compared to first test).

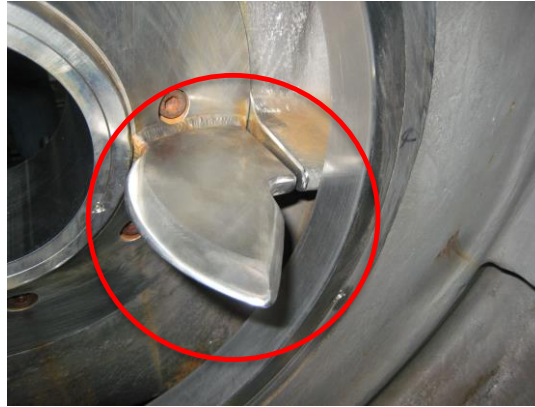
The Rework 3: Inlet Guide Vane at Casing

- Install the guide vanes at inlet of stage 2 impeller. The guide vanes extend right into the suction eye.
- This will reduce the hydraulic loss due to inlet pre-rotation.

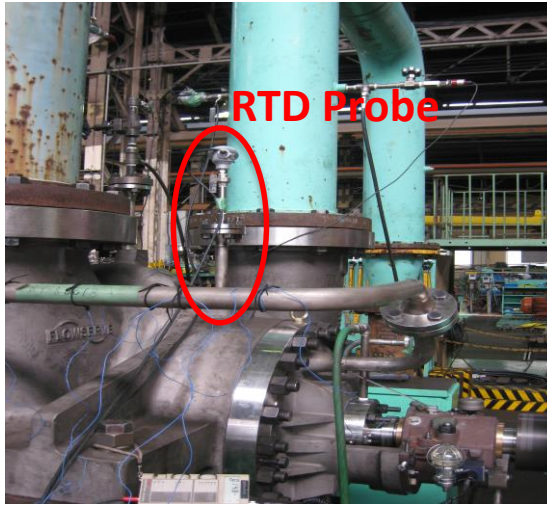
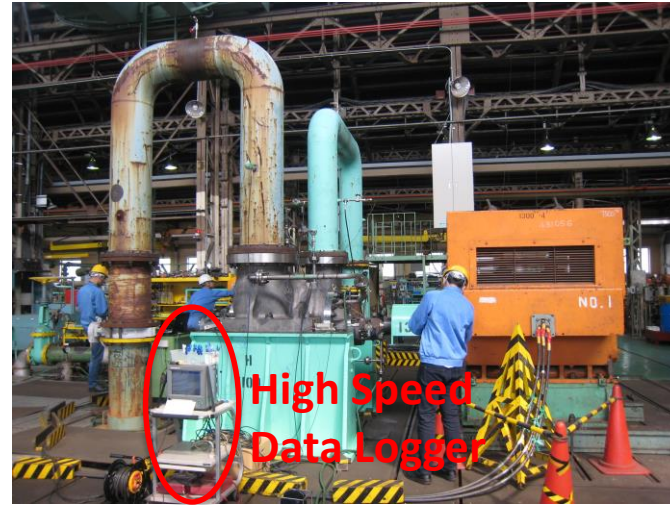
The Modified Test Setup

- Fast response RTD probe was installed at casing vent to monitor the temperature rise.
- Higher sampling rate was set in the data logger.

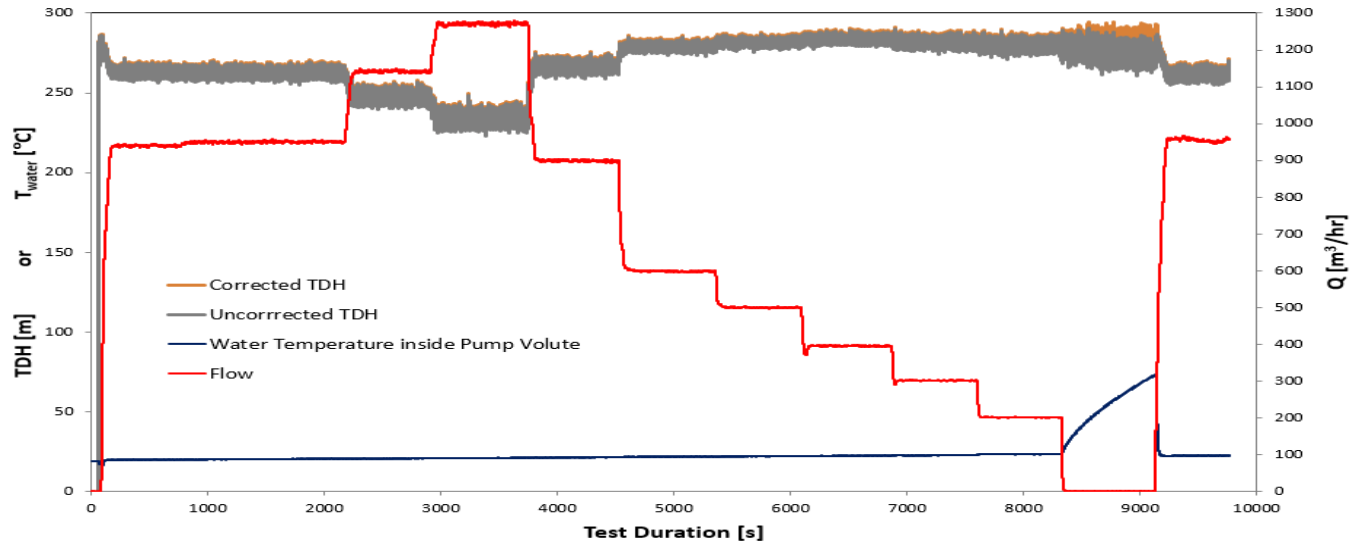
The Pump Shutoff Test Result

- No hunting curve effect was observed during the low flow test.
- Unsteady dynamic pressure head was not accounted in the TDH calculation.
