# Underwater Inspection of Bridge Substructures Using Imaging

# Underwater Inspection of Bridge Substructures Using Imaging Technology

June 14, 2018

**Sponsored by**  
Federal Highway Administration  
Office of Infrastructure  
FHWA-HIF-18-049

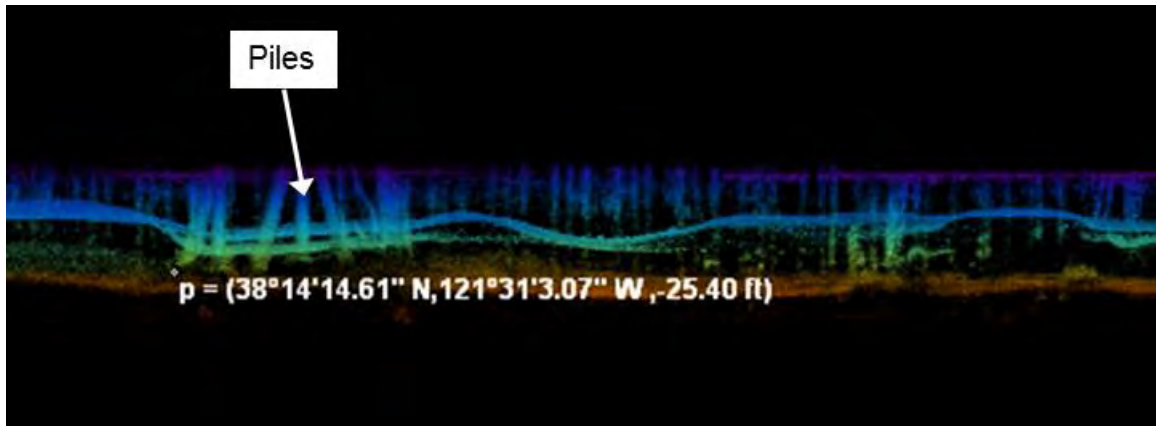
Figure 26. Image. Piles from back side of the fender (Georgiana Slough).

Using a real-time multibeam sonar, inspection team A collected data in the field that produced images that captured general pile features. The images in figure 26 and figure 27 reveal the piles supporting the fender in profile and plan view, respectively. In the profile view, it is evident that several piles are not aligned vertically. In the plan view, the curved alignment of the set of piles is clearly seen.

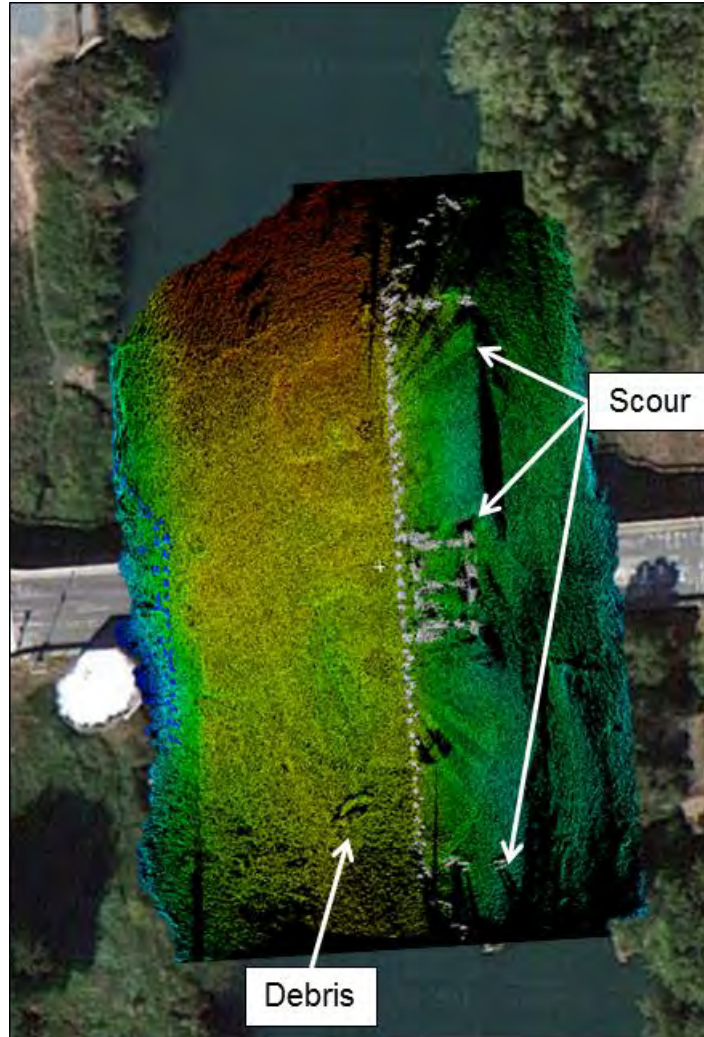
Figure 32 provides a sonar image overlain on an aerial photo that highlights darker areas indicative of minor scour around the structures. The image also shows moderate levels of debris, including tree limbs and tires, but no visible damage to the substructure.

**Figure 32. Image. Indications of scouring from 3D image (Georgiana Slough).**

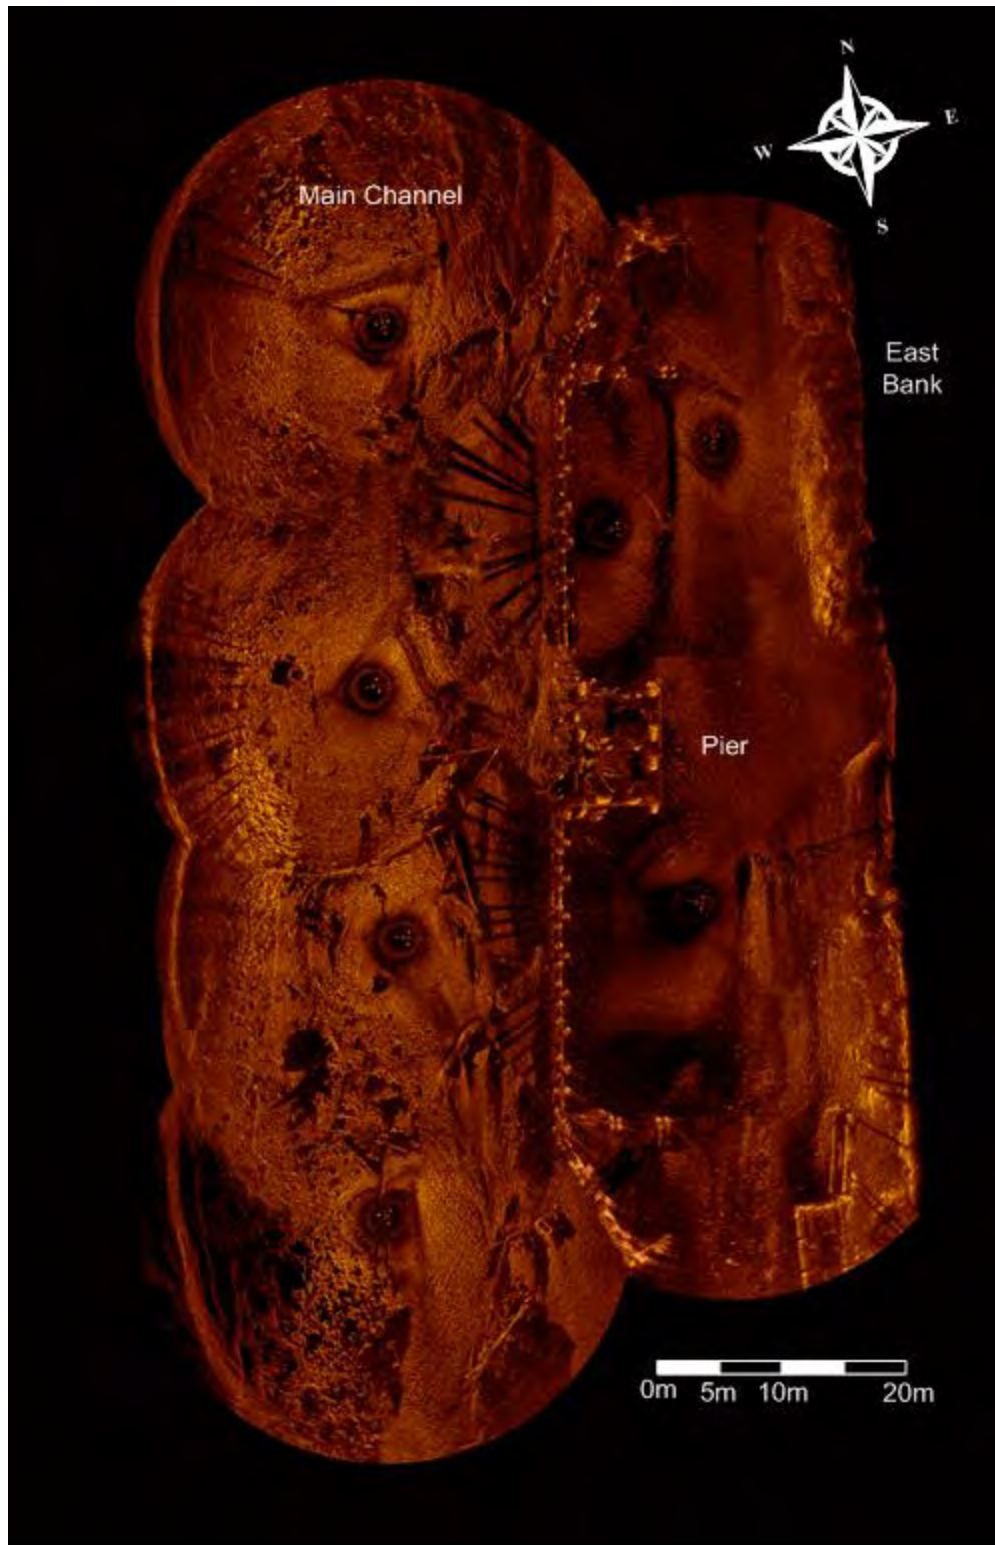
Inspection team C used 2D sector-scanning sonar and 3D profiler sonar to collect riverbed and vertical visualization scans of the underwater portion of pier 2 of the Georgiana Slough Bridge. Bottom scans, taken with the sonar head fitted onto a tripod, were collected adjacent to the structure. The bottom scan locations are shown in figure 33 with a resulting mosaic of the drop images shown in figure 34. The bridge pier, piling, bathymetry, and some debris are visible.

In the main channel the imaging data showed different stratigraphic units comprised of gravel, or possibly, hardpan clays. The imaging also showed the complexity of the generally stable river bottom. A box-shaped target was observed near the fender piles on the main channel downstream side; this target was confirmed by divers to be an old refrigerator. There are several angular targets in the main channel; their angularity and out of character nature to the natural bottom suggest they are human debris.

Figure 34. Image. Mosaic of bottom drop images.

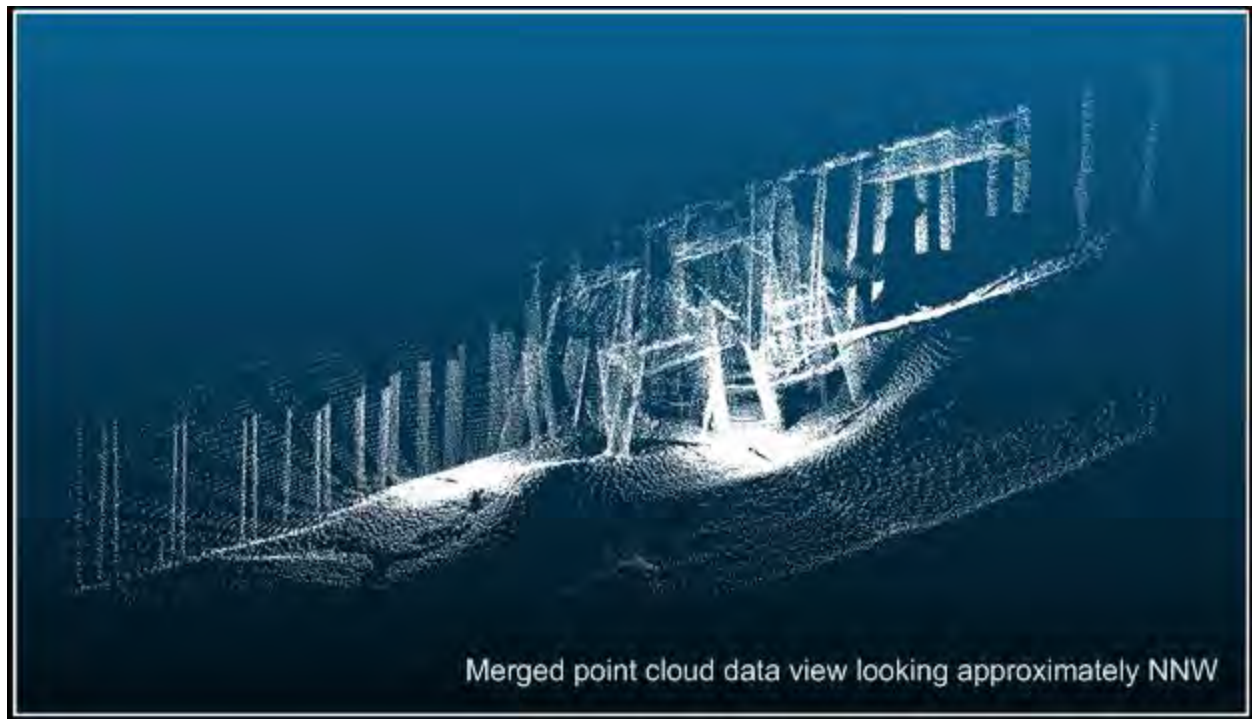
After completing the bottom drops, the head was horizontally mounted on a pole and positioned three feet below the surface to vertically scan the fender wall. The data collected from the bottom drops and vertical scans were merged to create 3D representations as shown in figure 35.

The inspection team observed in both the imaging and profiling datasets that although the fender system is there to protect the structure from vessel traffic, it appears to have caused localized scour on the upstream side of the pier. This local scour has induced sediment degradation on the upstream nose and aggregation on the downstream side of the structure. The fender system

appears to be structurally sound with no breaks or splits in the piles. Debris build up was noted on the upstream dogleg. The team reported that the vertical and batter pipe piles appeared to be structurally sound with no visible impact damage or structural deterioration.

**Figure 35. Image. Merged point cloud data at Georgiana Slough Bridge.**

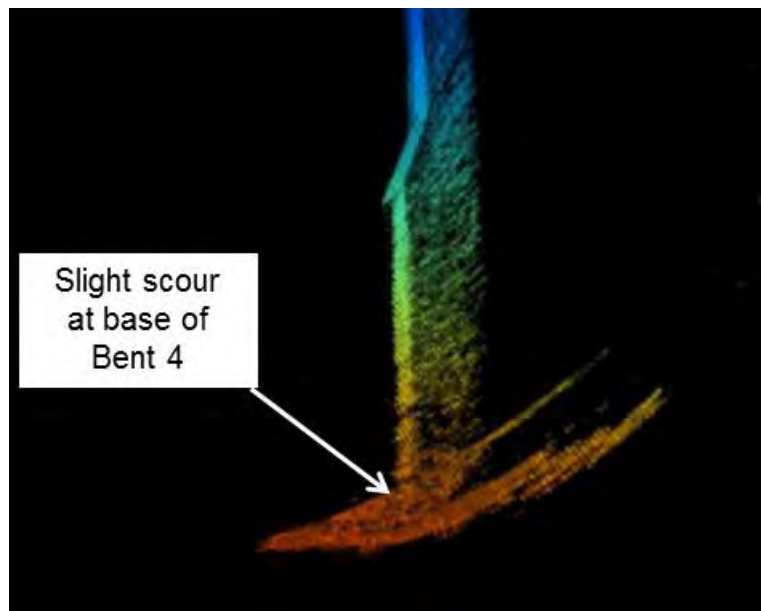
Figure 40 shows the image of bent 4 captured by the sonar. A symbol representing the data collection boat is also shown to illustrate the range required of the sonar at this site. Figure 41 is a data mosaic showing bents 4 and 5 as viewed from the west side of the bridge. The annotations on the figure demonstrate how structure dimensions can be obtained from the image. Close analysis of the images may reveal reportable observations. For example, a closer view of the base of bent 4 shown in figure 42 provides an indication of scour at the base of the bent.

Figure 42. Image. Bent 4 mud line side image.

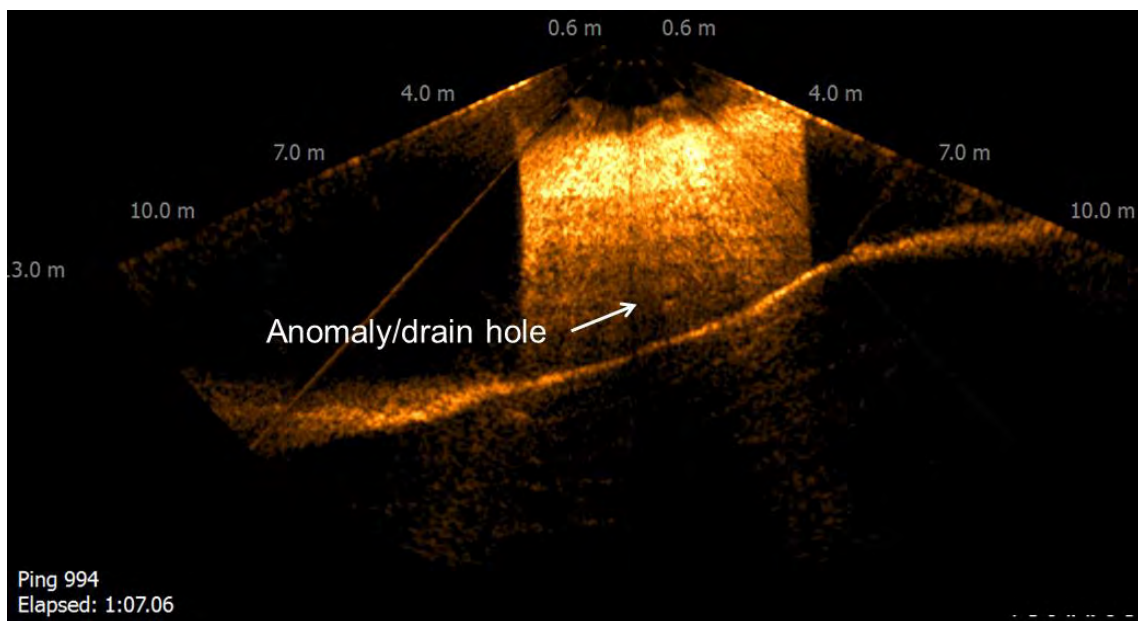
Figure 43 displays a plan view of the James E. Roberts Bridge with the naming convention used by inspection team B to label data and images on bent 4. Figure 44 is a sonar wing close-up of the base of face 3 that reveals evidence of an anomaly on the surface.

**Figure 44. Image. Sonar wing at the bottom of face 3.**

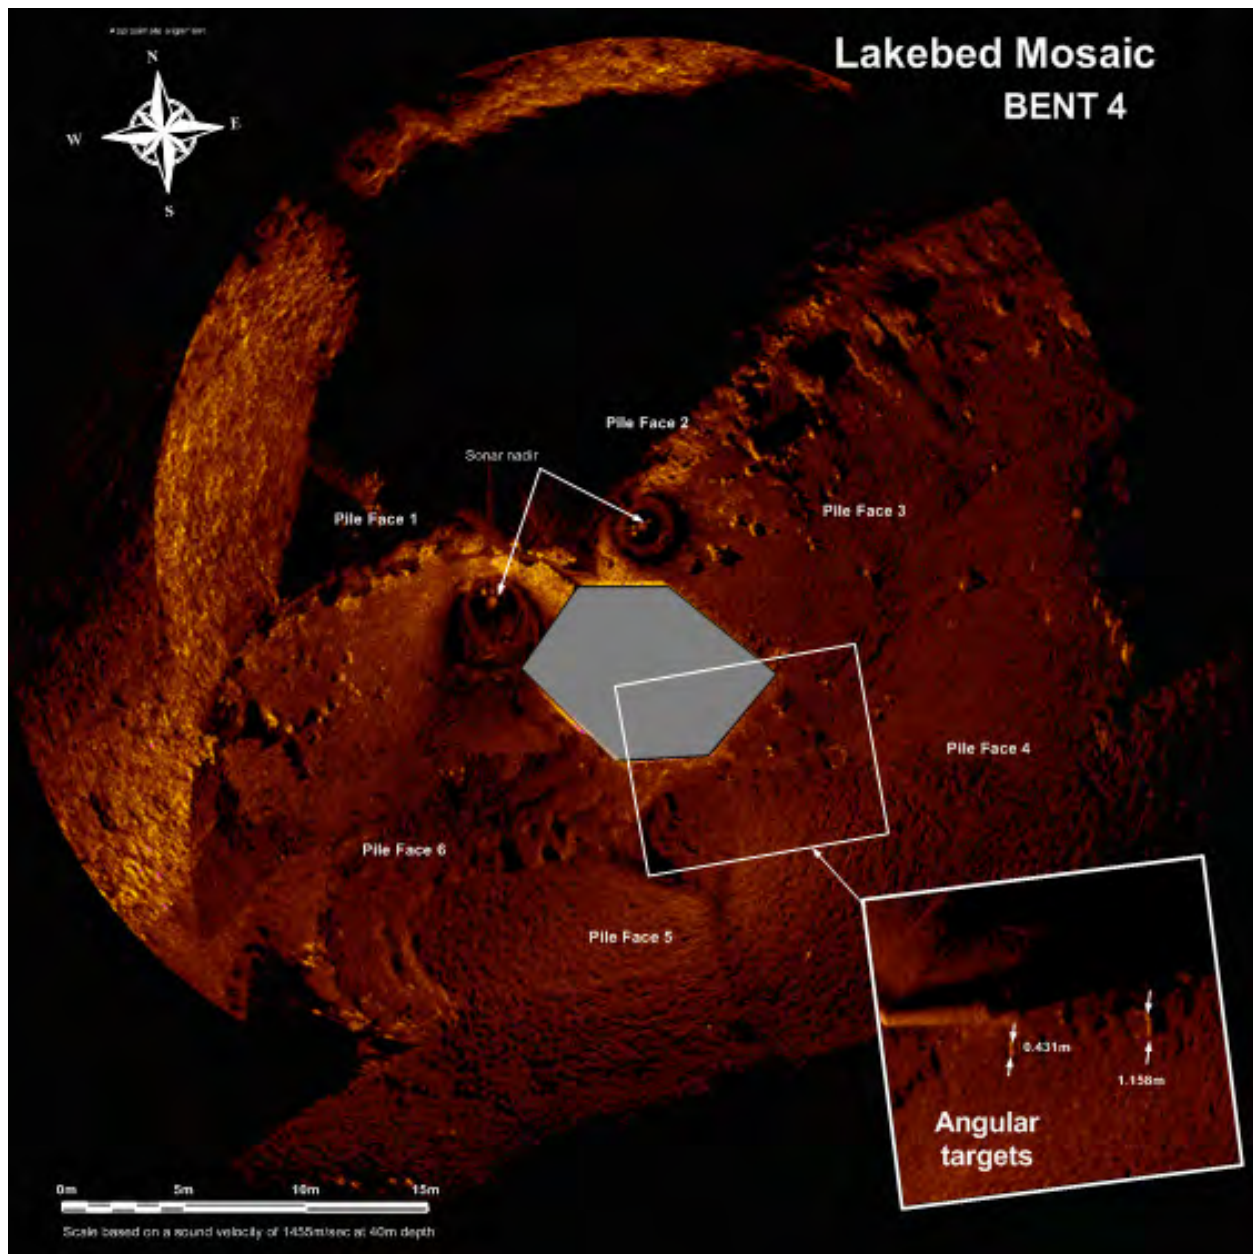
A total of six 98 ft (30 m) radius scans were collected. These were combined into a mosaic of the vicinity around bent 4 as shown in figure 46. The bottom shows significant upward elevation change to the northwest of bent 4 (shadowed area). This elevation difference has resulted in some acoustic distortion in plotting the shape of the base of bent 4 as the record cannot be slant-range corrected to a single elevation plane without introducing additional range errors. There are a few angular targets situated close to the structure; their shape suggests they are not natural objects. There is no indication of bottom scour adjacent to the structure or of slope instability in this mosaic.

**Figure 46. Image. Mosaic bed image of the James E. Roberts Bridge.**

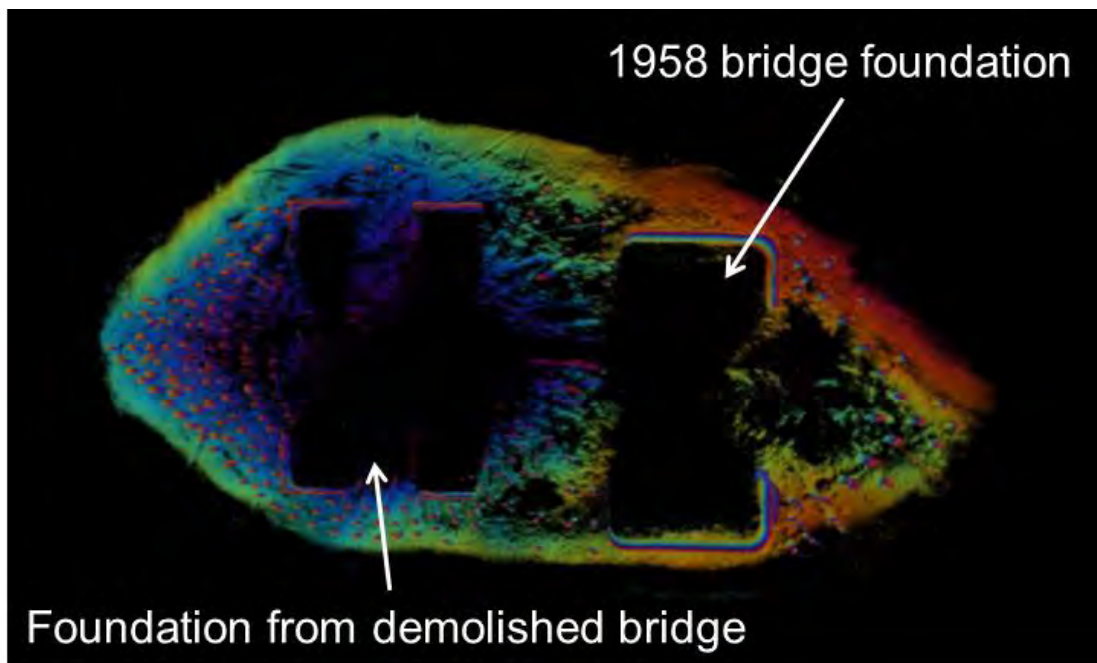
Figure 54. Image. Pier 3 plan view.

Water depth at the pier at the time of the inspection by team A was approximately 75 ft (23 m) on both the north and south sides of the pier. A plan view of the sonar results is shown in figure 54. The foundation for the 1958 bridge is the dark area on the right; the darker area on the left is the remaining foundation from the demolished 1927 bridge. A fender is shown to enclose both foundations. Figure 55 and figure 56 show views from the north and the south, respectively. The partial demolition of the 1927 foundation is clearly visible.

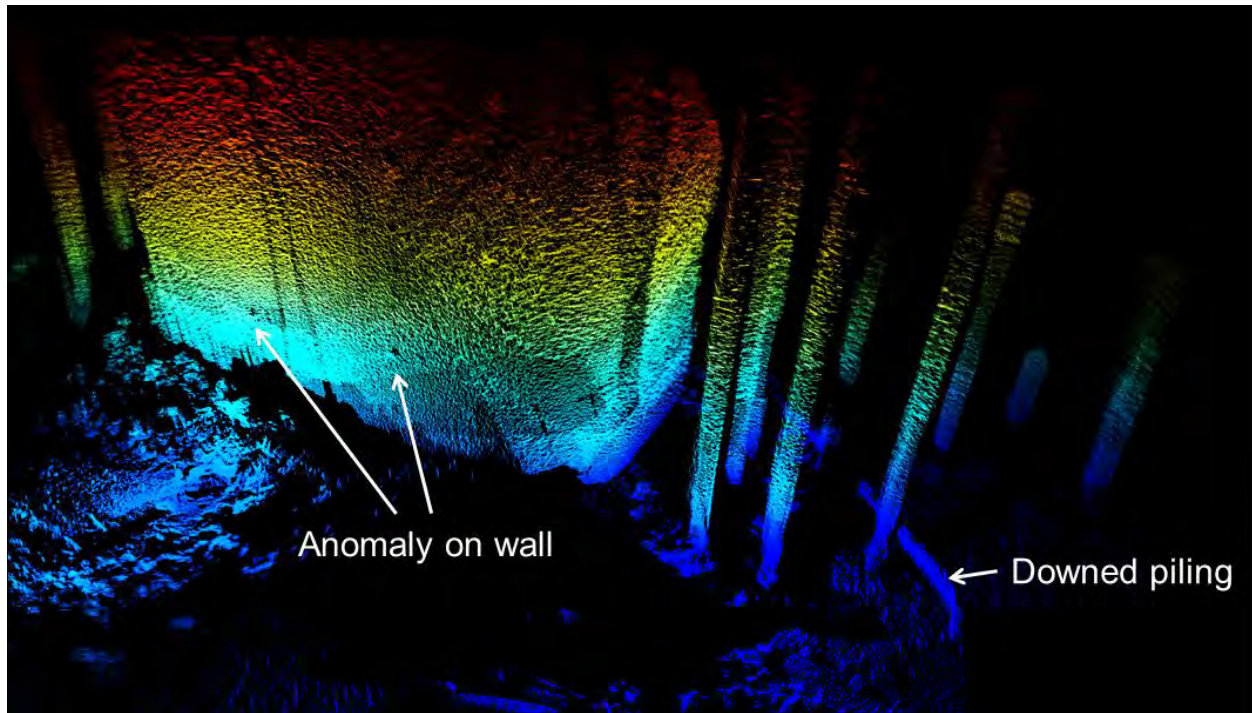
Inspection team C performed a combination of 2D and 3D scanning of the 1958 Carquinez Bridge. Figure 57 displays the areas on the pier foundation subject to inspection. An example of the 2D imaging is shown in figure 58. The reference location for this image is indicated in figure 57. An example of one of the 3D images, that among other features reveals a downed pile, is shown in figure 59.

Overall, the inspection team reported little evidence of scour and moderate to high levels of debris. Several small anomalies were noted on the concrete footings and many downed piles were identified.

**Figure 59. Image. 3D view of base of pier 3.**

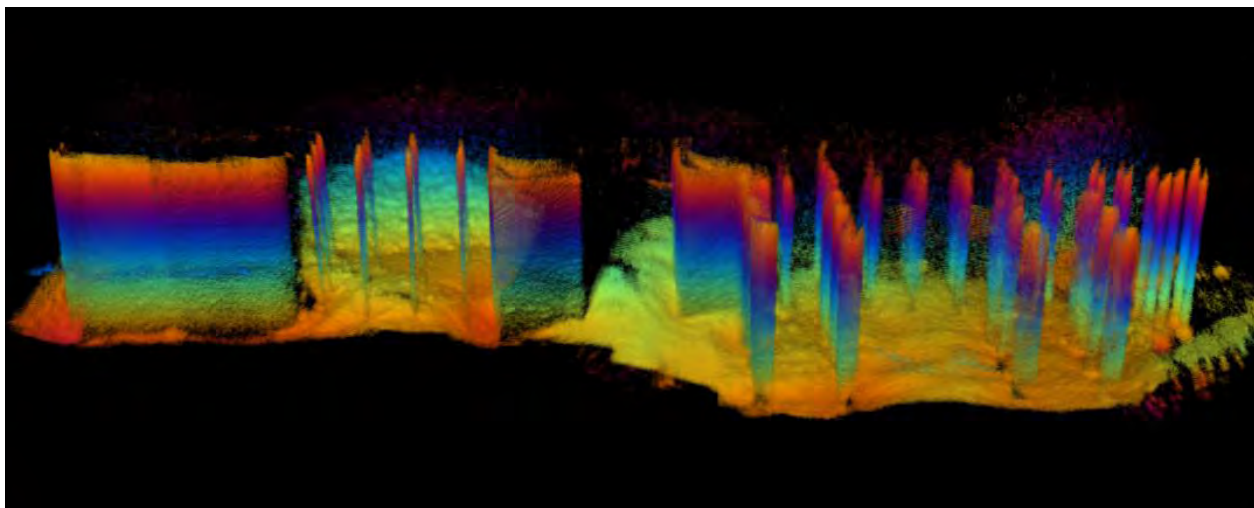
**Figure 65. Image. View of tower 3 from the north.**

Water depth at tower 3 at the time of the inspection by team A was approximately 50 ft (15 m) on the west side and 80 ft (24 m) on the east side. A plan view of the sonar results is shown in figure 64. Figure 65 and figure 66 show views from the north and the south, respectively.

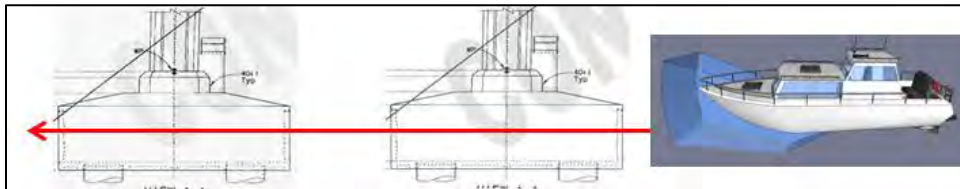
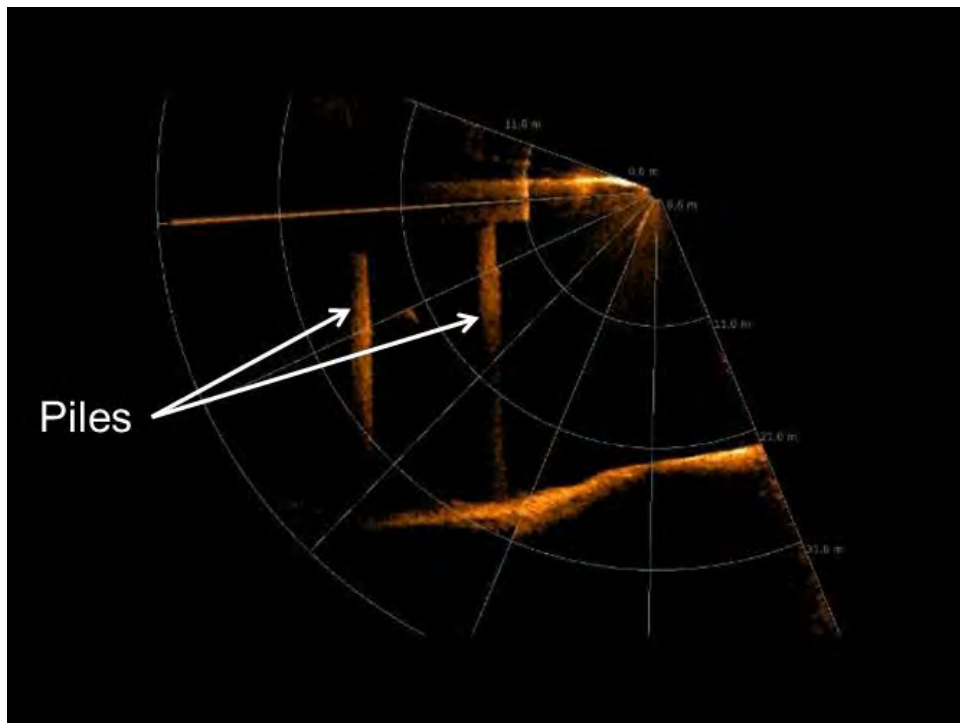
**Figure 67. Image. 2D image from an eastward scanning pass.**

Inspection team B performed a combination of 2D and 3D scanning of the 2003 Carquinez Bridge. An example of the 2D imaging is shown in figure 67. The figure is an image of the north pilings imaged as the boat was traveling from west to east using the 2D multibeam sonar in the vertical orientation. An example of 3D imaging is shown in figure 68 where several signs of debris are apparent.

Overall, the inspection team reported little evidence of scour and moderate levels of debris to the west with little debris elsewhere. No indication of structural damage was identified.

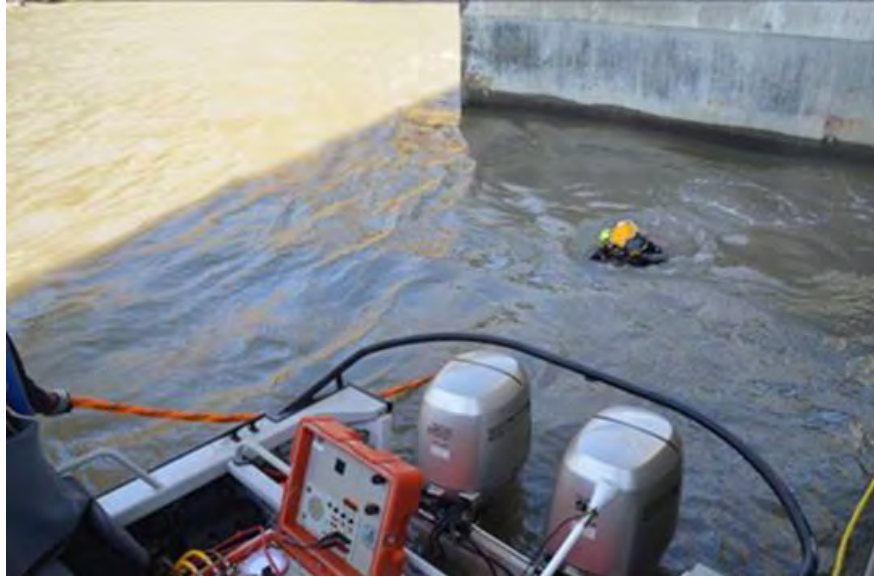
**Figure 69. Photos. Wave and current condition during the diving operation.**

With respect to the diving team at the Carquinez Bridge, the first dive was timed close to a slack tide. Overall, the current was manageable, but challenging for the divers. Examples of the water surface conditions are shown in figure 69. In addition, the depth was approximately 90 ft (27 m). The diver used the maximum amount of time allowed for the depth (30 min) to inspect one pile including one level II cleaning. The second dive occurred at a time between slack tide and maximum current. Inspection was nearly impossible because of the current. While the estimated current was likely between 2 ft/s (0.6 m/s) and 3 ft/s (0.9 m/s), the diver reported experiencing an approximately 4 ft/s (1.2 m/s) equivalent current. Based on the post-dive description and observation of the flow condition, it was hypothesized that the blockage caused by the massive pile cap might have produced a high velocity area some distance below the bottom face of the pile cap. This condition was hazardous for the diver.

In order to increase the dive time the depth of the second dive was set at 60 ft (18 m). This allowed a dive time of 57 minutes. However, the diver found it extremely difficult to hold onto the 9.8 ft (3 m) pile to maintain position. The diver managed to complete the inspection of pile 8 down to a 60 ft (18 m) depth in approximately 10 minutes. The diver then attempted to switch to pile 9, but found it extremely difficult to maintain a position. After approximately 20 minutes, the diver was exhausted and requested pull-back.

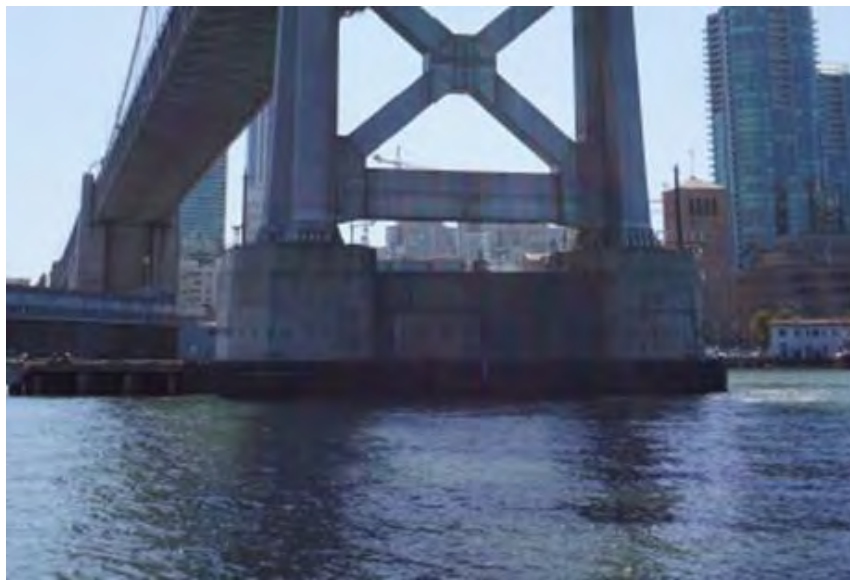
**Figure 76. Photo. Pier W2 viewed from the east.**

The SF–OBB, west span carries traffic over the San Francisco Bay between Yerba Buena Island and San Francisco. The bridge consists of six suspension spans. The superstructure is supported by two abutments and five intermediate piers. The piers consist of submerged concrete cofferdams beneath concrete pedestals that support the steel towers. The piers are numbered from west to east, with pier W2 (figure 76) adjacent to San Francisco and pier W6 (figure 77) adjacent to Yerba Buena Island.

The caisson on pier W2 includes remnants of sheet pile, probably from the construction of the coffer dam. Also contained within close proximity to the west side of pier W2 are piles supporting a remnant of the old Wharf Pier 24, which had been truncated during the construction of the west span of the SF-OBB.

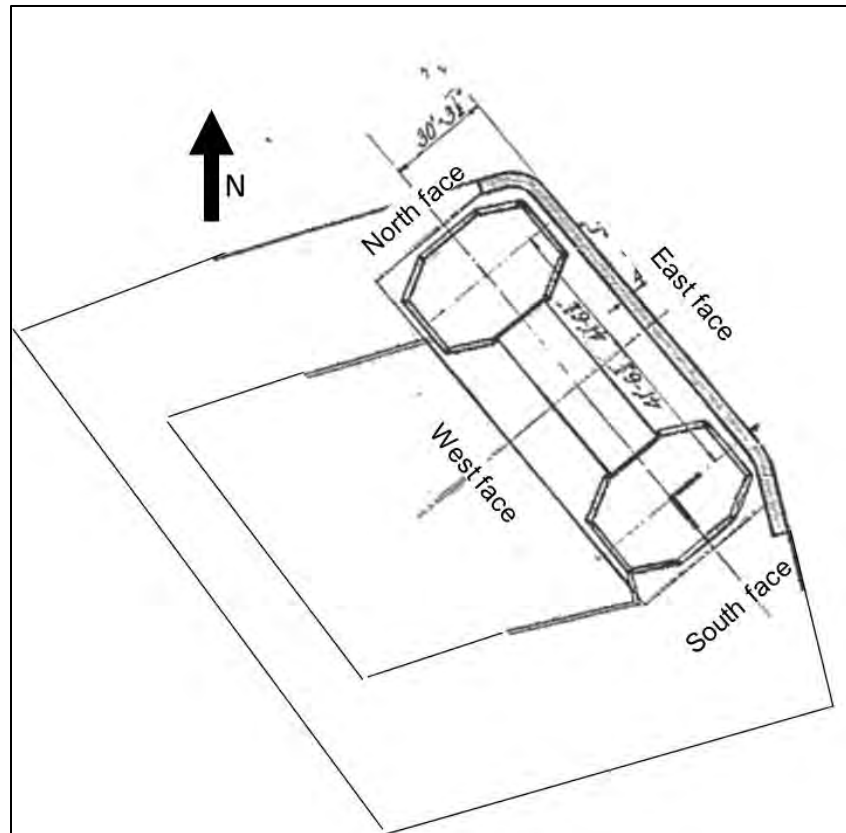
**Figure 78. Drawing. Plan view schematic of pier W2.**

A schematic of pier W2 is provided in figure 78. The directional faces referenced in the inspection reports are also defined in the figure. Inspection findings from the dive inspection and the three sonar inspections performed as part of this study are described in this section and are summarized in table 12. The summary includes overall conclusions of the inspection, observations related to bed forms, scour, or objects identified, as well as materials conditions and defects.

The dive inspection report noted occurrences of exposed reinforcing steel. On the south face, random reinforcing steel measuring up to 1.5 inches (38 mm) in diameter was encountered in some voids. The report also noted exposed reinforcing steel on the north face.

All three sonar inspection teams reported that the submerged portion of pier W2 was in fair to good condition. Each noted that the general concrete condition is normal for in-service, sheet pile formed concrete piers of this size and age. They noted bands of voiding in pier W2, but concluded they were not sufficient to independently pose a significant threat to the integrity of a pier of this size. The teams made no repair recommendations.

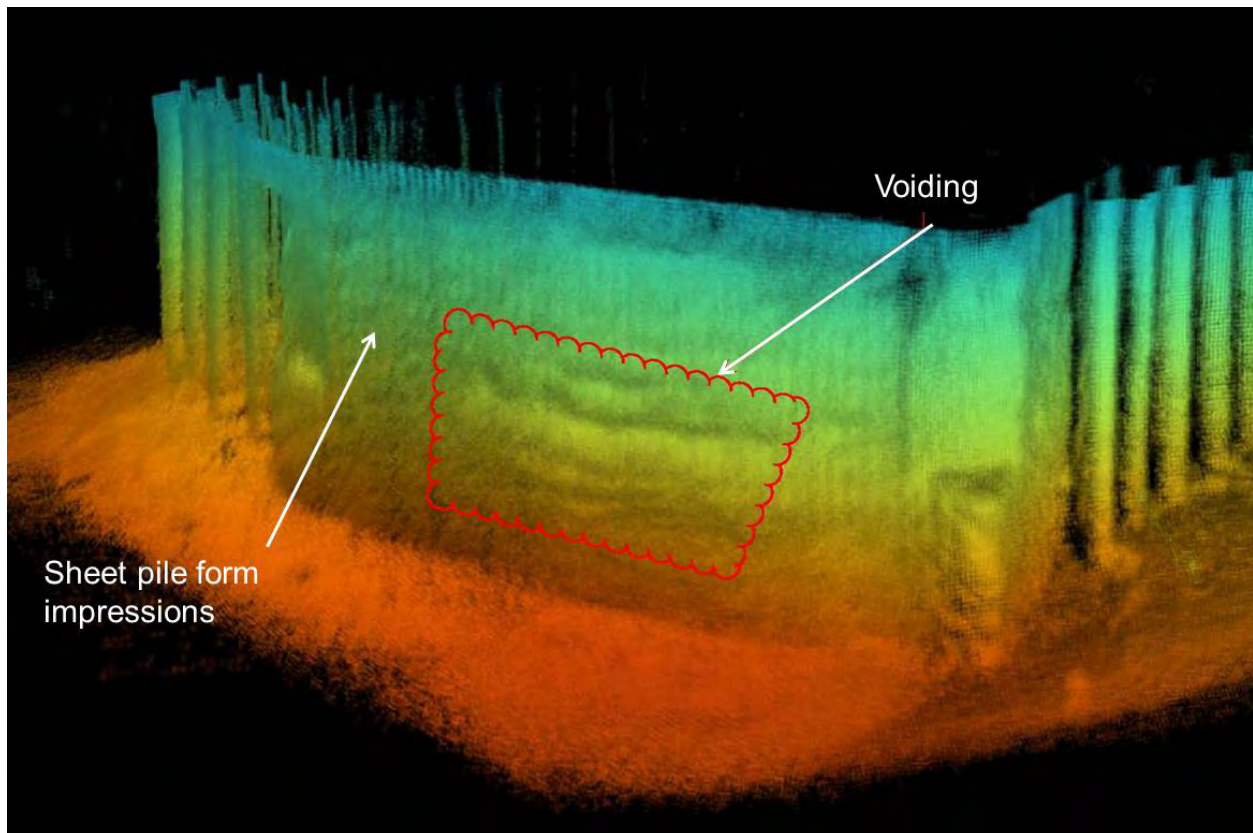
**Figure 79. Image. Pier W2 viewed from the east.**

The piles from old Wharf Pier 24 prevented access to the south and west faces of the concrete caisson for inspection team A. Team A reported that sheet pile form impressions were visible on all inspected faces (east and north) of pier W2. As shown in figure 79, the underwater acoustic imaging results show areas of voiding along the east face of pier W2. These horizontal bands varied in size, up to a maximum of 50 ft (15 m) long by 4 ft (1.2 m) high by 1.5 ft (0.46 m) deep, and are located near the center of the east face, ranging from approximately 10 ft (3 m) above the channel bottom to approximately 30 ft (9 m) above the channel bottom.

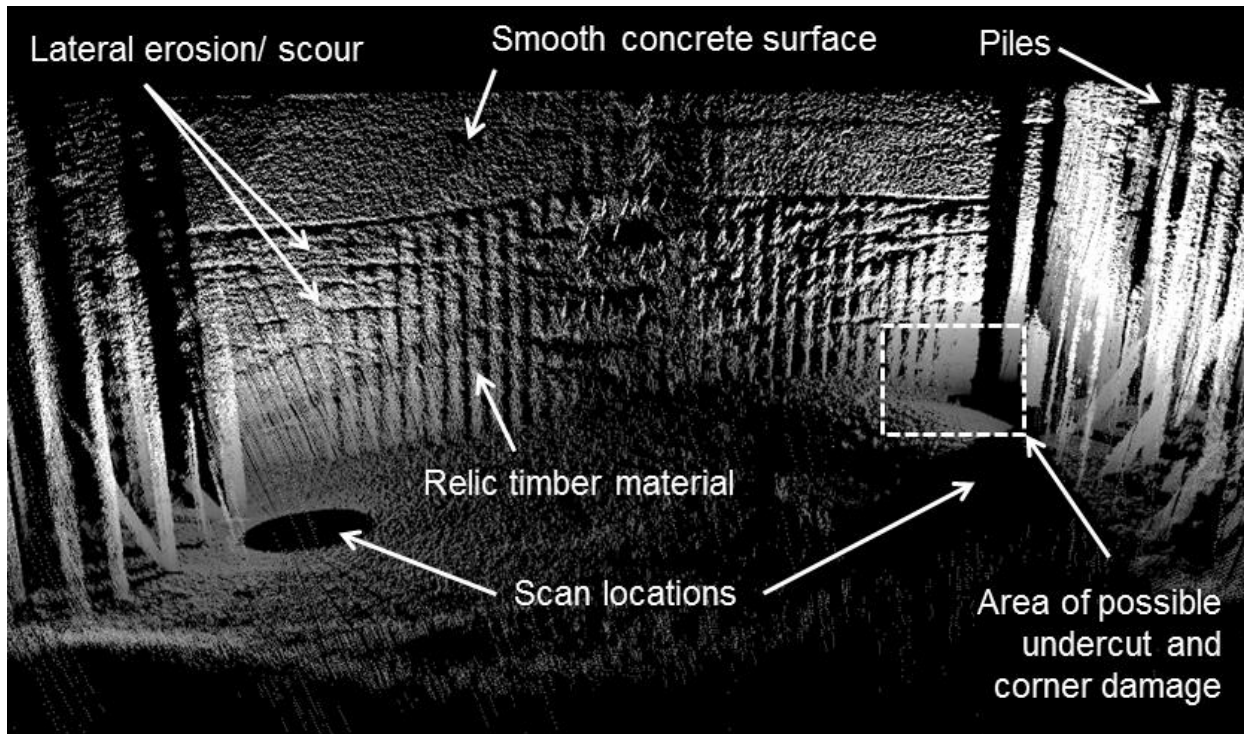
**Figure 80. Image. Pier W2 3D data viewed from west.**

Inspection team B reported that much of the sheet pile appears to have deteriorated from the submerged portions of the caisson at pier W2. As shown in figure 80, there were intermittent horizontal bands of voiding in the concrete caisson throughout the lengths of the entire east and west faces, with a maximum height of approximately 6 ft (1.8 m) and a maximum depth of approximately 1 to 2 ft (0.3 to 0.6 m). On the east face, the voids were most prominent at approximately 15 ft (4.6 m) and 30 ft (9.1 m) above the channel bottom. On the west face, the voids were evident beginning just below the top of the sheet pile form and extending down to approximately 8 ft (2.4 m) above the channel bottom near the center of the face. These voids were also visible on the northeast and southeast corners of the caisson.

analyst identified the transition from smooth concrete in the upper portion of the image to where the original concrete forms had been removed. They further identified numerous lateral erosion pockets, which were easily discernable in the data.

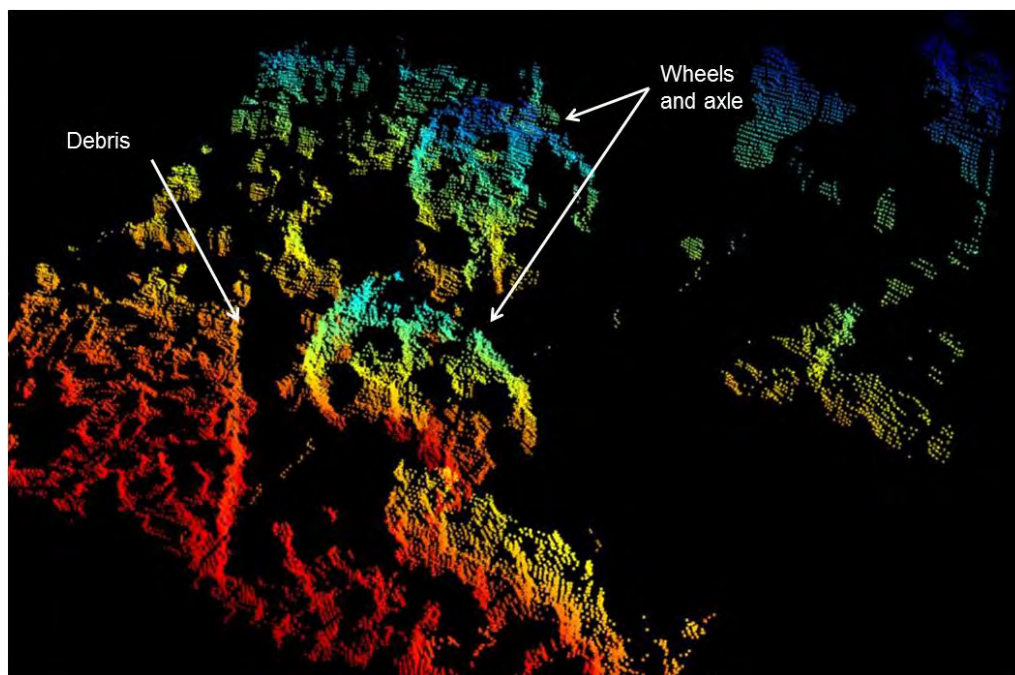
**Figure 81. Image. Detail at bed near pier W2.**

Inspection team B also identified debris on the bed near pier W2. The image in figure 81 shows evidence of debris including an axle with a pair of wheels.

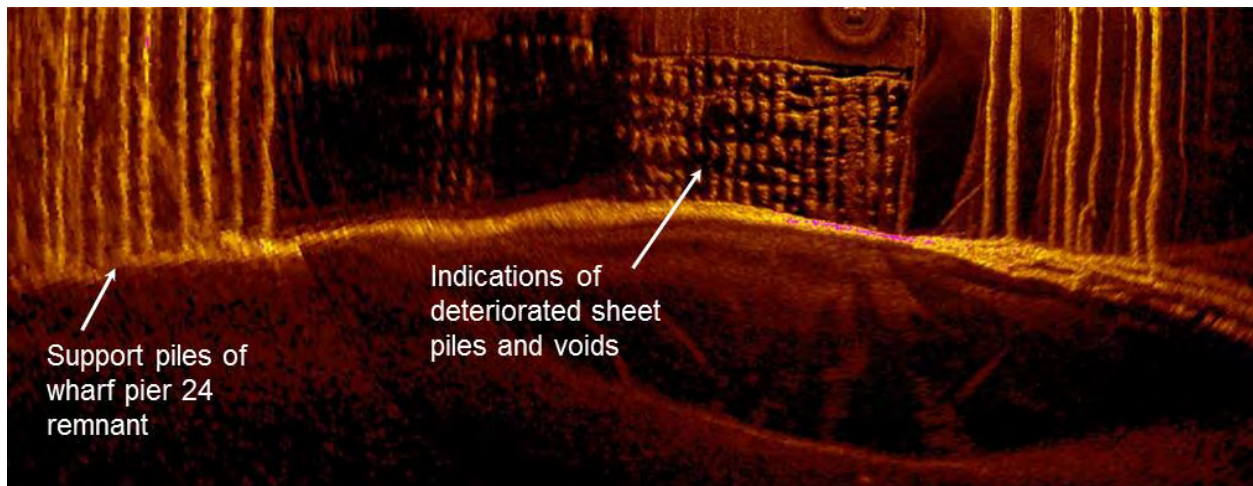
**Figure 82. Image. Southeast corner of pier W2.**

Inspection team C reported that the imaging results showed sheet pile form impressions at pier W2. They noted that much of the sheet pile appeared to have deteriorated from the submerged portions of the caisson at pier W2 as shown in figure 82. They further observed that there were intermittent horizontal bands of voiding in the concrete caisson and that they varied in size, up to a maximum of approximately 50 ft (15 m) long by 8 ft (2.4 m) high by 2 ft (0.6 m) deep. On the east face, the voiding was visible beginning near the top of the sheet pile form, and extended down approximately 15 ft (4.6 m). On the west face, the voiding was found throughout the entire submerged height of the sheet pile formed caisson. These voids were most prominent on the east

and west faces of the pier, but were visible in varying degrees on all of the scanned faces. The remaining sheet pile appeared to be delaminating from the pier.

The dive team and all three sonar teams drew the same general conclusions regarding the overall stability of the underwater portions of pier W2: voids were common, but nonthreatening, and scour was not evident. The sonar teams also noted aggradation at the southeast corner of the pier (visible in figure 82), but this was not reported by the dive team. Except for sonar team A, all inspection teams were able to access all four pier faces.

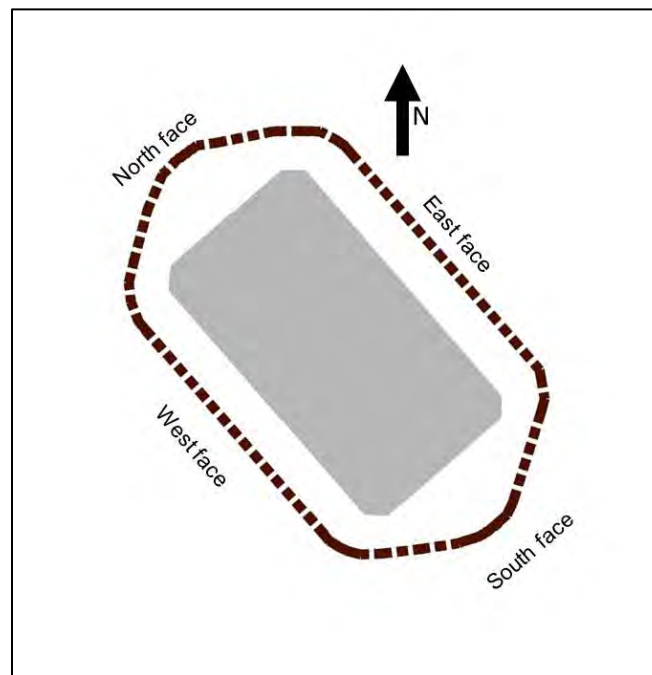
**Figure 83. Drawing. Plan view schematic of pier W6.**

The report from the 2013 dive inspection concluded that there were no structural deficiencies that could jeopardize the structural integrity of pier W6. However, the inspection could draw no

conclusions regarding scour because the dive range was limited to a depth of 100 feet and the channel bottom was at a depth of approximately 130 ft (40 m). The lower 30 ft (9.1 m) of the pier surface and the channel bed were not inspected by the divers.

For the surfaces of pier W6 that were inspected, the dive inspection report noted that the concrete surfaces were typically smooth and sound with no significant deterioration noted down to a depth of 35 ft (10.7 m). Below 35 ft (10.7 m) timber formwork was observed around the concrete to the lower dive limit of 100 ft (30.5 m). The formwork, while deteriorating in some areas, covered 95 percent of the pier face between depths from 35 to 80 ft (11 to 24 m) and covered 90 percent between depths from 80 to 100 ft (24 to 30 m). The report described the formwork as a well-defined surface of diagonal 1 ft by 1 ft (0.3 m by 0.3 m) members on the south and north faces and as more irregular with mostly 1 ft (0.3m) vertical timber members on the west and east faces.

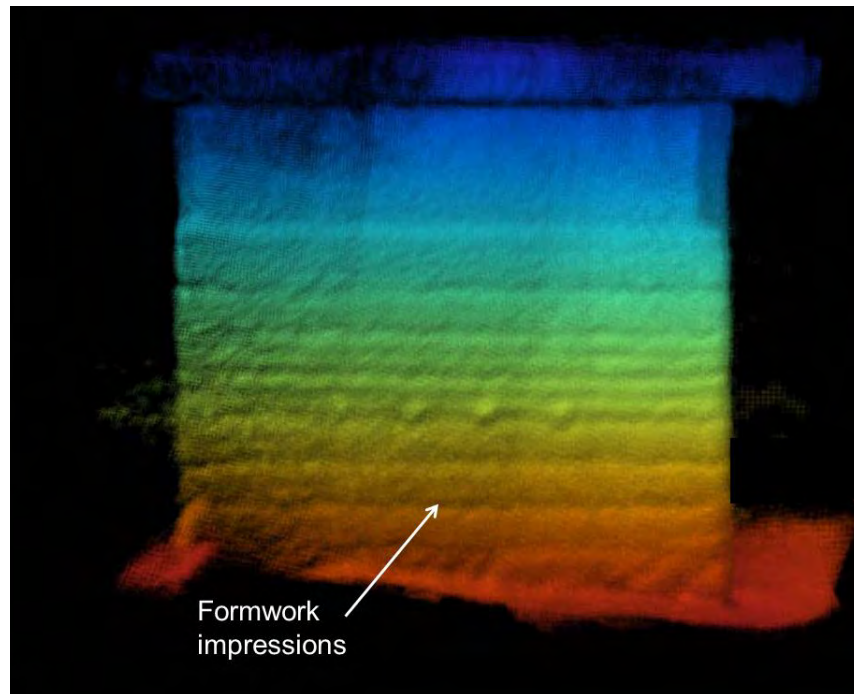
**Figure 84. Image. Pier W6 viewed from the west.**

Inspection team A reported that there were no significant deficiencies visible at pier W6. The report identified that formwork impressions are visible on all submerged faces of the caisson as shown in figure 84. The change from the smooth concrete to the formwork is visible in the figure.

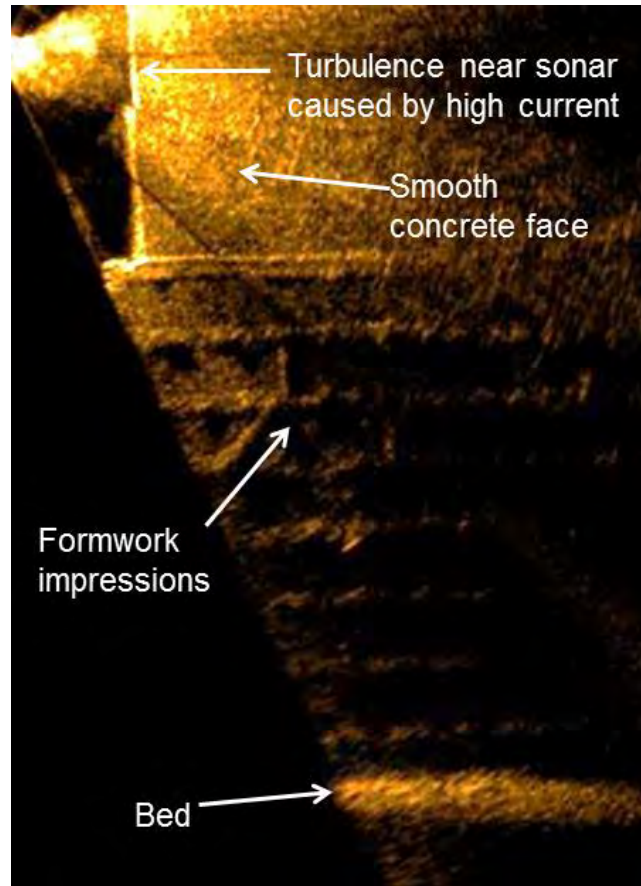
**Figure 85. Image. South face of pier W6 in a 2D sonar image.**

Inspection team B noted formwork impressions visible on the submerged caisson as shown in figure 85. A possible area of abrasion is distinguishable at the southeast corner, near the top of the caisson, just below the step-out.

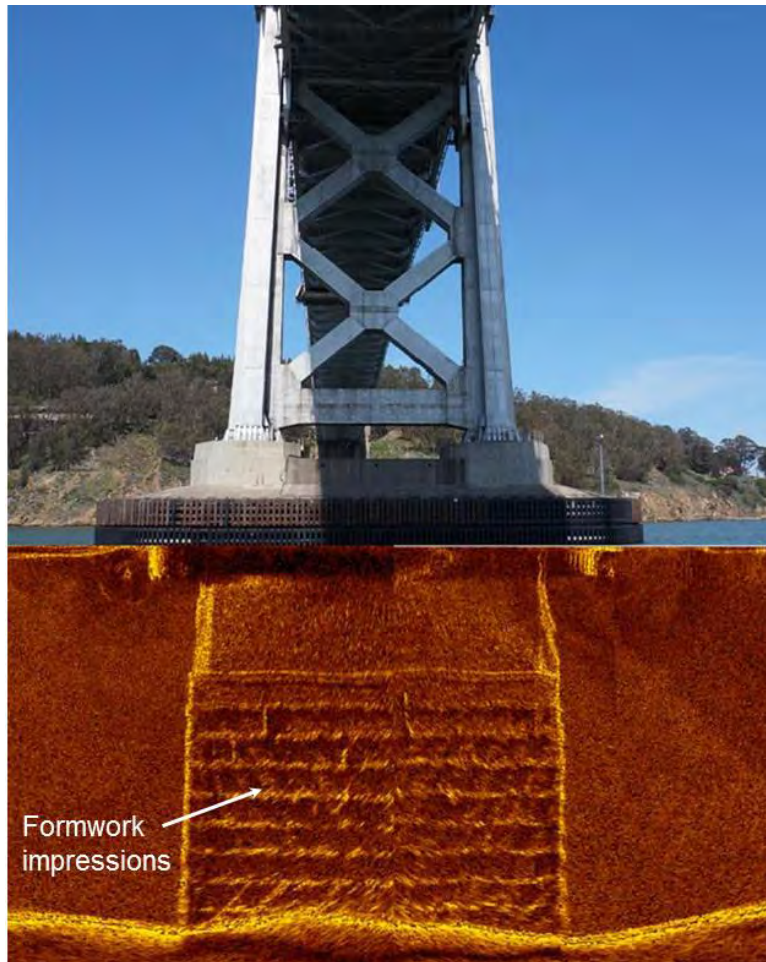
**Figure 86. Image. West face of pier W6.**

Inspection team C also noted formwork impressions visible on the submerged caisson at pier W6 as shown in figure 86. There are also possible diagonal sheathing remnants or impressions visible on the south and west faces near the southwest corner.

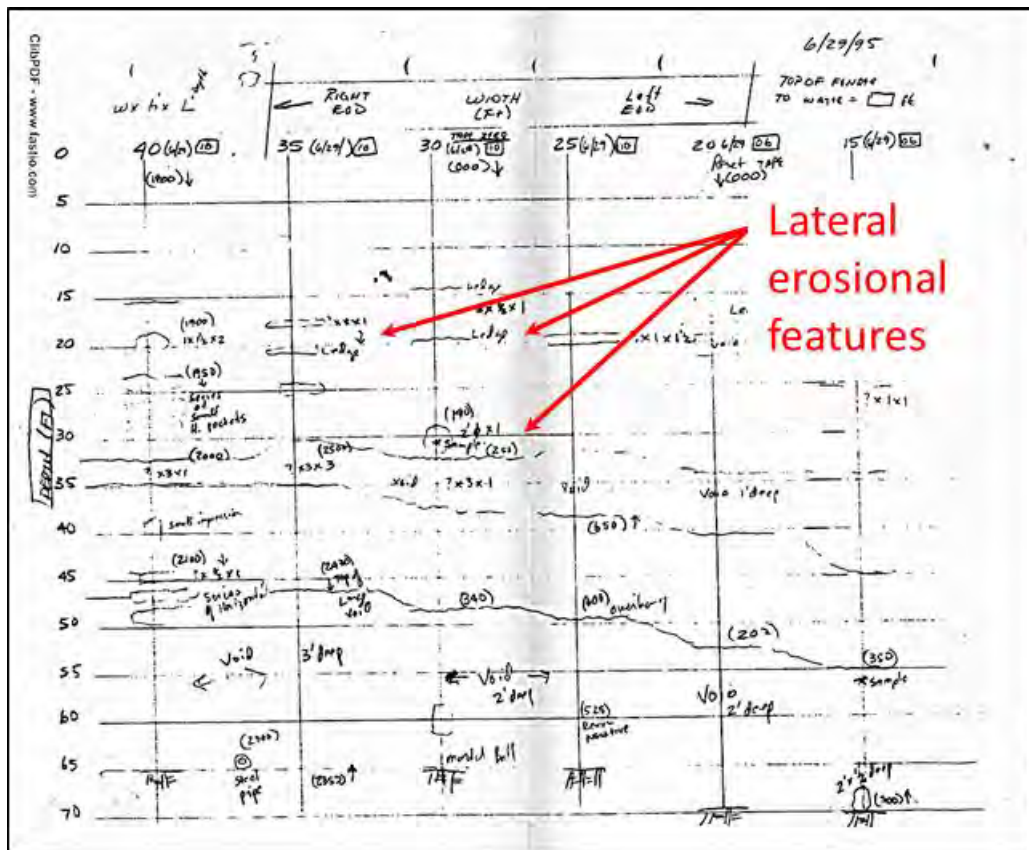
Figure 87. Image. Page from the 1995 diver inspection report on SF-OBB pier W2.

Analysts from sonar team B noted that the 1995 dive inspection report pertaining to pier W2 showed many linear features as shown in figure 87. They stated that similar features are readily noticeable in both the 2D multibeam images and the 3D mechanical multibeam point cloud data. For example, the analyst estimated that the lateral erosion was approximately 2 to 3 ft (0.6 to 0.9 m) deep from the image shown in figure 88. In addition, using the image shown in figure 80, the
