# Underwater Inspection of Bridge Substructures Using Imaging

# Underwater Inspection of Bridge Substructures Using Imaging Technology

June 14, 2018

**Sponsored by**  
Federal Highway Administration  
Office of Infrastructure  
FHWA-HIF-18-049

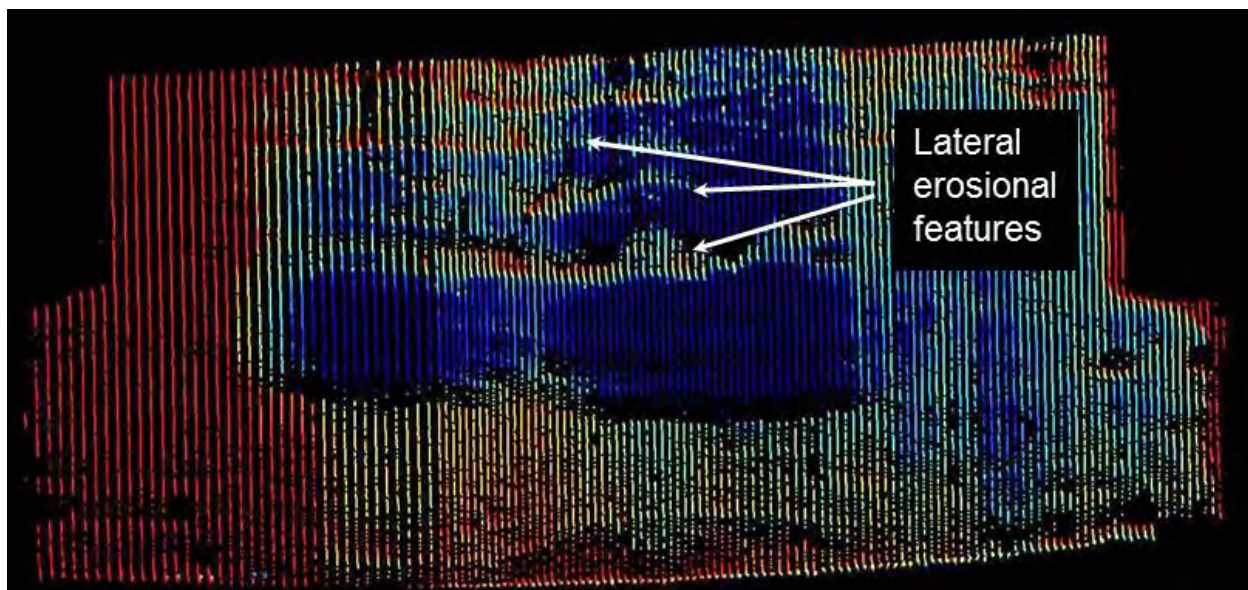
**Figure 88. Image. 2D multibeam point cloud data of the east face of the W2 pier.**

Analysts from sonar team B noted that the 1995 dive inspection report pertaining to pier W2 showed many linear features as shown in figure 87. They stated that similar features are readily noticeable in both the 2D multibeam images and the 3D mechanical multibeam point cloud data. For example, the analyst estimated that the lateral erosion was approximately 2 to 3 ft (0.6 to 0.9 m) deep from the image shown in figure 88. In addition, using the image shown in figure 80, the

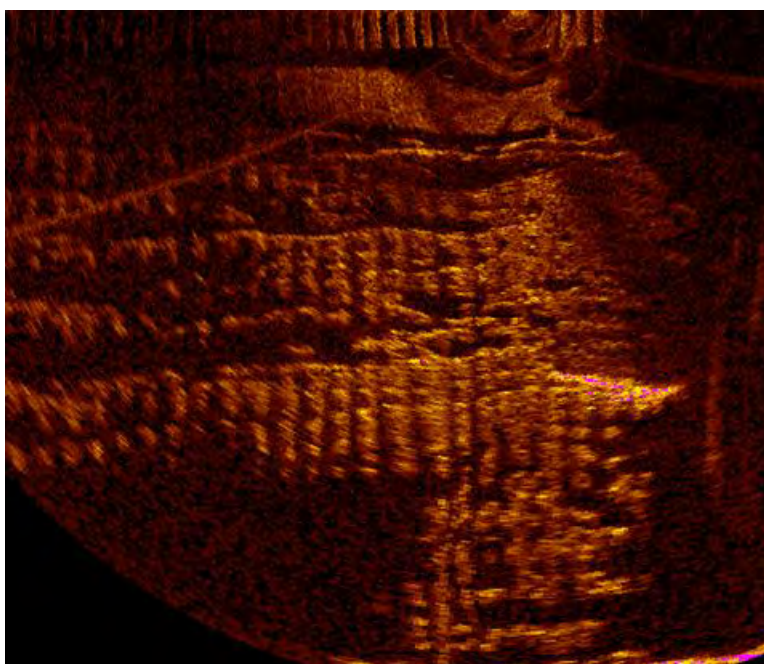
**Figure 89. Image. Close-up view of the east face of pier W2.**

The reanalysis noted that the close up views, such as the one shown in figure 89, revealed the deteriorated concrete and voids that number far more than the dive reports indicated and are too numerous to detail in light of the lack of structural significance. However, they maintained that it is possible to estimate penetration depths and to document each specific spall and void with the equipment and software used by team C.

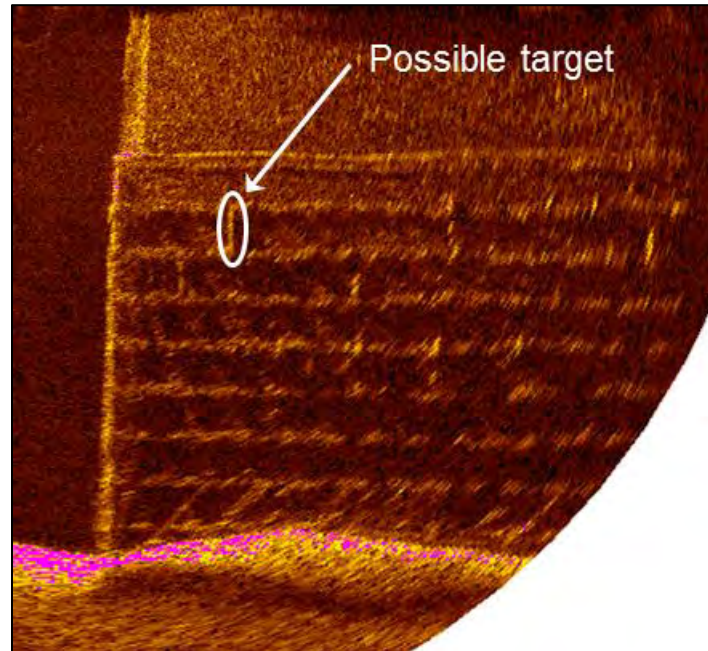
**Figure 90. Image. South face of pier W6.**

The reanalysis by inspection team C also resulted in several observations regarding the planted targets on pier W6. The analyst observed that while there is a signature shown in figure 90 that is in the correct location and exhibits the appropriate dimensions for planted target 2 (a 7 ft (2.1 m), 3/8-inch (9.5 mm) chain), the nature of the object, if present, could not be identified. Several other linear articles of debris hanging on the pier are observed in the sonar images. The analyst noted that this is typical so it is not practice to call out each article of debris if it is not of consequence to the structural integrity.

In addition, the analyst speculated that the targets were not placed on pier W6, but on a different pier. The targets were planted in 2013 and the analyst notes that there was a pier designation change for the pier W6 inspection that occurred in early March of 2014 the month before the sonar inspection. However, there is no documentation supporting this assertion.

Further, the analyst from team C observed that there is no indication in the sonar imagery of the diagonal wood formwork around the caisson reported by the dive team. To the contrary, there is the observed characteristic typical of remnants of a concrete pour that has squeezed through horizontal formwork. The analyst suggested that the sonar indicated that the formwork is no longer surrounding the pier.

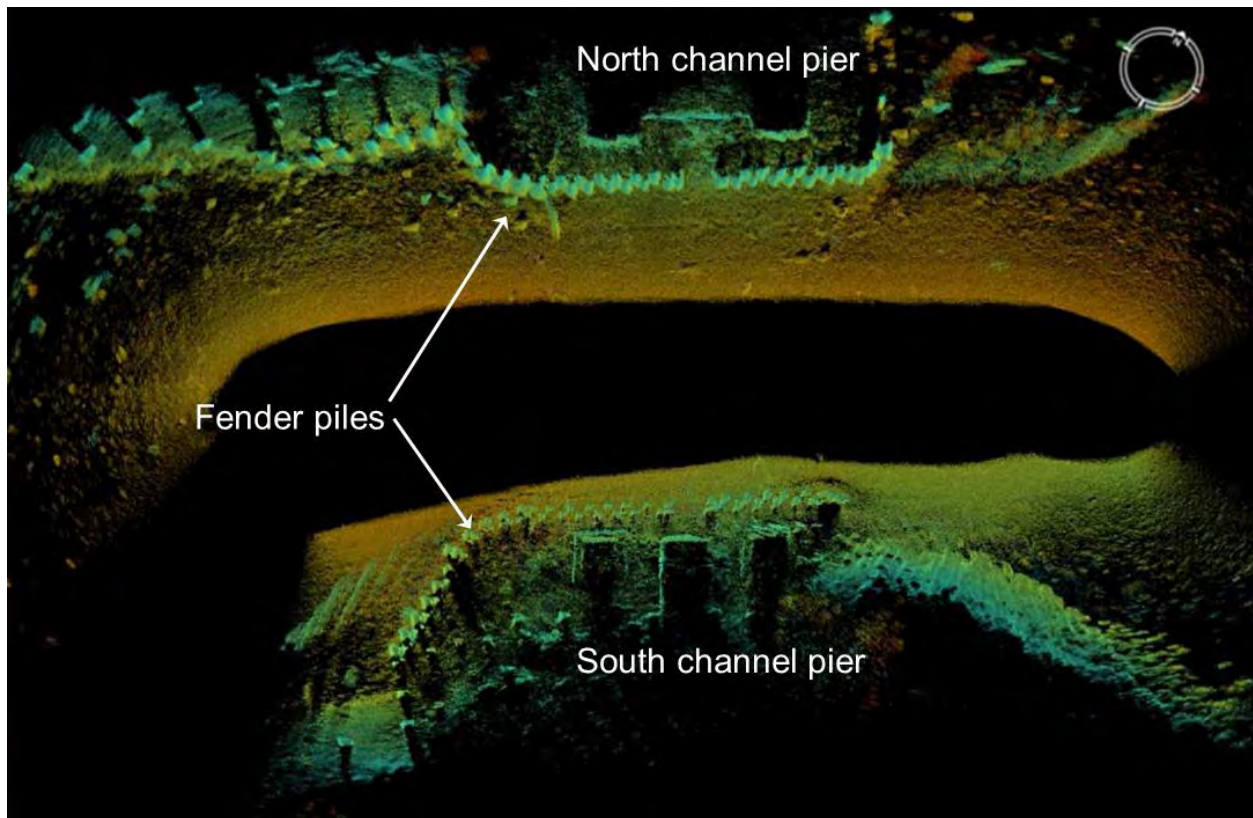
Figure 93. Image. North and south piers of the Third Street Bridge.

An image of both piers from sonar inspection team A is shown in figure 93. The report from sonar team A states that acoustic imaging of both the south channel pier (figure 94) and the north channel pier (figure 95) revealed no major deficiencies. The team reported that because of limited access, in-depth scanning was limited to the east support (column 2) of the north channel pier.

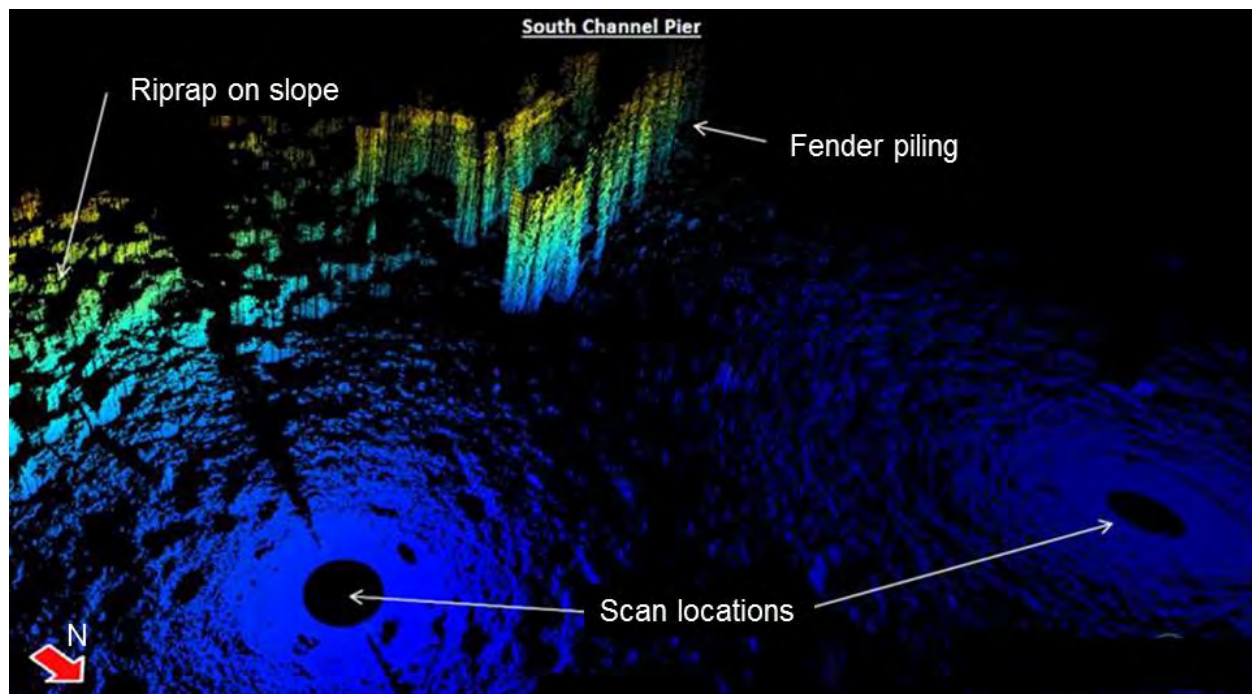
**Figure 96. Image. South channel pier viewed from the northeast.**

Inspection team B noted that because of limited access and time constraints, scanning of the south channel pier was limited to a few scans of the east support (column 2). These images, such as found in figure 96, revealed no significant deficiencies.

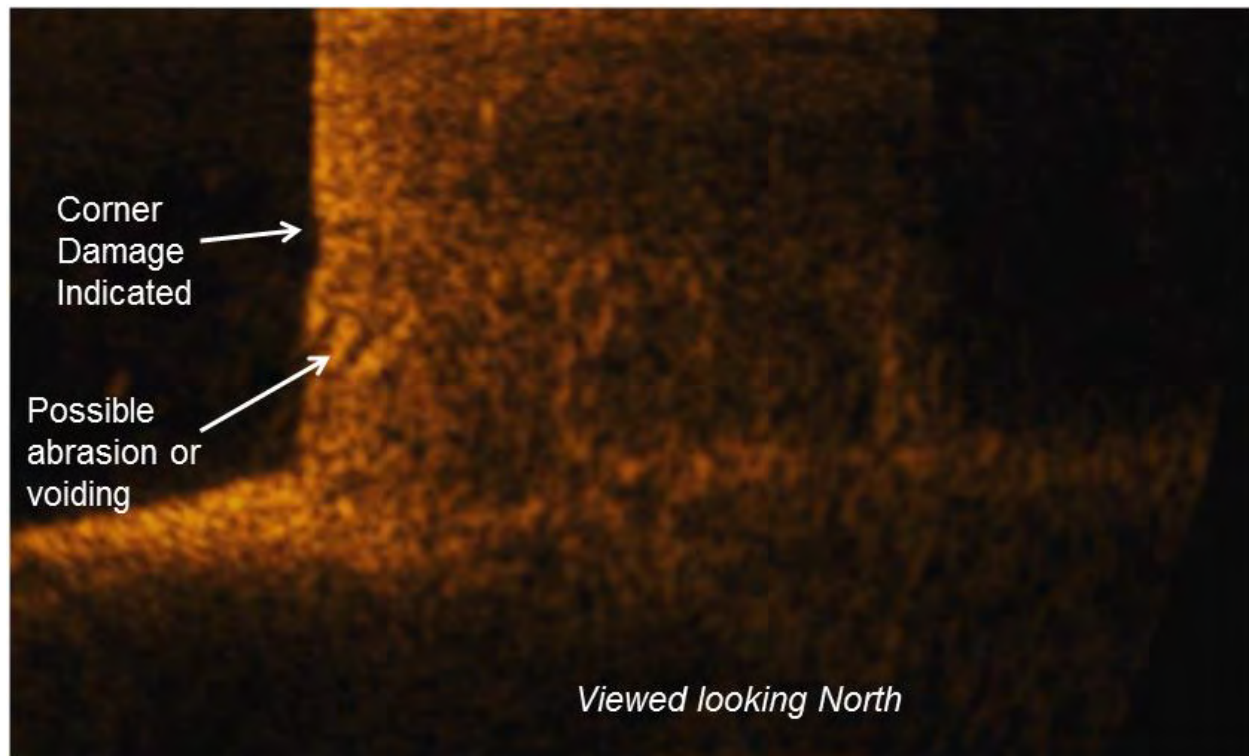
**Figure 97. Image. Detail of south face of west support of the north channel pier.**

With respect to the west support (column 1) of the north channel pier, team B did identify possible abrasion damage or voiding along the west end of the south face as shown in figure 97. This area was reported as approximately 3 ft (0.9 m) long by 2 ft (0.6 m) high and positioned

approximately 5 ft (1.5 m) above the channel bottom. On the northwest corner of the same support column, the report also noted two possible areas of corner spalling or abrasion. These areas were reported as being approximately 1 to 2 ft (0.3 to 0.6 m) high by up to approximately 3 inches (76 mm) deep and located approximately 5 to 8 ft (1.5 to 2.4 m) above the channel bottom.

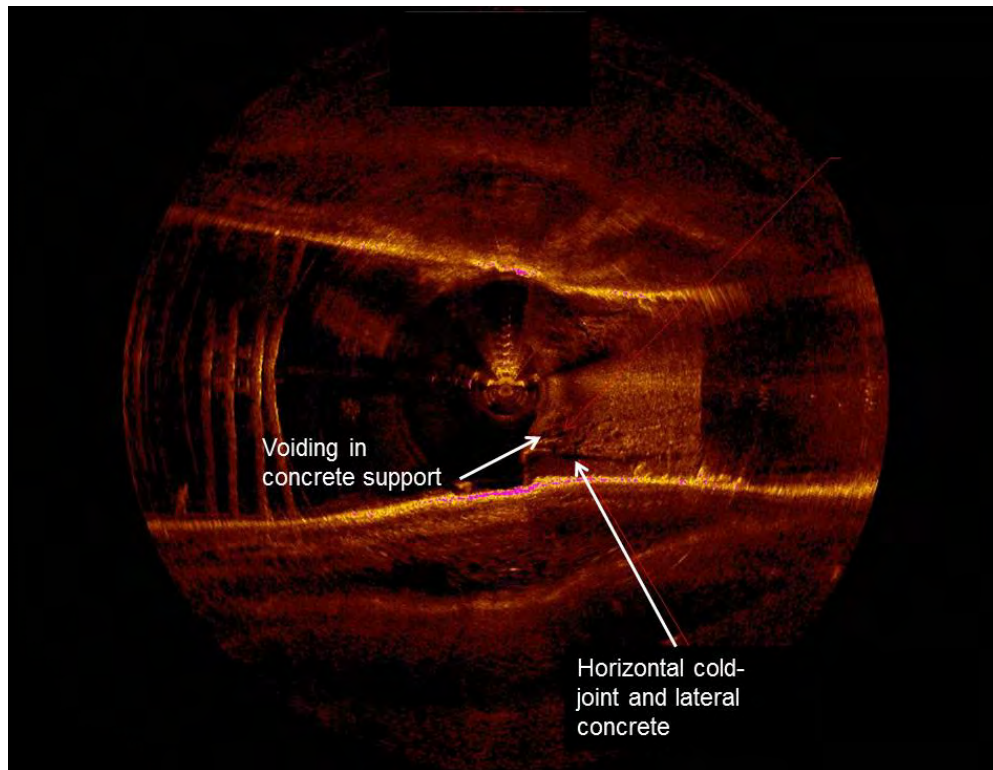
**Figure 98. Image. Raw image of north channel pier, east support, south face.**

At the north channel pier, the inspection report noted horizontal cold-joints and associated latent concrete visible on the supports as shown in figure 98 as well as vertical and horizontal

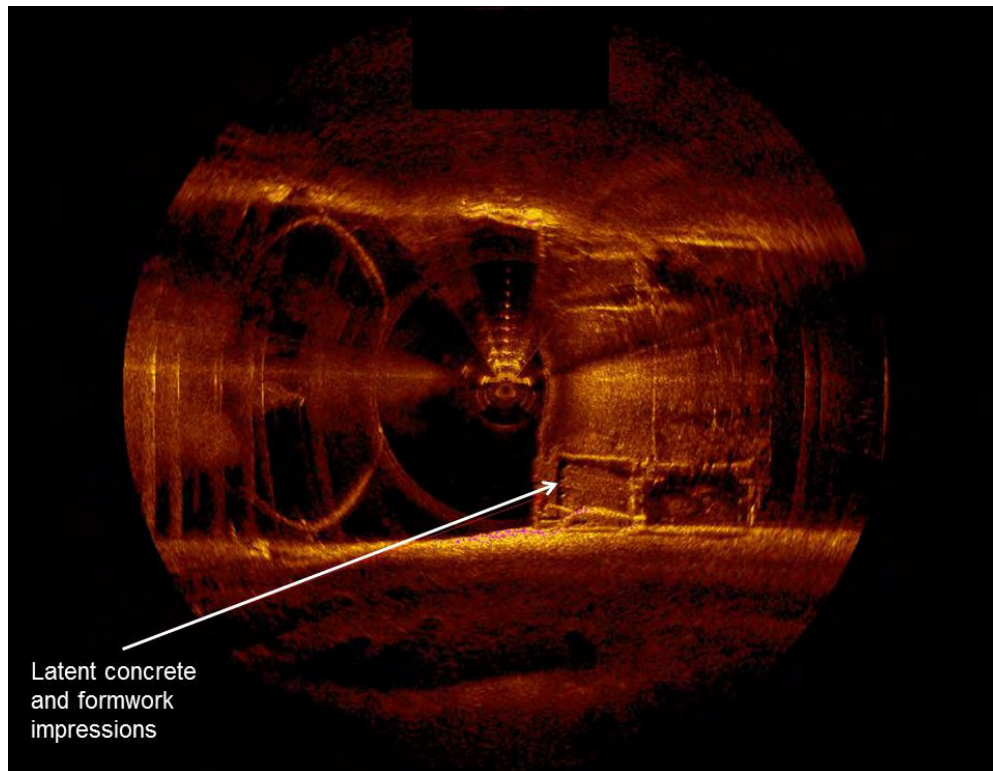
**Figure 99. Image. Raw image of north channel pier, west support south face.**

formwork impressions as shown in figure 99. In addition, the report noted voiding on the east support of the north channel pier. On the east face a void ranging from approximately 0.5 ft (0.15 m) to 2 ft (0.6 m) high located approximately 12 ft (3.7 m) below the top of the concrete support was identified. The report noted this voiding extended intermittently along the entire length of the east face and continued around the northeast corner to the north face for approximately 5 ft (1.5 m). Additional voiding at the east end of the south face approximately 5 ft (1.5 m) long by 6 inches (150 mm) high positioned approximately 19 ft (5.8 m) below the top of the concrete support was reported.
