**43<sup>rd</sup> Turbomachinery  
30<sup>th</sup> Pump SYMPOSIA**

# MORTON-LIKE EFFECT IN A CENTRIFUGAL PUMP

- Two 50% capacity (Pacific 20x17 HVF) pumps were installed in 1984 in a nuclear facility in Louisiana. The pumps were designed with a single-stage double-suction arrangement in feed water service, driven by a steam turbine. Pump rotor supported by tilting pad bearings.

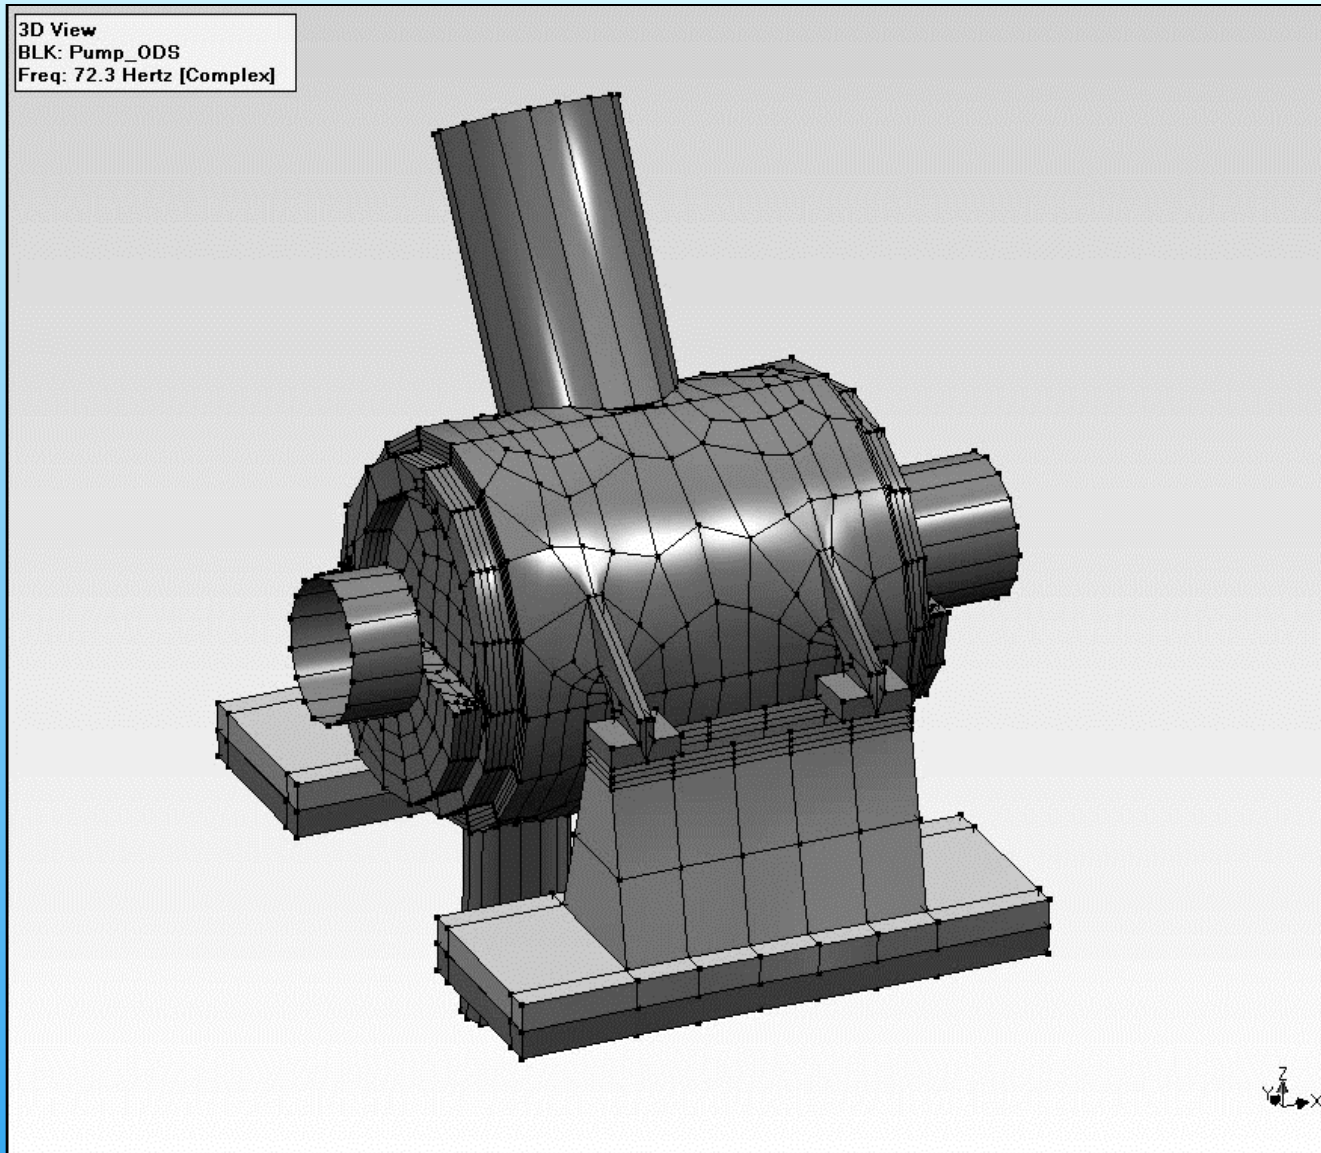
# ODS Animation at 1x rpm (72.3 Hz)

- April 2012, after a major outage, the same pump began increasing shaft vibration at the inboard and outboard end. The pump was completely refurbished during the outage.

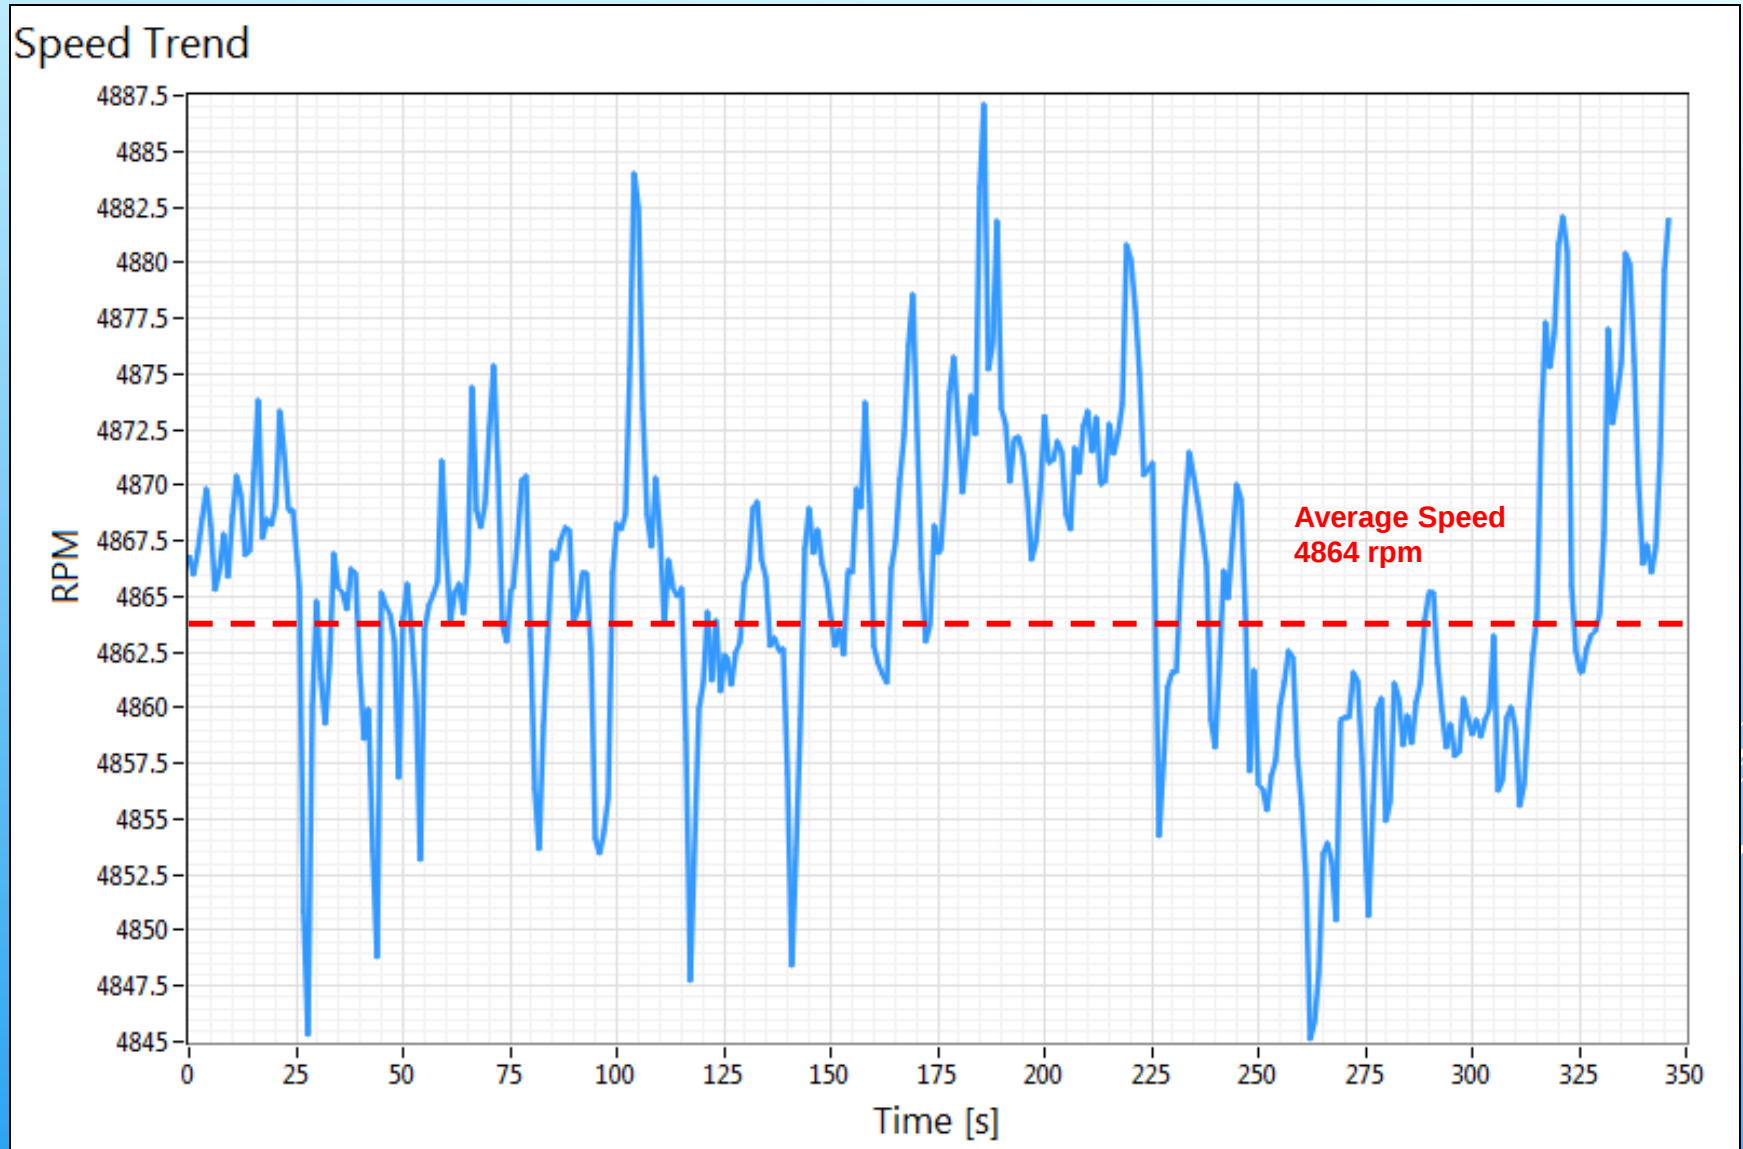
# Vibration Testing – Speed Trend

- The vibration amplitude was not constant. The overall amplitude was fluctuating with a period between 10 to 60 seconds.

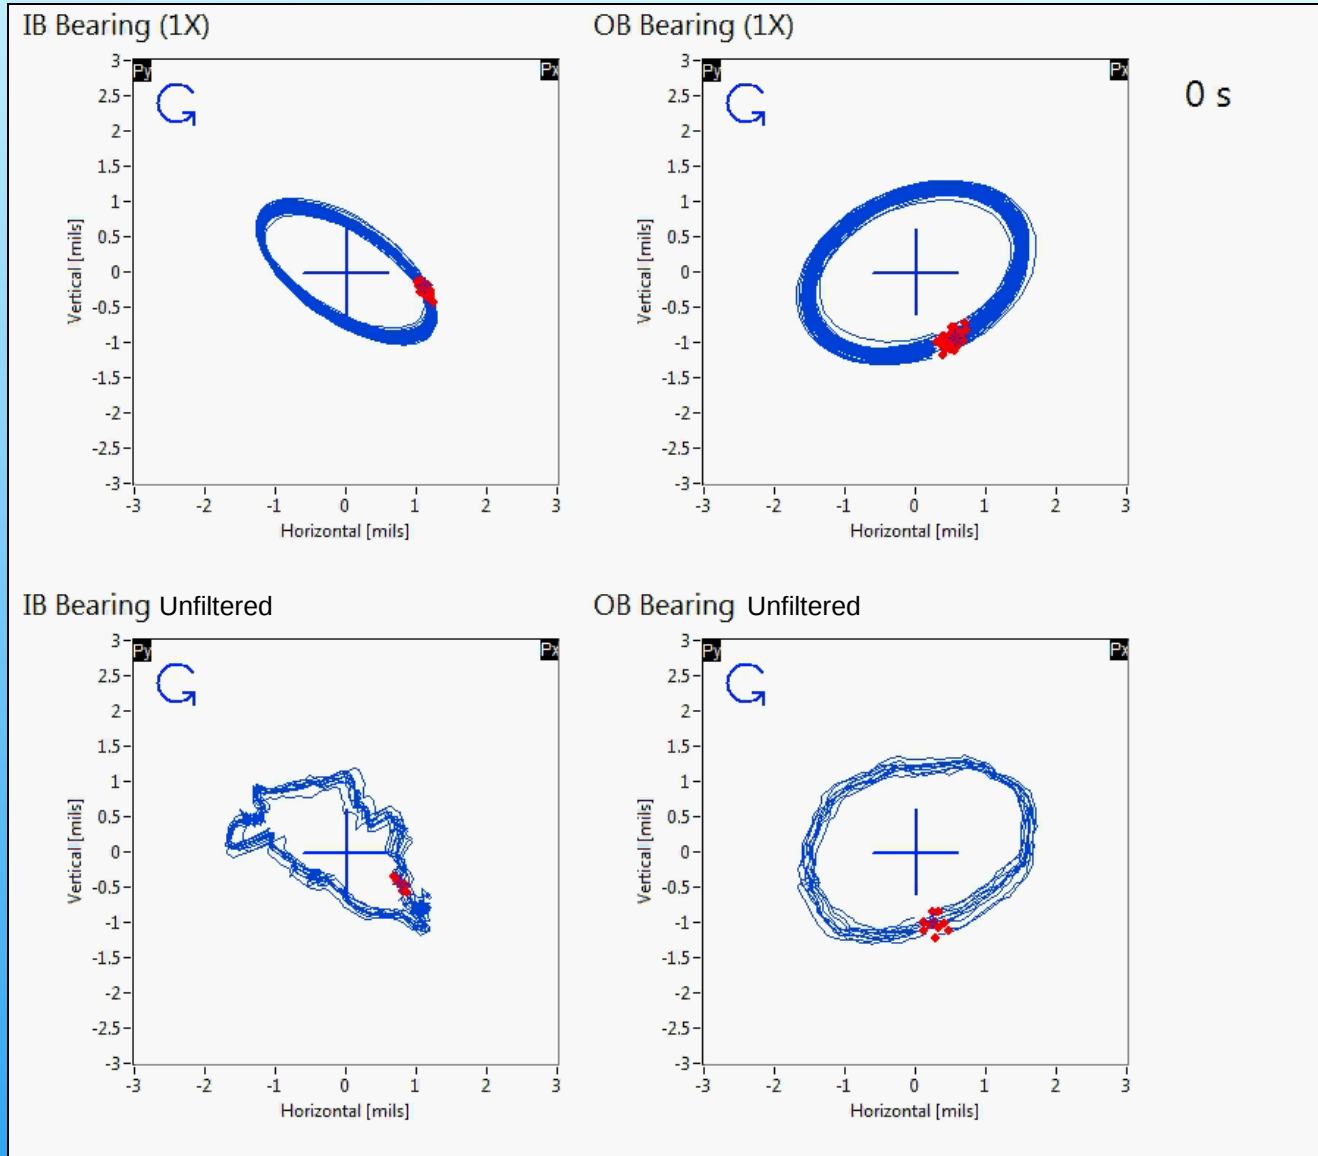
# Vibration Testing – Orbit Plots

- ***Morton-like Effect:*** static imbalance vector (i.e. the steady average mechanical imbalance) combined with a secondary vector (non-constant phase imbalance vector). The secondary (cycling) imbalance vector is produced from a thermal distortion of the shaft in which a localized high temperature area of the shaft travels the full circumference with every vibration swell. The imbalance vectors behaving in this way are what cause the vibration level cyclic trends such as those experienced by the pump.

- This phenomenon is typically caused by either a light rub or a “near rub” (boundary lubrication at the “pinch point”) in a synchronously whirling shaft leading to a “hot spot” on the “heavy side” of the shaft that leads to thermal bow of the shaft, changing the “heavy side” location. Such a condition can occur in either a bearing or a seal, but in the case of a bearing the vibration cycles are typically longer (on the order of 5 to 10 minutes) than observed in the present case.
