ASIA **TURBOMACHINERY** & **PUMP** SYMPOSIUM  
MARCH 2018 | SUNTEC SINGAPORE

# Large Vibrations on Centrifugal Compressor Caused by Inappropriate Operation During Mechanical Running Test

Y. Bidaut, MAN Diesel & Turbo Schweiz AG

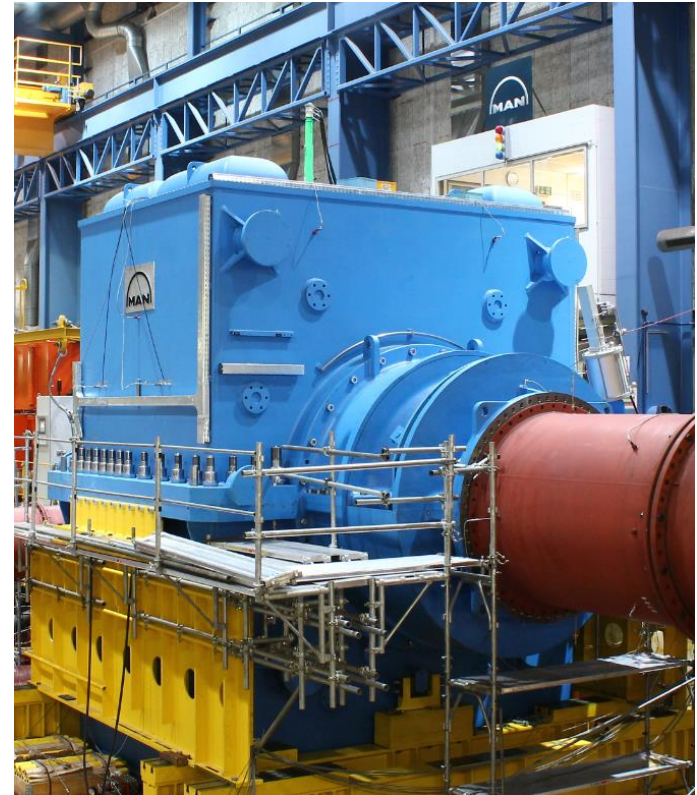
- In house mechanical test in facility test
- Sudden increase of radial vibrations on DE bearing probes → shut-down
- After shut-down
  - Compressor started again
  - Excessive vibration levels

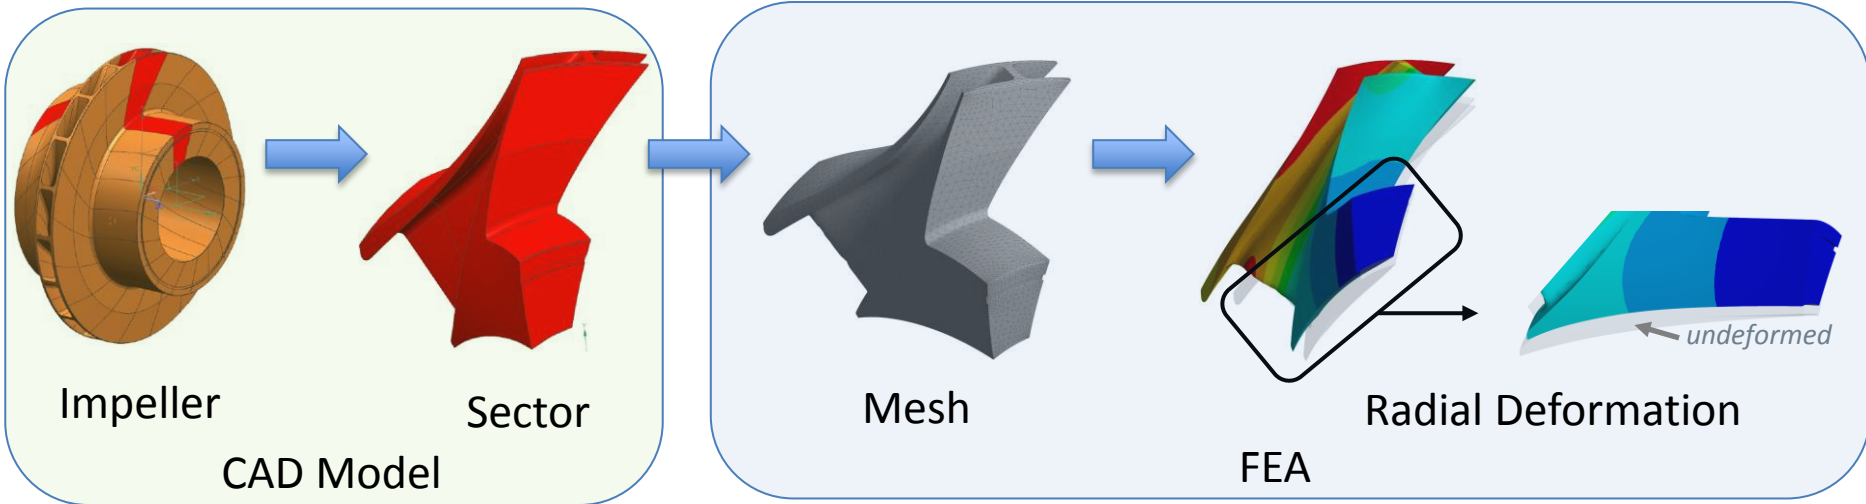
Evaluation of impeller radial displacement at the interference fit due to centrifugal forces

- Current shrink 1.22 ‰ is sufficient for normal operating conditions
- Shrink is not sufficient for operation at  $n_{\text{trip}}$  & surge !

1. Shrink increased from 1.22 ‰ to 1.40 ‰
2. Mechanical test run carried out at trip speed for 15 minutes duration and well outside the stability limit

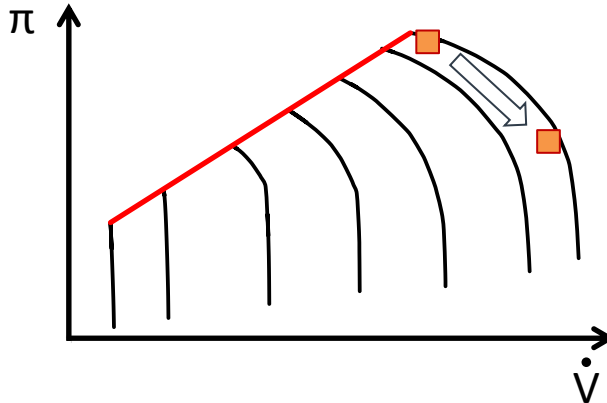
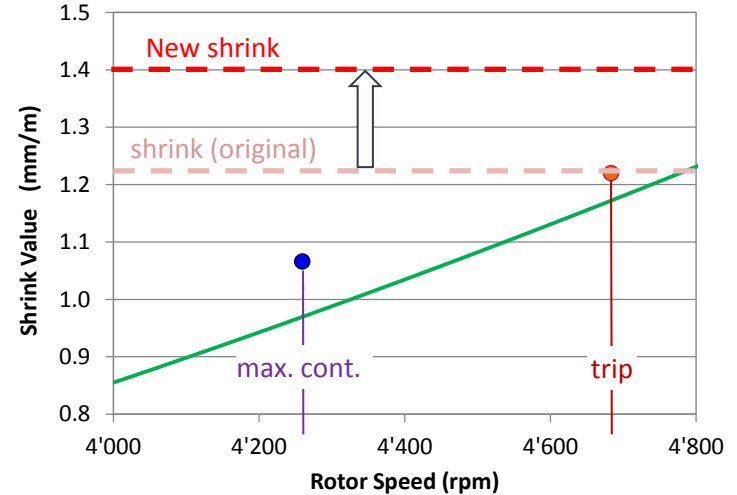
→ No peculiar vibration observed, machine accepted and delivered
