## Manufacturing: ERW Pipe Defects

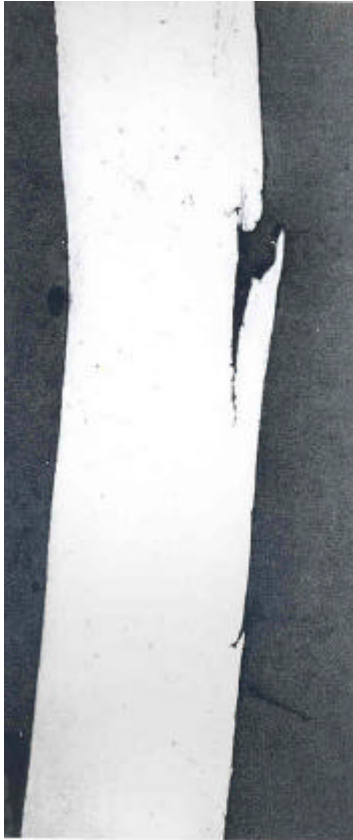
### LAPS

A flap of metal lying flat on the pipe surface, usually with a trapped residue of oxide or scale beneath it.

A metal protrusion that is folded and rolled into the hot metal surface during rolling of the plate from which the pipe is made.

Generally small laps have little or no structural significance. Laps to create holidays, or defects, in thin film coatings. Soluble salts trapped in the scale or oxides beneath the lap may initiate corrosion pitting.

Superficial laps may be removed by grinding before application of the coating.

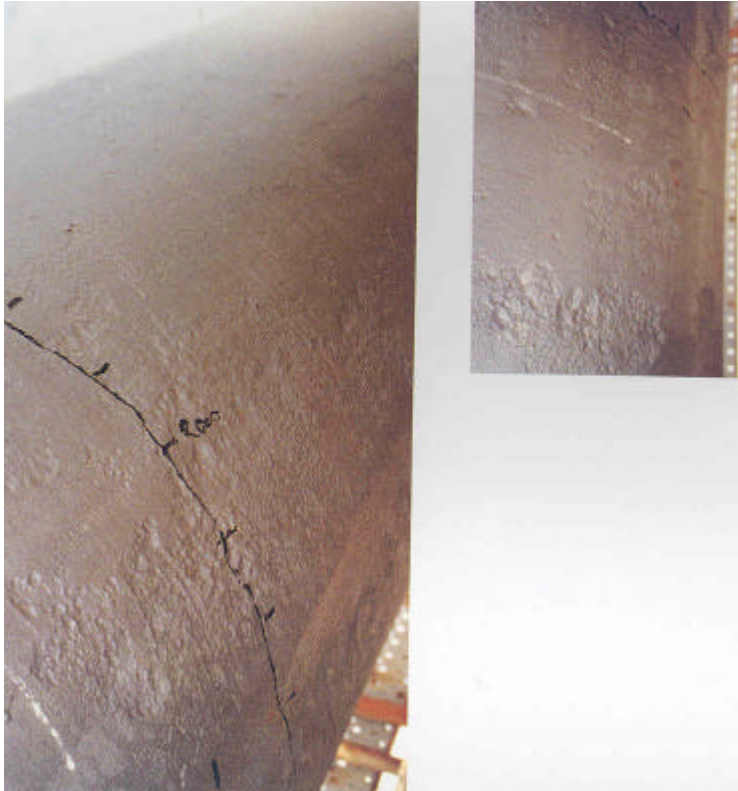
### GENERAL CORROSION

Areas of irregular metal loss or pitting

Coating damage or disbanding combined with ineffective cathodic protection, for example due to shielding of the cathodic protection current under a disbanded coating.

General corrosion may also occur where soil contamination is entrained beneath a field applied coating.

General corrosion on exposed steel can be controlled by an effective cathodic protection system. General corrosion due to water ingress under a disbanded coating may not be controlled by cathodic protection due to shielding effect of the coating. In this situation the corrosion problem can only be identified, reliably, by intelligent pig inspection.

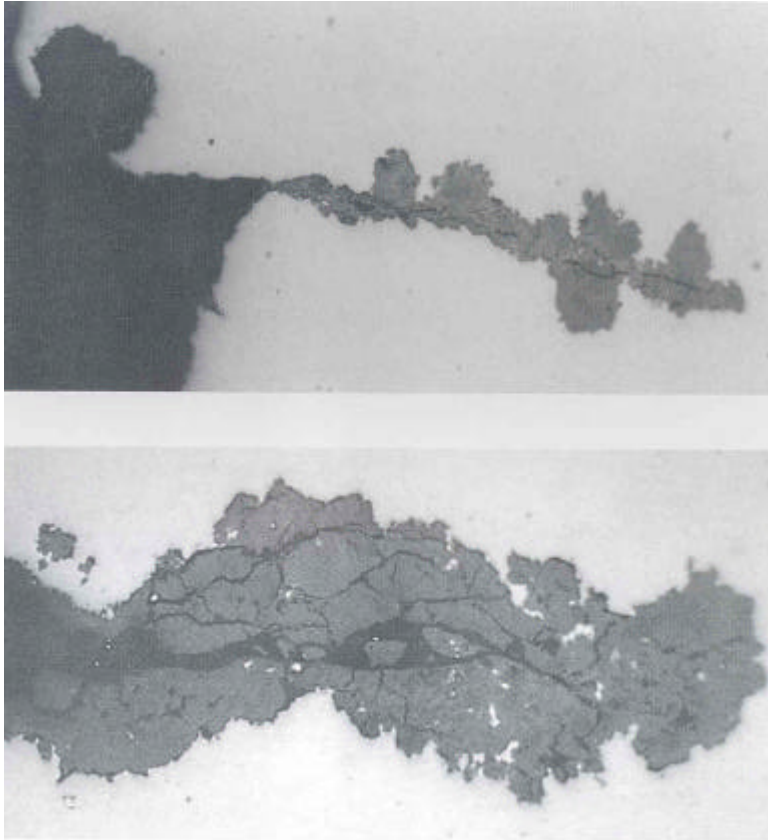
## **SCC – STRESS CORROSION CRACKING, NEAR NEUTRAL**

Axial, transgranular cracks that are typically oxide or scale filled. Cracks may occur in association with pits and general corrosion.

This form of stress corrosion cracking occurs where the pipe surface is shielded from cathodic protection current, for example by a delaminated coating. It is thought to be most prevalent in high latitudes where there is a marked seasonal change in the carbon dioxide content of the soil. Some pressure cycling is required for initiation and growth.

On affected pipelines areas of corrosion, which may be under disbonded coating, should be excavated and re-coated or fitted with a repair sleeve and re-coated as appropriate.

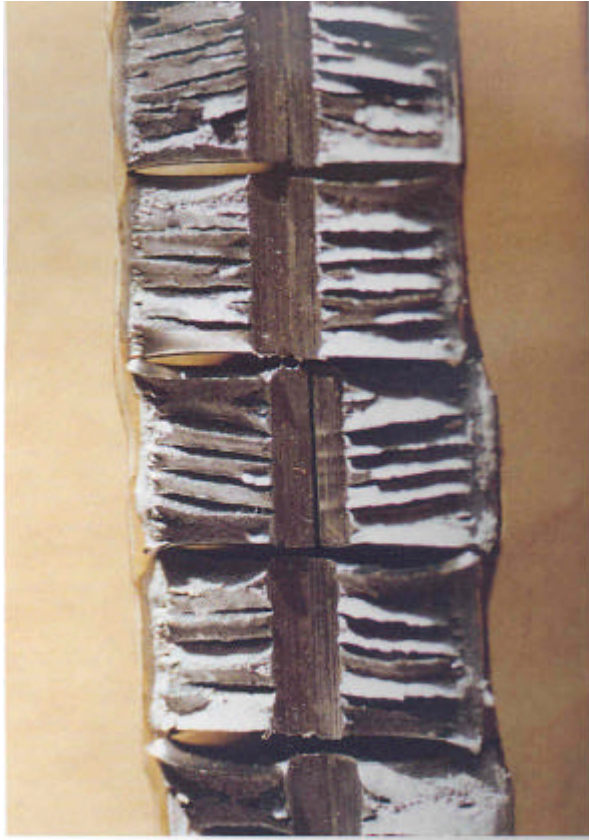
## SEPARATIONS, CHARPY

Cracks, or crack like features that appear in the fracture face of mechanical test pieces.

Separations appear in Charpy, Crack Tip Opening Displacement and Drop Weight Tear Test pieces. Their occurrence may be influenced by steel chemistry and plate rolling conditions, particularly heavy deformation at low rolling temperatures. The crack like features are related to the steel structure, for example fine bands of martensite.

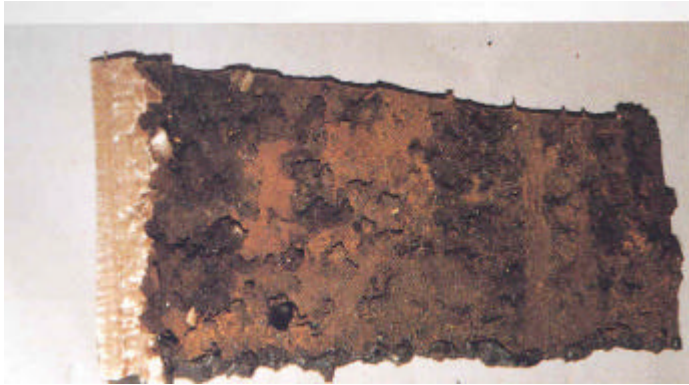
## **MESA**

Extensive, steep sided corrosion between areas showing little or no corrosion.

In high temperature conditions, above ~ 60 C, protective scales are formed in sweet conditions. If these scales are damaged in conditions where they cannot re-form, for example in turbulent flow regimes, rapid sweet corrosion occurs.

Additions of an appropriate corrosion inhibitor and control of flow rates below the limits for erosion (e.g. turbulence, cavitation etc.) can control this problem.

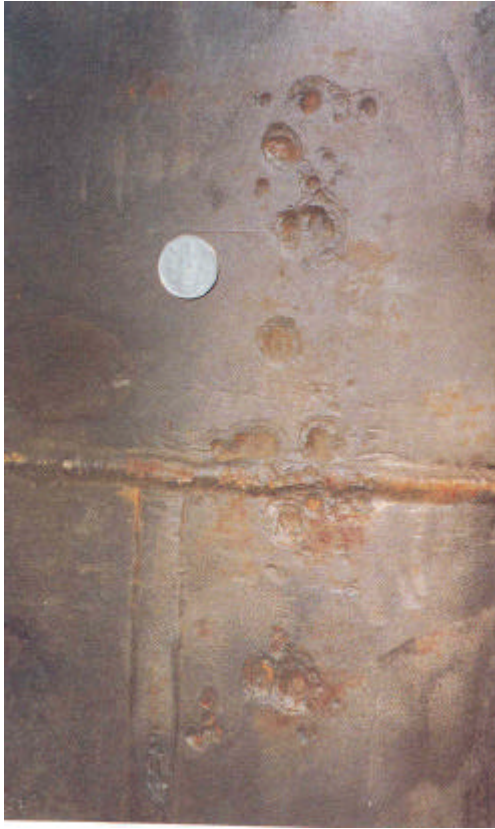
## **MIC – MICROBially INDUCED CORROSION**

Commonly occurs as distinct, deep and steep sided pits.

Use an effective biocide treatment. If corrosion is active thoroughly clean the pipe surface before implementing the biocide programme.

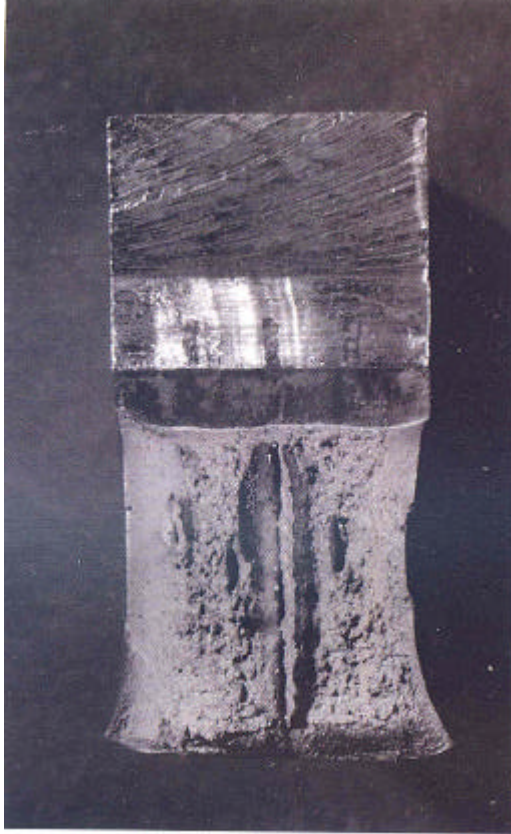
## SEPARATIONS, CTOD

Cracks, or crack like features that appear in the fracture face of mechanical test pieces.

Separations appear in Charpy, Crack Tip Opening Displacement and Drop Weight Tear Test pieces. Their occurrence may be influenced by steel chemistry and plate rolling conditions, particularly heavy deformation at low rolling temperatures. The crack like features are related to the steel structure, for example fine bands of martensite.

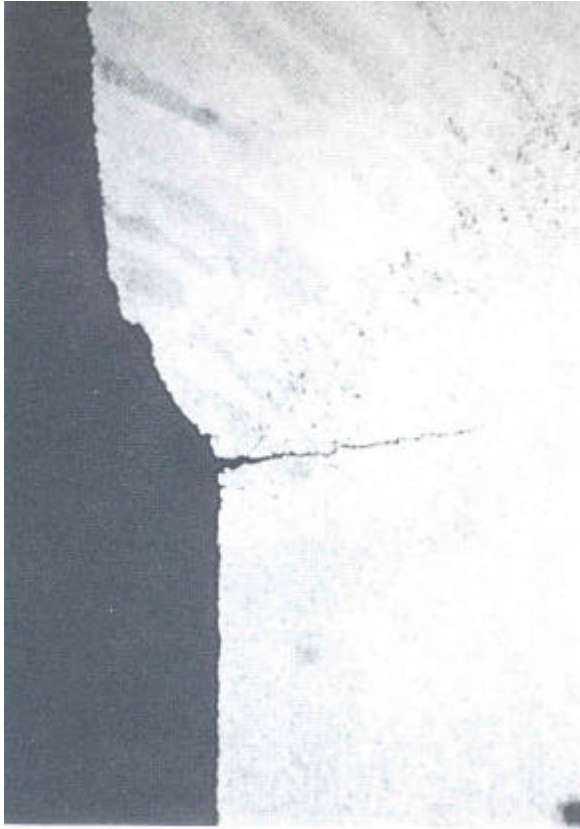
## **SSCC – SULPHIDE STRESS CORROSION CRACKING**

Through wall cracking at hard spots, such as the heat affected zone of girth welds.

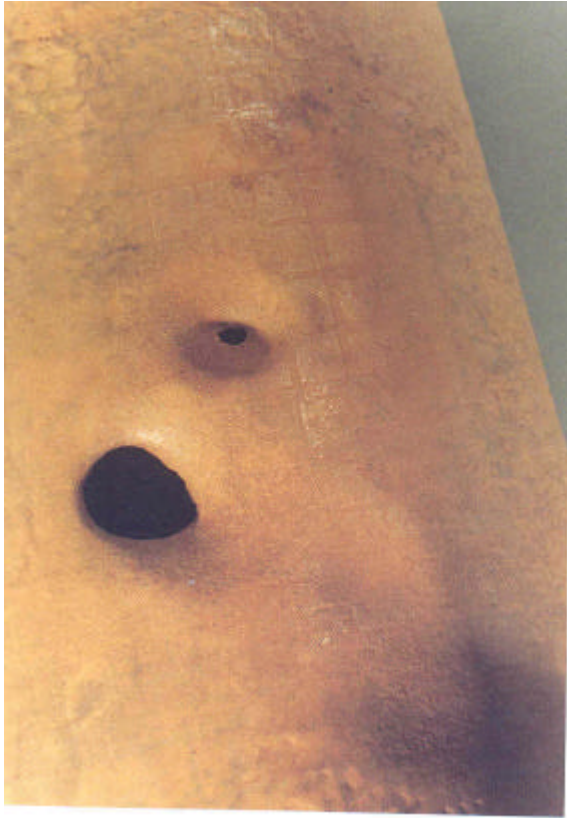
## **EROSION CORROSION**

Localized, severe metal loss at location where the product flow is turbulent or where particles impact the pipe surface due to a change in direction of flow.

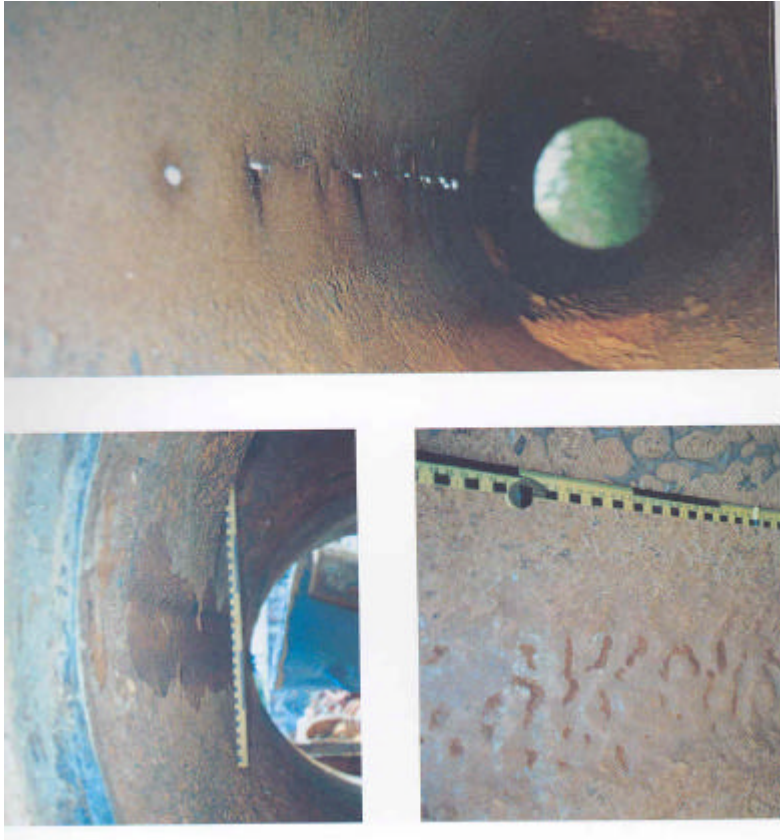
## **PARTICULATE EROSION**

Metal loss, usually concentrated at the 6 o'clock position.

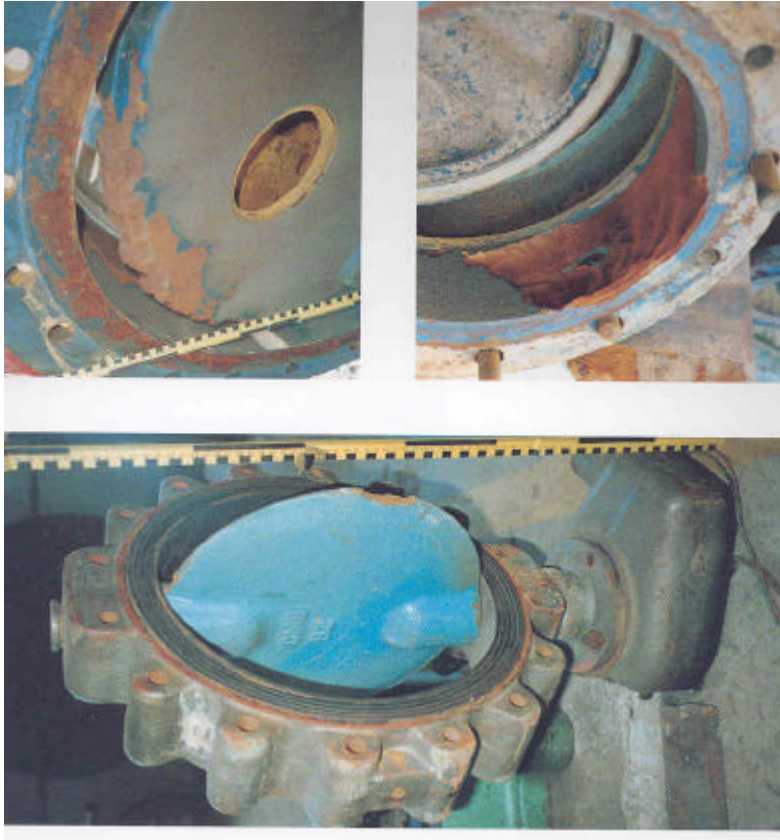
## TURBULENT FLOW EROSION

Severe, often localized, metal loss at locations where the product flow is disturbed.

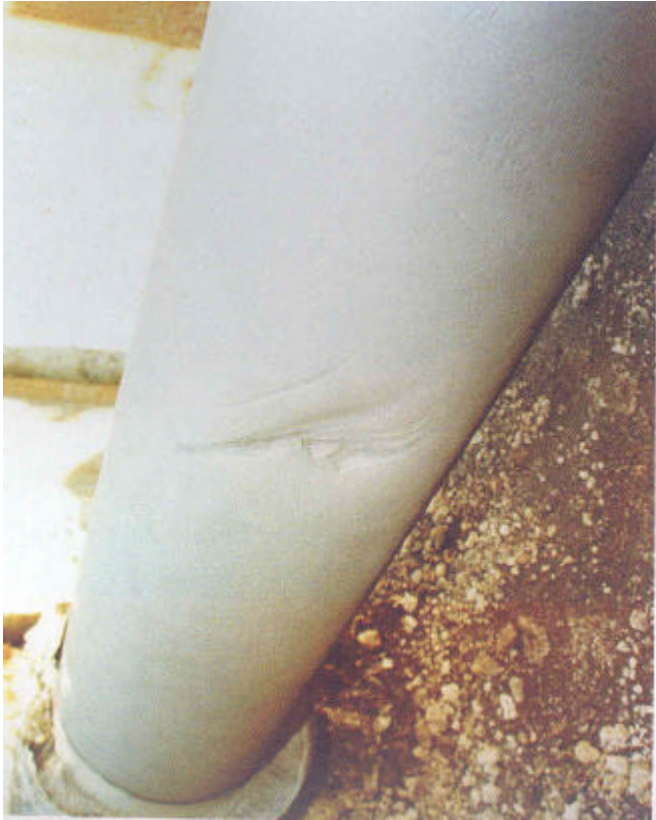
## **GOUGE AND DENT**

Irregular scores and gouging of the metal surface contained within a dent.

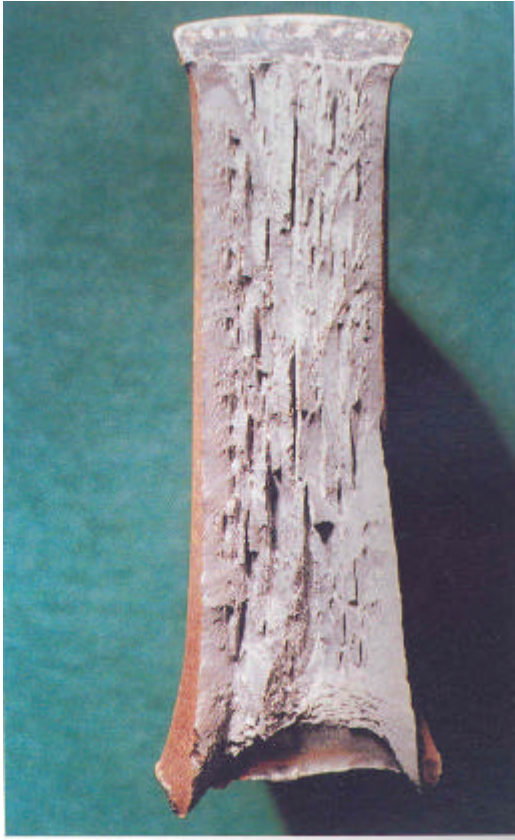
### SEPARATIONS, DWTT

Cracks, or crack like features that appear in the fracture face of mechanical test pieces.

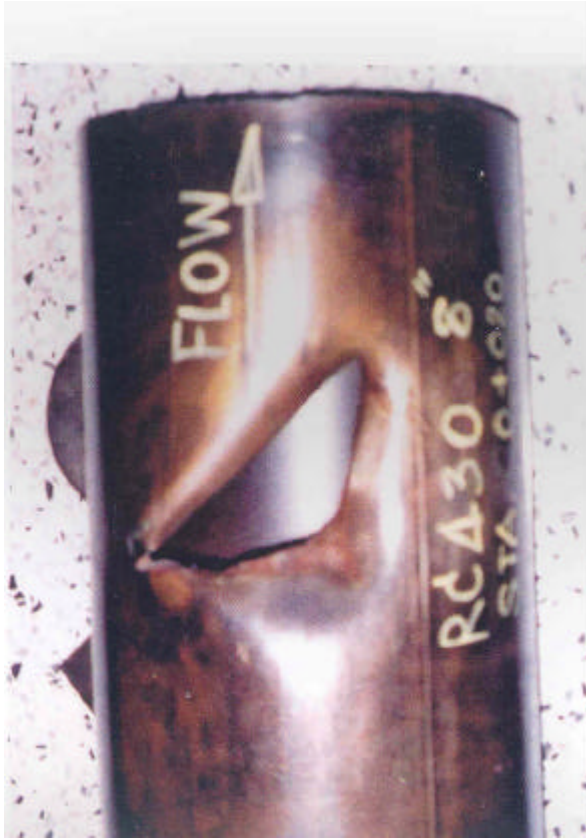
## **PENETRATION**

Denting and penetration of the pipe wall.

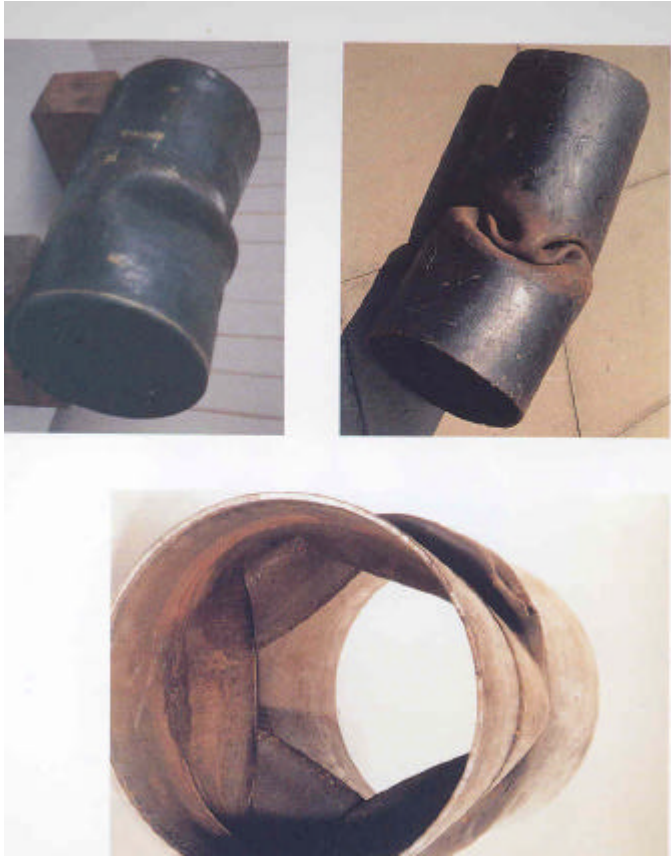
## BUCKLE

Deformation of the pipe.

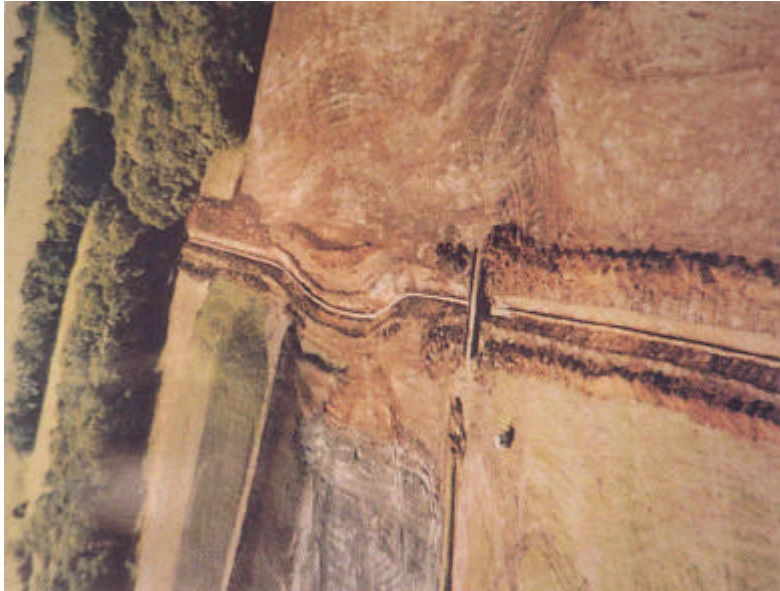
## **LANDSLIP**

Sudden bulk movement of soil downslope.

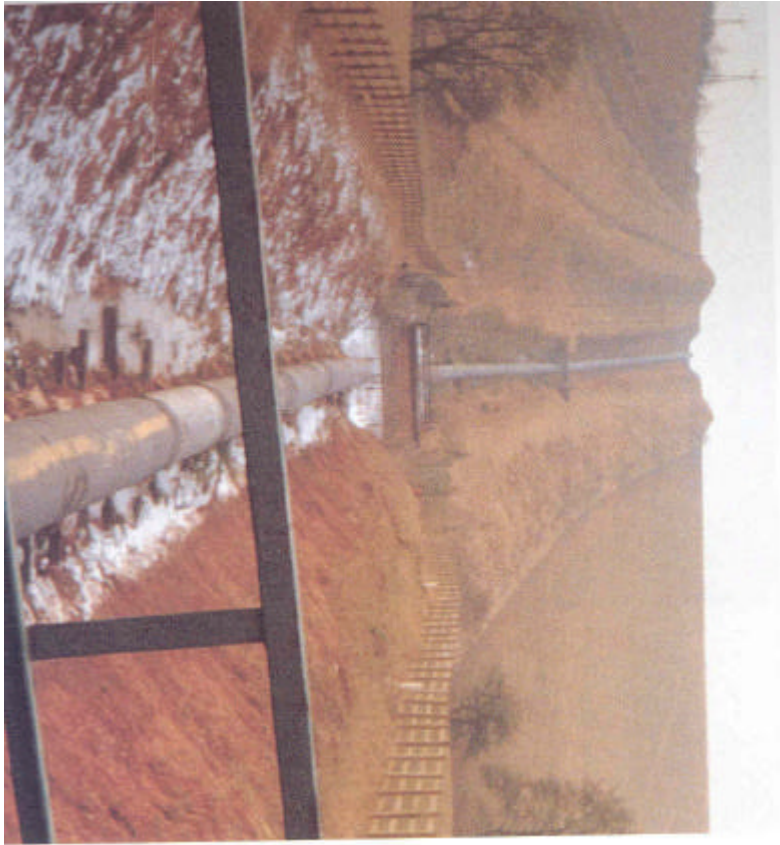
## **STRESS RELIEF**

Soil creep, landslips, subsidence, swallow holes etc.

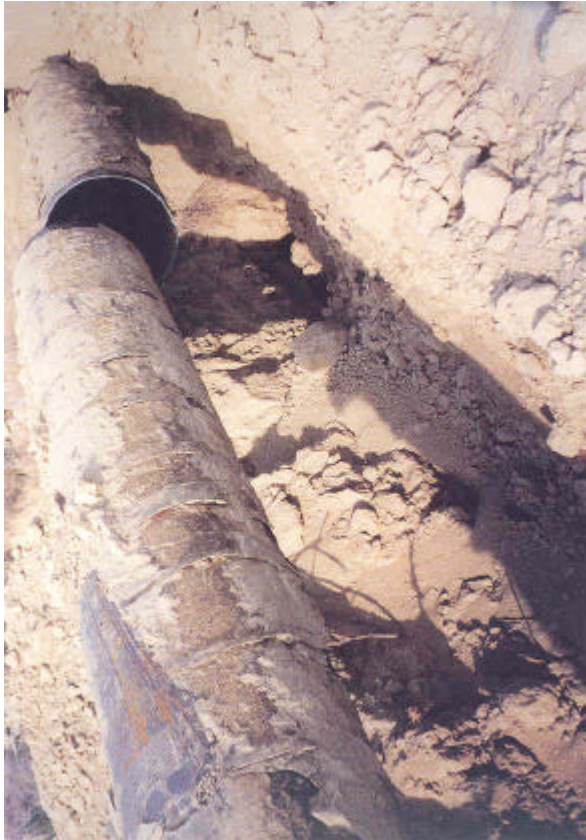
## **SUBSIDENCE**

Sudden, localized collapse of the subsoil under a pipeline.

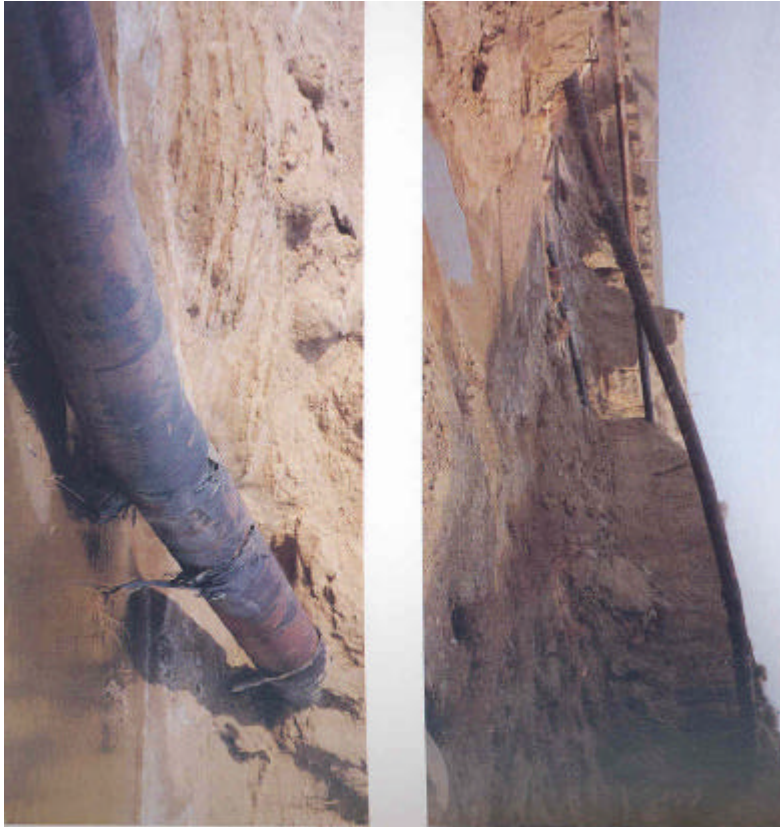
## WASHOUT

Loss of backfill and the pipe bed

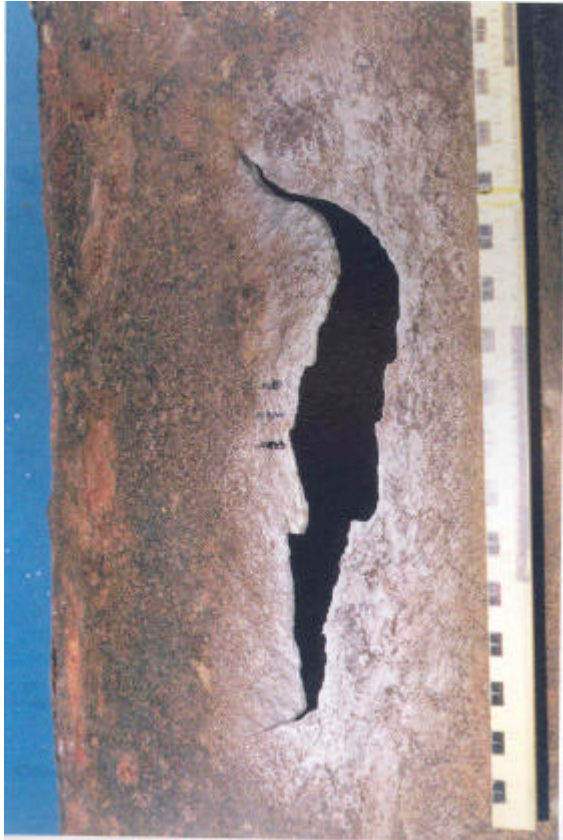
### DUCTILE TEARING

Localized tear or rupture through the pipe wall.

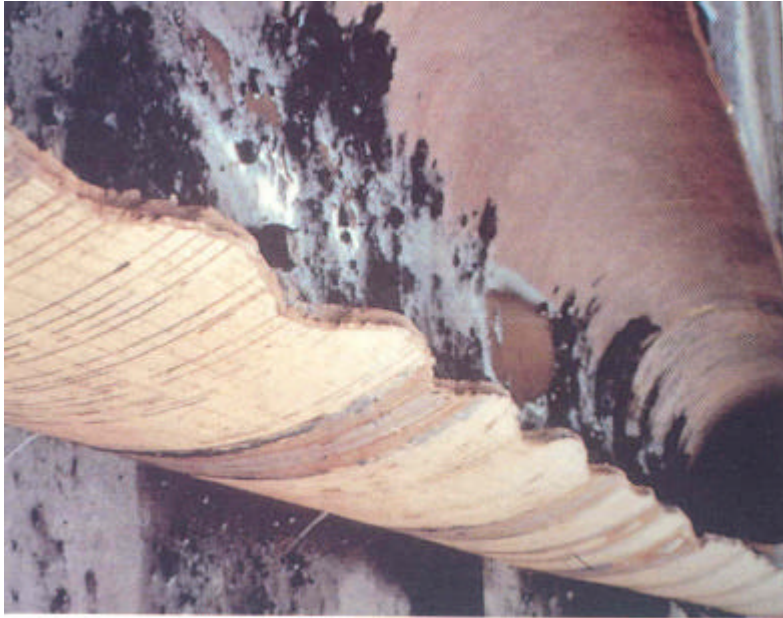
### RUPTURE

Sinusoidal fracture

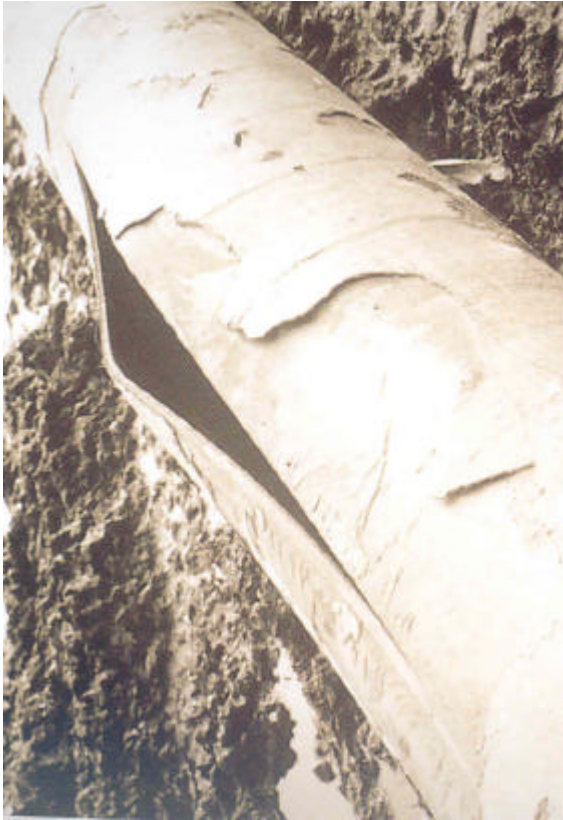
## **SEAM WELD FAILURE**

Localized rupture

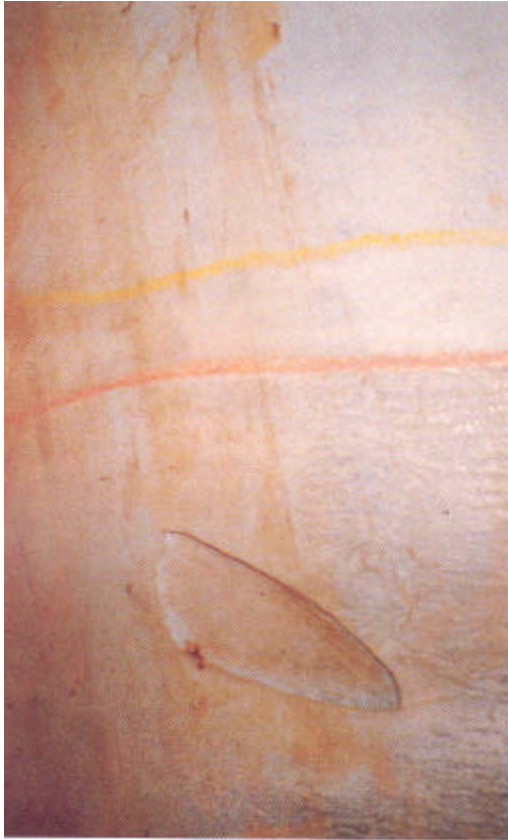
### **SLIVER**

A thin, elongated flap of metal rolled into the pipe surface, often with oxide or scale trapped beneath it.

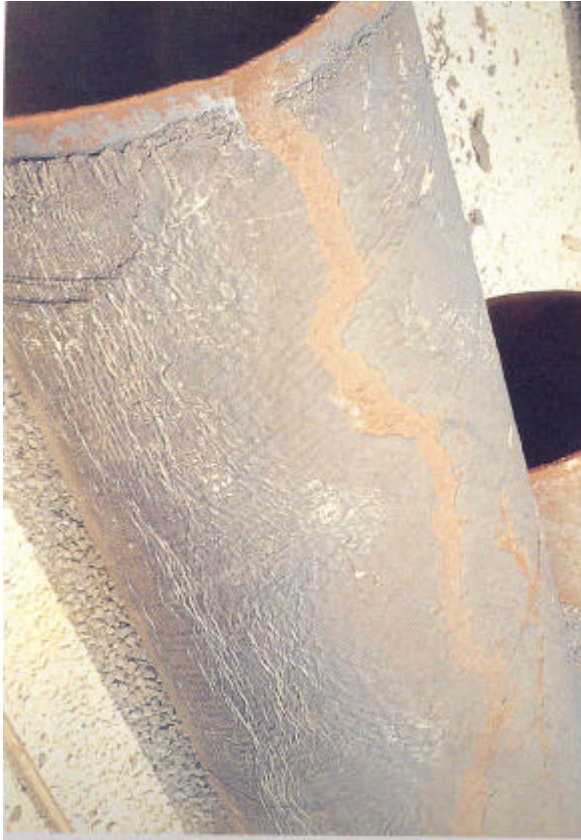
## HIGH TEMPERATURE

Brittle, degraded coating which may show cracking, wrinkling and porosity.

Control product temperatures to a level below the softening point of the coating, especially at compressor or pumping station outlets.

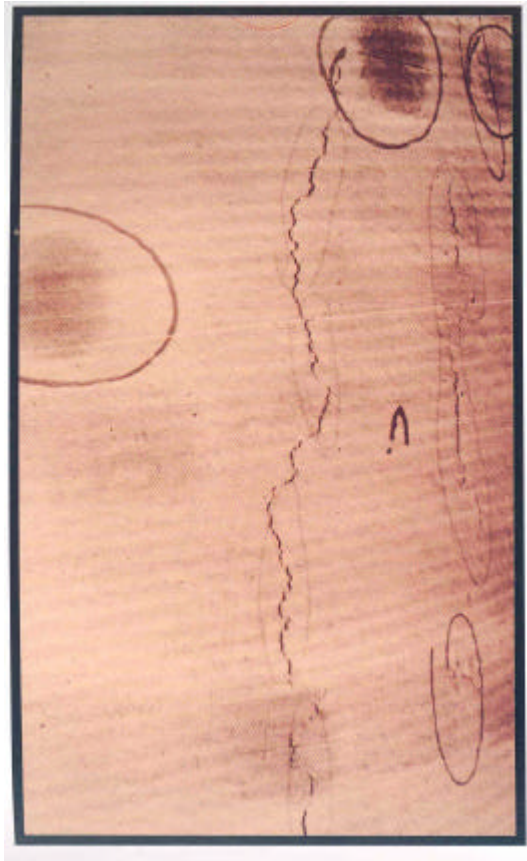
## HYDROSTATIC TEST CRACKS

Irregular axial cracks through the coating.

Remove all loose coating and any contaminants from the pipe surface. Mechanically wire brush the substrate and coating and use a trowelling grade, two pack liquid urethane coating to fill the prepared void and overlap onto sound coating.

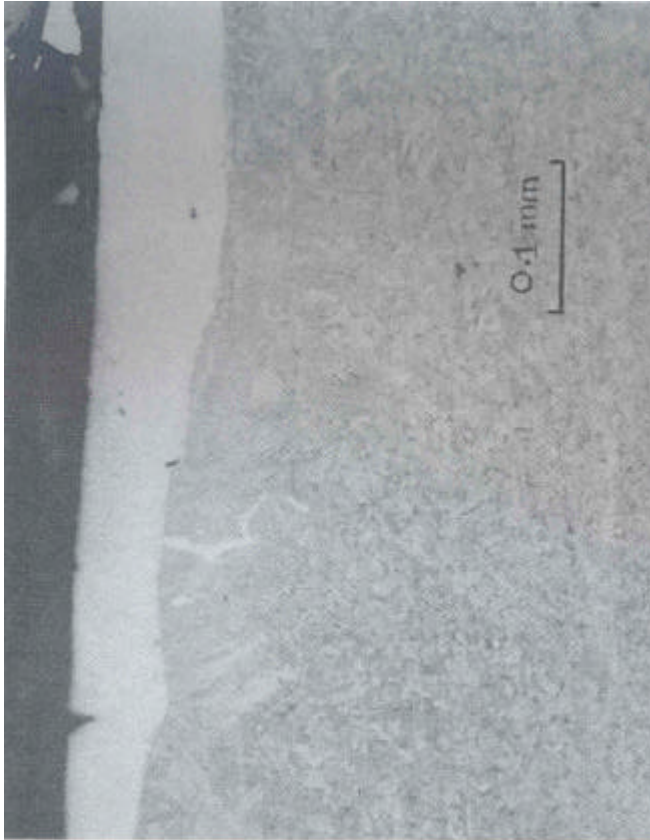
## COPPER PENETRATION

Cracks like features normally at right angles to the pipe or plate surface.

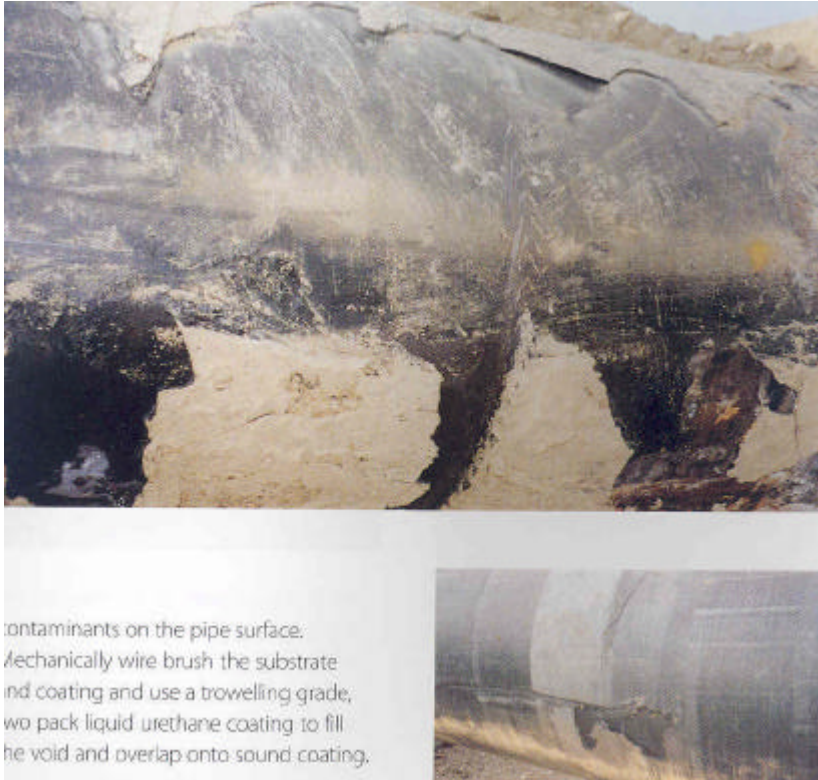
## MECHANICAL DAMAGE

Scores or damage to the coating with possible loss of adhesion around the area of mechanical damage.

Strip all areas of coating that show loss of adhesion or voids and all areas with moisture beneath the coating. Re-coat with a compatible, two pack liquid repair system after appropriate surface preparation.

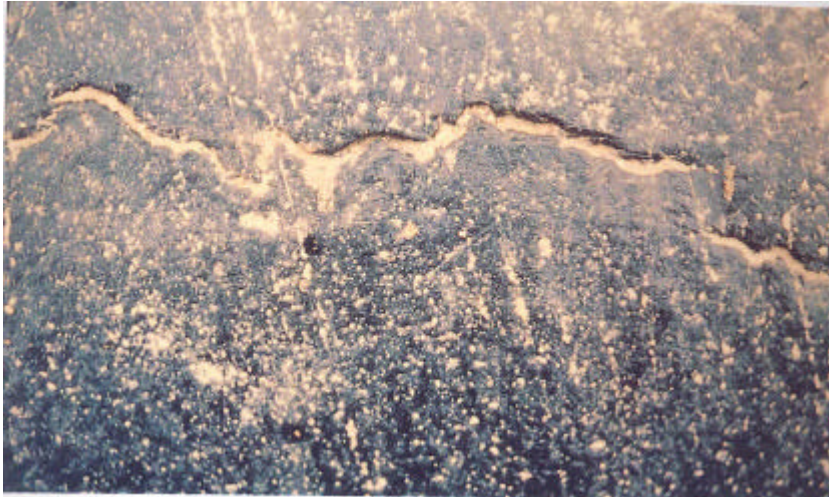
## SOIL STRESSING

Irregular cracking and wrinkling of the coating with possible loss of adhesion.

Use coatings that are not susceptible to creep. Overwrap the primary corrosion protection coatings with an adherent, low friction coating. Overwrap with a loose, deformable protective layer, but this layer MUST NOT interfere with CP current access to the pipe. Strip all areas of coating that show loss of adhesion or voids and all areas with moisture beneath the coating. Re-coat with a compatible, two pack liquid repair system after appropriate surface preparation.

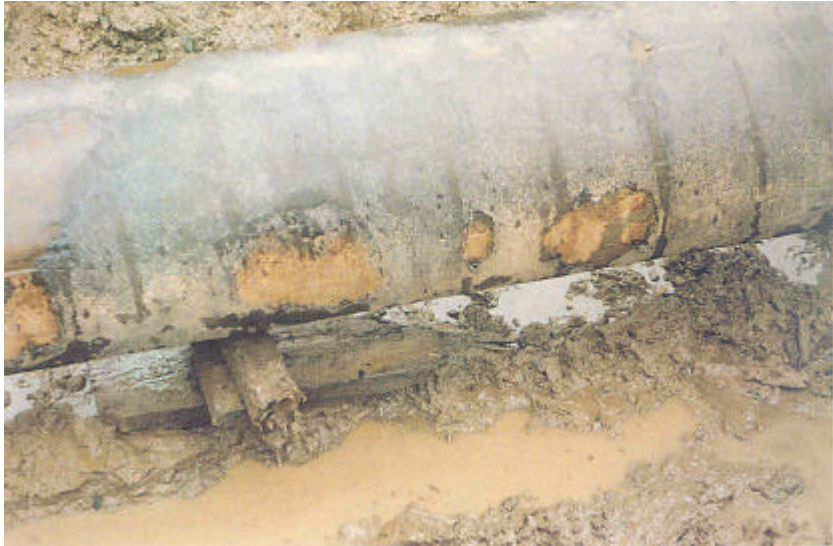
## STONE DAMAGE

Irregular shaped holes in the coating, possibly in association with delamination or disbonding.

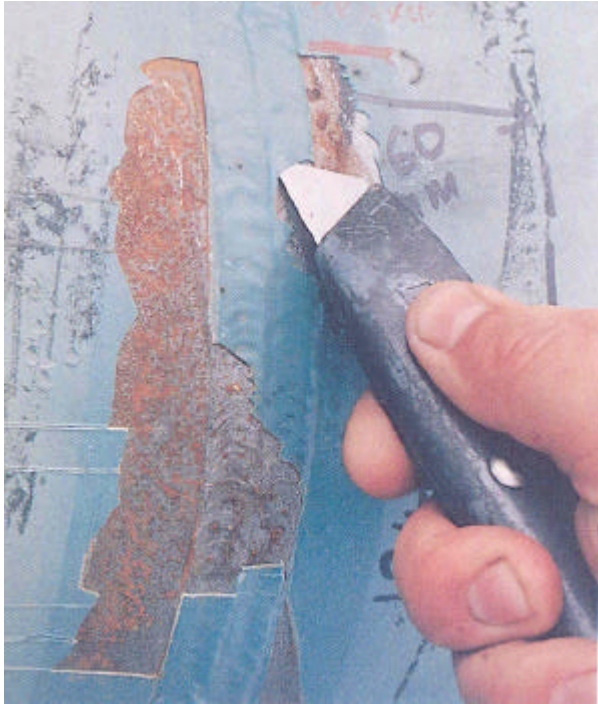
### BLISTERING AT FIELD JOINTS

Very poor adhesion of the coating to the pipe.

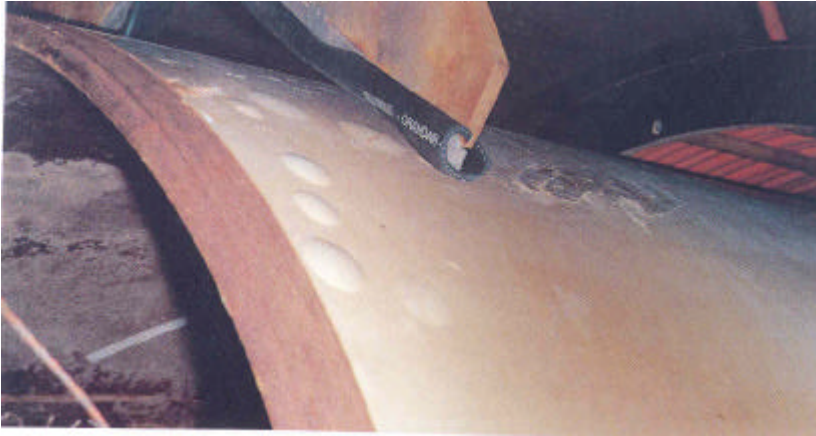
### BLISTERS

Raised areas of coating.

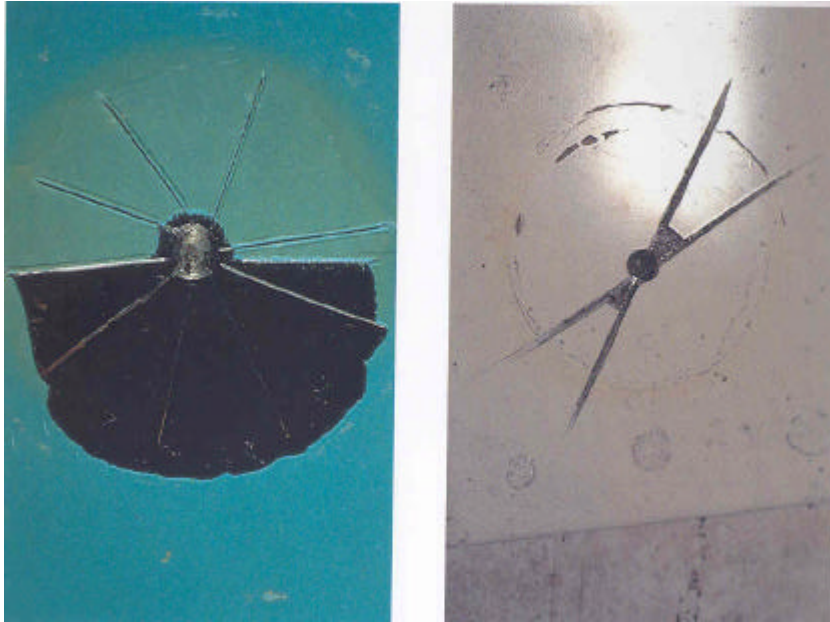
### CATHODIC DISBONDING

Complete loss of adhesion at the coating – metal interface around an area of damage.

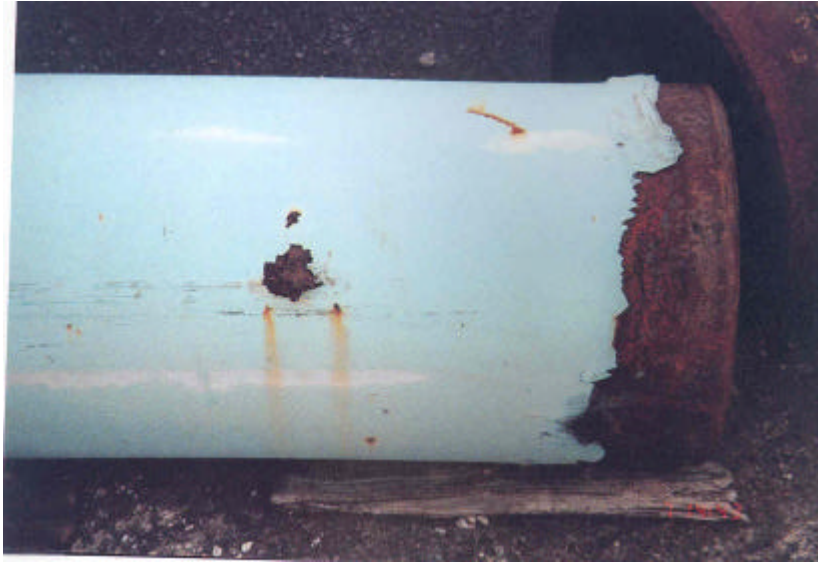
### **CORROSION AT CUT BACK**

Lifting of the coating at the ends of the pipe with corrosion underneath.

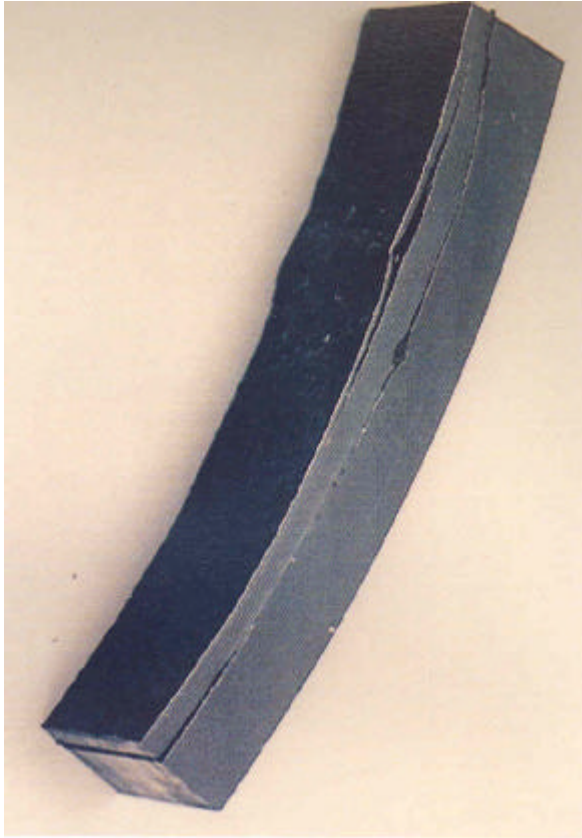
### DOUBLE SHELL

A discontinuity in the pipe wall that, in extreme cases, splits the pipe wall into two segments.

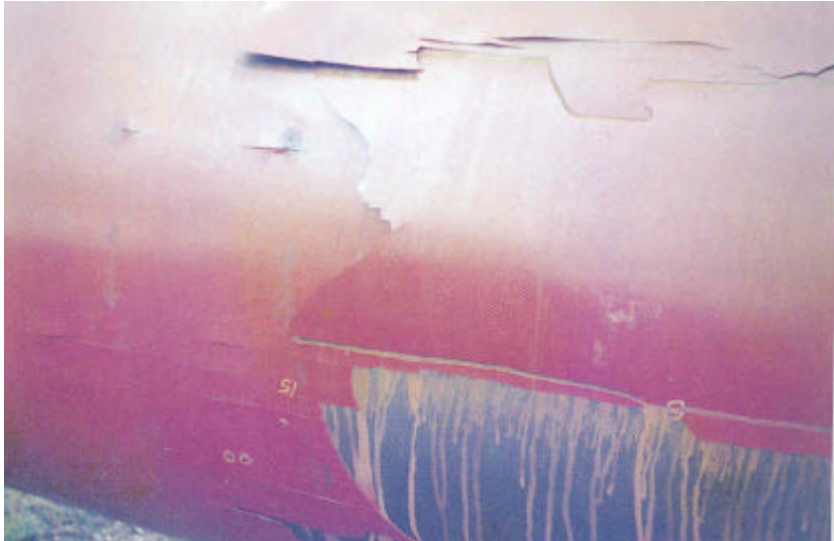
### CRACKS

Thin lines that appear as a different colour to the main body of coating. After weathering rust staining may accentuate the line of the cracks.

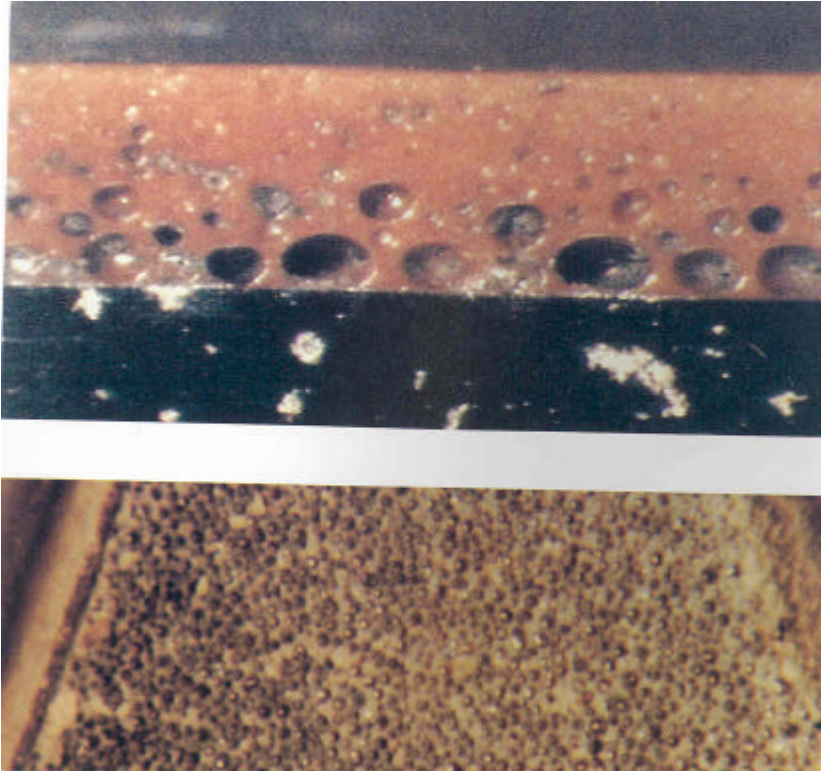
### FOAMING

Round, gas filled voids within the coating. The void content is usually highest close to the metal surface.

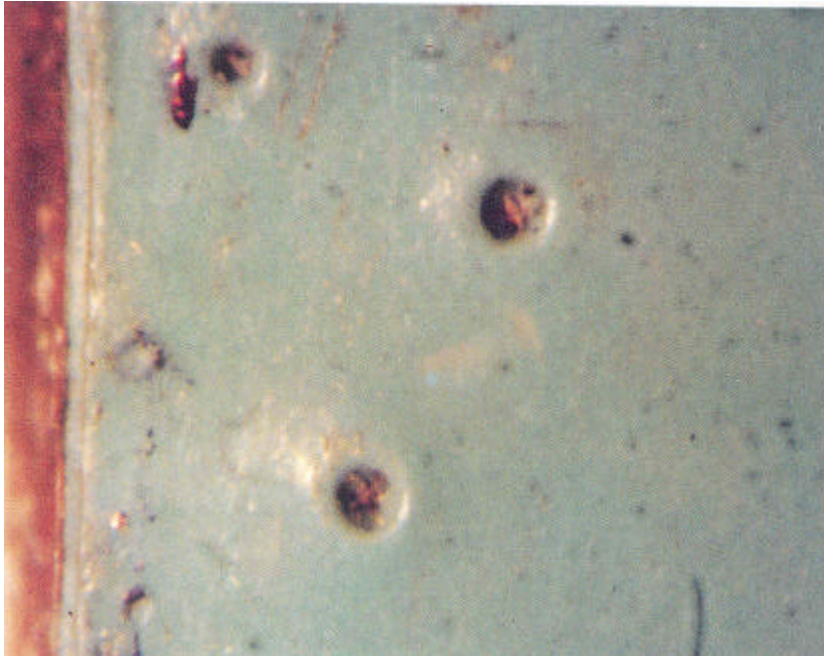
### INCLUSION

Bumps and protrusions on the surface of the coating.

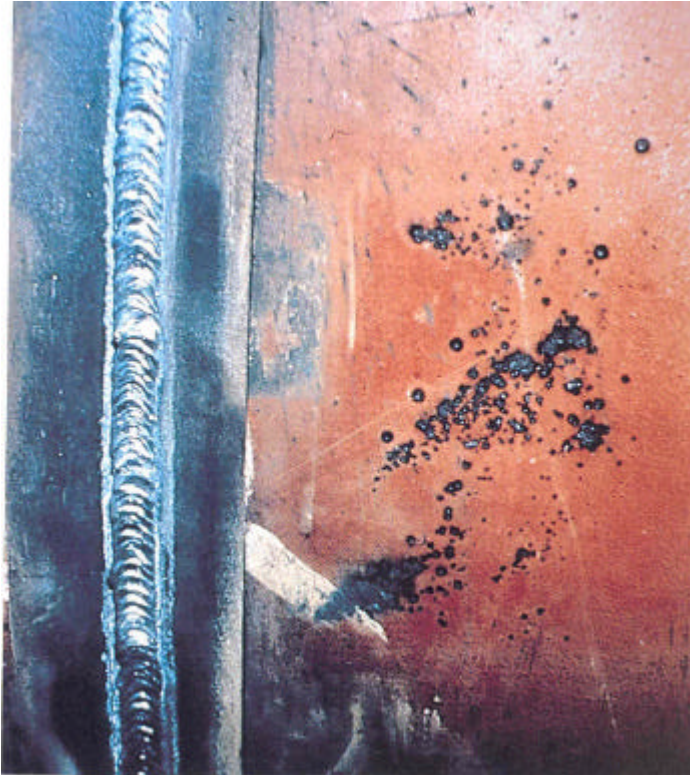
### WELD SPATTER

Irregular holidays in the coating adjacent to girth welds.

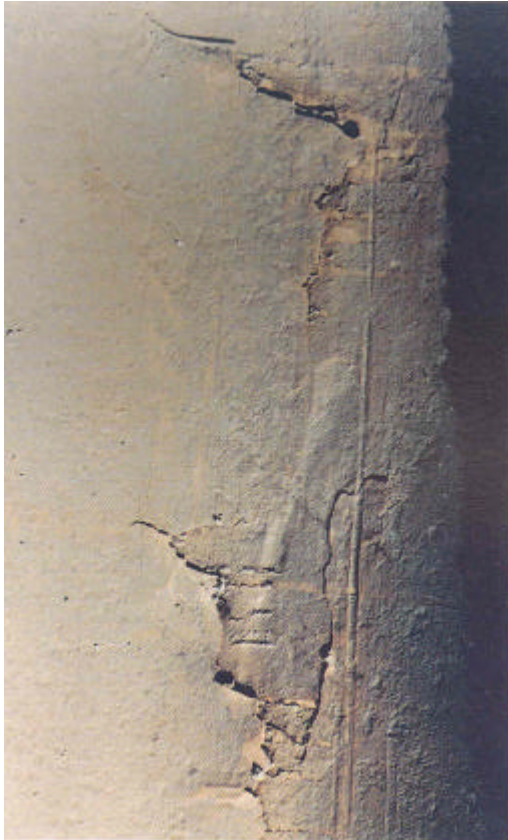
### INGOT DEFECTS

Irregular shaped crack-like defects running into the pipe wall at a high angle to the pipe surface.

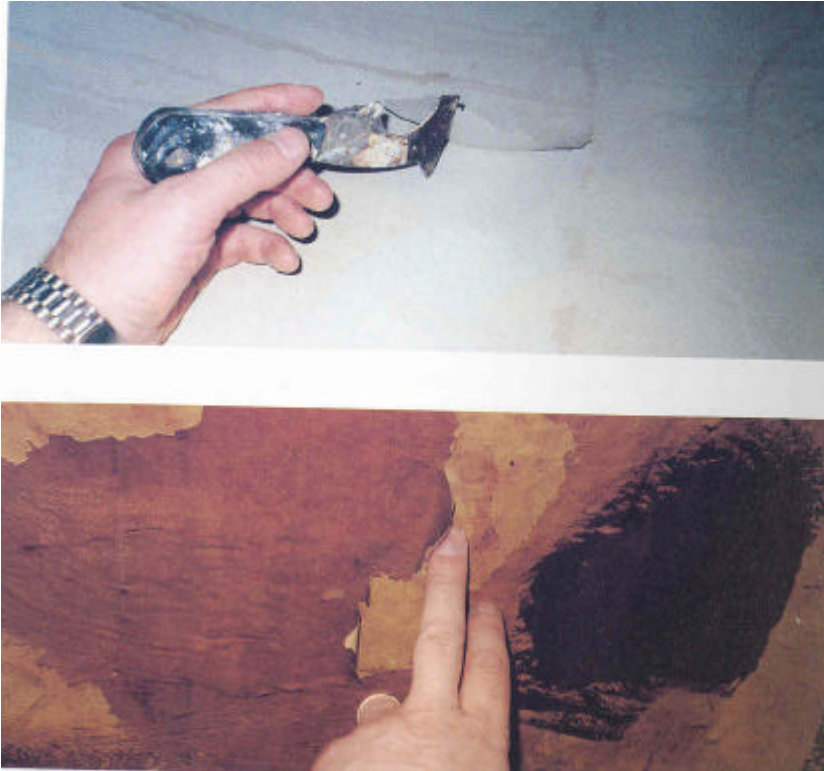
### DELAMINATION

Loss of adhesion between one layer of coating and the next.

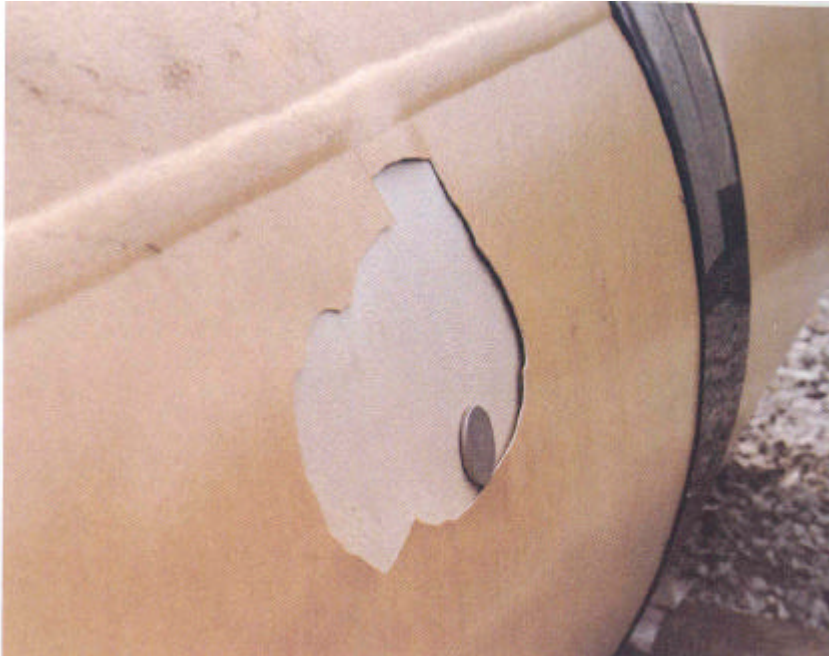
### POOR ADHESION

Coating may be removed from the substrate.

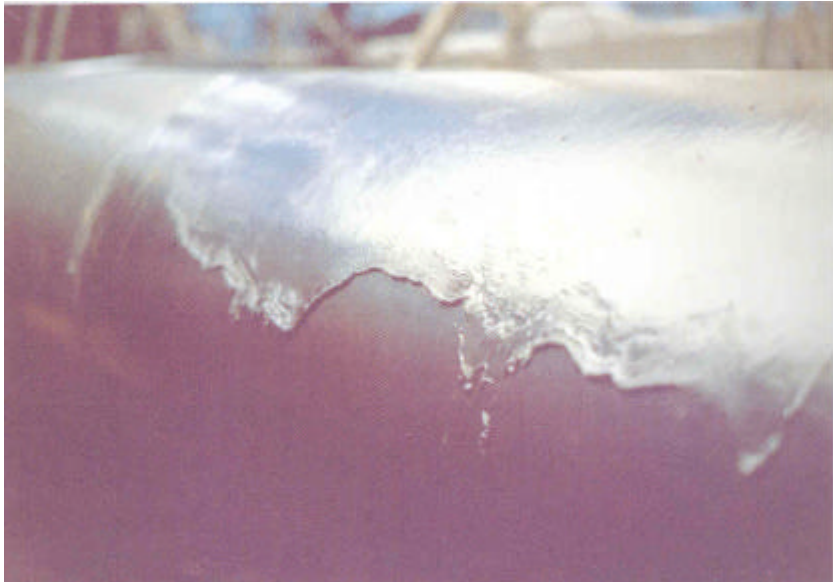
### **SAGGING**

Runs and sags visible on the coating surface.
