## Manufacturing: ERW Pipe Defects

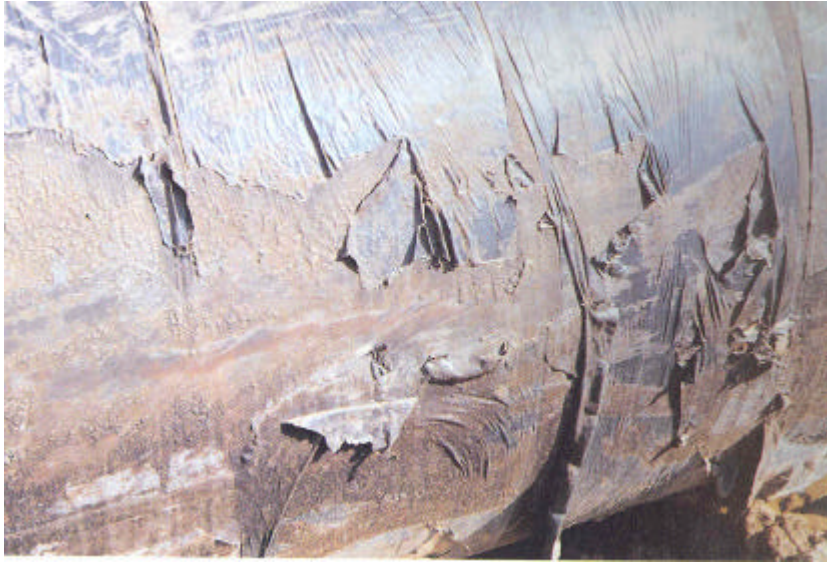
### MECHANICAL DAMAGE

Tearing or lifting of the coating in areas where it has been subject to an impact load.

Remove all loose coating.

For small areas of damage use an overwrap of cold applied laminate tape, ensuring a minimum of three complete turns around the pipe and an overlap of 55% between turns.

For large areas of damage prepare the exposed metal substrate and the adjacent coating and apply a compatible two pack, liquid coating or rewrap with cold applied laminate tape ensuring a 55% overlap between successive turns of tape.

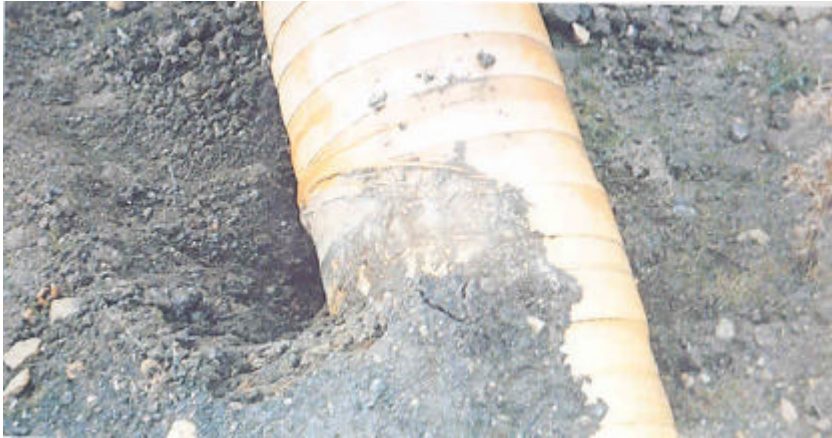
### SOIL CREEP

Coating is wrinkled and may be displaced longitudinally along the pipe axis.

Soil creep occurs on slopes and this movement will be at a maximum after backfilling as the fill settles and compacts. The net movement is downslope, under the action of gravity. Coating damage will be greatest where the pipeline route follows the line of maximum slope. Only coatings that are susceptible to creep will be affected.

Overwrap the primary corrosion protection coatings with an adherent, low friction coating.

Overwrap with a loose, deformable protective layer, but this layer MUST NOT interfere with cathodic protection current access to the pipe.

Strip all areas of coating that show loss of adhesion or voids and all areas with moisture beneath the coating. Re-coat with a compatible repair material, such as a two pack , liquid urethane.

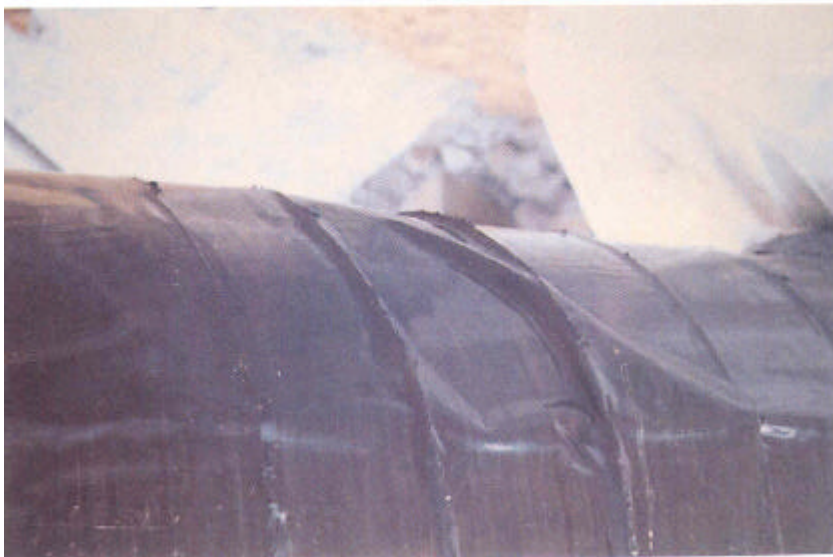
### SOIL STRESSING

Loosening and lifting of the tape, with associated loss of adhesion, particularly at the edges of the tape and at the end of the 'wrap'.

Heavy clay soils can expand on wetting and contract on drying. This expansion and contraction can be transferred from the clay to the coating resulting in loosening, lifting and loss of adhesion.

All the damaged coating must be removed and the metal substrate and surrounding sound coating must be cleaned. Re-coat using a compatible two-pack, liquid coating, heat shrink materials or cold applied laminate tape.

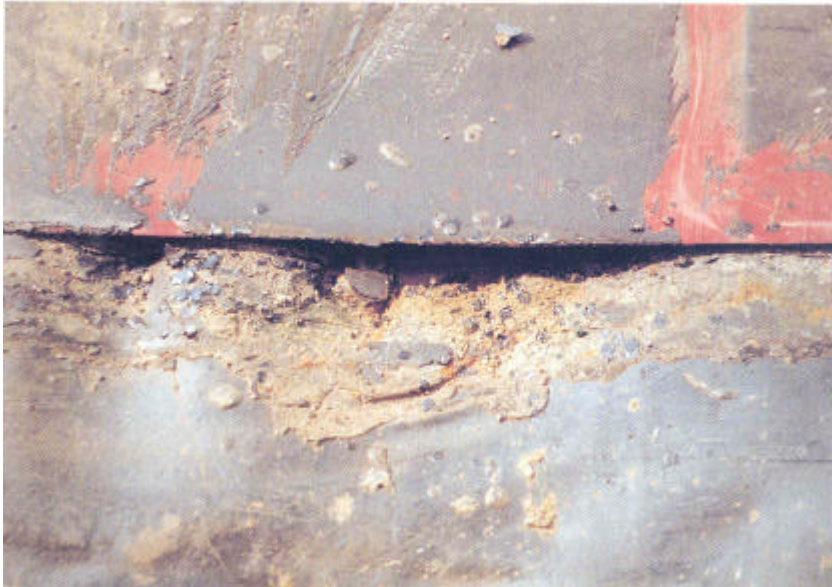
### POOR APPLICATION

Poor adhesion, or complete loss of adhesion, usually at the 6 o'clock position.

Strip the coating and re-coat with cold applied laminate tape, where the backfill conditions are good, or apply a new heat shrink wrap-around. Alternatively a two pack liquid coating may be applied provided it is compatible with the coating on the pipe body.

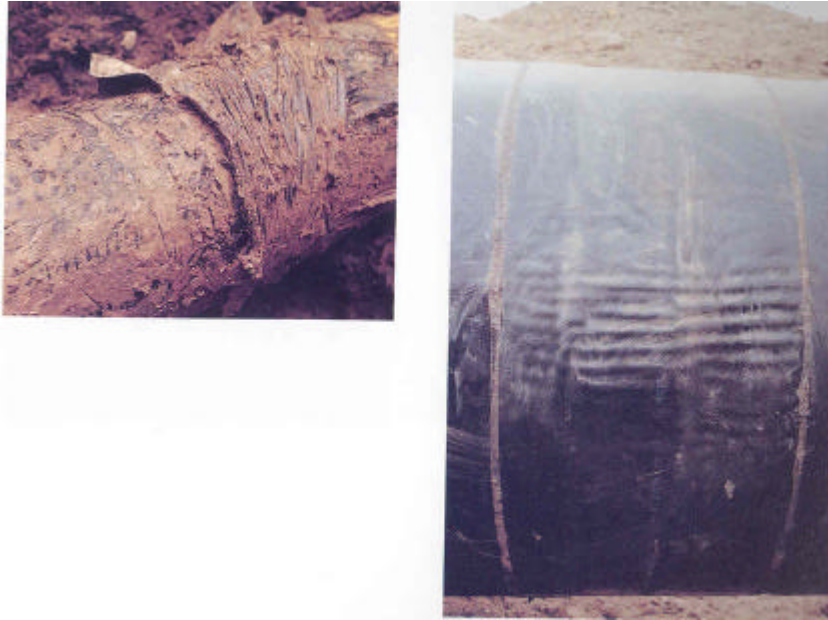
### SOIL LOADING

Wrinkling of the heat shrink material at the 3 o'clock and 9 o'clock positions in response to soil settlement. Axial wrinkling may result from soil creep on slopes.

Over-wrap with a loose, deformable protective layer which MUST NOT interfere with cathodic protection current access to the pipe.

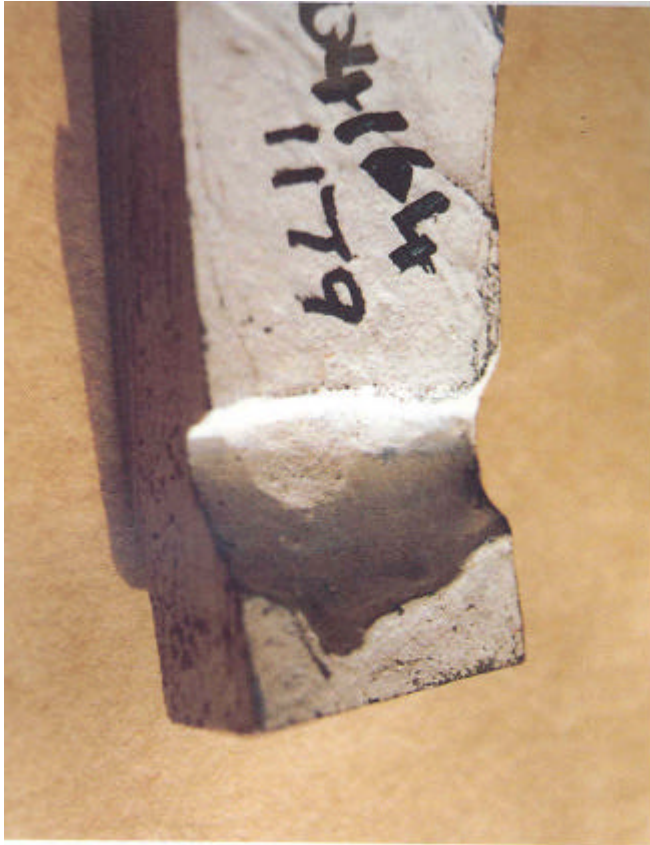
### MANUFACTURING DEFECTS

Irregular shaped defects in the pipe wall.

Solidification defects in the ingot that are carried through into the pipe or pieces of lapped material that have fallen out.

Significant manufacturing defects should be identified by pressure testing in the pipe mill or during the pre-commissioning pressure test.

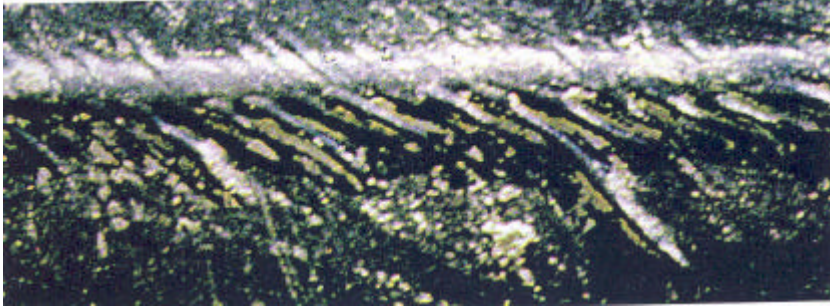
### TAPE AND SPIRAL WELD

Bridging of cold applied tape over the cap of the seam weld leaves a void on either side of the weld line. When water gets into this void a corrosion risk is created. The applied cathodic protection current cannot control this corrosion risk because the pipe is shielded from the CP current by the insulating coating.

Lines of 'narrow axial' corrosion result. These areas of corrosion may also be susceptible to the initiation and growth of near neutral pH stress corrosion cracks.

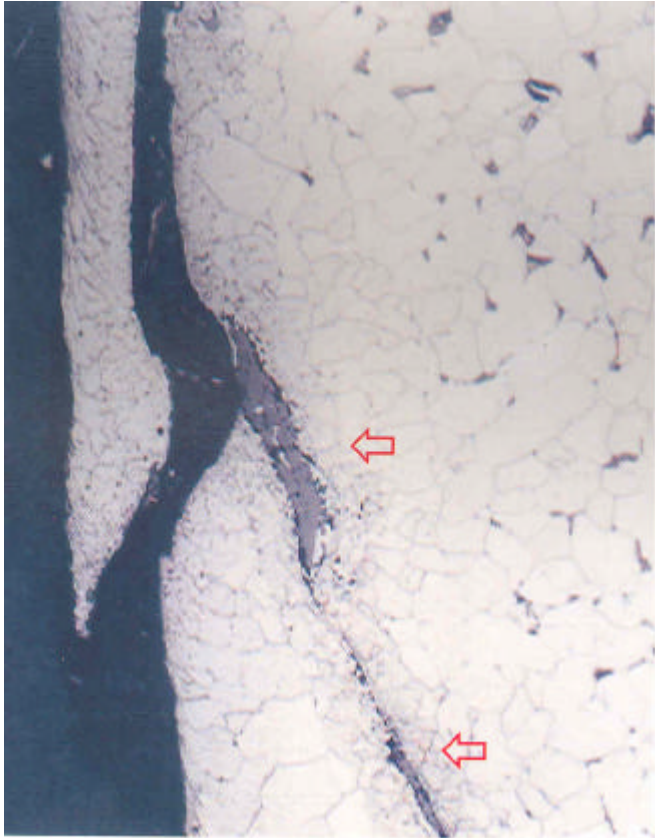
### SLAG INCLUSION

Non-metallic inclusion in the pipe wall.

Caused when an ingot is contaminated with slag. In well controlled pipe production most slag inclusions are removed during the piercing process and when the ends of the ingot are trimmed during the pipe forming process. The shape of the slag inclusion will be governed by the forging process.

Slag inclusions are usually too small to be structurally significant. However, surface breaking slag may initiate a corrosion 'hot spot' or a defect in a thin film pipe coating. Superficial slag inclusions may be removed by grinding before application of the coating.

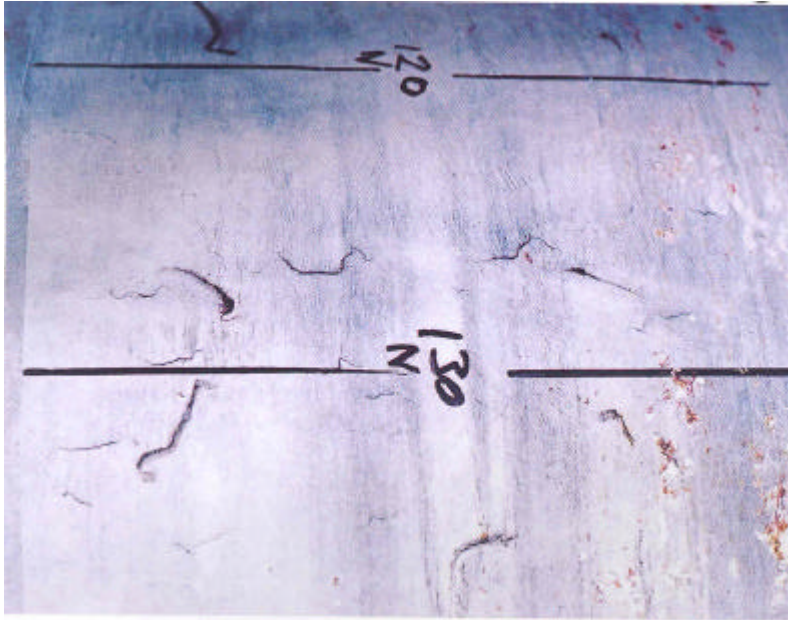
## **SURFACE DEFECTS**

Shallow defects that appear at the pipe surface.

Various causes including ingot defects, longitudinal surface laps, slag inclusions, slivers, transverse tears and surface roughness.

Most defects are not structurally significant but may create defects in thin film coatings and act as an initiation point for pitting corrosion.

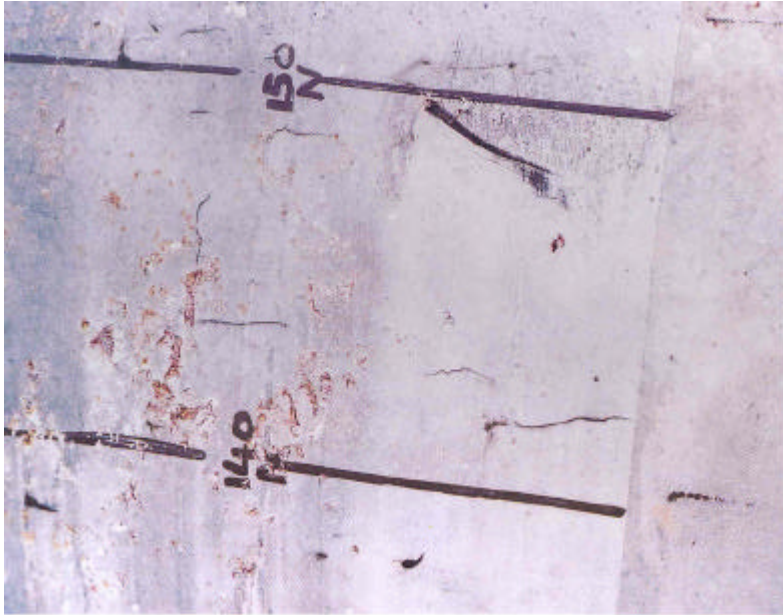
## TRANSVERSE TEARS

Crack like features at the pipe surface running in the hoop direction.

Cracks in the ingot, for example transverse shrinkage cracks, may be carried through to the pipe if insufficient material is removed from the ingot surface during the scarfing process.

Transverse tears may create defects in thin film coatings. Superficial transverse tears may be removed by grinding before application of the coating.

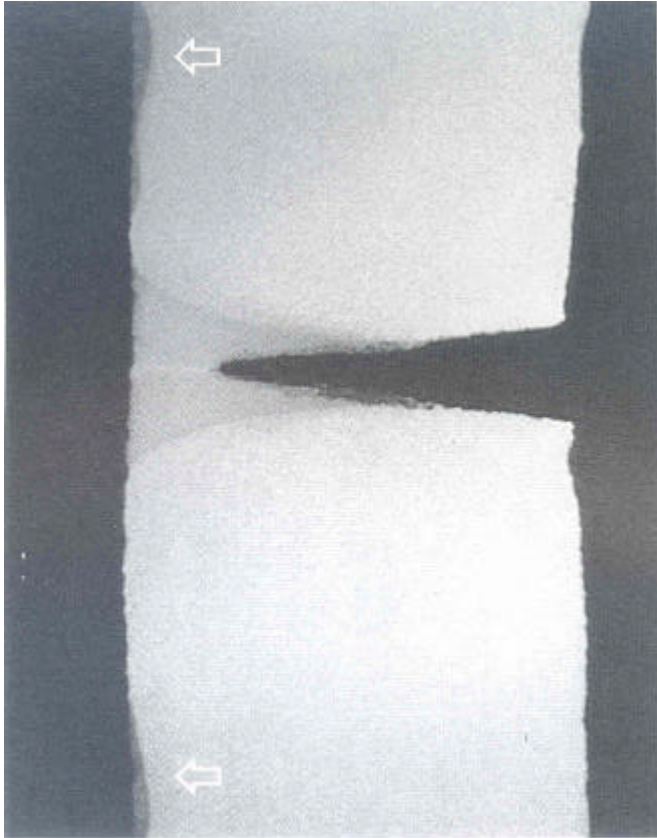
### BURN MARKS

Local area of transformed, hardened, microstructure. It occurs on either side of the seam weld on the outer surface of the pipe. Burn marks may be associated with lack of fusion in the seam weld.

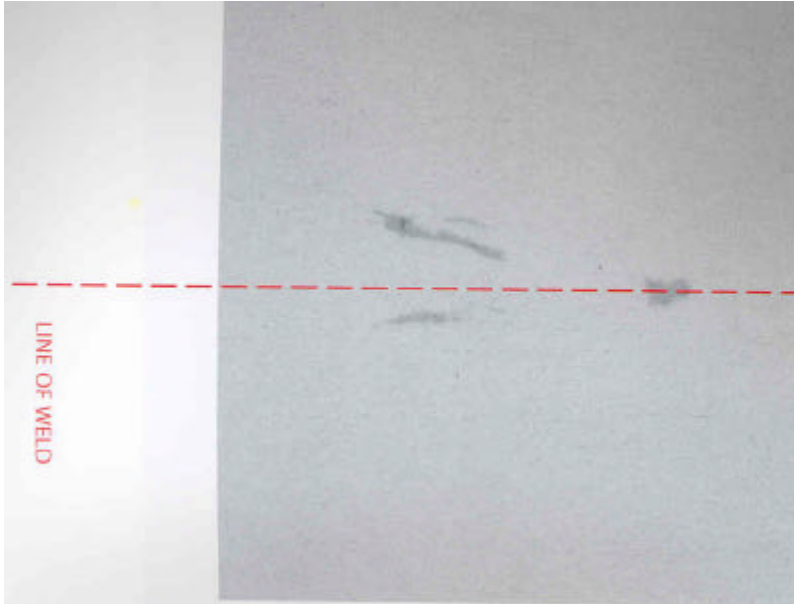
### DIVERTED INCLUSIONS

Aligned, non-metallic inclusions in the parent strip are diverted through 90 degrees at the weld seam causing a plane of weakness.

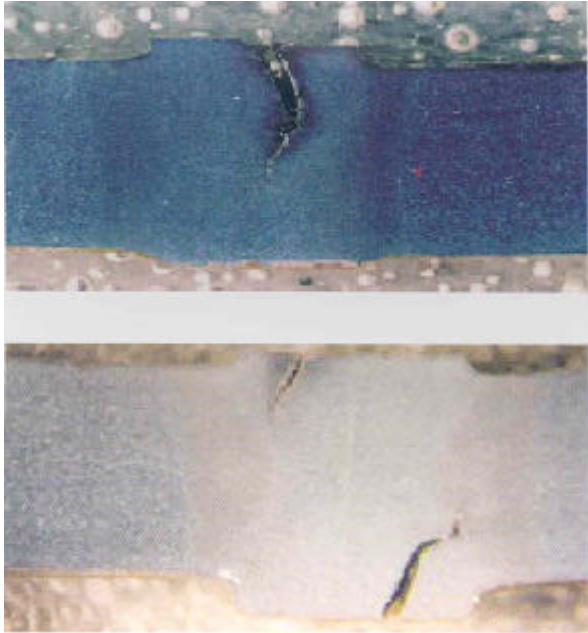
### HOOK CRACKS

Internal or external cracks within the weld, usually curved in shape. The cracks are axial and at right angles to the pipe surface.

Use good quality, clean strip. Replace pipe or install repair clamps or repair shells as appropriate.

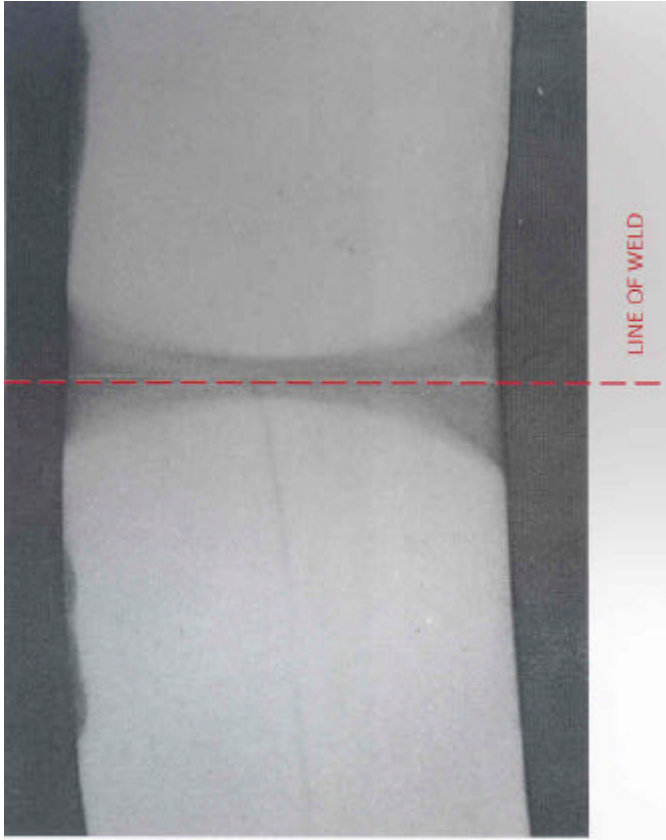
### MISSED NORMALISING

Lack of grain refined structure at the weld line, leading to poor weld line toughness. Visible on the macro-section as the well defined heat affected zone on either side of the line of the weld.

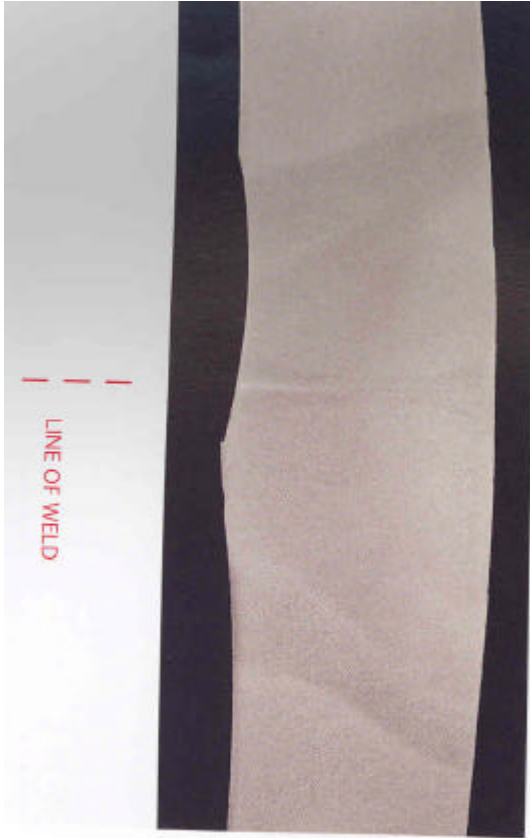
### SEAM MISPLACED TRIM

Axial groove or depression aligned to one side of the seam weld.

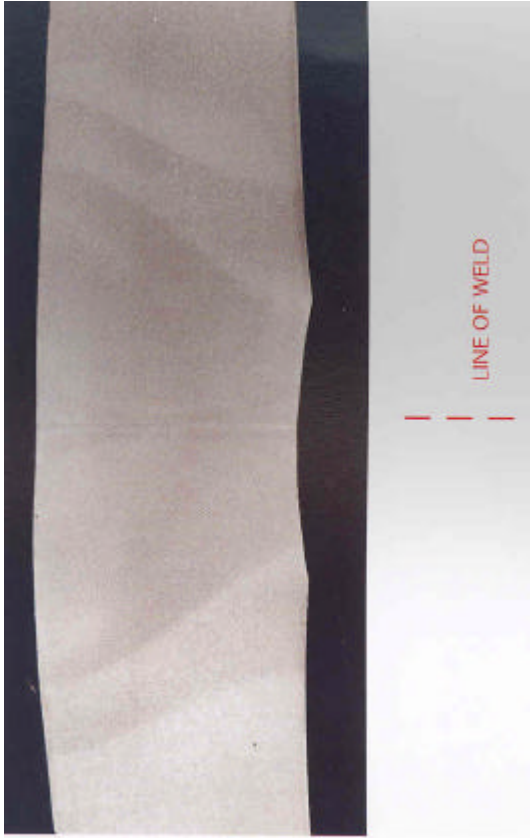
### SEAM OVERTRIM

Axial groove or depression on the line of the seam weld.

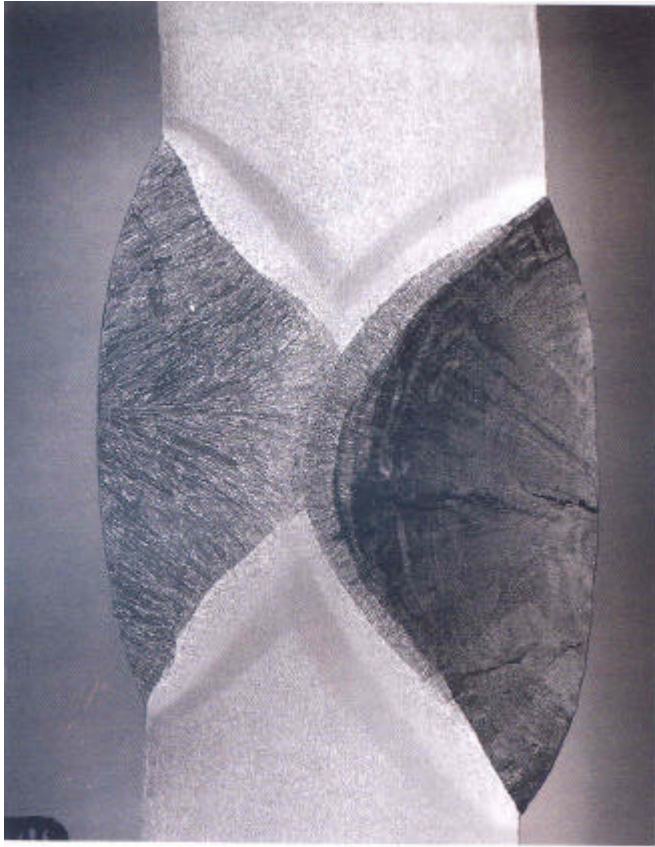
## **COPPER CRACKING**

Cracking in the weld metal, normally close to the weld centre line. Cracks follow the weld solidification structure.

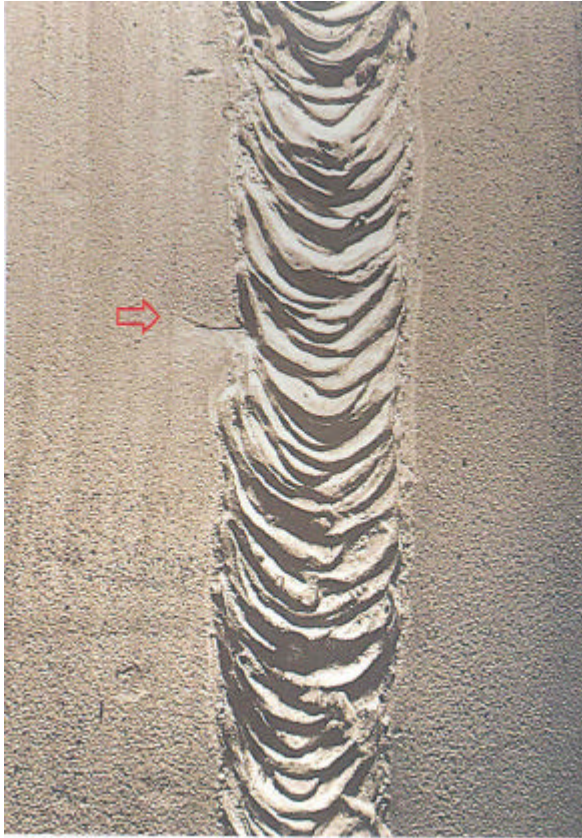
### END CRACK

Axial crack located at the end of the pipe.

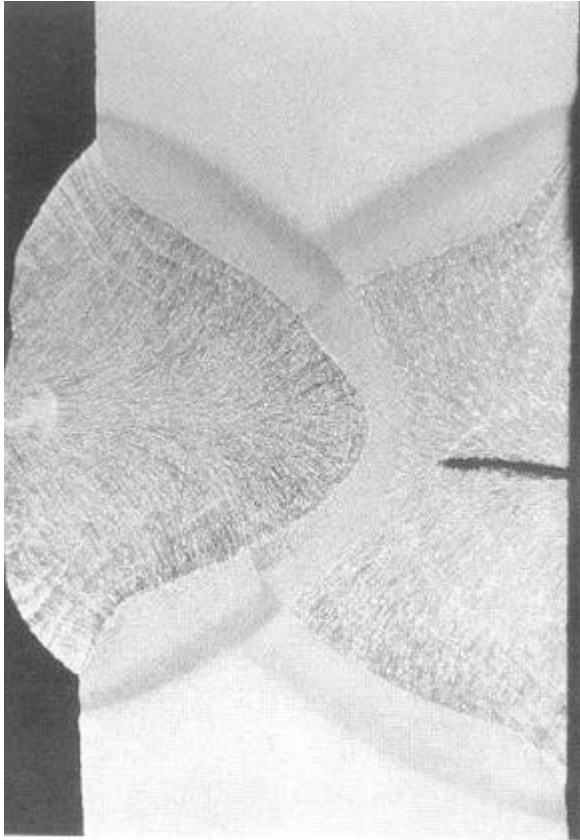
### END CRACK

Solidification crack in the centre line of the weld bead. Tends to occur towards the end of a pipe in the last metal to solidify.

Ensure correct welding procedures and welding conditions in the pipe mill. Cut out the pipe section and replace.

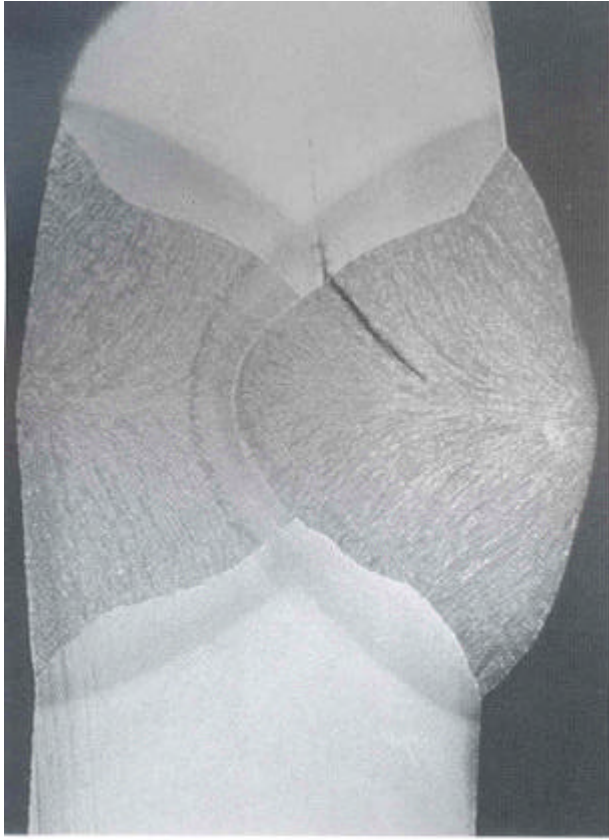
## **HOT TEAR AT LAMINATION**

Solidification crack in the weld bead that has initiated from a band of segregation in the parent plate.

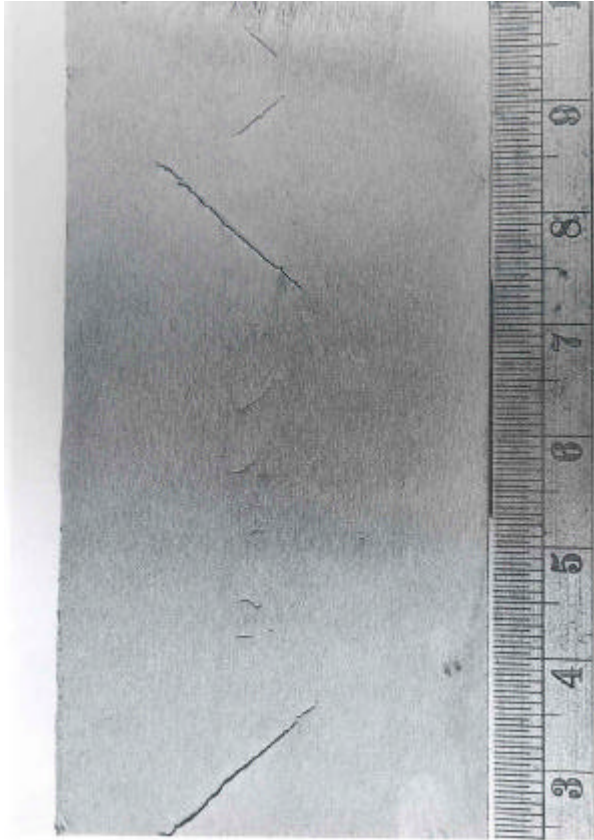
## **HYDROGEN CRACKING**

Transverse cracks in weld bead often lying on alternate 45° planes. Also referred to as 'chevron' cracking.

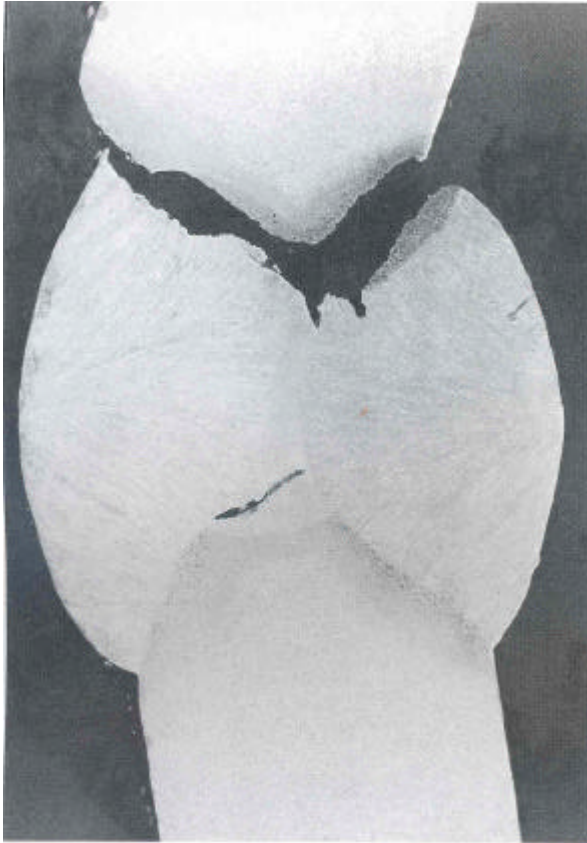
### LACK OF FUSION

Linear defect at weld sidewall, or in top edge of the weld.

Cut out and replace the affected pipe. Alternative repair procedures may be acceptable subject to a full defect assessment.

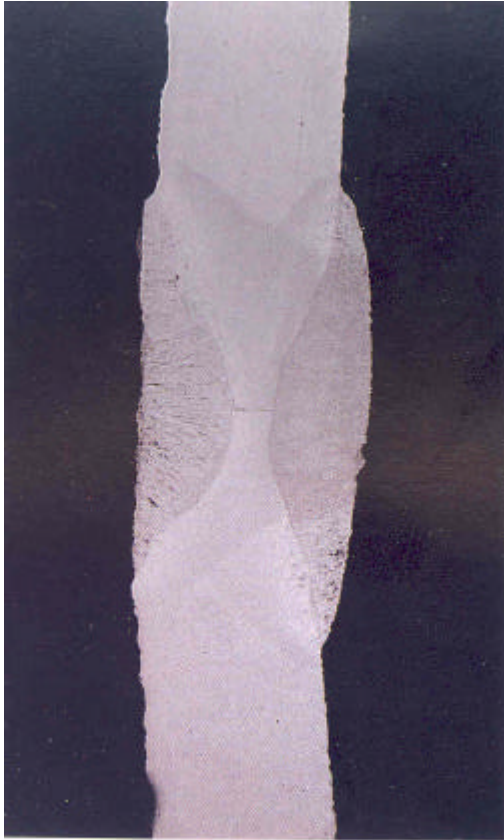
## LACK OF INTER PENETRATION

Linear defect between the inside and outside weld beads. The crack like defect is aligned through the wall thickness.

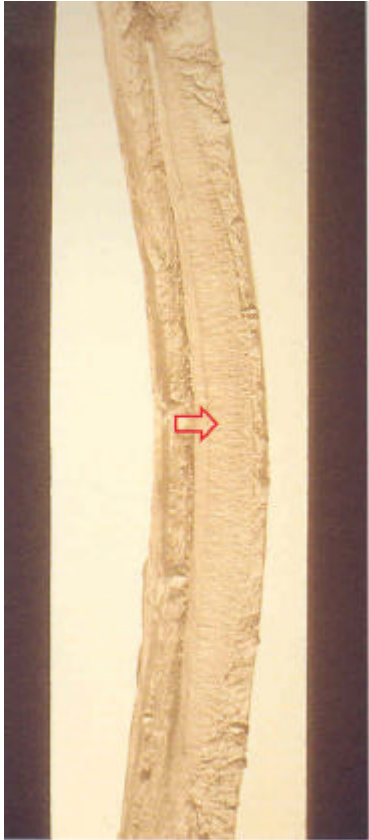
### MISALIGNMENT

Lack of fusion in the seam weld.

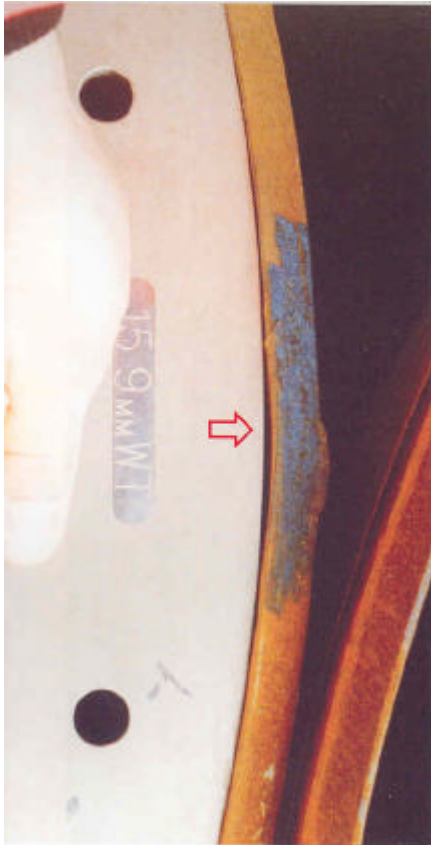
### ROOF TOPPING

Peaking at the SAW seam weld.

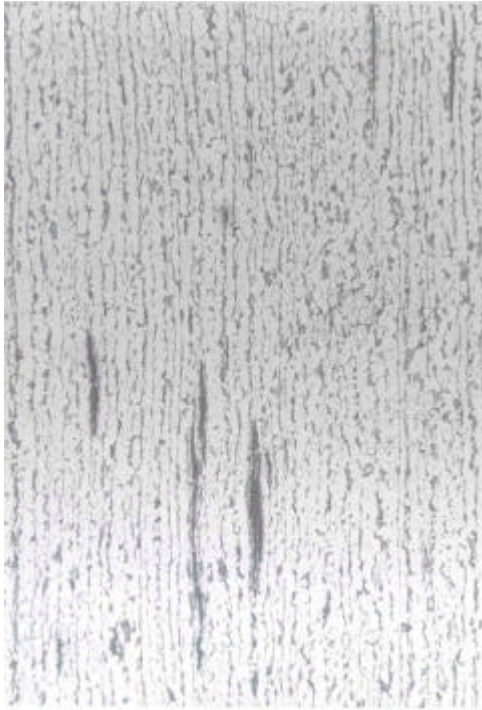
### SLAG INCLUSION

Non-metallic inclusions in the pipe wall.

Slag inclusions are usually too small to be structurally significant. However, surface breaking inclusions may initiate corrosion or create a defect in a thin film pipe coating.

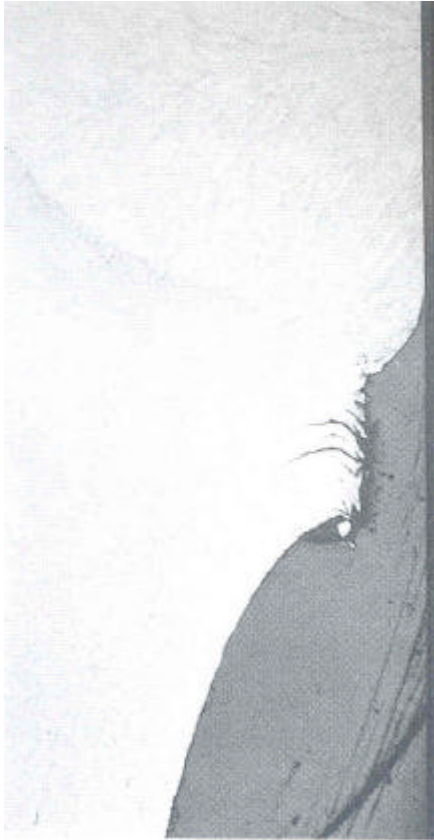
## **SURFACE LAP AT WELD**

Cracking in close proximity to the seam weld and running parallel.

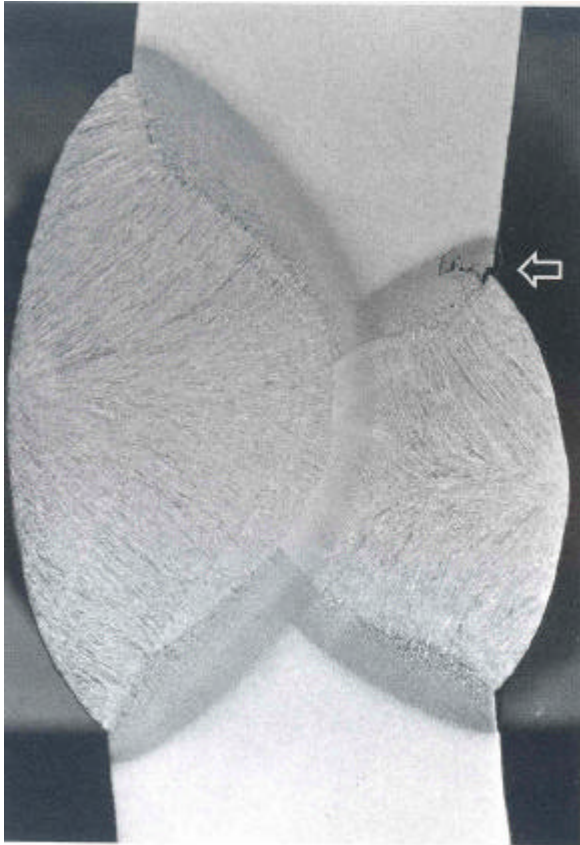
### TOE CRACKS

Cracks at the junction between the submerged arc bead and the pipe surface.

May only be discovered if the pipe sees severe service conditions.

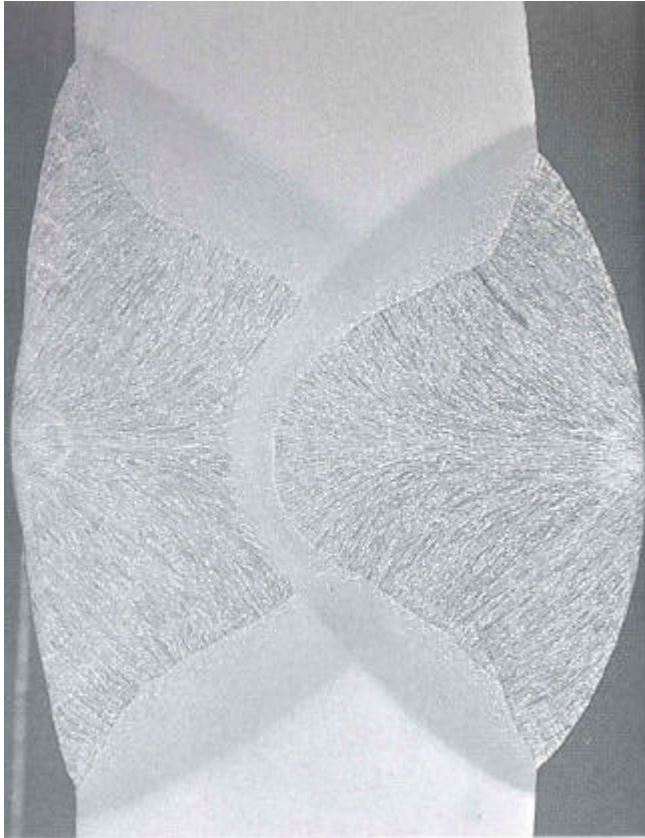
## TOP HAT CRACKING

Solidification crack in the weld bead initiated from a change in profile at the weld fusion boundary.

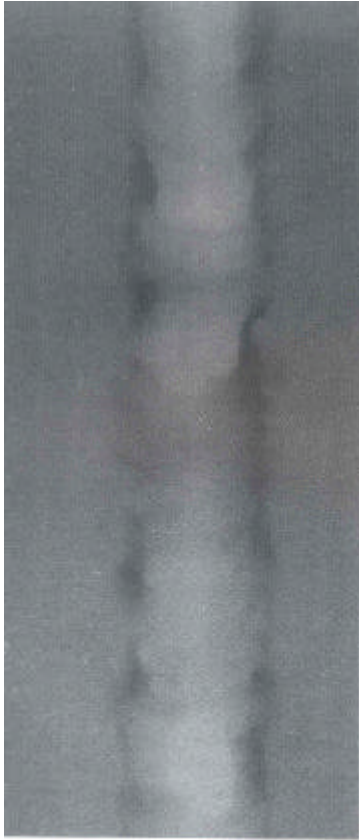
### **UNDERCUT**

A linear defect at the edge of the internal or external weld bead.

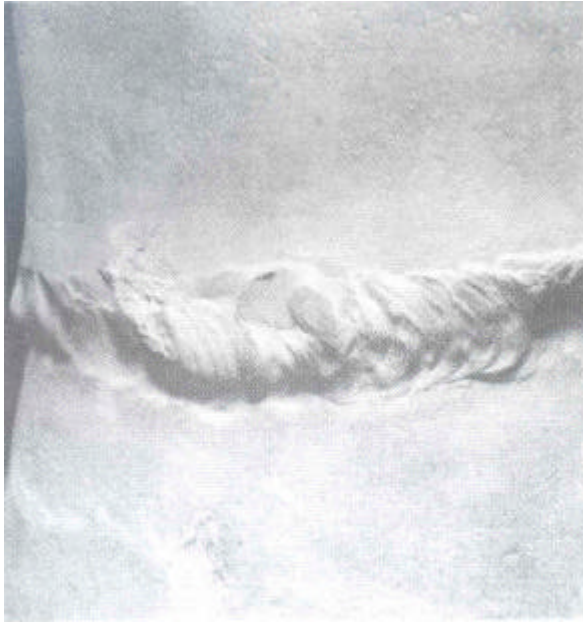
## **CAP UNDERCUT**

A smooth groove between the capping run of the weld and the parent plate.

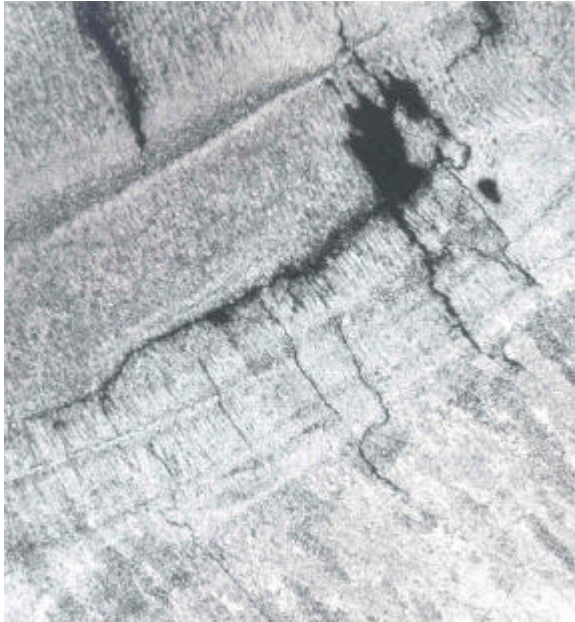
### COPPER CRACKING

Fine cracking in the weld metal, often with associated copper inclusions, and concentrated at the grain boundaries.

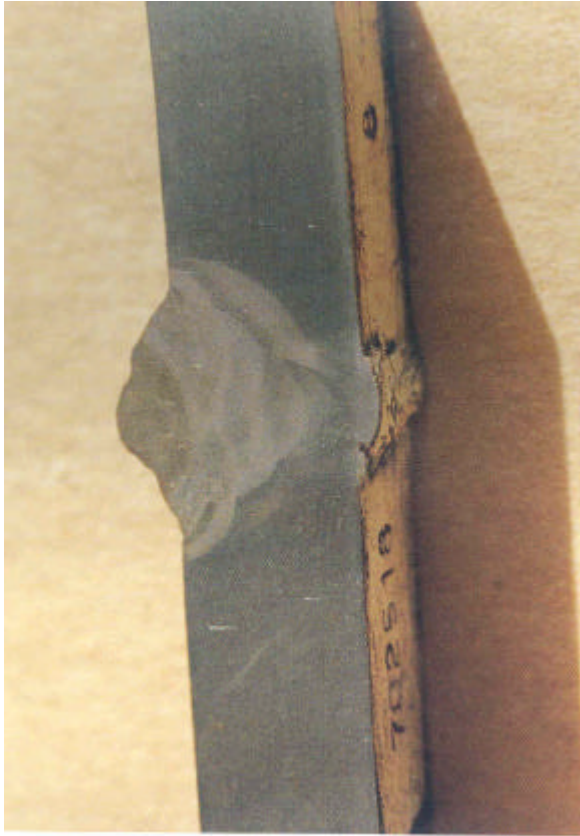
### EXCESS CAP HEIGHT

Excess weld reinforcement on the cap, usually greater than 3 mm. It is more common at the 6 o'clock position.

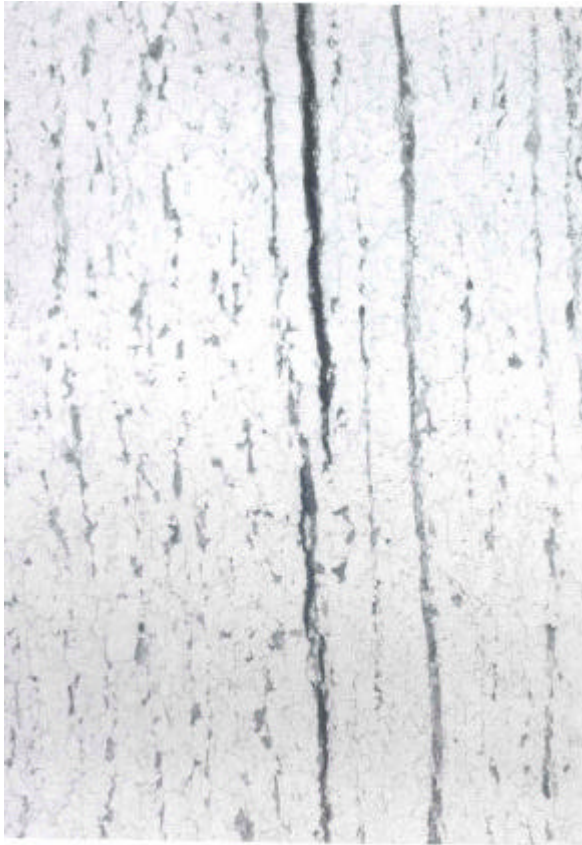
## **CENTRE LINE SEGREGATIONS**

Concentrations of non-metallic material in the mid-wall position including carbon and manganese rich bands.

They may provide an initiation point for cracking in sour service and may contribute to weld defects.

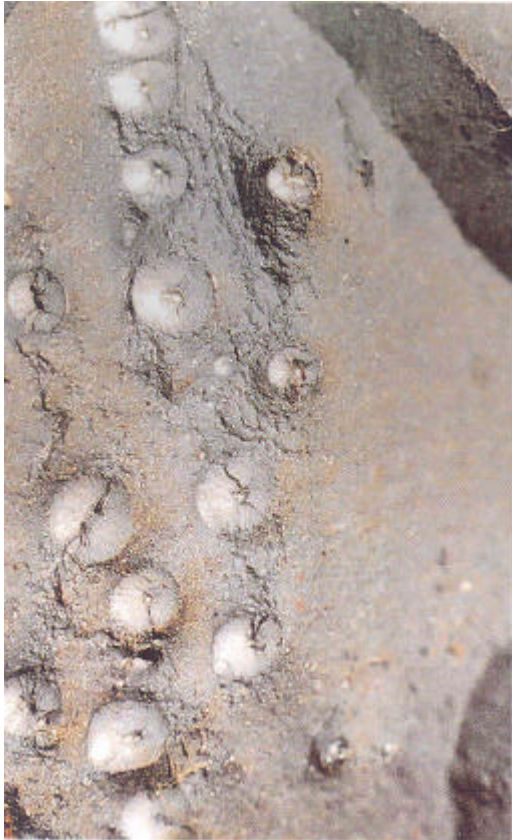
### FISH EYES

Weld metal hydrogen fissures, or 'fish eyes' are circular or elliptical features on weld fracture surfaces, usually tensile specimens, with a shiny grey appearance and a dark 'eye' at the centre.

Dissolved hydrogen in the weld metal which triggers a low ductility fracture when the material is strained. Found especially in test specimens from welds made with cellulosic electrodes which are strained a short time after welding.

Regarded as an artifact caused by the testing process and of no significance for the real weld. They can be avoided by using a low hydrogen welding process, by increasing the delay time between welding and testing, or by giving the weld a low temperature hydrogen removal treatment. Repair is not necessary.

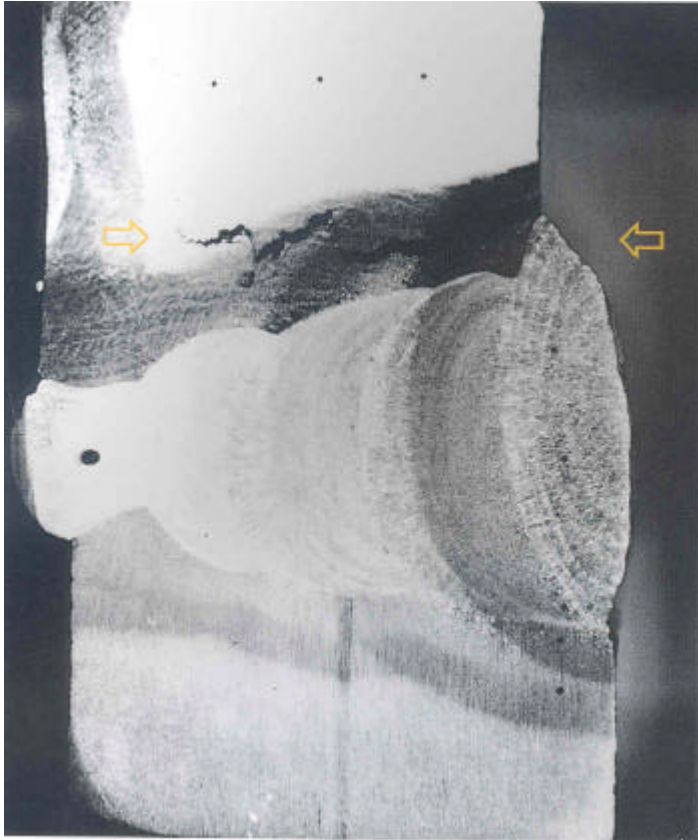
## H CRACKING CAP HAZ

Cracking originating at the edge of the weld cap and following the heat affected zone.

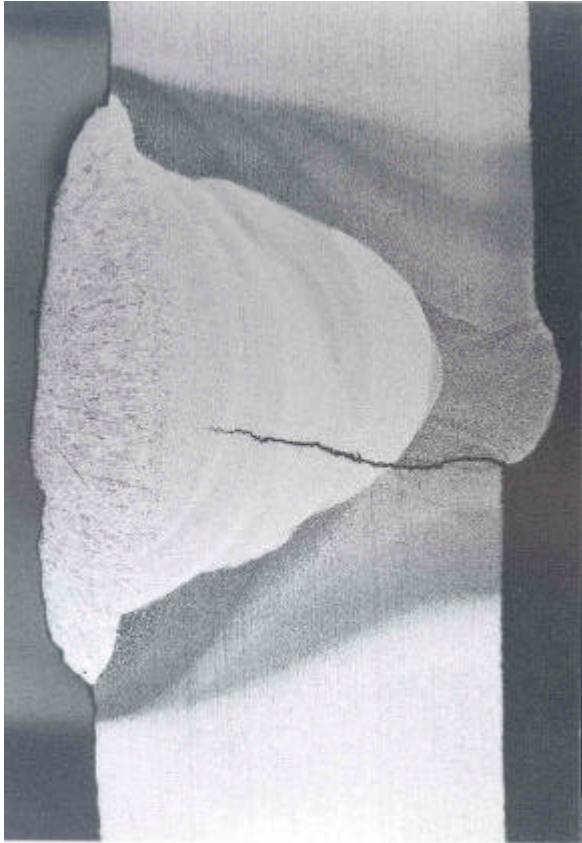
### H CRACKING, ROOT HAZ

Cracks initiating in the heat affected zone of the root bead and propagating up the heat affected zone or into the weld metal. Also known as 'cold cracks' or 'underbead cracks'.

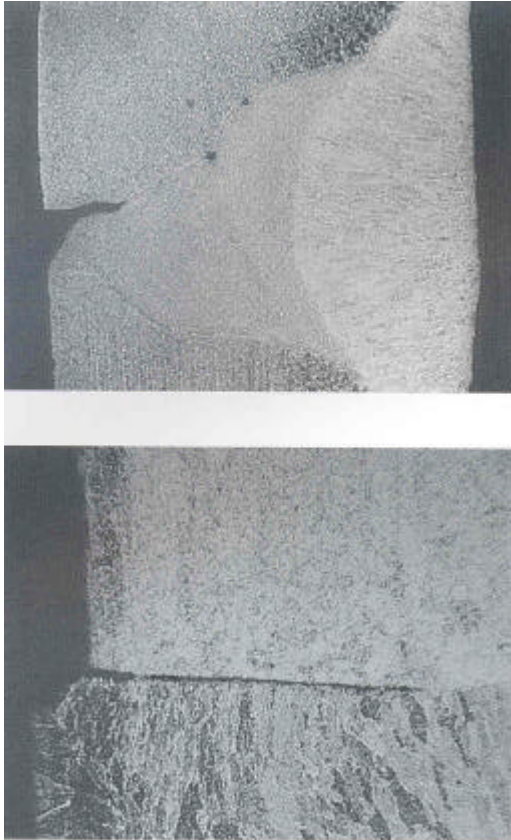
### LACK OF FUSION, ROOT

Lack of fusion between the edge of a fully penetrated root bead and the root face on one side of the joint. Also known as 'missed edge'.

Incorrect electrode angle.  
Inadequate cleaning of the root face.

May be acceptable if within specified length limits, typically 25 mm in 300 mm of weld length.  
Otherwise grind out and repair by re-welding.

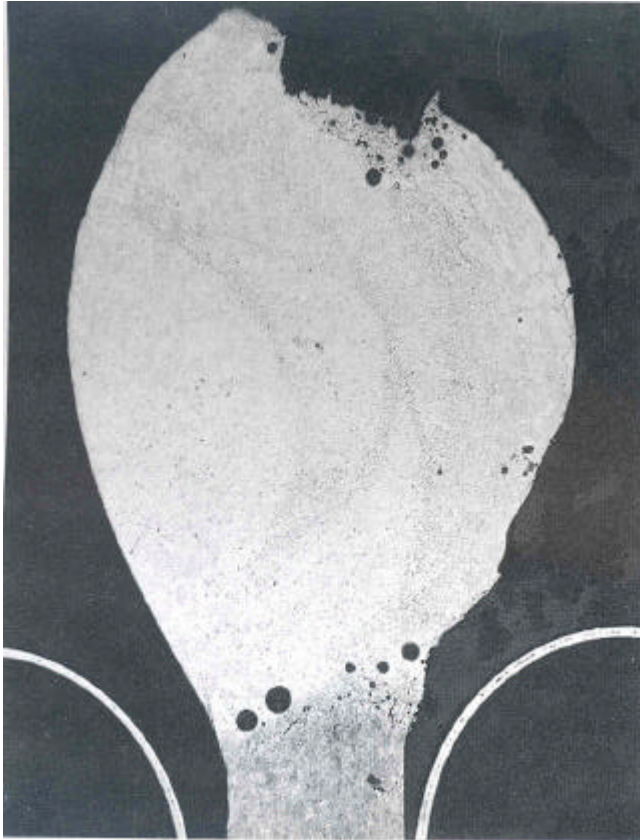
### **POROSITY, CLUSTER**

A group of pores within the weld metal

May be acceptable if evenly distributed within specified limits, usually based on distribution diagrams. Otherwise grind out and repair.

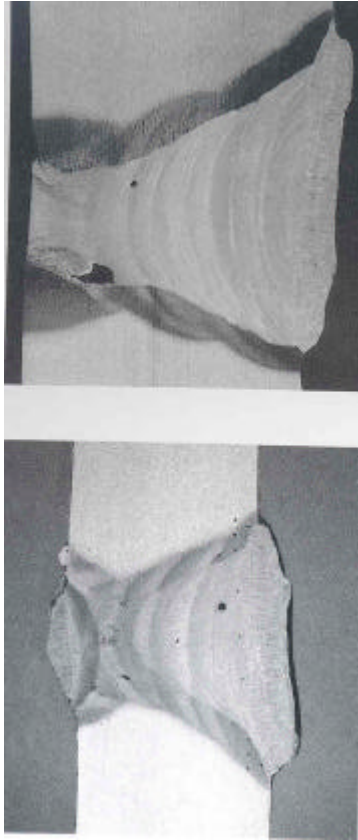
### PARALLEL SLAG LINES

Linear voids or slag inclusions most commonly found between the first and second pass welds in manual 'stovepipe' welds, and often appear on radiographs as two parallel lines. Also known as 'waggon track'.

May be acceptable within specified limits.  
Otherwise grind out and repair.

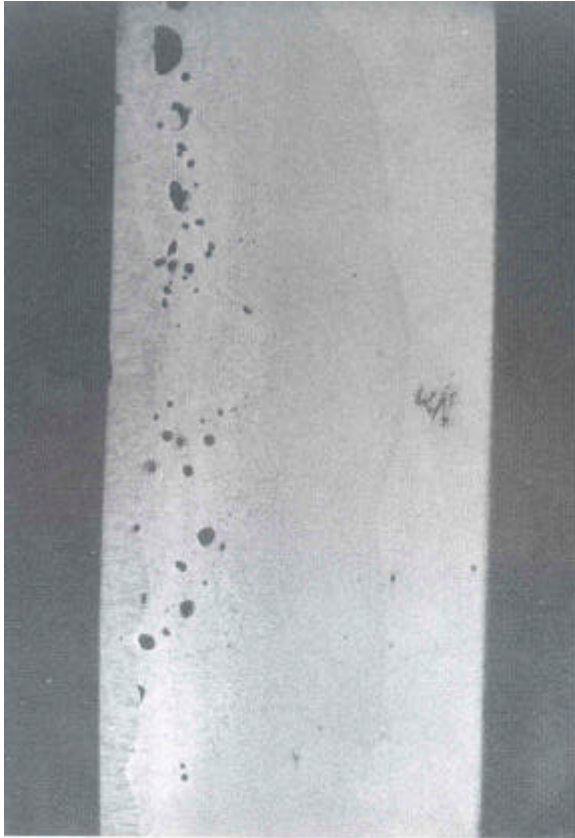
### **POROSITY, SCATTERED**

Scattered gas pores in the weld metal.

May be acceptable within specified limits, usually based on distribution diagrams. Otherwise grind out and repair.

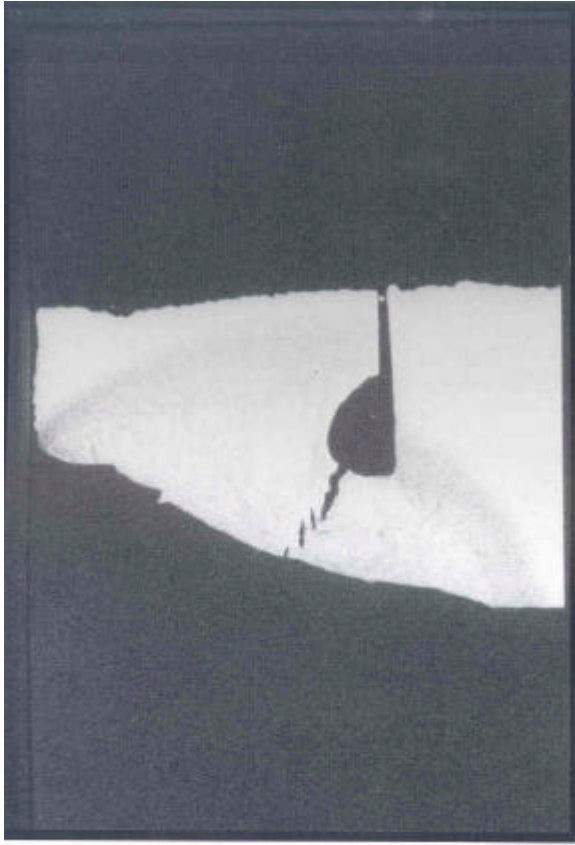
## **SOLIDIFICATION CRACKS**

Crack in the centre of the weld bead, especially within hot pass. Also known as 'hot tear'

Correct deficiencies. Change weld consumables. Grind out and repair.

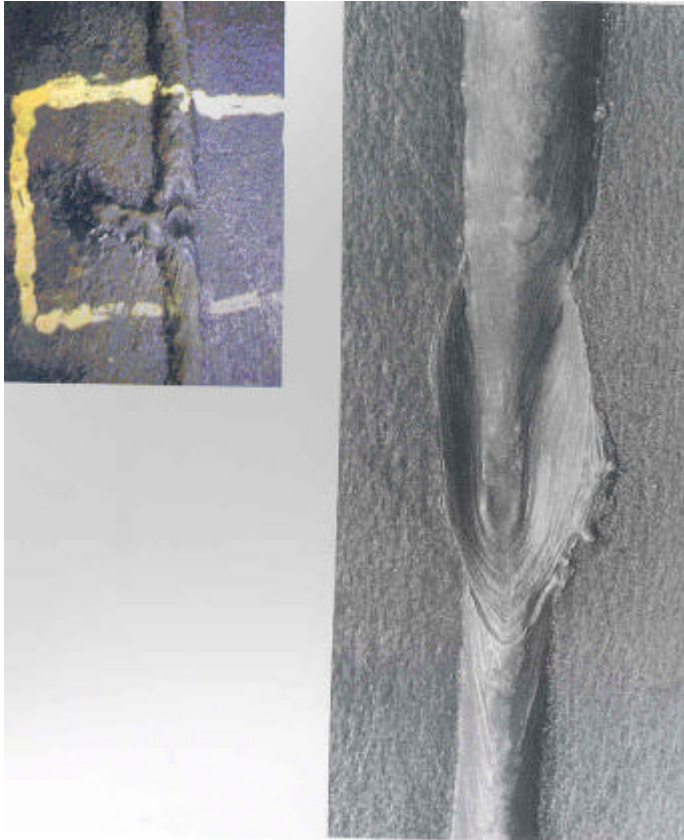
### STOP START DEFECT

A lack of fusion, a lack of fill or a lack of penetration at the stop / start position, often in the root bead. Also known as 'poor pick up'.

Failure to overlap the stop / start position when changing electrodes.  
Failure to grind the crater, failure to fill the crater or failure to establish weld pool properly when re-striking.

Visually acceptable within specified limits, depending on the type of defect.
