## Manufacturing: ERW Pipe Defects

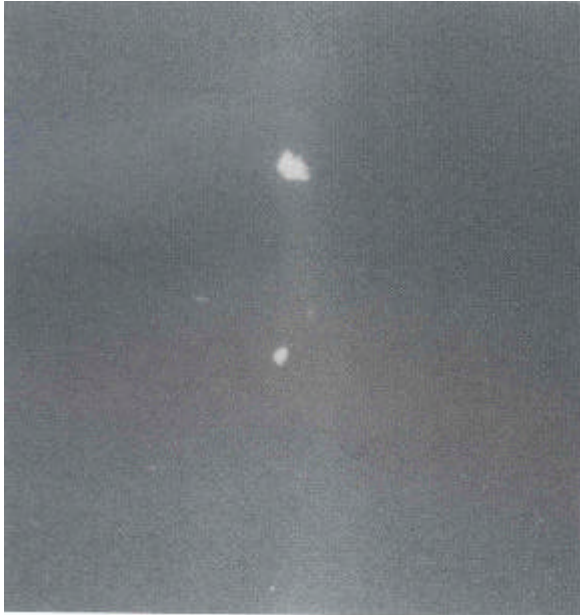
## TUNGSTEN INCLUSION

Isolated inclusions of undissolved tungsten in the weld bead. Appears as a white spot on the weld radiograph.

May be acceptable within specified limits, typically specified as a maximum number per weld. Otherwise grind out and repair.

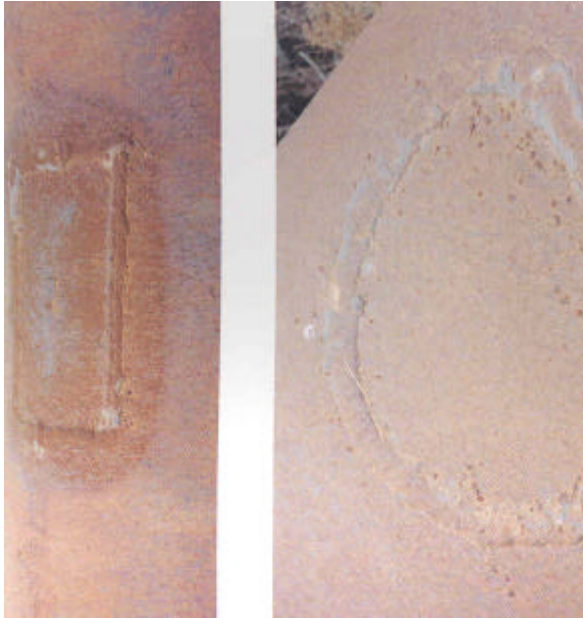
## **BUTT WELDED PATCH**

Butt welded patch in a pipeline

During construction a manhole has been cut into a pipe to gain access to the inside of the pipe for weld repairs. The 'cut out' is then welded back into the pipeline with a butt welded.

This is unacceptable construction practice. The area of the patch should be cut out and replaced or repaired with a full encirclement sleeve.

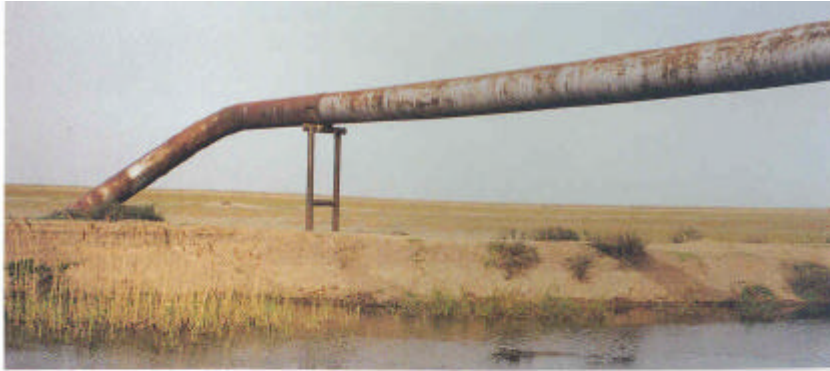
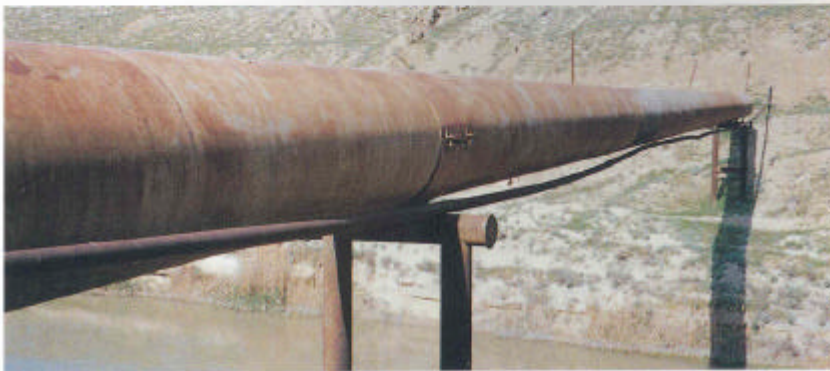
## CONTACTS

The pipeline is in electrical contact with 'foreign' structures such as pipe supports or reinforcing bars in concrete

Electrical contacts create a drain on the applied cathodic protection current and may prevent effective protection. Galvanic or interference current corrosion may result and lead to rapid pitting and through wall penetration in the affected area.

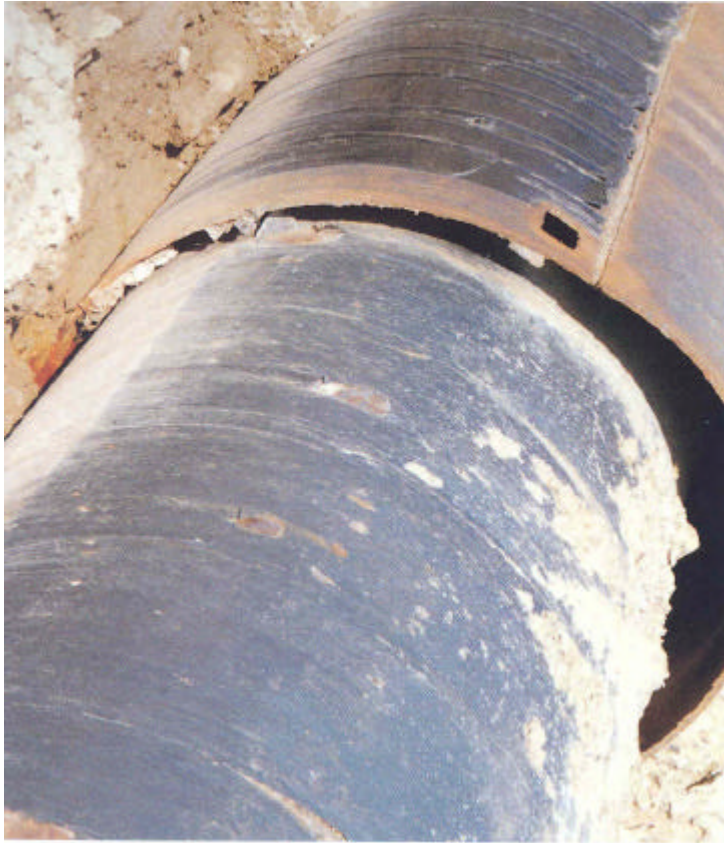
## **ECCENTRIC TOUCHING CASING**

The casing is not aligned parallel with the carrier pipe and, in extreme cases is in contact with the carrier pipe

Electrical contact between the casing and the carrier pipe may create a local drain on the applied cathodic protection and create a localized corrosion cell.

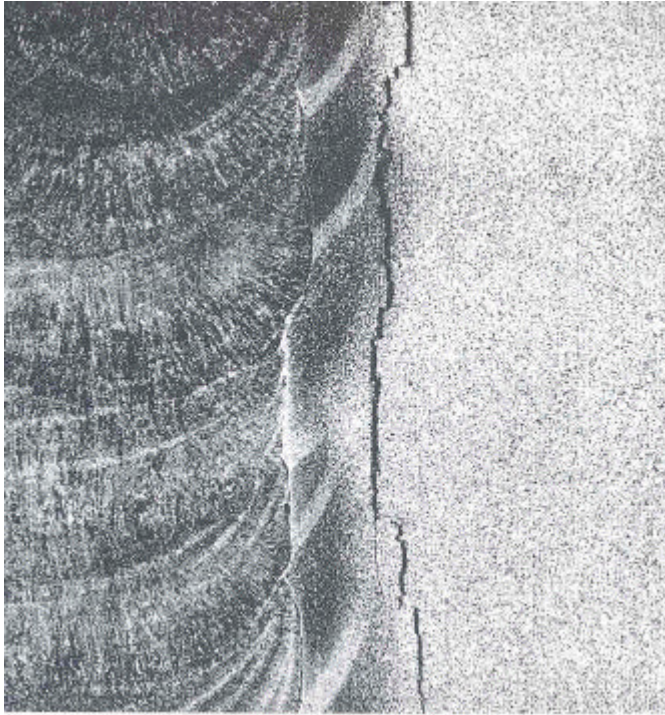
## LAMELLAR TEARING

A crack like feature within the plane of the plate

Lamellar tearing is most marked in dirty plate. Small tears may not require attention but large tears should be assessed.

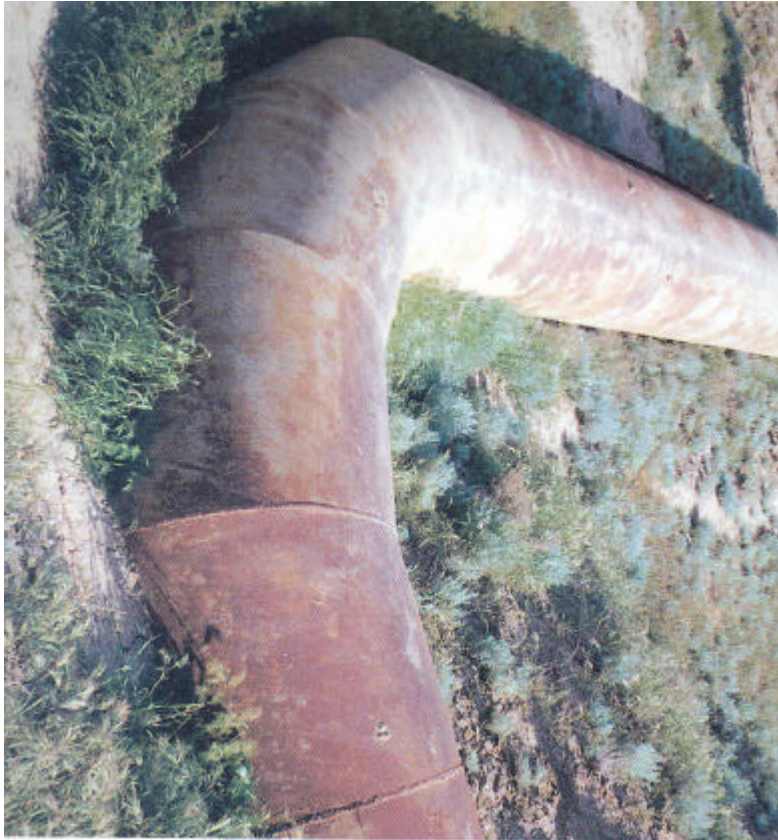
## MITRE BEND

Mitre bends, also known as 'lobster back bends' are made by welding together short pieces of pipe with mitred ends.

Mitre bends should be replaced with forged bends in high pressure pipelines.

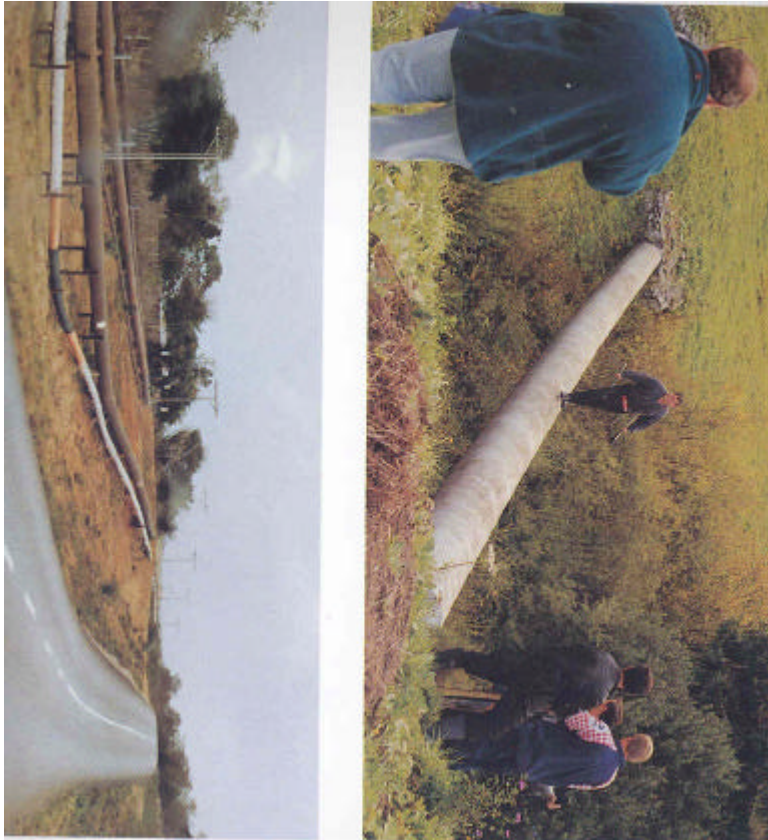
## UNPROTECTED PIPE

The pipeline is exposed above ground without security fencing or other protective measures.
