# FIELD INVESTIGATION OF GEARBOX VIBRATION DUE TO CRACKED MOTOR ROTOR BARS

BY ROSS PINNER  
AND TROY FEESE

42<sup>nd</sup> Turbomachinery  
29<sup>th</sup> Pump SYMPOSIA

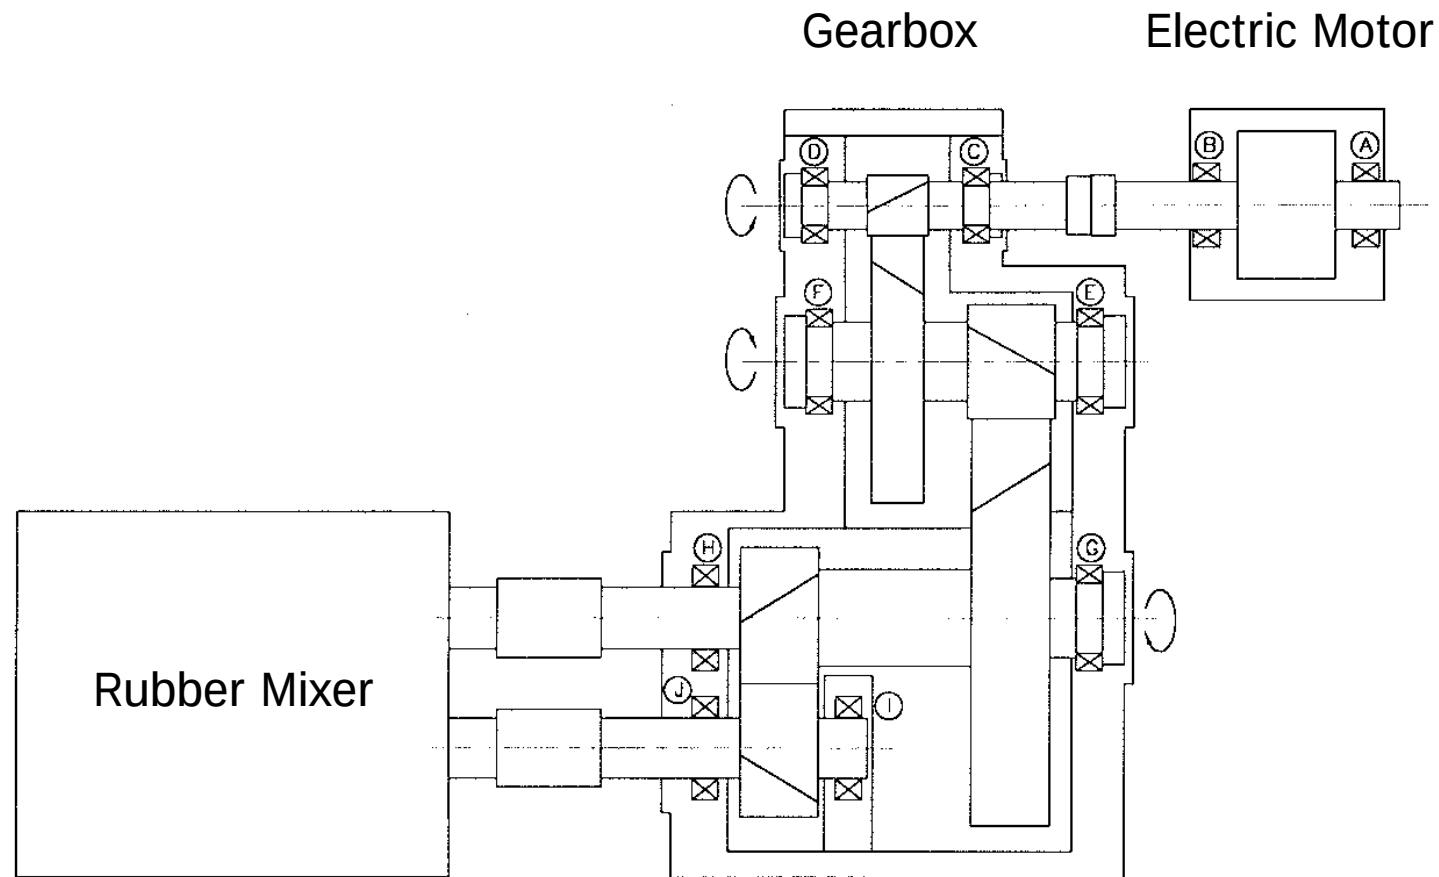
# Motor – Gearbox – Mixer Unit For Tire Production

Approximately one year after installing a new gearbox, vibration levels were gradually increasing. The tire plant requested that the gearbox manufacturer investigate under warranty. A field study was performed by an independent engineering company to measure the vibration of the motor, gearbox, and rubber mixer unit at the plant.

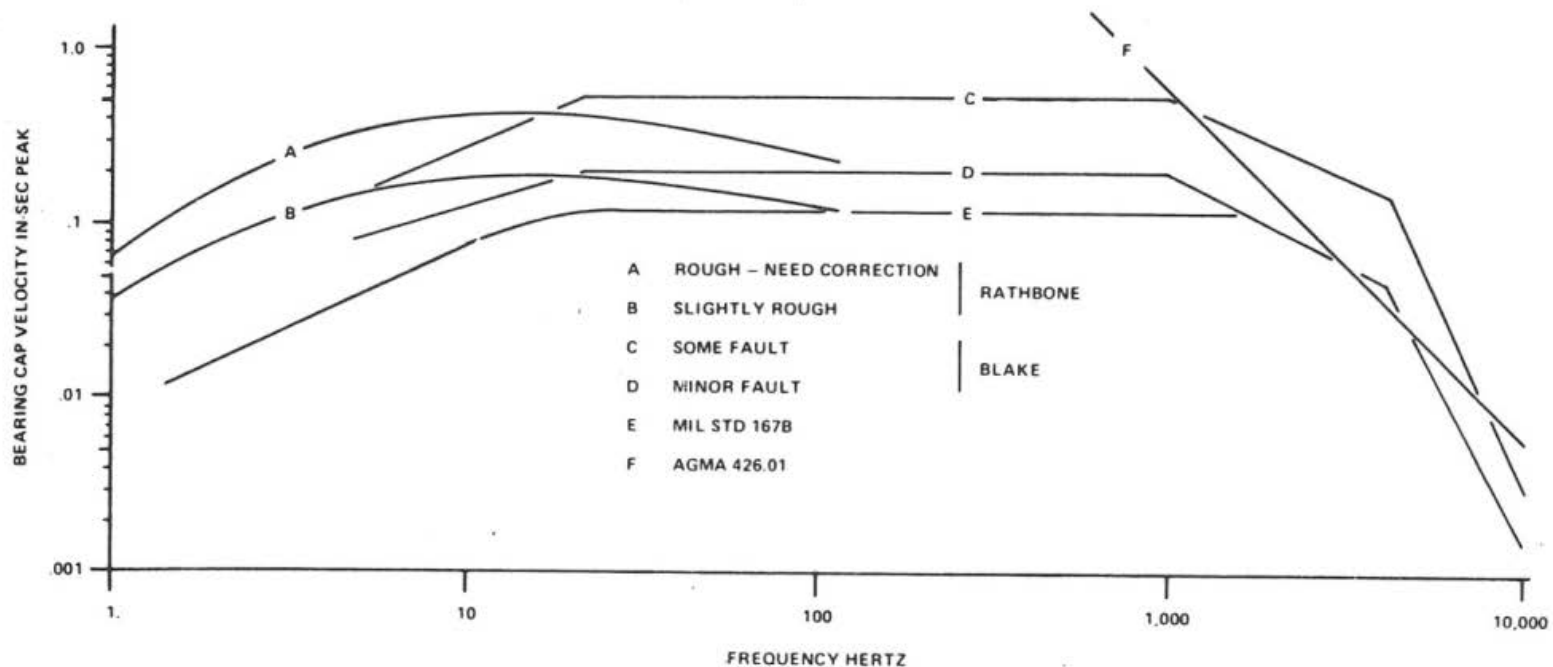
**Figure 10-4** Comparison of Casing Vibration Limits

Above 600 Hz, AGMA allows  
gearbox case vibration up to 10 g's

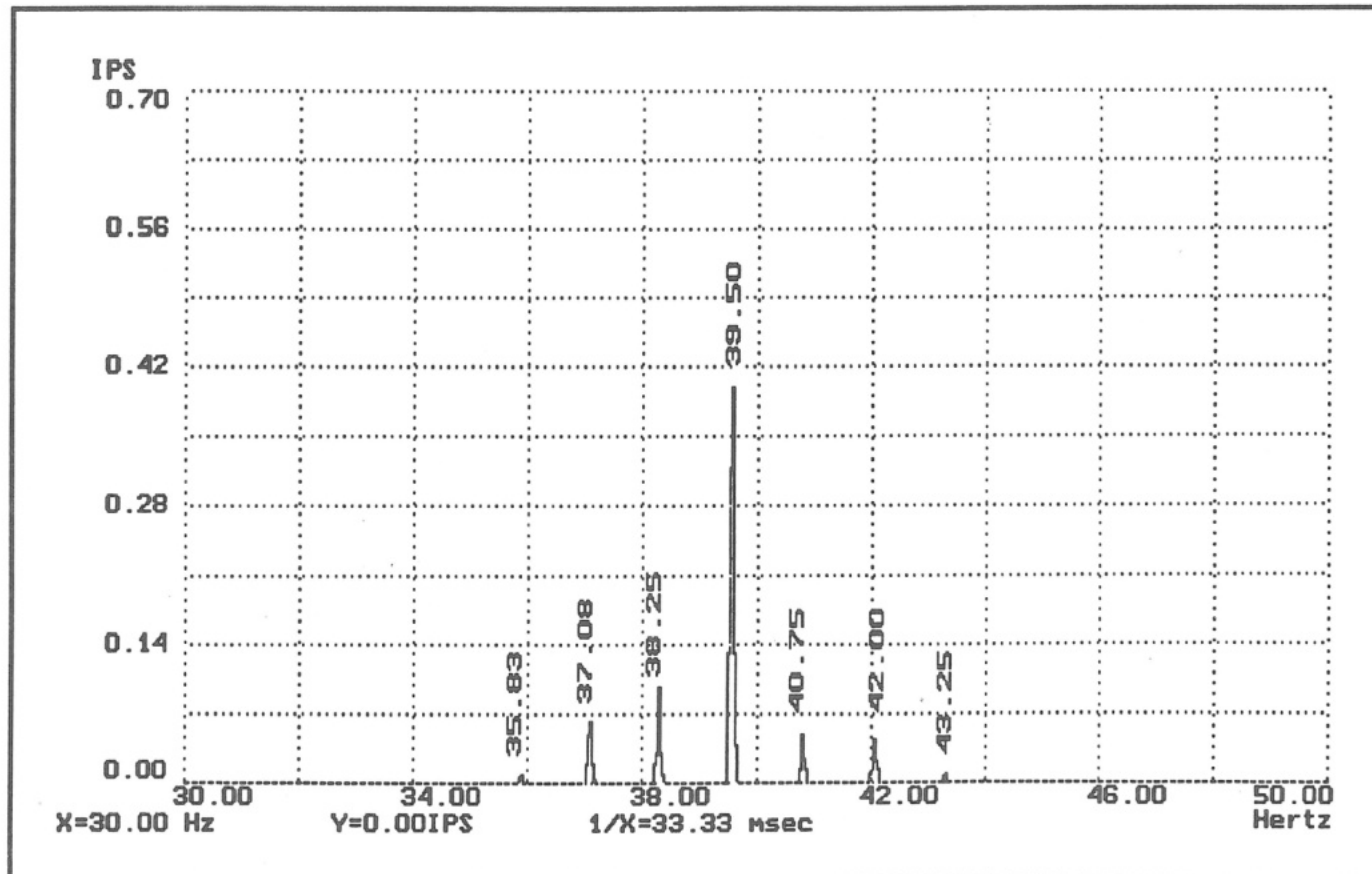
Fig. 4-28. Frequency Spectrum of 20 Hz Window around the Second Harmonic of Motor Speed.

# Compare to “Text Book” Example of Broken Rotor Bars [Taylor]

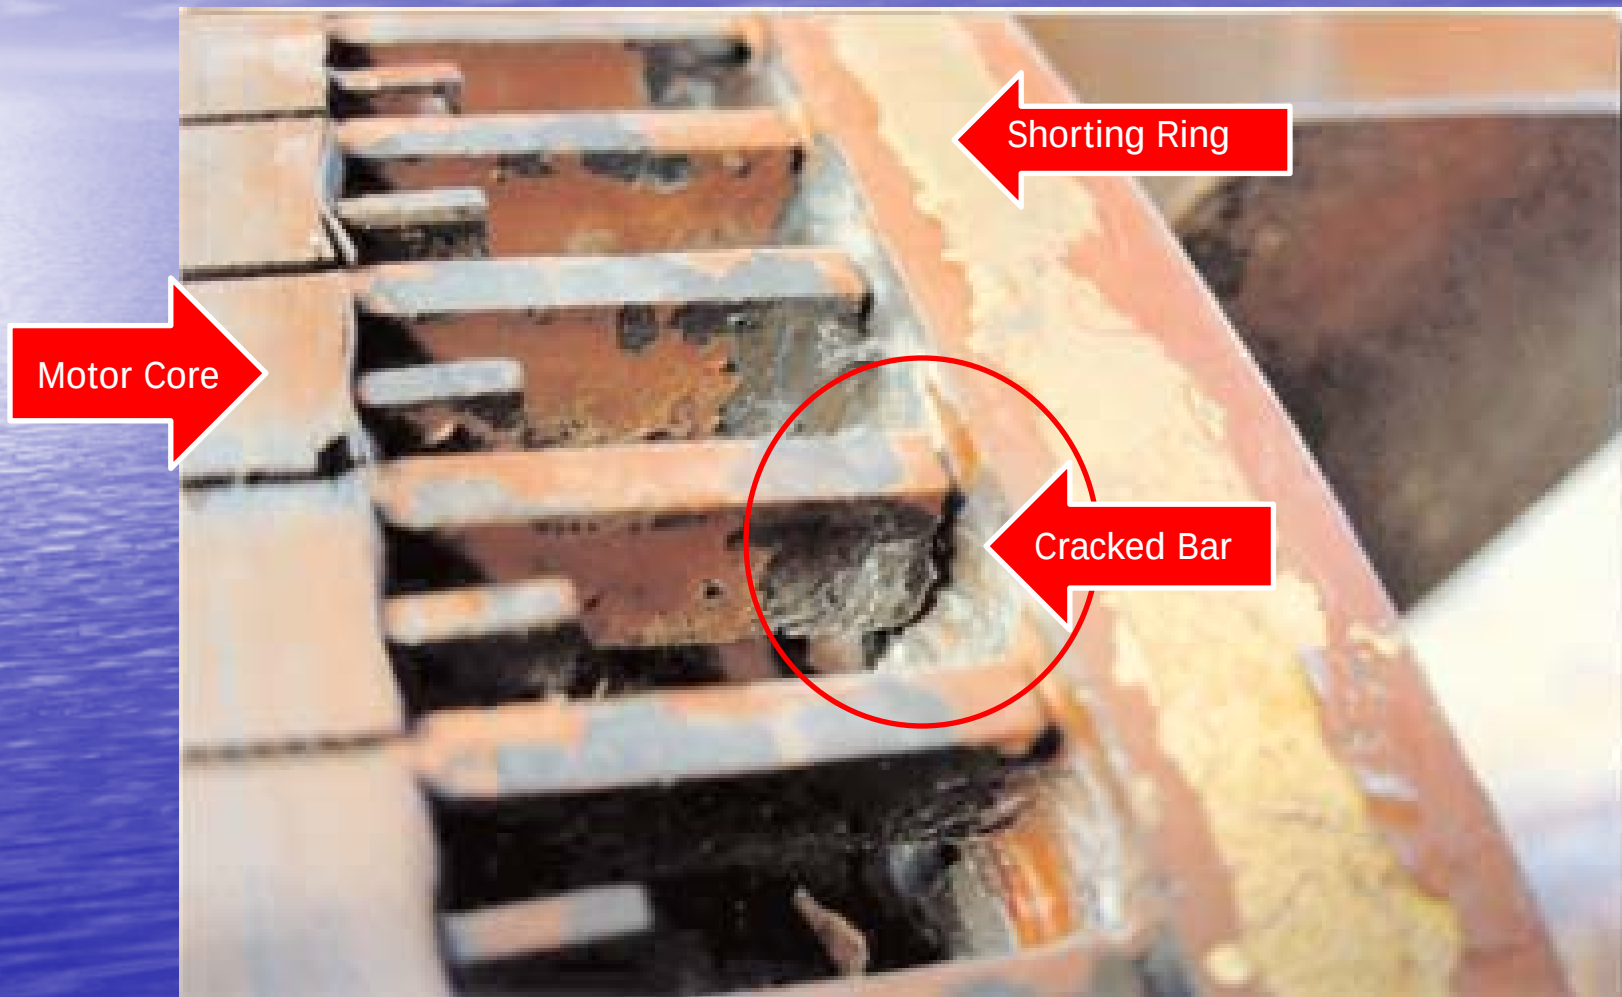
# Unrelated Example of Broken Bar / Cracked Weld \*
