46<sup>TH</sup> TURBOMACHINERY & 33<sup>RD</sup> PUMP SYMPOSIA  
HOUSTON, TEXAS | DECEMBER 11-14, 2017  
GEORGE R. BROWN CONVENTION CENTER

# RESOLVING STRUCTURAL VIBRATION ISSUES ON A WATER FLOOD PUMP

This case study is designed to outline how the high vibration issue of two Water flood modules was successfully diagnosed, the root cause for the high vibration and finally how it was mitigated using some structural analysis techniques.

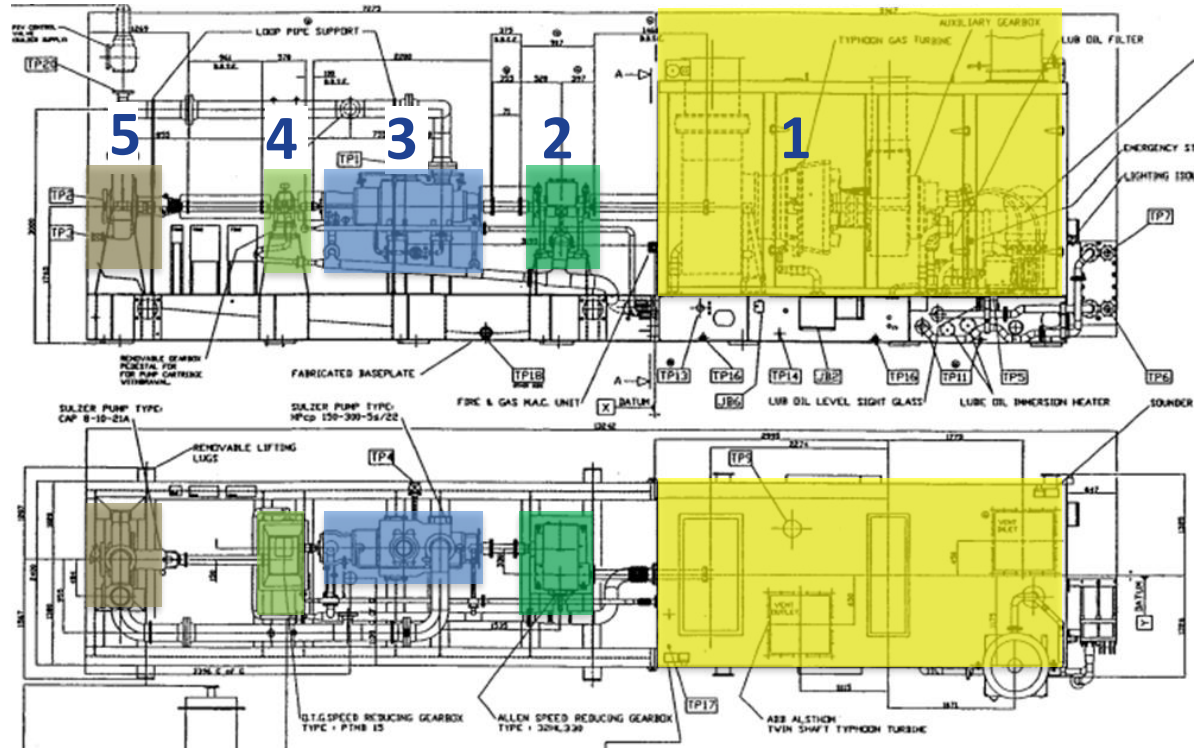
- Based on Operations request, to provide maximum designed water flow, the Unit's speed was increased up to maximum allowed state value.
- While units were operated at increased speed, Power Turbine Shaft relative vibration was exceeding Manufacturer defined *Alarm*, close to *Trip* state levels.
- This was repeated each time when Units were operating at speed close to maximum allowed speed.
- It had not been noticed earlier because both units did not reached that speed during previous operation, based on less flow needs.

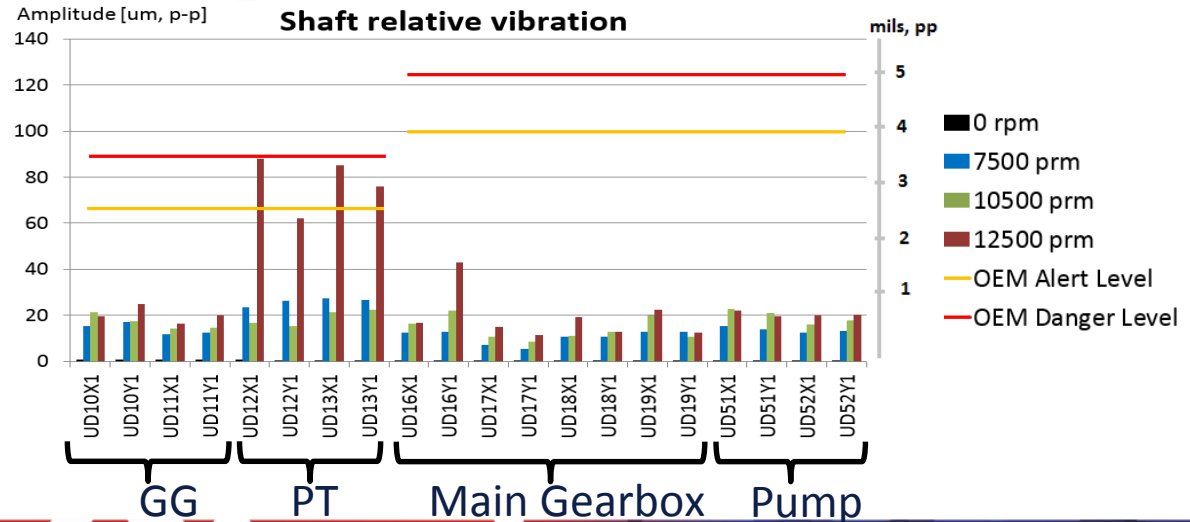
**Power Turbine**  
 High level of Shaft  
 relative vibration  
 > 90  $\mu\text{m pp}$  (3,5 mils)

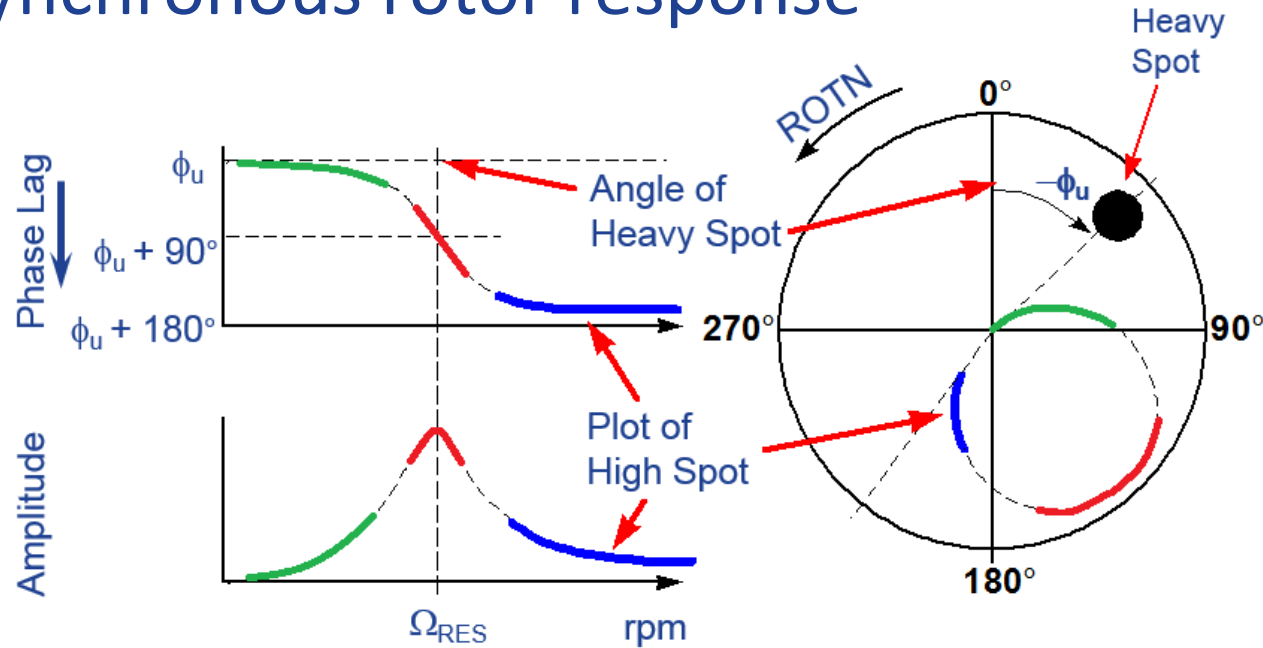
Green line - well below resonance, red line - on resonance, blue line - well above resonance.

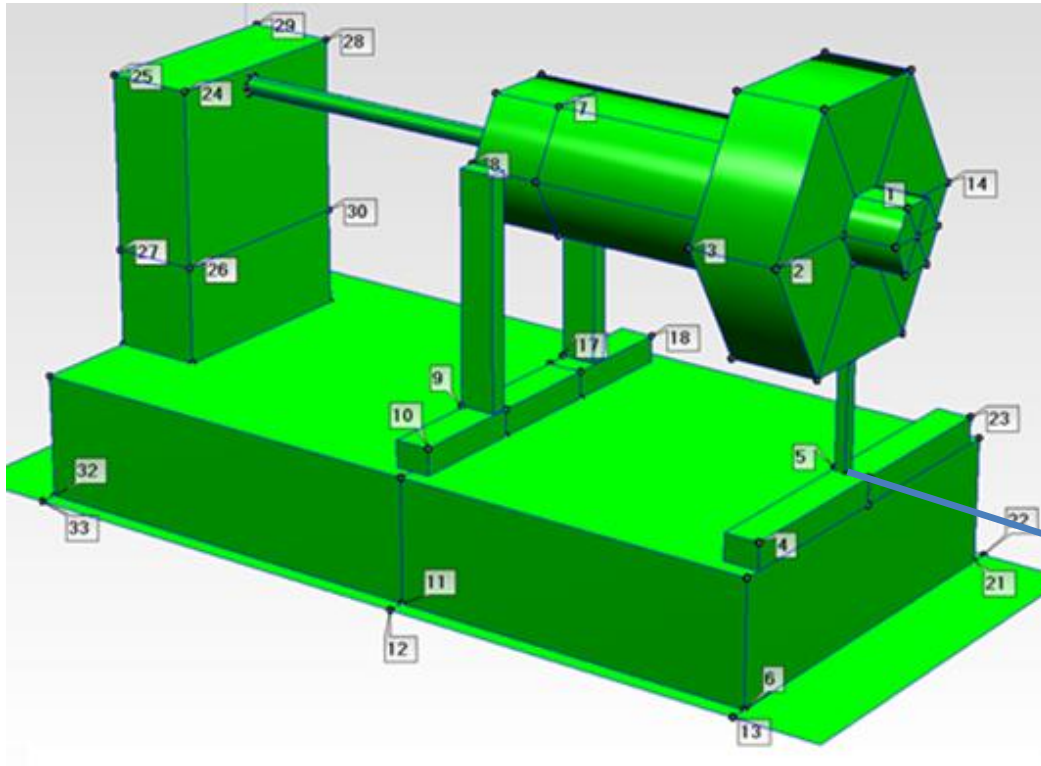
Roved Triaxis  
accelerometer  
(points 1-35)

This PT Drive end side supporting system movement can be the result of supporting system stiffness degradation, or lack of supporting system or frame design.

The stiffness of supporting system was increased in axial direction, U beam was removed and Power turbine legs supports were replaced by new, more stiffer design. This modification was done by Customer and new supports design wasn't scope of this job.
