**SO WHAT DID WE LEARN ABOUT PUMPS DURING THE PAST 20 YEARS?**  
**AN ESKOM PUMP STORY / EXPERIENCE**

The paper discusses and highlights the most prominent critical pump related challenges and experiences Eskom has been faced with during the past 20 years.

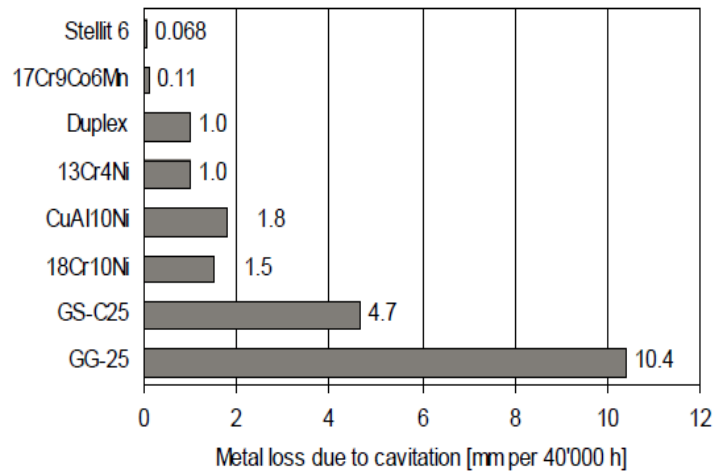
Figure Courtesy of "Centrifugal Pumps" - Johann Friedrich Gülich  
 Figure 1.3: Metal loss due to cavitation for different materials

- The impeller material is bronze which was the preferred material used during the construction of the Grootvlei water supply pumps in the mid to late 1960's. Bronze is classified as a soft material and does not have a high resistance to cavitation erosion, see Figure 1.3 indicating the metal loss due to cavitation for different materials.

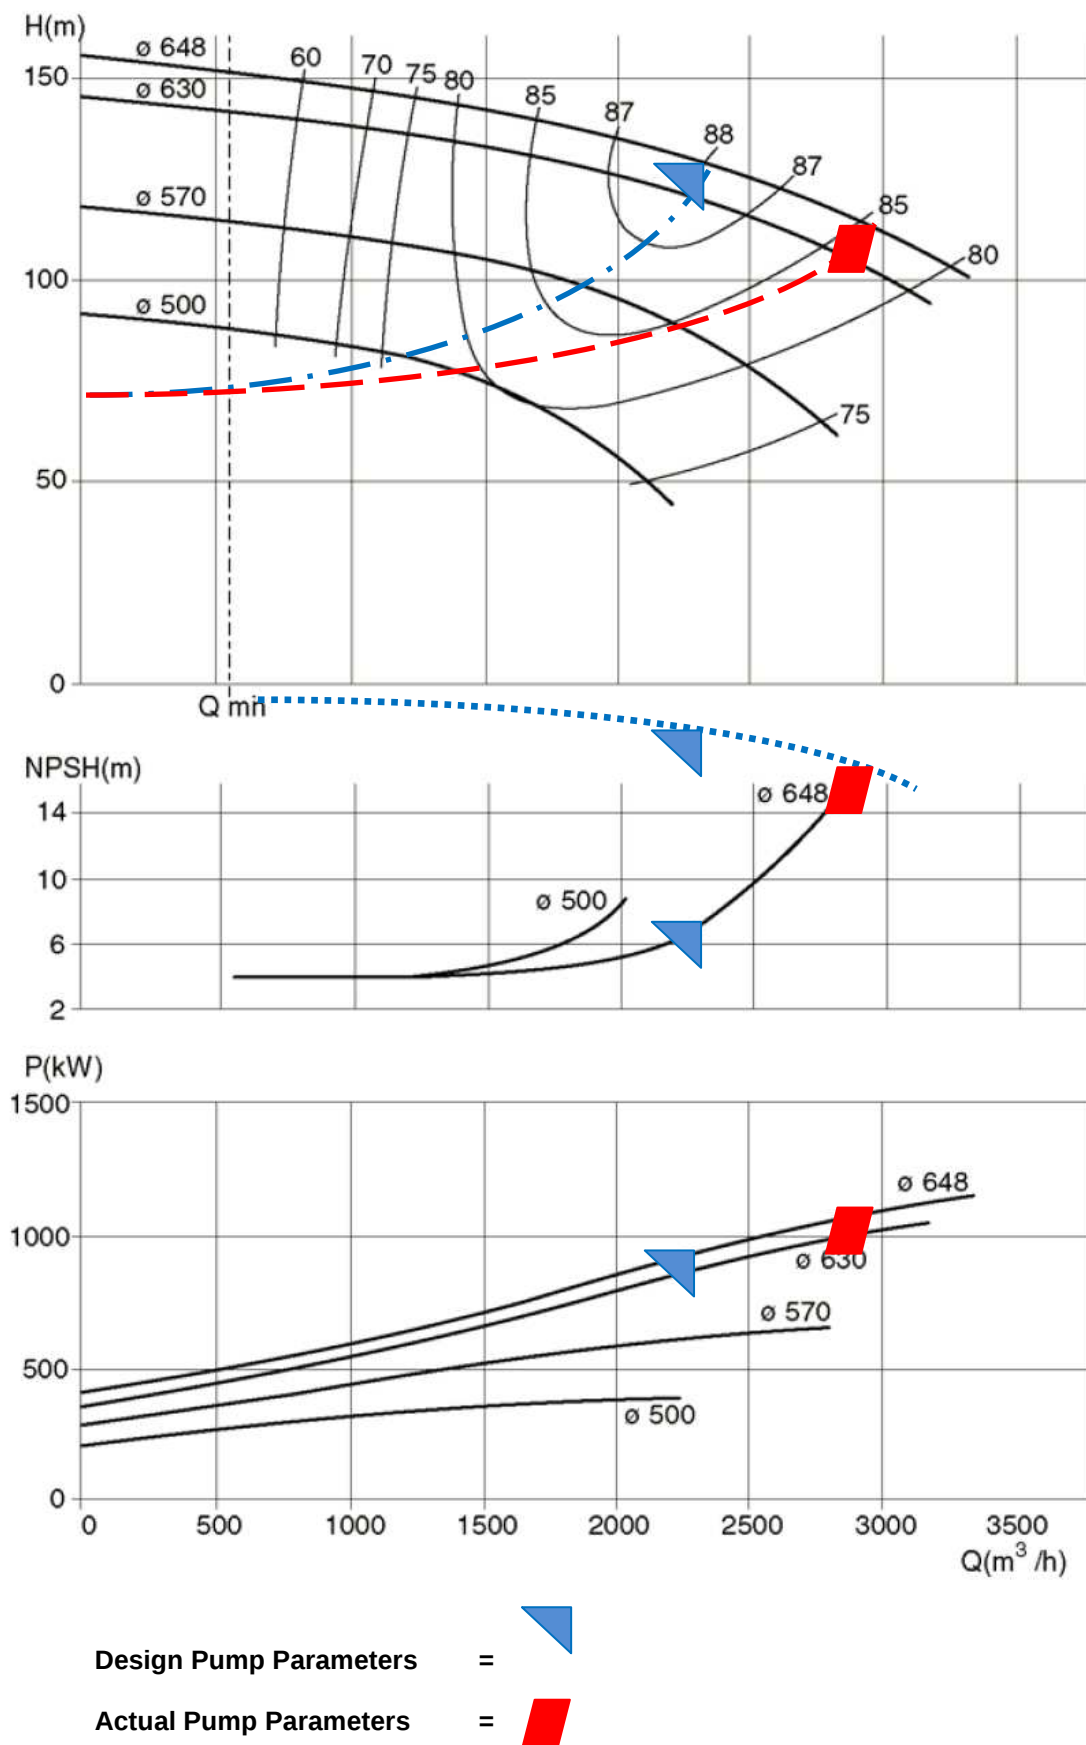
Figure 1.4: Typical Pump Characteristic Curves

- The pumps were running to the right of the duty point and BEP – overload operation, see Figure 1.4
- The NPSH available from site versus the NPSH required by the pump were found to be marginal, especially when pump is running to the right of the duty point and BEP, see Figure 1.4. Figure 1.5 indicates the NPSH curves and cavitation identification for radial impeller designs.

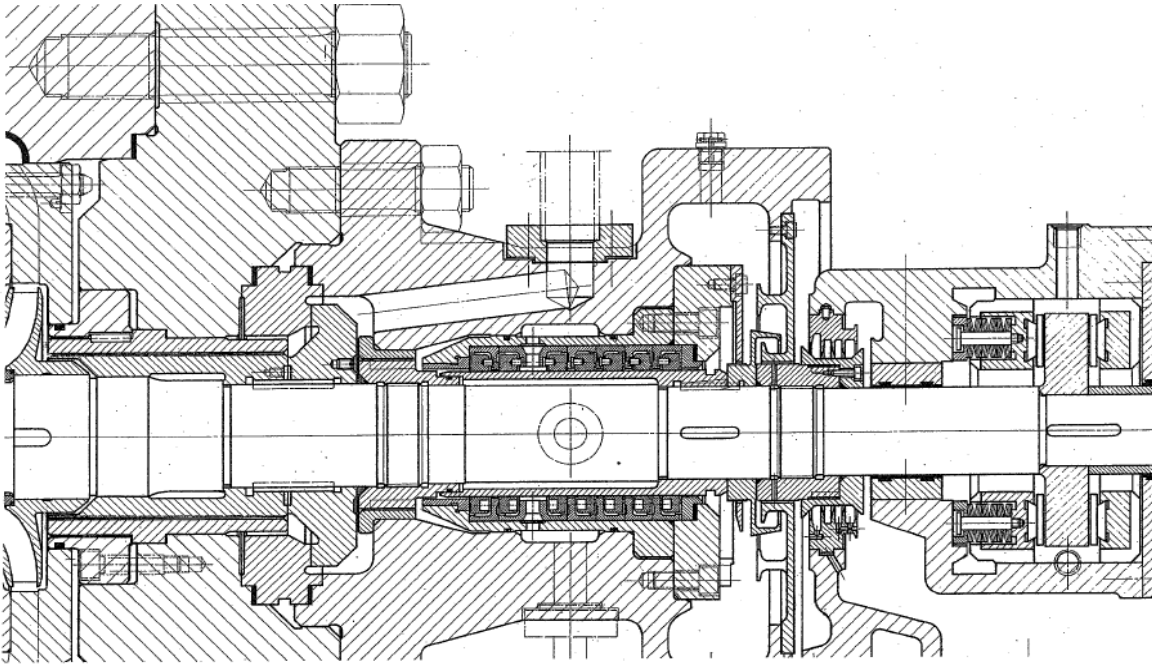
*Figure 4.1: Arnot EFP Thrust Balancing Design (prior to ACIP)*

The original Arnot EFP (Electric Motor Driven Standby Boiler Feed Pump) thrust balance equipment design consists of a balance disc and counter disc arrangement in combination with a throttle bush and balance piston arrangement as shown in Figure 4.1 below:

During the Arnot Capacity Increase Project (ACIP) it was decided to retrofit the existing balance disc; counter disc arrangement of the EFP's (Electric Motor Driven Standby Boiler Feed Pumps) with a balance piston/throttle bush arrangement in conjunction with a redesigned thrust bearing, see Figure 4.2 below:

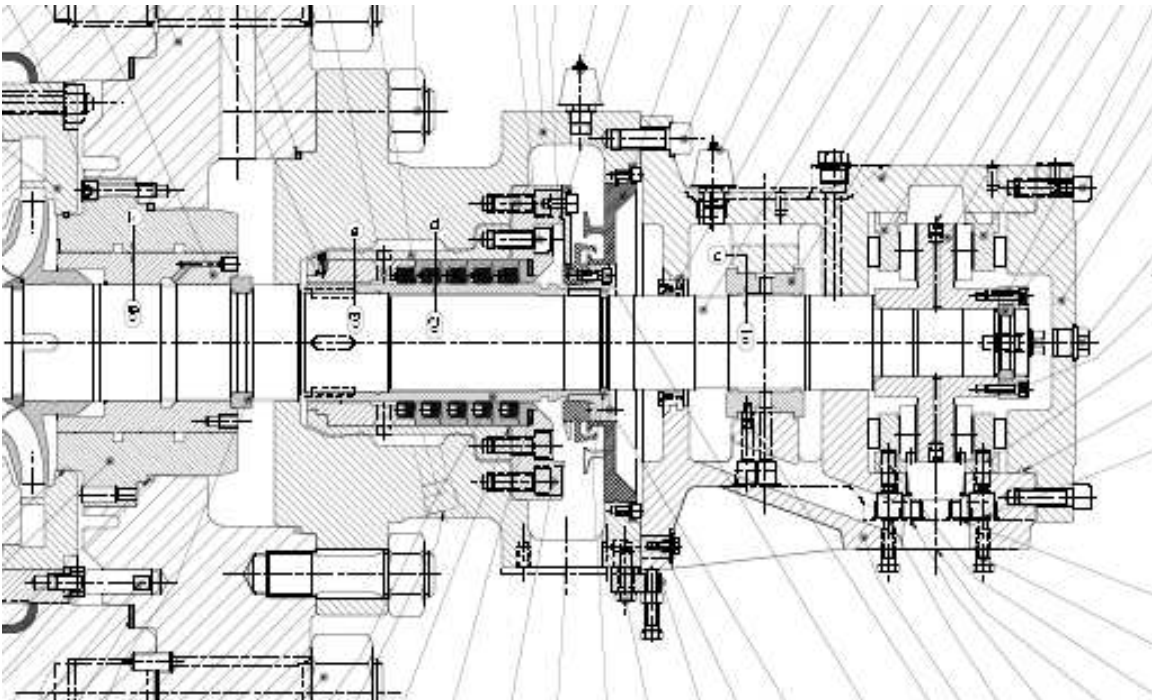
*Figure 4.2: Upgraded Arnot EFP with New Balancing Device Design*

During the Lateral Vibration Analysis investigation conducted on the new upgraded Arnot EFP (Electric Motor Driven Standby Boiler Feed Pump) it was found that the EFP (Electric Motor Driven Standby Boiler Feed Pump) actually runs very close to its second critical speed see Figure 4.3 below of the Frequency and Campbell diagram.

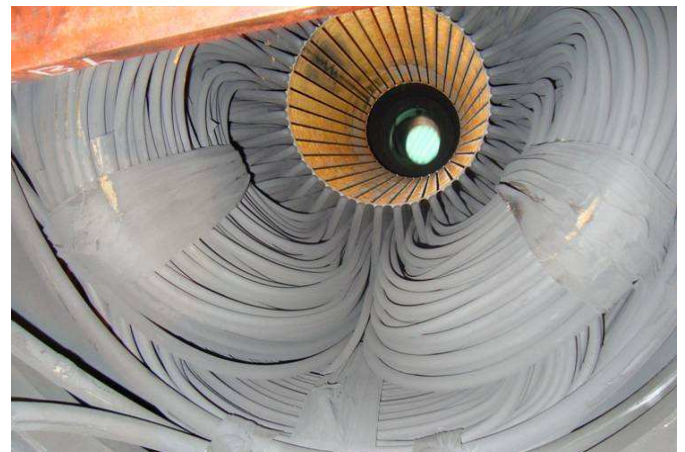
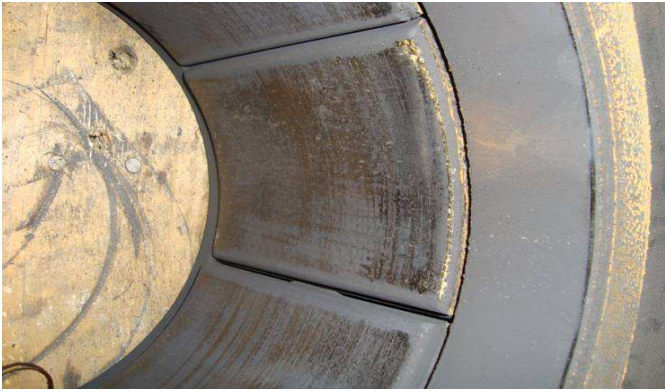
Photographs 15 to 18 below indicate differences in OEM and Non-OEM supplied components.

Photographs 15 and 16: OEM supplied BWCP components

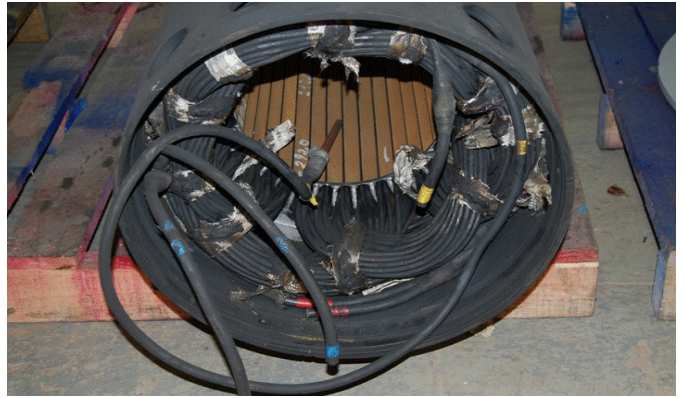
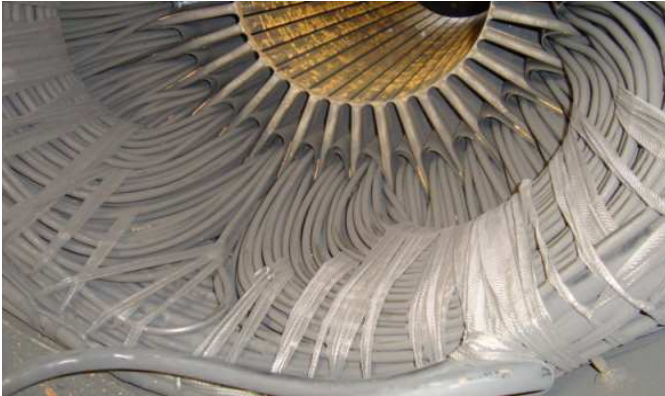
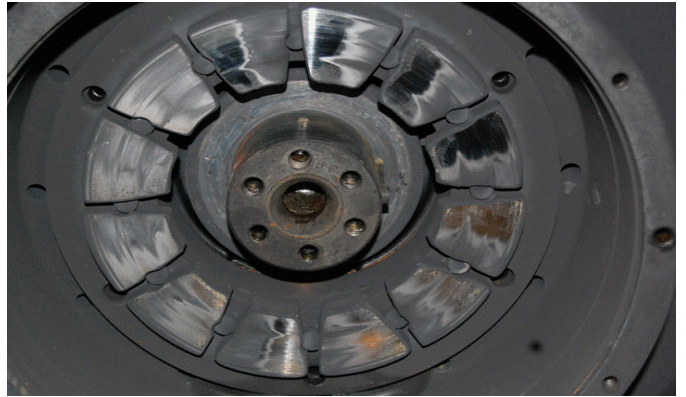
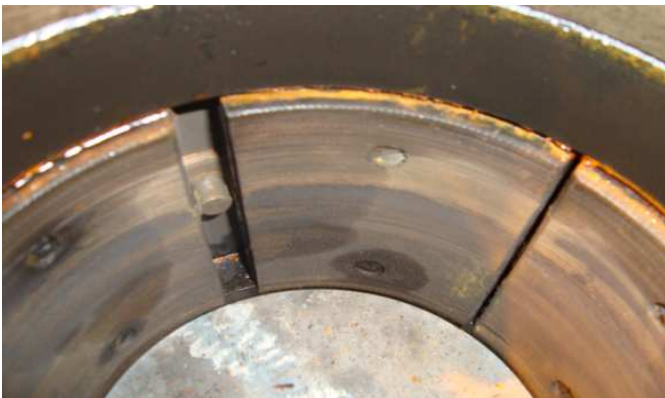
- Plant aging – wet wound motor wire down to ground
- Inferior bearing material for the product lubricated bearing application
- Loss of cooling water – wire overheating – loss of insulation
- High number of frequent starts
- Poor water quality and debris in BWCP circulation loop
- Incorrect shaft material for the application
- Impeller and thrust collar bolt shearing due to not using high tensile steel and high temperature materials for the application.
- Using inferior winding material – not sufficiently insulated and correct thickness for the specific BWC and application.
- Poor operating practices

Photographs 17 and 18: Non-OEM supplied BWCP components
