TURBOMACHINERY
& PUMP SYMPOSIA

Poor Hydraulic Performance from Large Barrel Pumps

Johnny Pellin

Flint Hills Resources, Pine Bend, MN Refinery

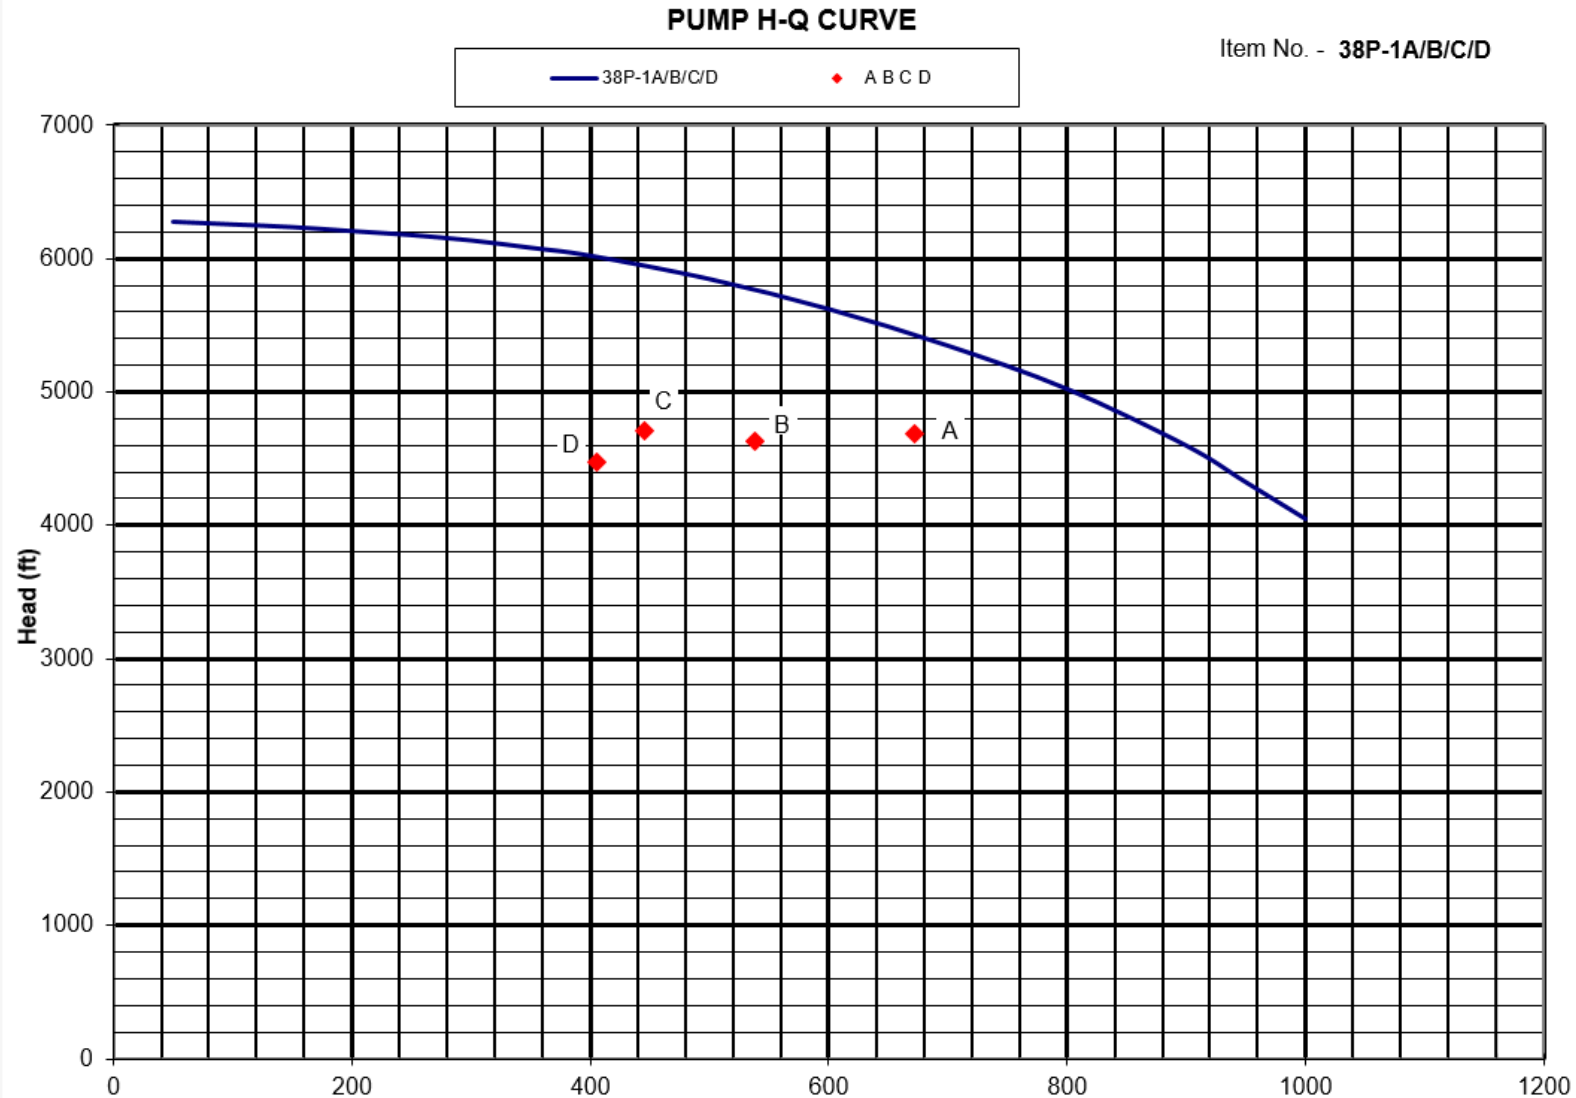
- No individual flow measurement for each pump prior to 2010
- After flow transmitters were added:
 - A pump at ~90 percent of curve after 22 years
 - B pump at ~85 percent of curve after 15 years
 - C pump at ~75 percent of curve after 2 years
 - D pump at ~80 percent of curve after 4 years

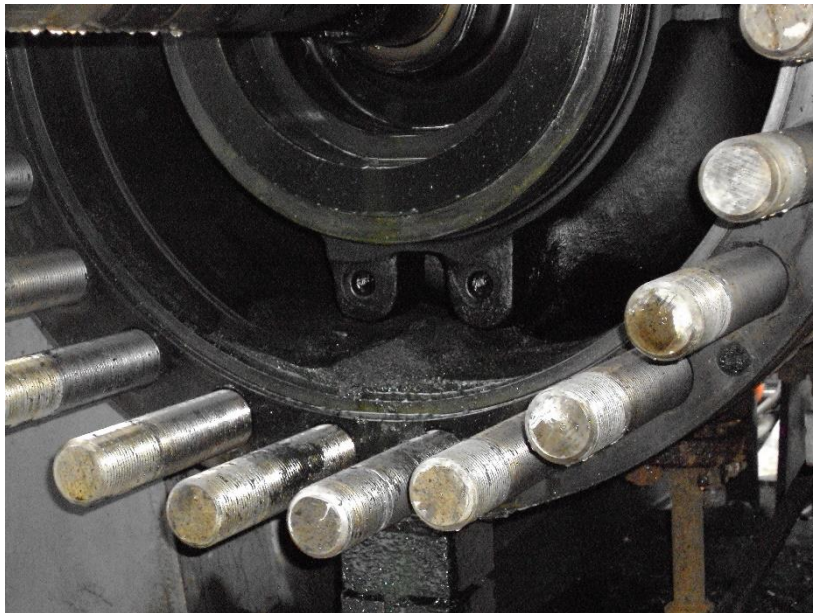
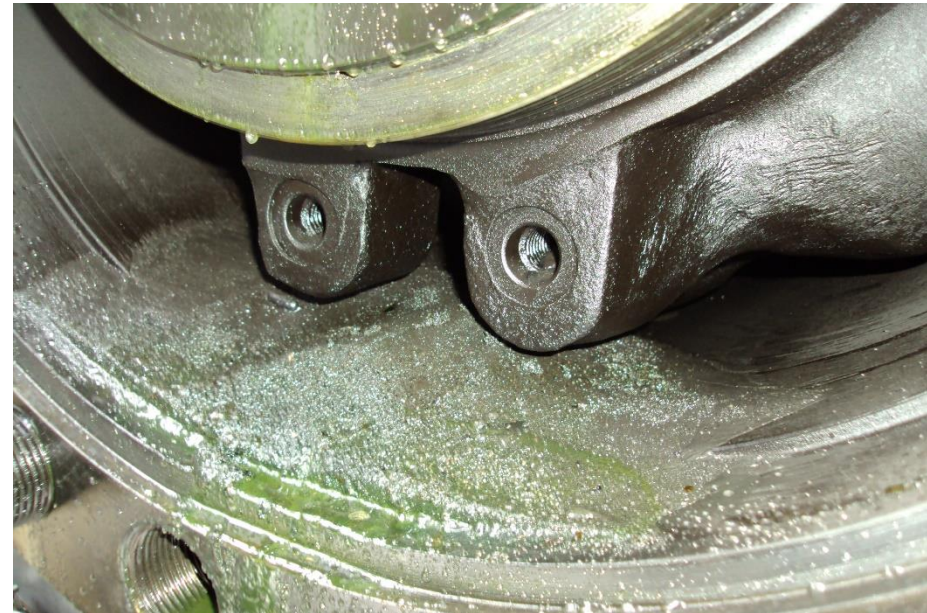
The location and appearance of the damage is indicative of abrasive wear from passing hard solid particles. Pictures and notes from past overhauls confirmed the presence of abrasive solids.

Because of the flow path, solids tend to be directed into the back hub rings and away from the eye rings.

- Harder materials on the affected wear rings and bushings
- The back wear rings, bushings and sleeves were upgraded to 420 and 440A stainless steel with Direct Laser Deposition surfacing. Hardness increased to 44 to 50 Rc
- Upstream changes to reduce the concentration of abrasives in the process stream

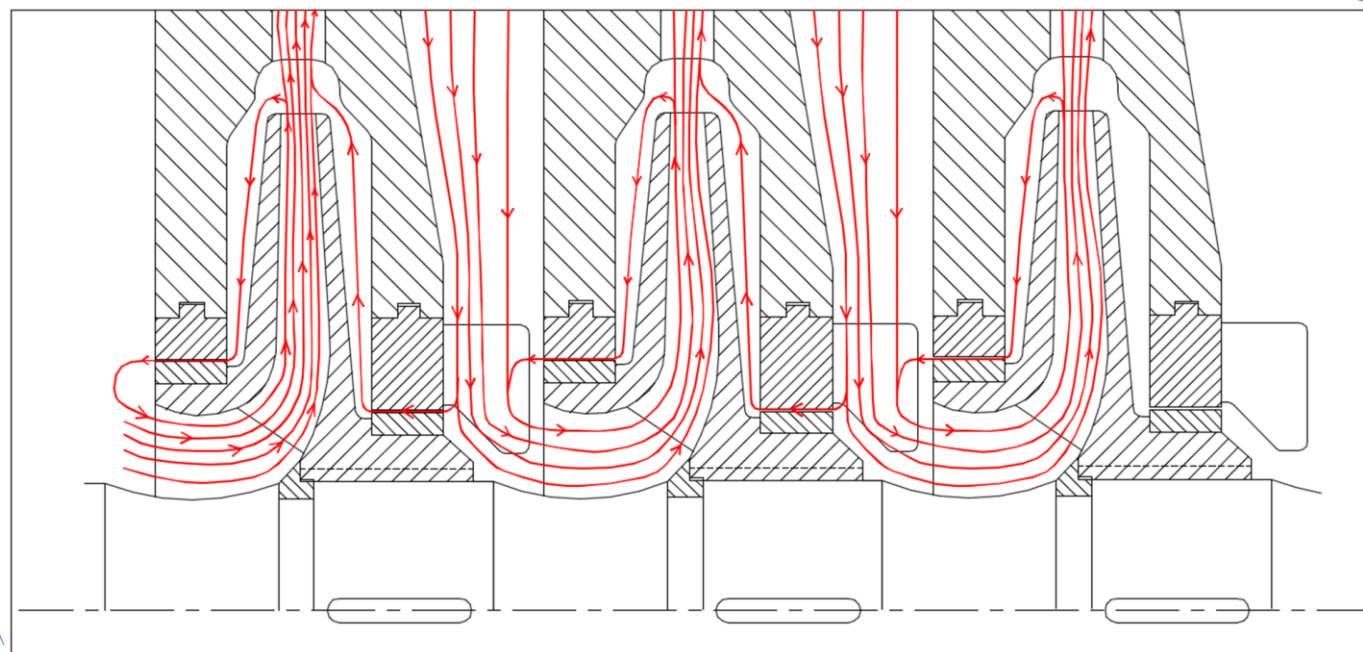
Flow entering the eye rings has been drawn inward against centrifugal force which tends to remove heavy solids.

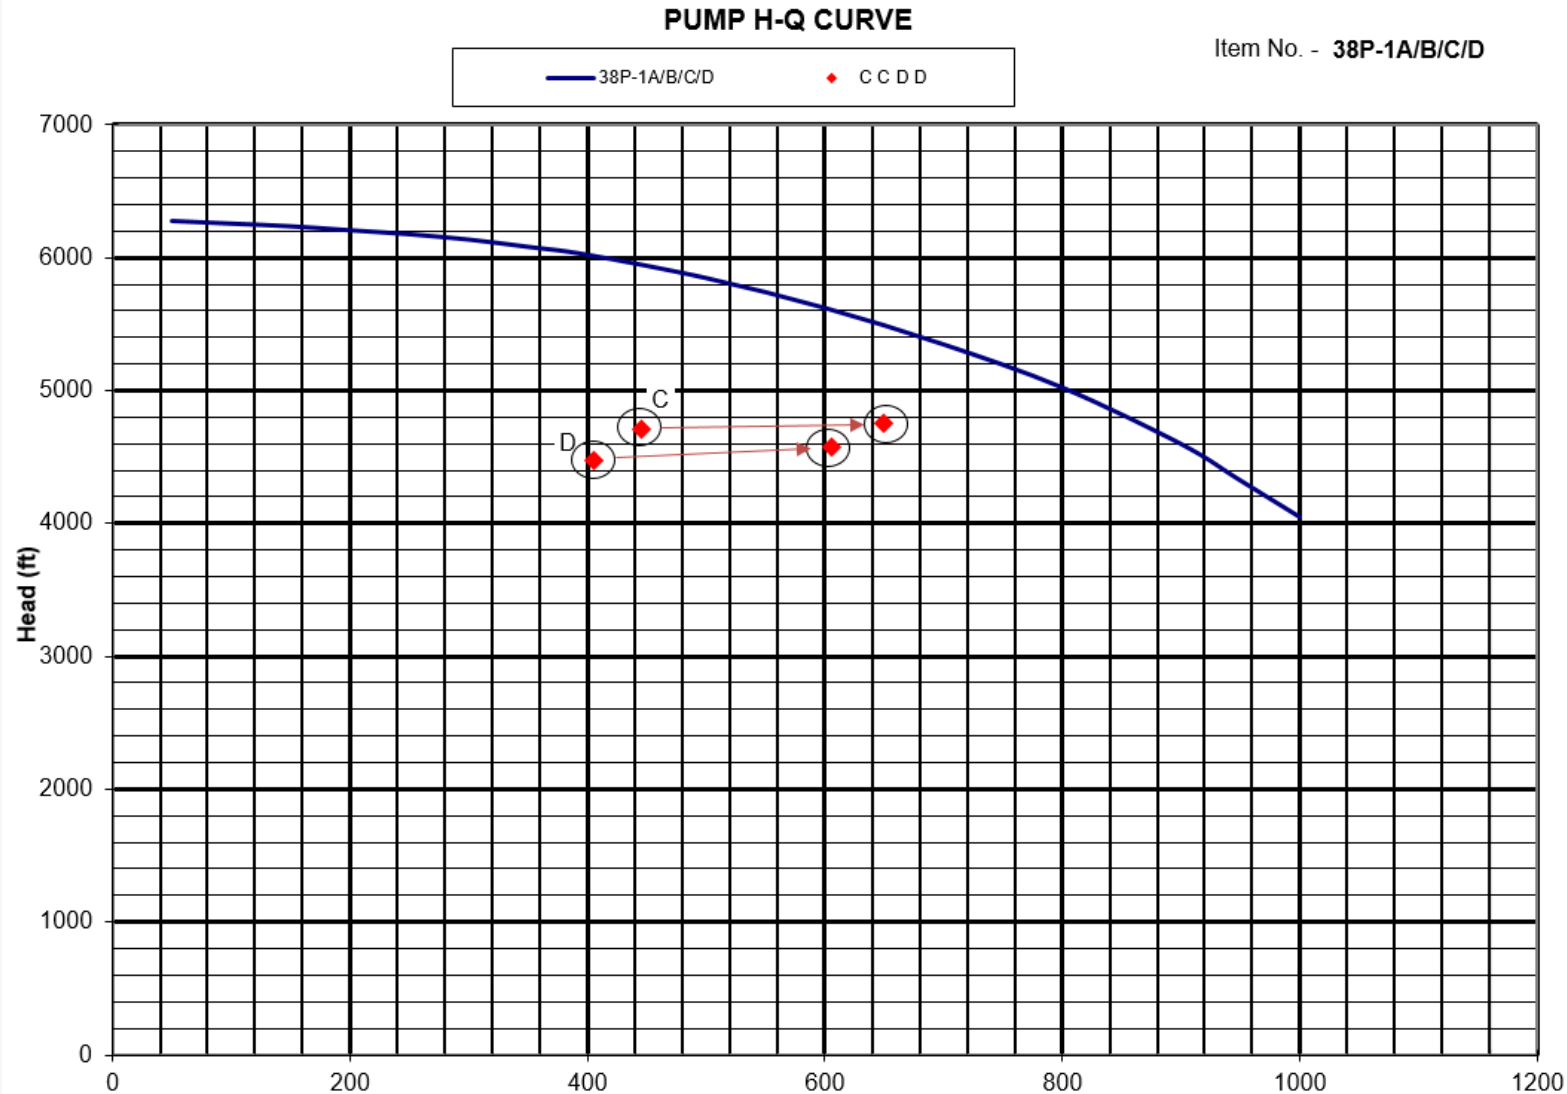
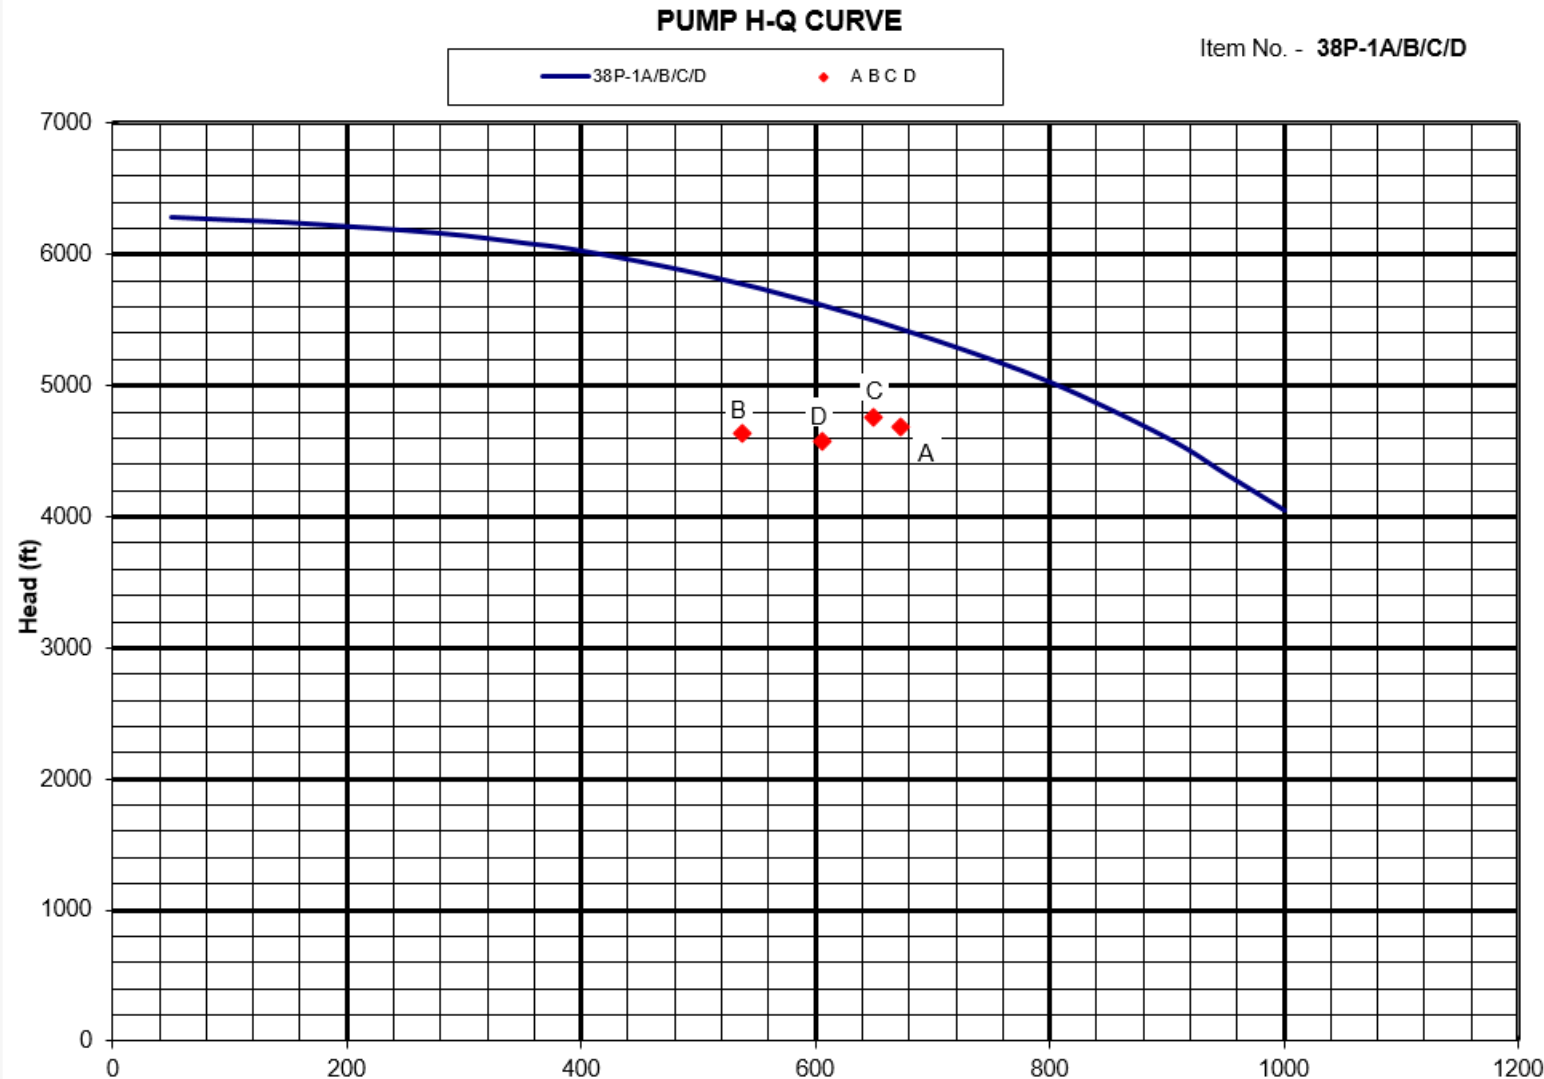
The drain lines on the D pump were modified to eliminate the bypass. The flow from that pump increased by about 7000 bbl/day. Performance improved from 76% of curve to 86% of curve. Operators were able to drop back to running three pumps out of four and increase the capacity of the unit by about 2000 bbl/day.

Because of leaking block valves, we have not been able to complete the modifications to the C pump. This is planned for the unit turnaround currently in process. The following plots are based on the expectation that we will see the same improvement with C pump as we did with D pump.

Full performance was not restored because the pumps had been running for years with abrasive solids present. It is believed that the case drain error was also accelerating the abrasive damage by directing the solids back to the suction, over and over again.

Replace the case drain piping. Run two independent lines with separate drain valves.
