Compiled by Ir. Tan Yoke Lee Reference: Failure analysis of machine shafts @ Efficient Plant Magazine

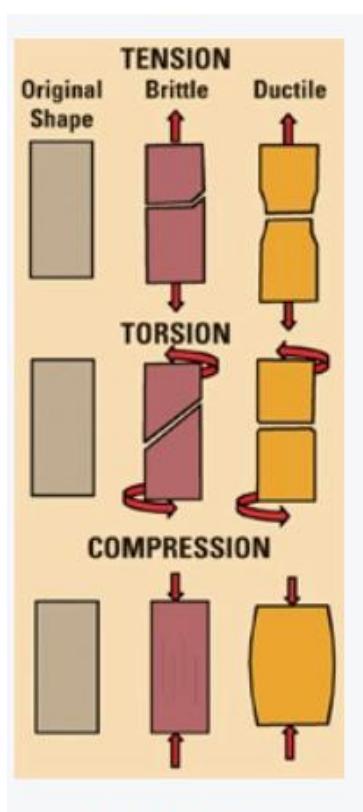
Fig. 1 The appearance of an overload failure depends on whether the shaft material is brittle or ductile.

Overload failures are caused by forces that exceed the yield strength or the tensile strength of a material. As depicted in Fig. 1, the appearance of an overload failure depends on whether the shaft material is brittle or ductile. No shaft materials are absolutely brittle or absolutely ductile.

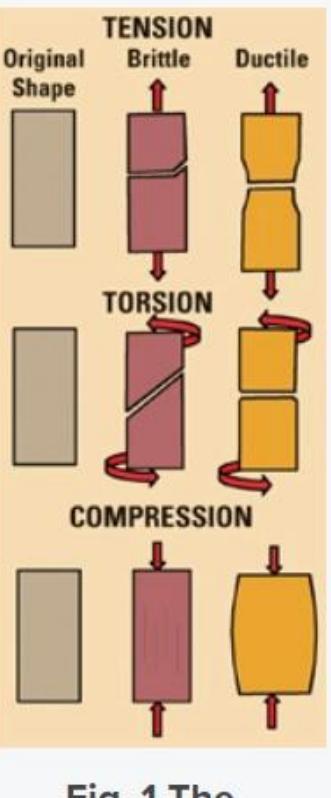
Fig. 1 The appearance of an overload failure depends on whether the shaft material is brittle or ductile.

Ductile failure normally shows plastic deformation before failure while brittle failure can be quite abrupt without signs of materials deformation.

Ductile failure exhibits dull and fibrous surface with some signs of necking.

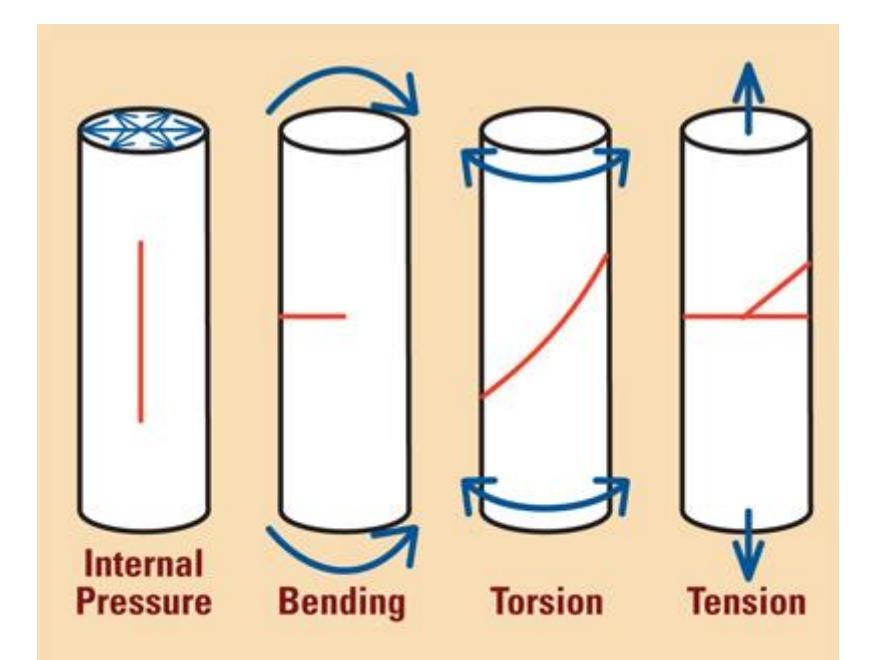
Once they are visible to the naked eye, cracks always grow perpendicular to the plane of maximum stress. Figure 2 shows the fracture planes caused by four common fatigue forces.

Fig. 2. Fracture planes caused by four common fatigue forces: Because the section properties will change as the crack grows, it's important to look carefully at the point where the failure starts to determine the direction of the forces.

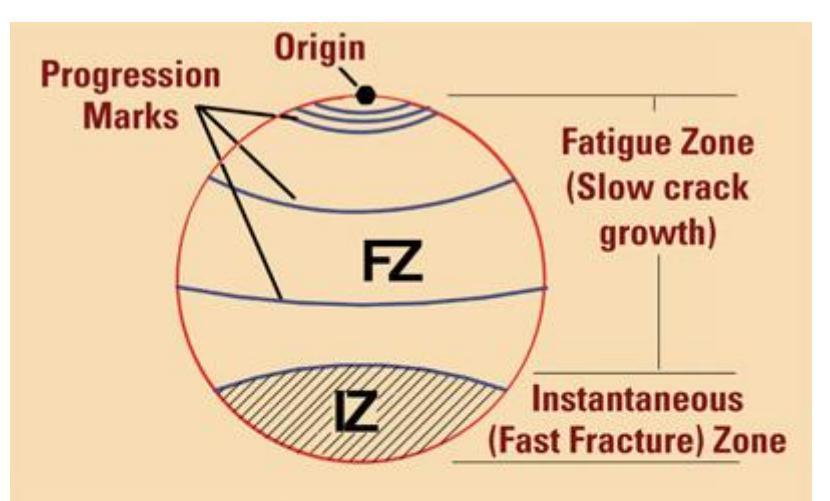
A typical plain **bending fatigue** failure is depicted in Fig. 3. The crack started at the origin and slowly grew across the Fatigue Zone (FZ).

When it reached the boundary of the Instantaneous Zone (IZ) the crack growth rate increased tremendously and the crack traveled across the IZ at approximately 8000 ft/sec.

During the period of growth across the FZ, there may be changes in the loading on the shaft, which result in changes in the surface that appear as progression marks.

A valuable feature of fatigue-failure interpretation is that the crack growth, i.e., the surface appearance, tells how the load was applied. If the crack grows straight across the shaft (as shown in Fig. 3), the force that caused the failure must have been a bending load operating in a single plane.

Fig. 3. This typical plane bending fatigue failure shows how a crack starts at the origin and slowly grows across the Fatigue Zone. When the crack reaches the boundary of the Instantaneous Zone, its growth rate increases significantly.

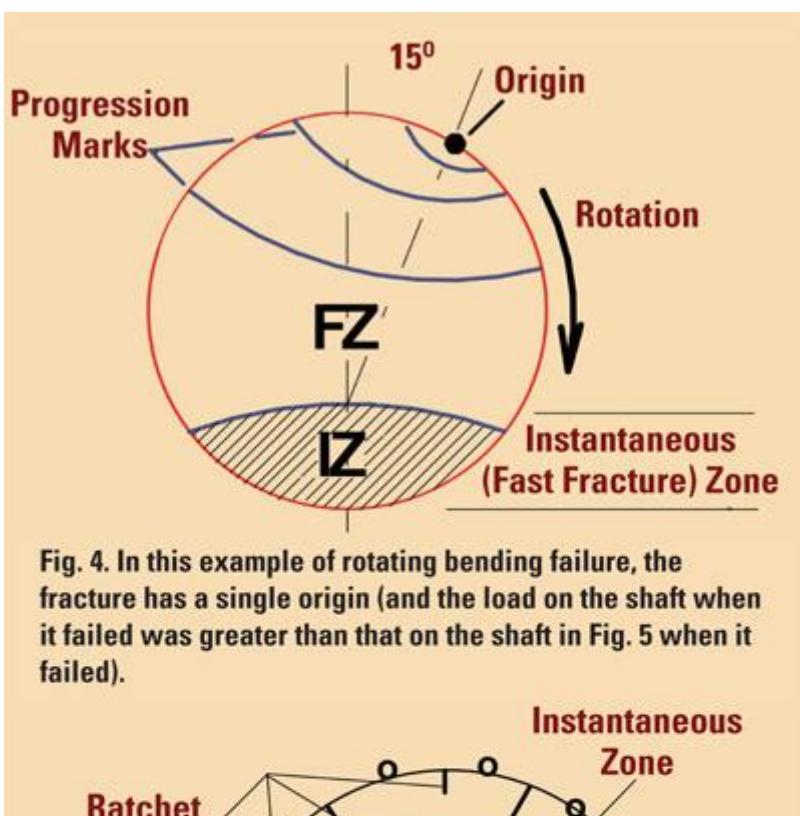
Figures 4 and 5, however, show examples of **rotating bending.** The difference between these two failures is that the shaft in Fig. 4 has a single origin, while the fracture in Fig. 5 has multiple origins.

Looking at the two sketches, we see the IZ of Fig. 4 is the larger of the two—*which indicates that the load on the shaft when it failed was greater than that on Fig. 5.*

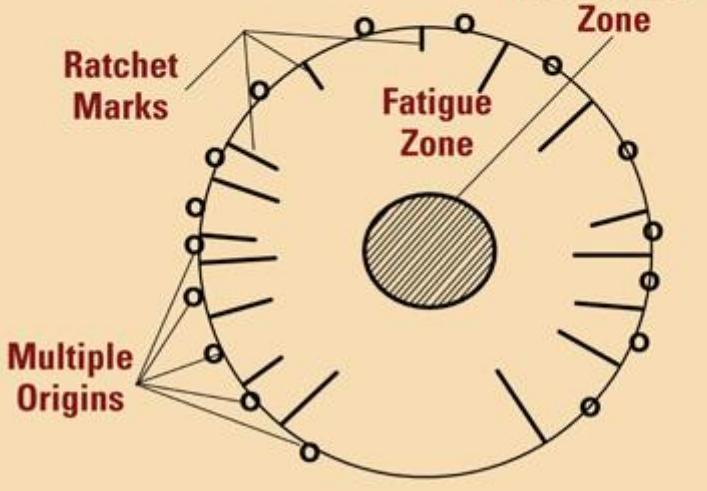
The analysis also shows that, even though Fig. 5 was less heavily loaded, it had many more fracture origins, an indication of a high stress concentration, such as a shaft step with a very small radius. The ratchet marks are the planes between adjacent crack origins and grow perpendicular to the crack propagation.

Fig. 5. Analysis of this rotating-bending failure (with its multiple fracture origins) showed that the shaft was less heavily loaded than that in Fig. 4 when it failed.

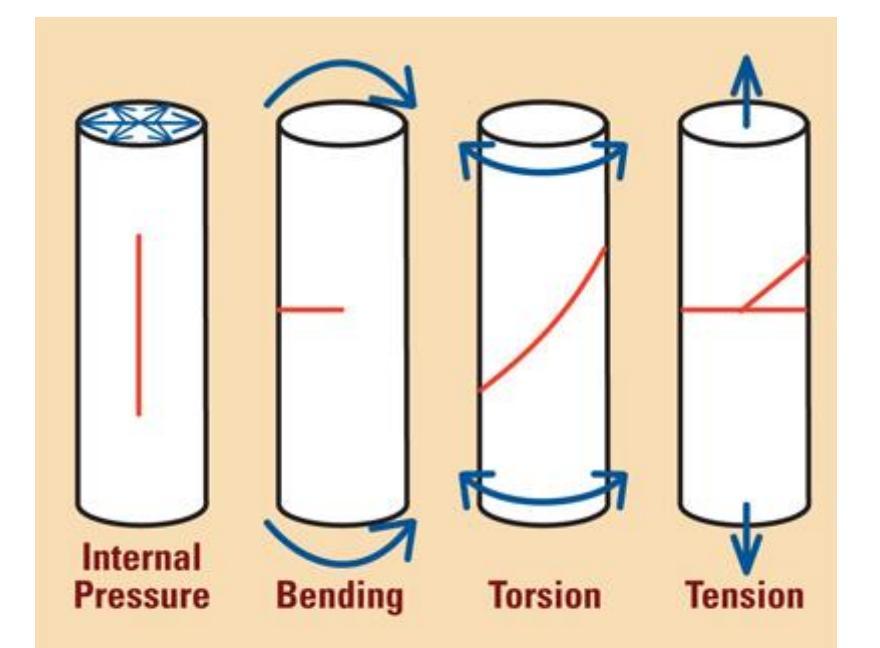
That, unfortunately, has led to many motor and drivenshaft failures due to torsional-fatigue factors. While the most common torsional fatigue cracks start at the sharp corner (stress concentration) at the bottom of the keyway when couplings are poorly fitted, another common appearance is the diagonal shaft crack (like that shown in Fig. 2).

Fig. 2. Fracture planes caused by four common fatigue forces: Because the section properties will change as the crack grows, it's important to look carefully at the point where the failure starts to determine the direction of the forces.
