Storage tank - maintenance:

API 653: Tank lifting as an option to repair

Prepared by: DSc Dževad Hadžihafizović (DEng)

API 653: TANK INSPECTION CODE:

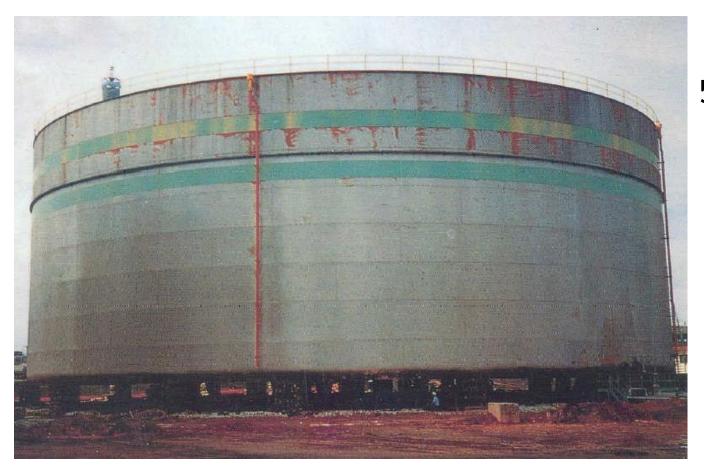
53 X 19M **SRC Singapore**

This tank had leaked twice at SRC Singapore and the floor was to be replaced. After lifting it was found that the MFL Scan was in error and there was only two holes in the floor due to stones the rest of the floor had the heat numbers still visible in perfect condition!

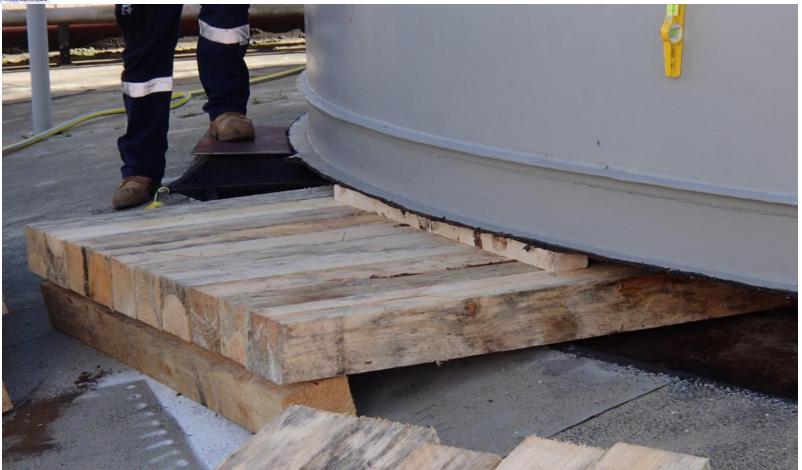
Tank 21 at ALMC had suffered planar tilt outside the limits stated in API 653 Appendix B. The tank was built in 1938 and had leaked through external floor corrosion.

As the tank rises pushed up by the airbags the height gain is consolidated by inserting timber gluts under the tank. The number anf support and lifting positions is dictated by a computer program which ensures the stability of the tank and that the compressive loads do not exceed the bottom strake buckling (API 650) of the tank.

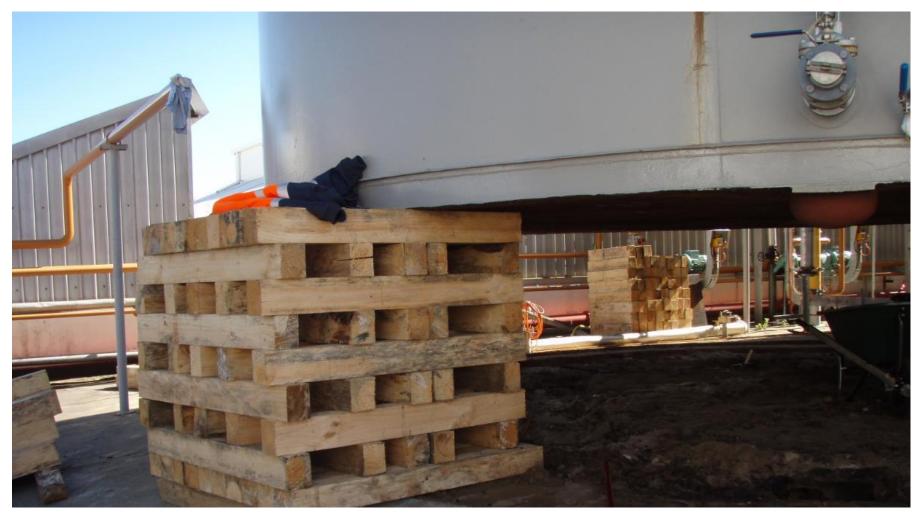
As the tank rises the airbags are placed on cribs of timber which then allows the tank to be lifted increasingly higher. The height gain is constantly consolidated by inserting further timber gluts on the support cribs. The tank always remains LEVEL +/- 6 inches side to side minimising any stresses imposed in the lifting.

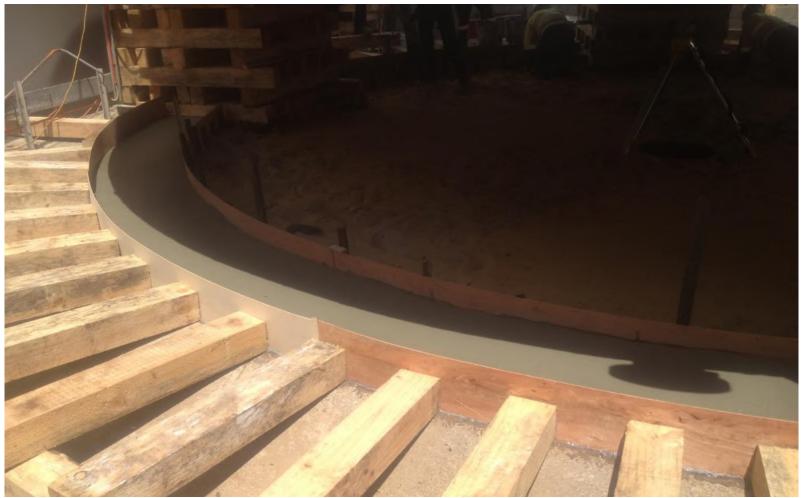
Upon attaining access height under the tank the lifting cribs are removed and the basecourse foundation cap is taken out. This particular tank dihedral of the floor was changed from Cone-Up to 1:120 Cone Down....hence further excavation was required. The concrete ring beam was not level which accounted for the tank differential settlement.

Formwork was laid out to pour the increase in height of the ringbeam and level the tank

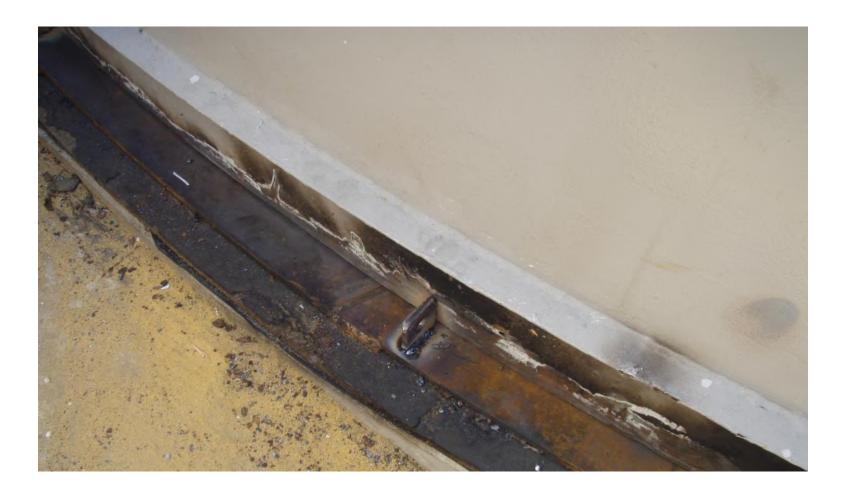
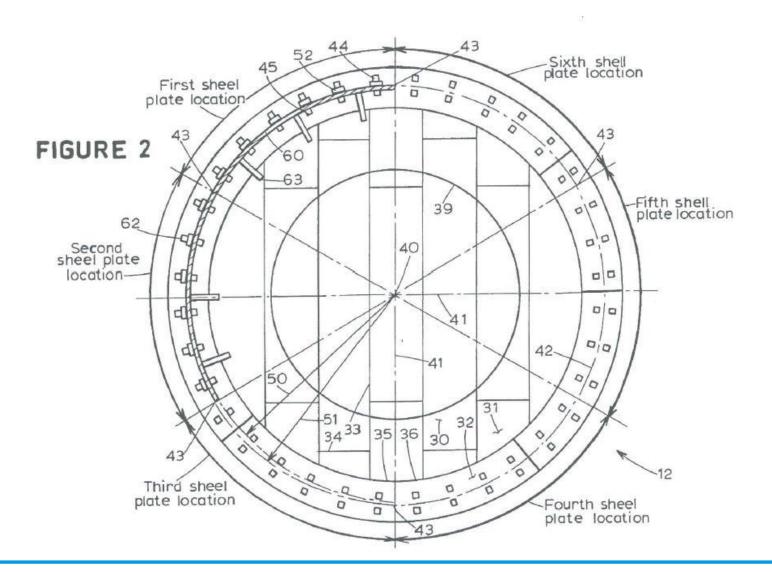
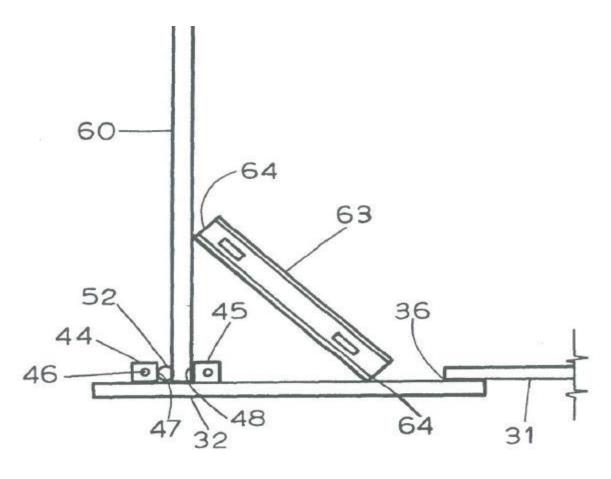
TANK LIFTING AS AN OPTION TO REPAIR

The setting of Blank Nuts (44 - 46) allow us to ensure that the tank wall is on the scribe line and can be adjusted by the insertion of the carrot pins (taper wedges - 52) ensuring the tank remains 'round'.

The tank will then be boxed up and hydrostatically tested and certificated to API 653
