Case Study on Failure of Gearbox of Cooling Tower Fan in Cement Mill

Mr. Rateesh Venugopalan
VIBSpECTRUM International LLC

Equipment Details:

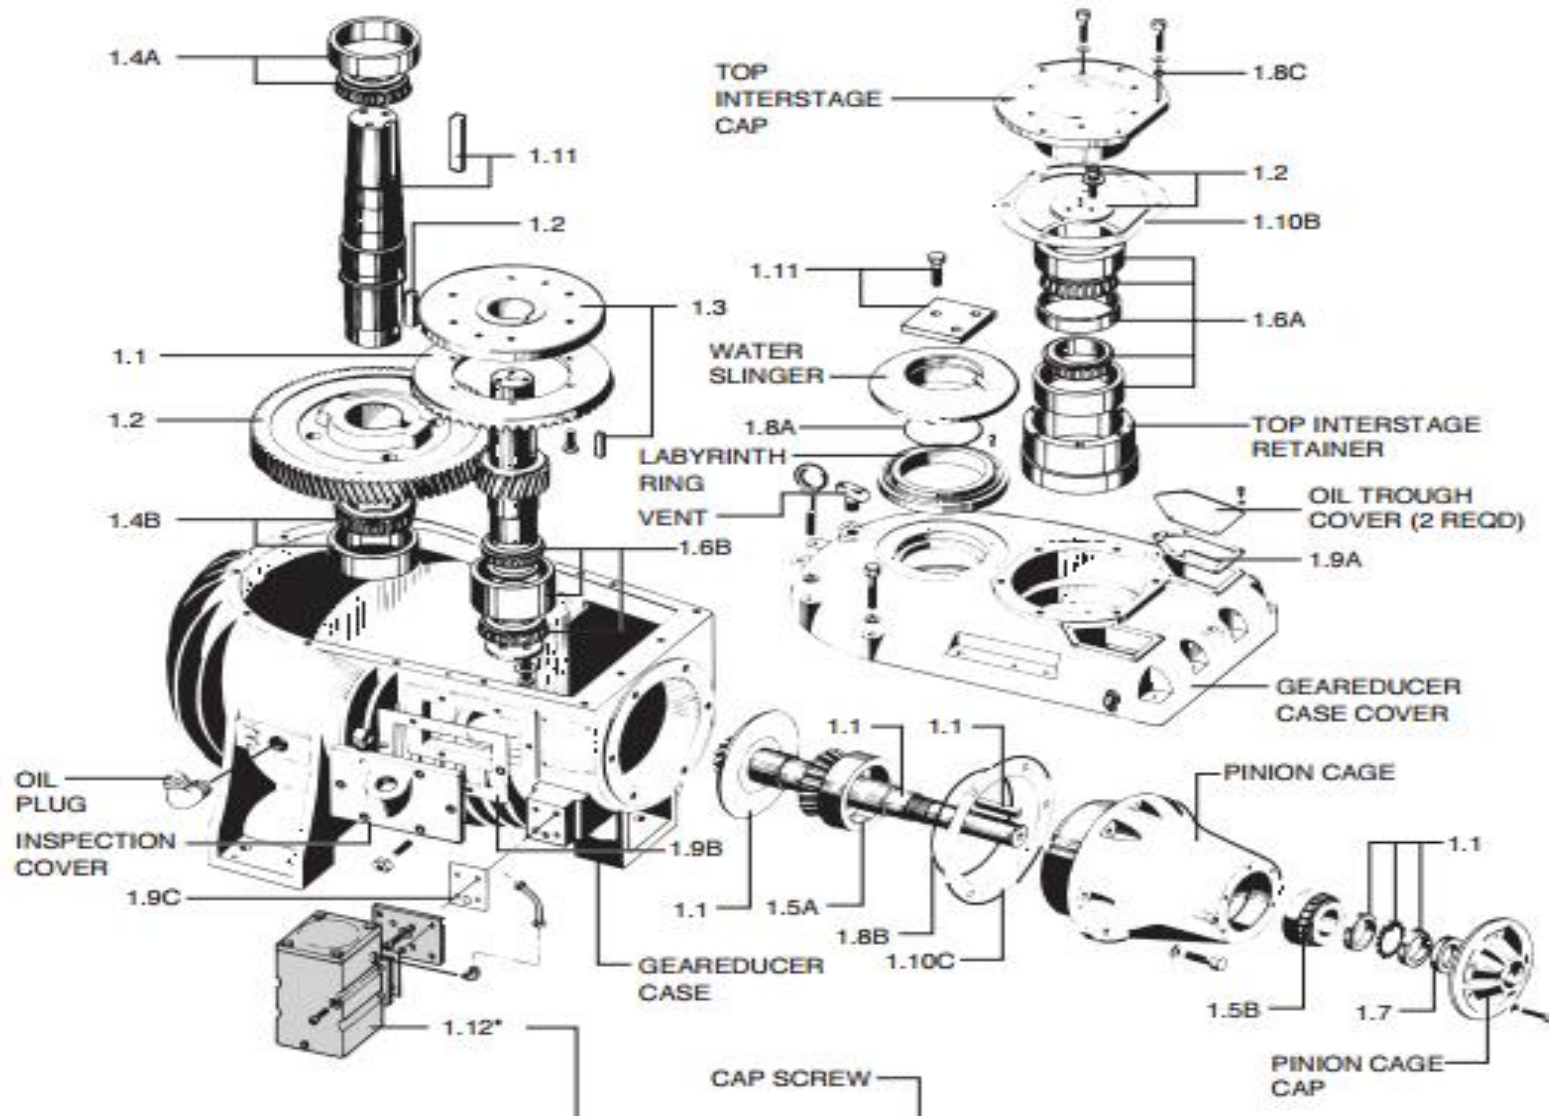
Paharpur Gearbox:

Input Speed, N1	-	1485 RPM
No. of Teeth on Input Pinion	-	21
No. of Teeth on Intermediate shaft Gear	-	58
Speed of Intermediate Shaft, N2	-	540 RPM
No. of teeth on Intermediate shaft Pinion	-	20
No. of Teeth on Output Shaft	-	94
Speed of Output Shaft, N3	-	115 RPM
Gearmesh Frequency for 1 st Gearset	-	31185 CPM
Gearmesh Frequency for 1 st Gearset	-	10800 CPM
