45TH TURBOMACHINERY & 32ND PUMP SYMPOSIA
HOUSTON, TEXAS | SEPTEMBER 12 – 15, 2016
GEORGE R. BROWN CONVENTION CENTER

Thermal Load Effect on Vibration on a Reactor Feed Water Pump (FWP)

Nine Mile Point Nuclear Station (NMPNS) Unit 2 – 1150 MW (Oswego, NY)

Application:	Reactor Feed Water Pump (FWP)
Type:	20x20x22 – 2 Stage (barrel type radial split)
Capacity:	8,000 gpm (min flow) to 22,870 gpm (max flow) Normal operation steady slightly above BEP
Suction Press.:	550 psig
Discharge Press.:	1,200 psig
Speed:	3,339 rpm (55.7 Hz)
Temperature:	382 °F
Normal Load:	10,500 to 11,500 BHP
Driver:	Induction Motor (16,500 HP @ 1785 rpm (29.8 Hz))
Gearbox:	Speed Increaser (Gear ratio 1:1.87)

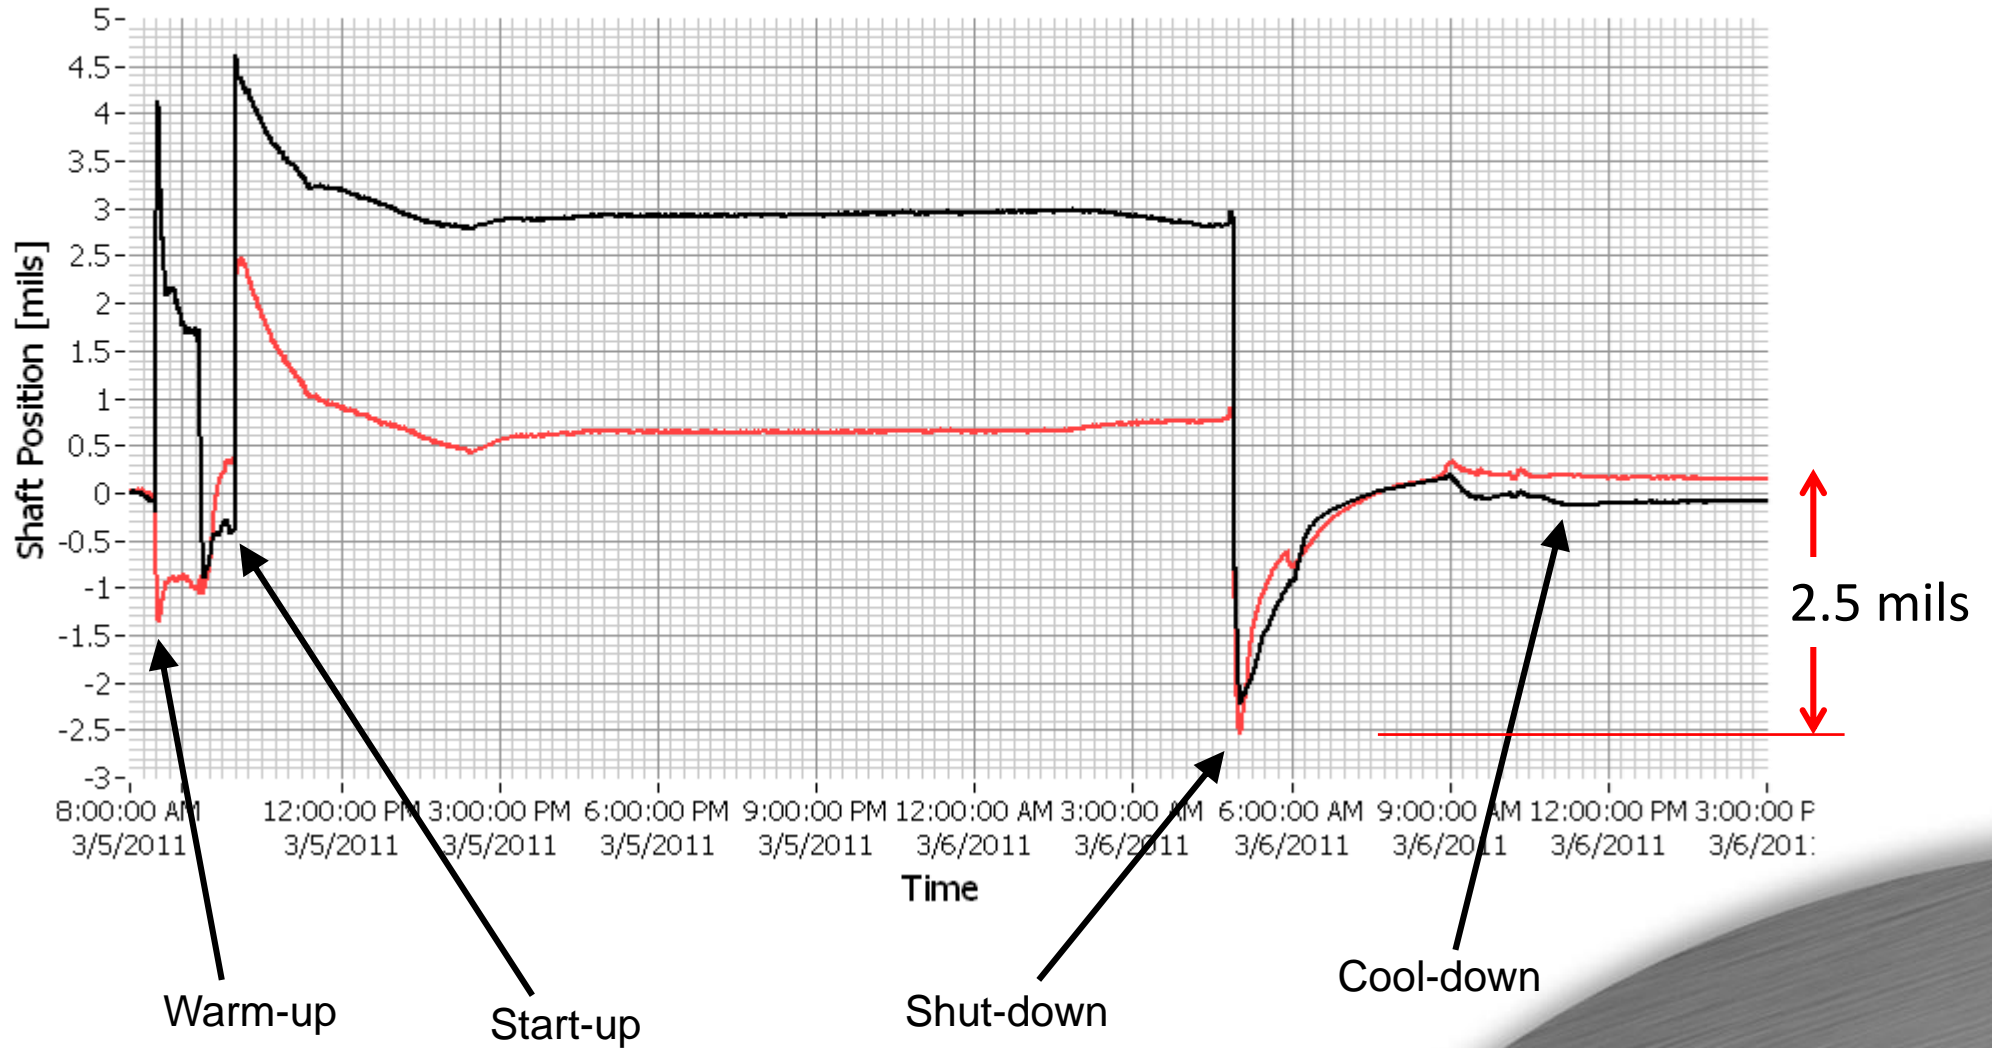
Pump IBB - Shaft Movement

1st stage flow path did not allow uniform thermal expansion of the pump casing at the IB end cover. Former seal injection design allowed accumulation of condensate seal water at the bottom of the pump casing with lower temperature than the reactor feed water. This was causing distortion of the inboard cover plate and therefore internal misalignment at the IBB.

- TIR on V-blocks and
- FEA thermal analysis of the casing
