47<sup>TH</sup> TURBOMACHINERY & 34<sup>TH</sup> PUMP SYMPOSIA  
HOUSTON, TEXAS | SEPTEMBER 17-20, 2018  
GEORGE R. BROWN CONVENTION CENTER

# *A Case Study of Vibration in Positive Displacement Pump Systems*

- *Reciprocating pump installation for salt water disposal*
- *Multiple reported piping failures*
- *Failure of pulsation dampener bladders*
- *Reported piping/skid vibration*

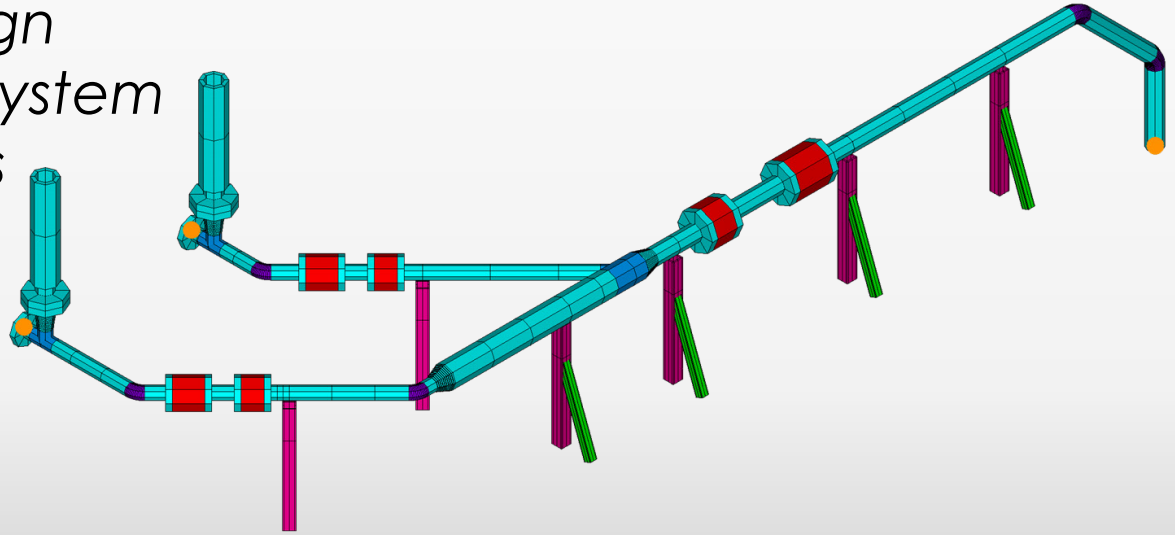
- *Finite Element model built to perform modal analysis of piping system*
- *Results used to design additional support system to place key modes beyond range of operating speed*

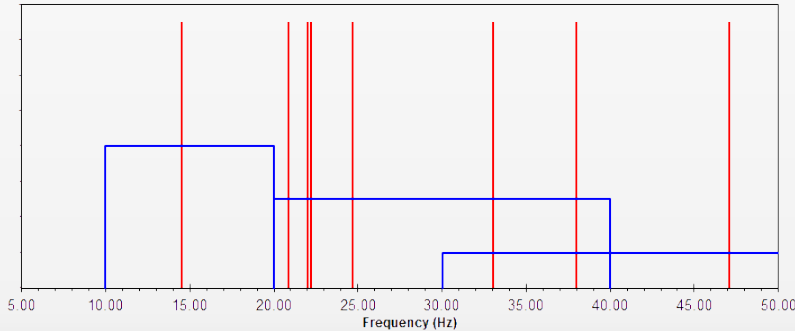
*Modal Interference Plot*

- Impact test data collected in the field
- Modal analysis evaluated with FE model

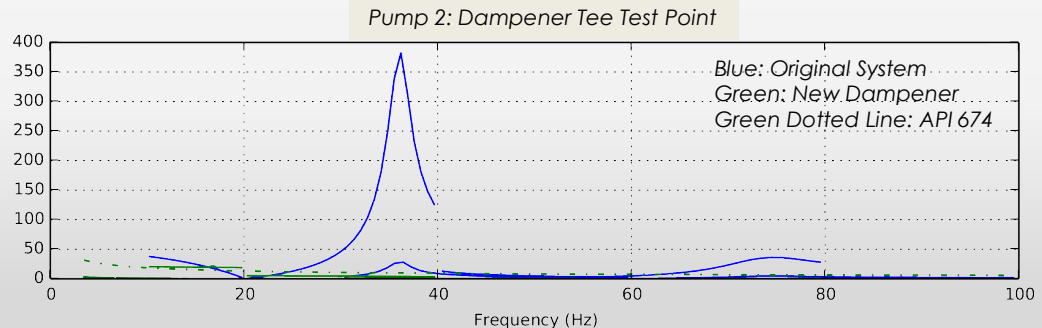
- Alternate dampeners in the field not rated for long-term operation at the higher end of discharge pressure
- Pulsation analysis performed to size new dampeners designed for this application
- Initial model results matched well with field data and the model with the new dampener showed sufficient attenuation of the pump excitations, similar to Field Test Case 7 results.

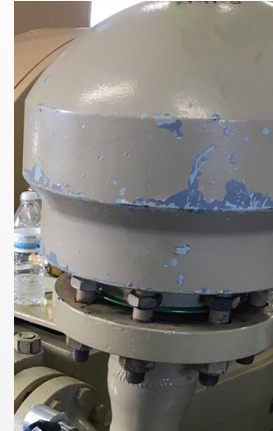
Tested

- Dampeners need to be charged to 70-90% line pressure
- Avoid tall and heavy dampeners that have low MNFs
- Use bladder material suited for the application

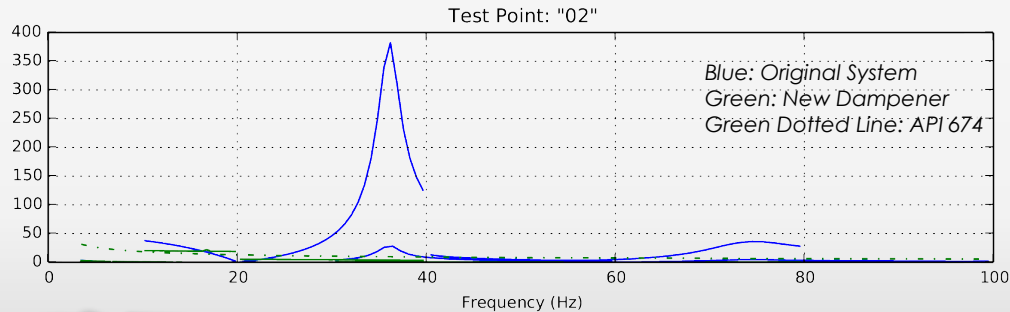
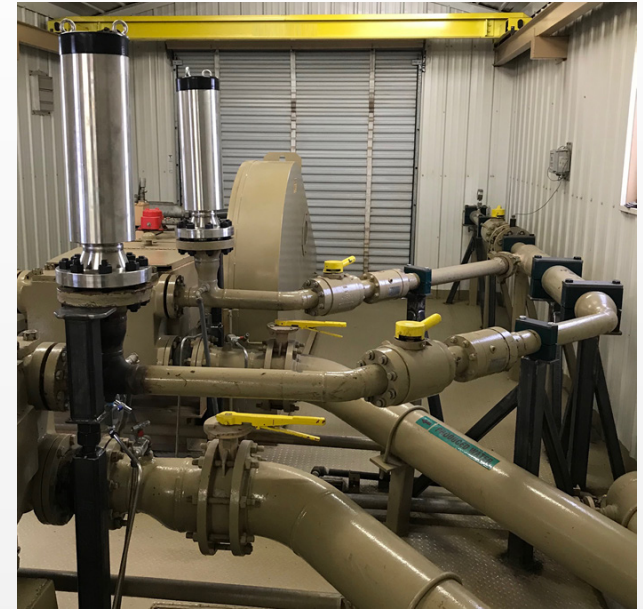
- System operating without failures or excessive piping/support vibration
- Pulsation dampeners performing without failure
