Think Out of the Box: Not All Sea Water Submerged Pump Failures Are Mechanical

by
Hussain Al-Baloshi & Isham Sudardjat
Reliability Section– Operations Engineering (Offshore)

2011

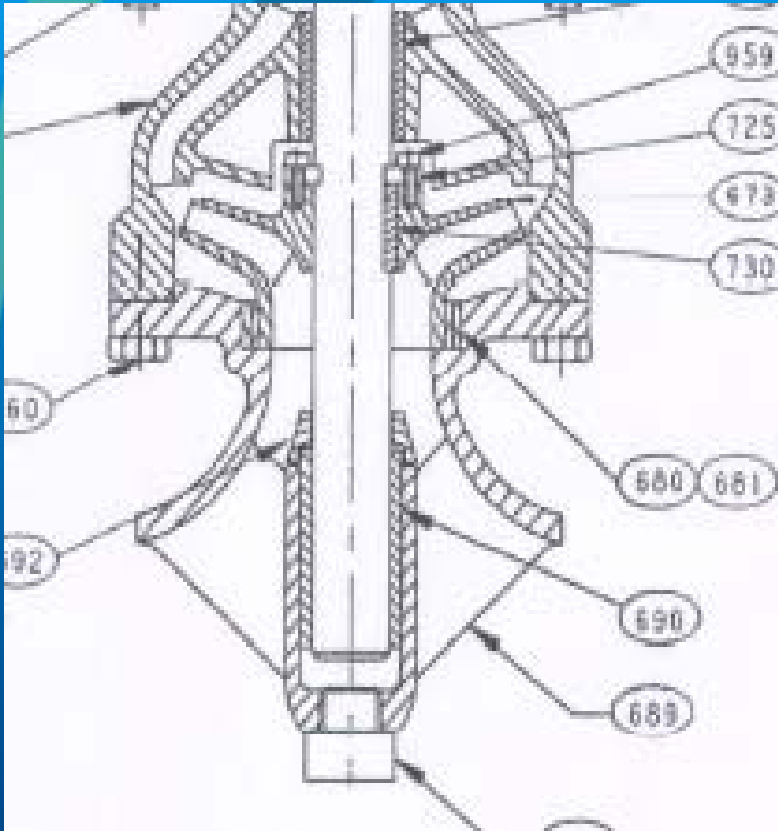
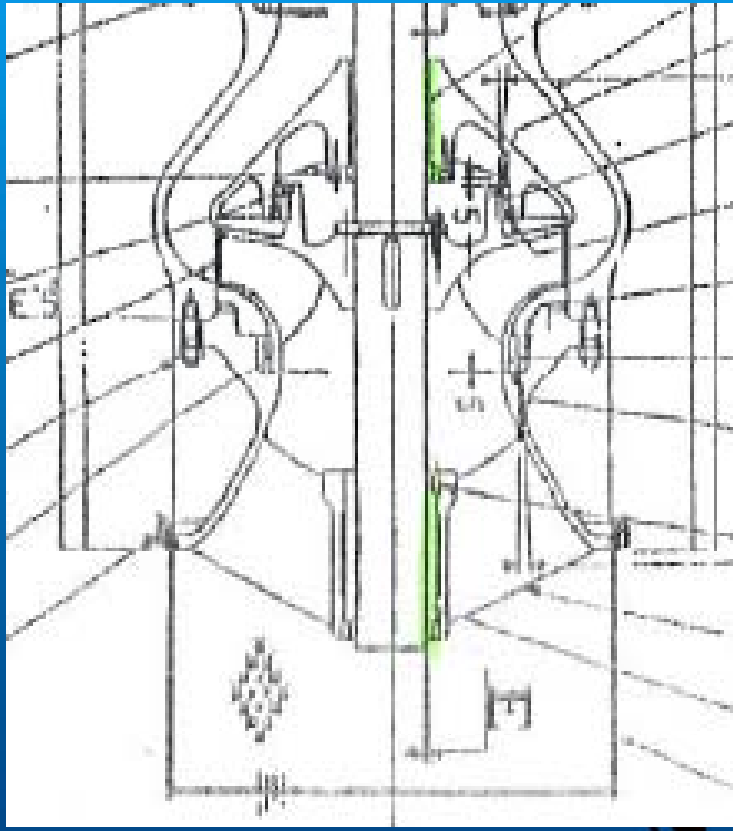
Suction Bearing Design

Pump	Tag No	Caisson Design	Suction Bearing Type
LQ Fire Water Pump	P-3207 / P-3306	5 m longer*	Bronze (no groove)
B Fire Water Pump	P-4206B / P-4306B	1.5 m longer	SST (no groove)
G Fire Water Pump	P-4206A/S & P-4306A/S	0.2 m longer	Bronze –Rubber with Groove (Cutlass)
Raw Water Pump	P-4213A/S & P-4313A/S	shorter	Bronze (no groove)
Old Raw Water Pump	P-4213A/S & P-4313A/S	shorter	Bronze –Rubber with Groove (Cutlass)
Sea Water Pump	P-4205A/B/S & P-4305A/B/S	shorter	Bronze –Rubber with Groove (Cutlass)

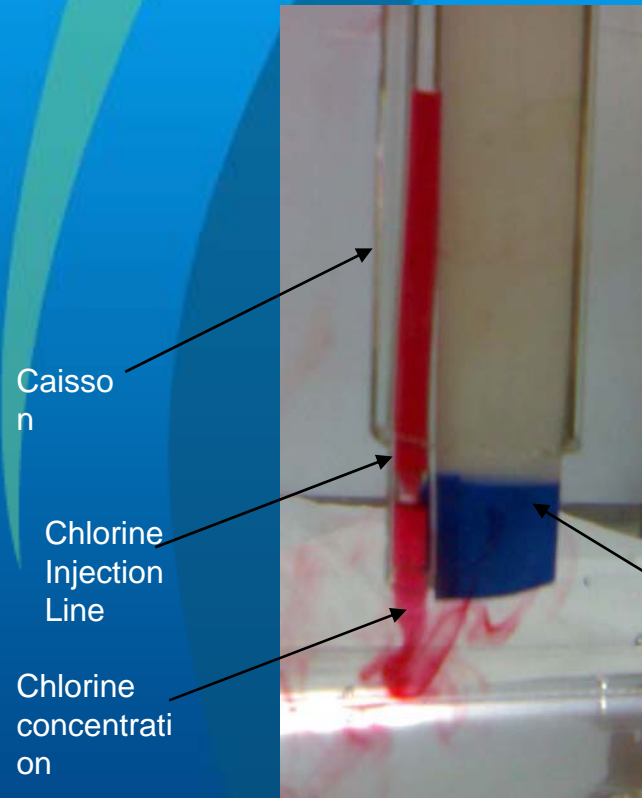
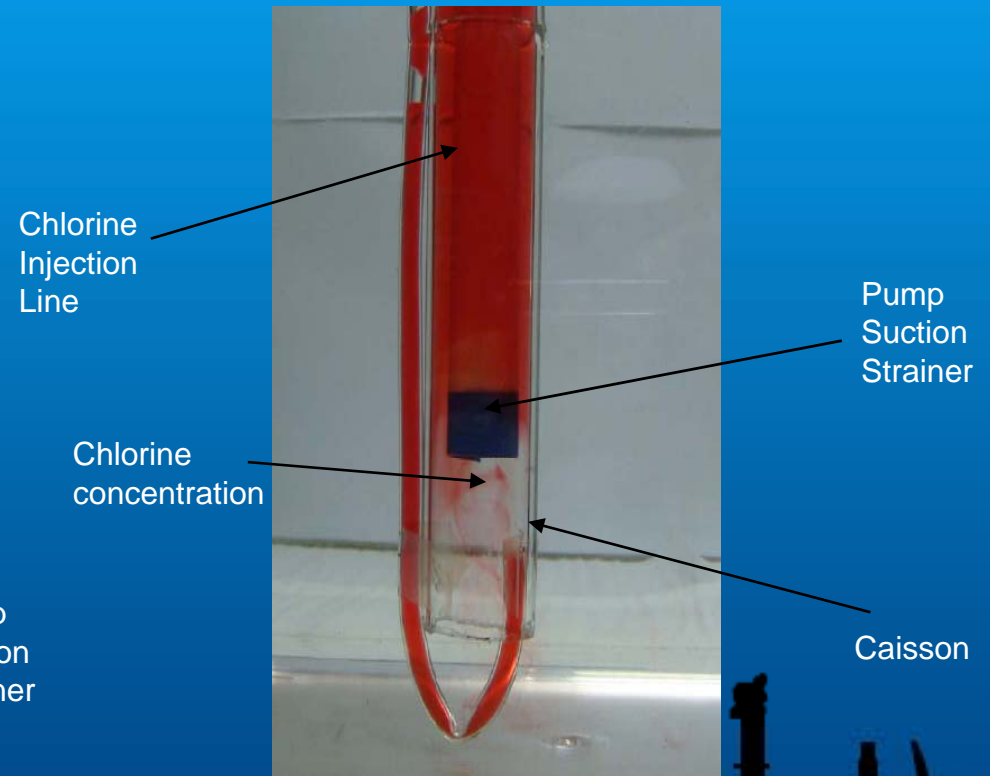
Experiment Findings

- ❖ The longer caisson design has the following advantages:
 - Retains chlorine concentration inside the caisson from being washed away by sea current
 - Prevents flying young mussels or barnacles brought by sea current to attach to the strainer body and grow inside it
 - Avoids direct chlorine injection to open sea
 - Protects the pump against force from sea bed
 - Allows our stations to meet MoE (formerly SCENR) requirement for residual chlorine content (0.1 mg / L)
 - Eliminates the need for diving inspection for cleaning the strainer
- ❖ The type of suction bearing has contribution to the pump reliability due to better abrasive resistance capability
